Case Studies:

Uppark, Sussex, England

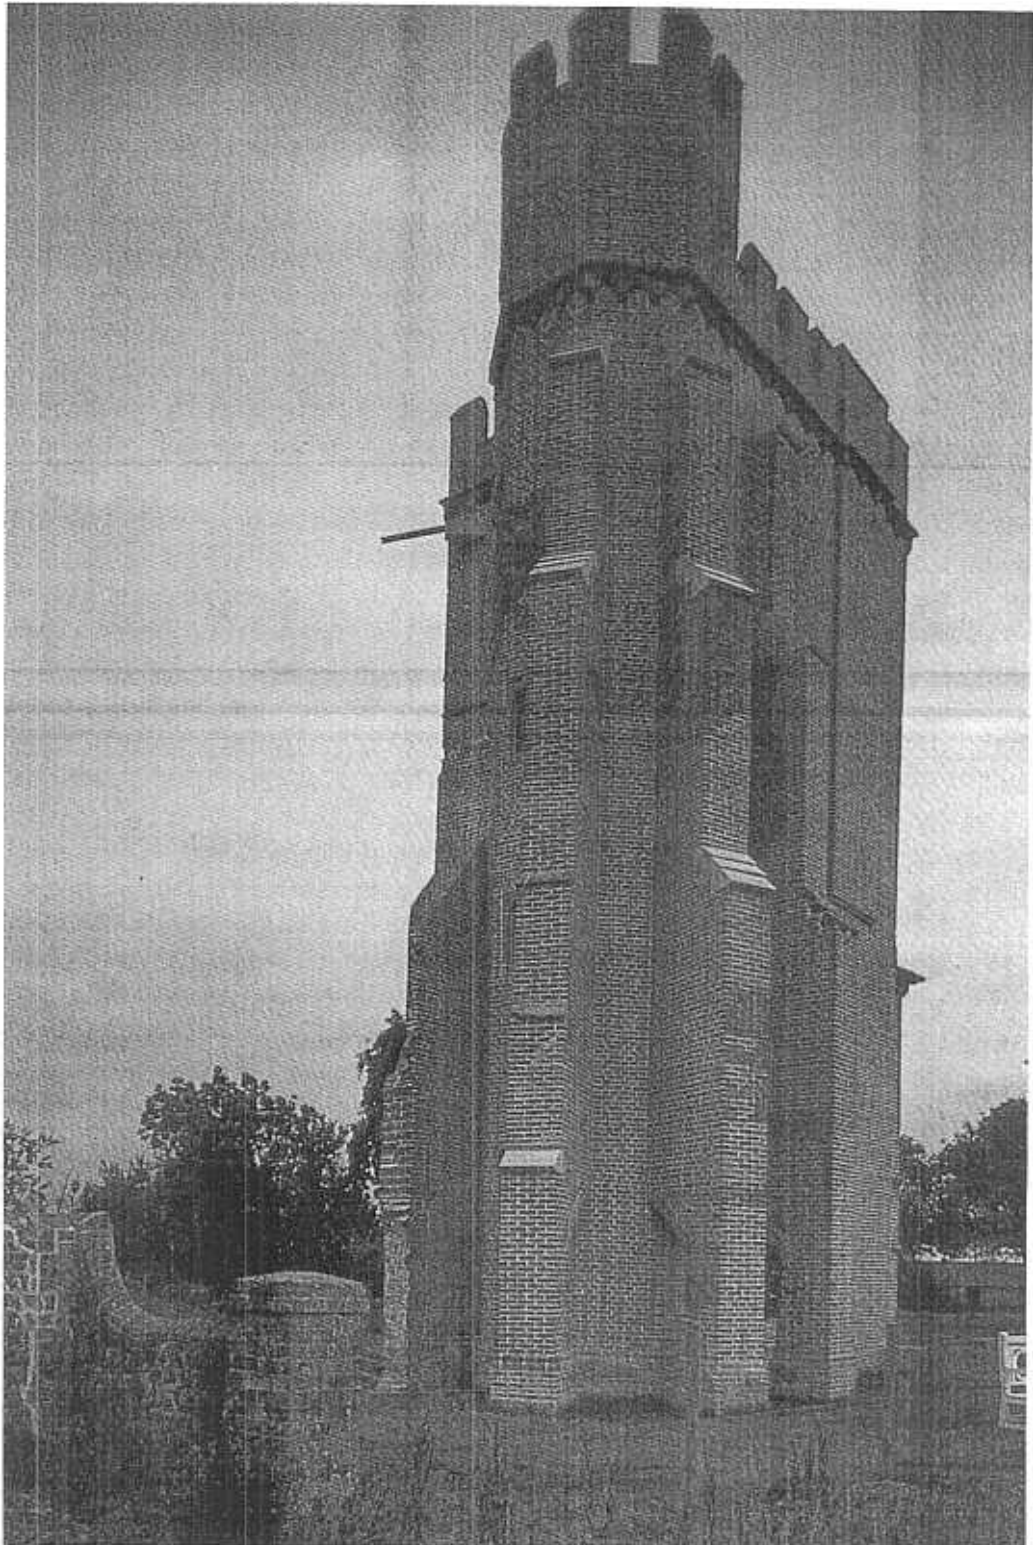
Laughton place: the tower after restoration. (Lewes, England).

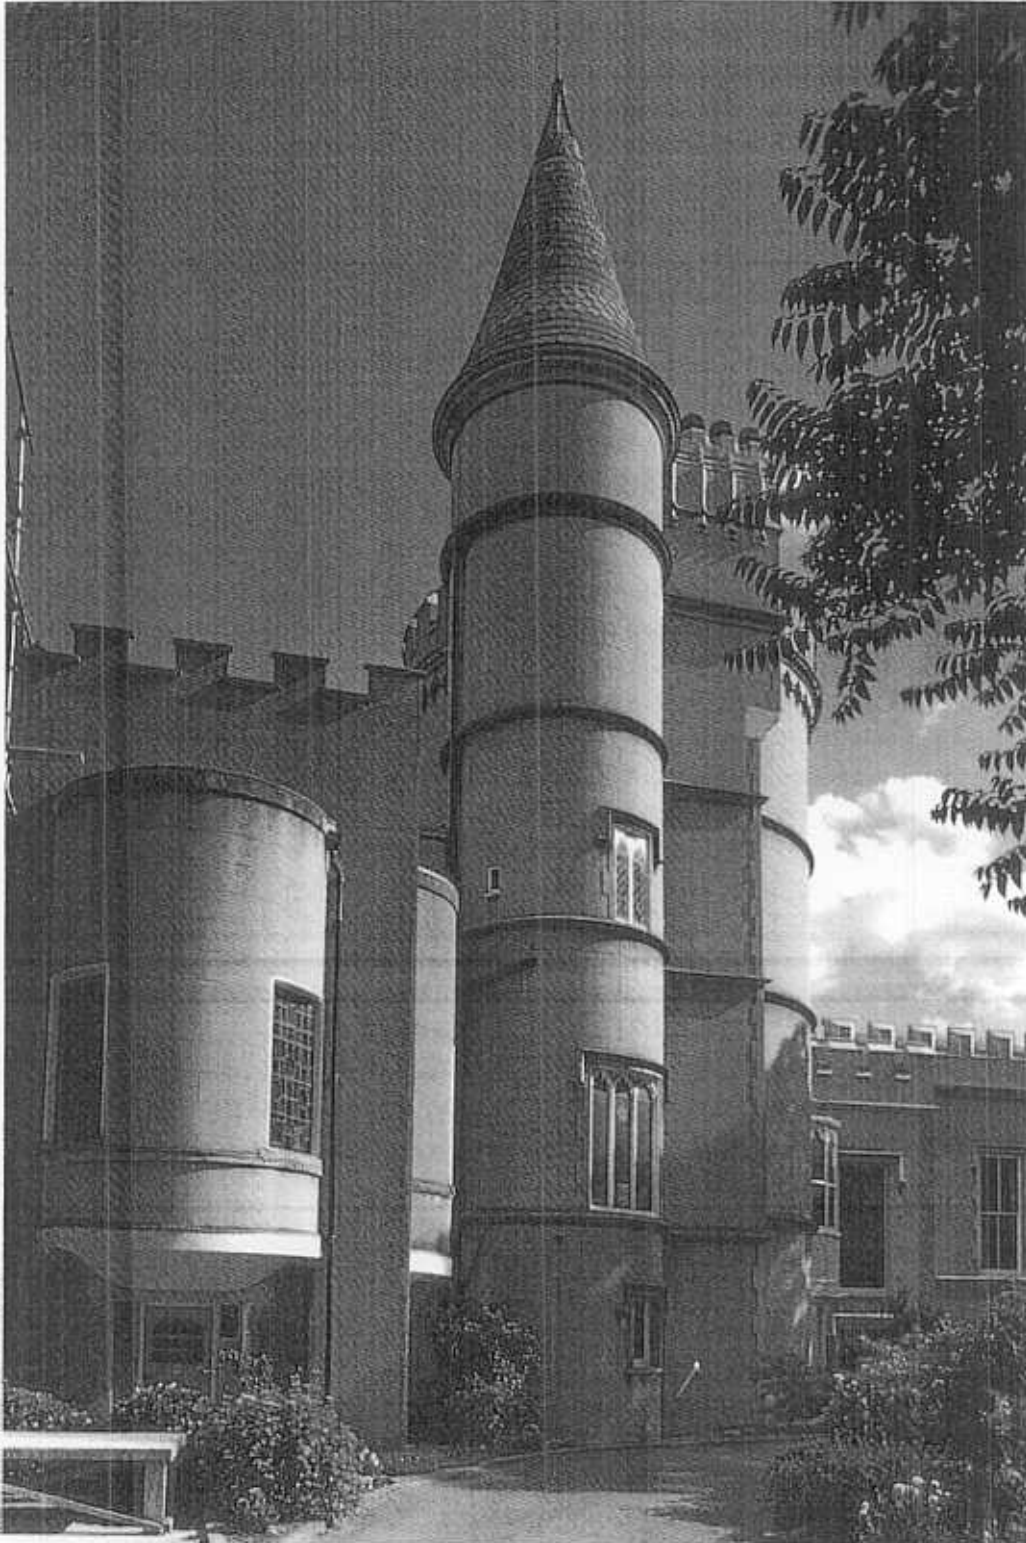
Strawberry Hill: Horace Walpole's mansion with Lady Waldegrave's additions. (London, England).

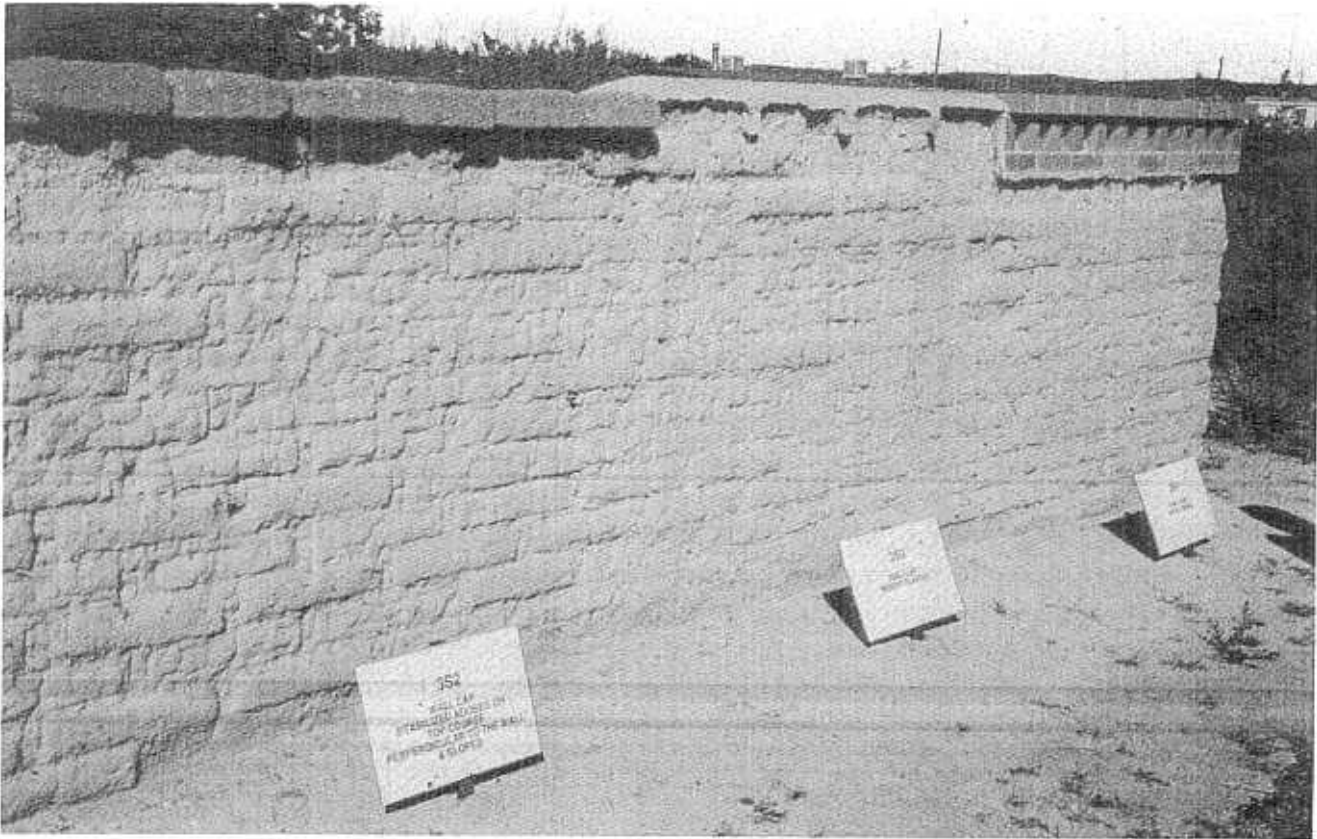
Fort Selden: test panels. (Las Cruces, U.S.A.).

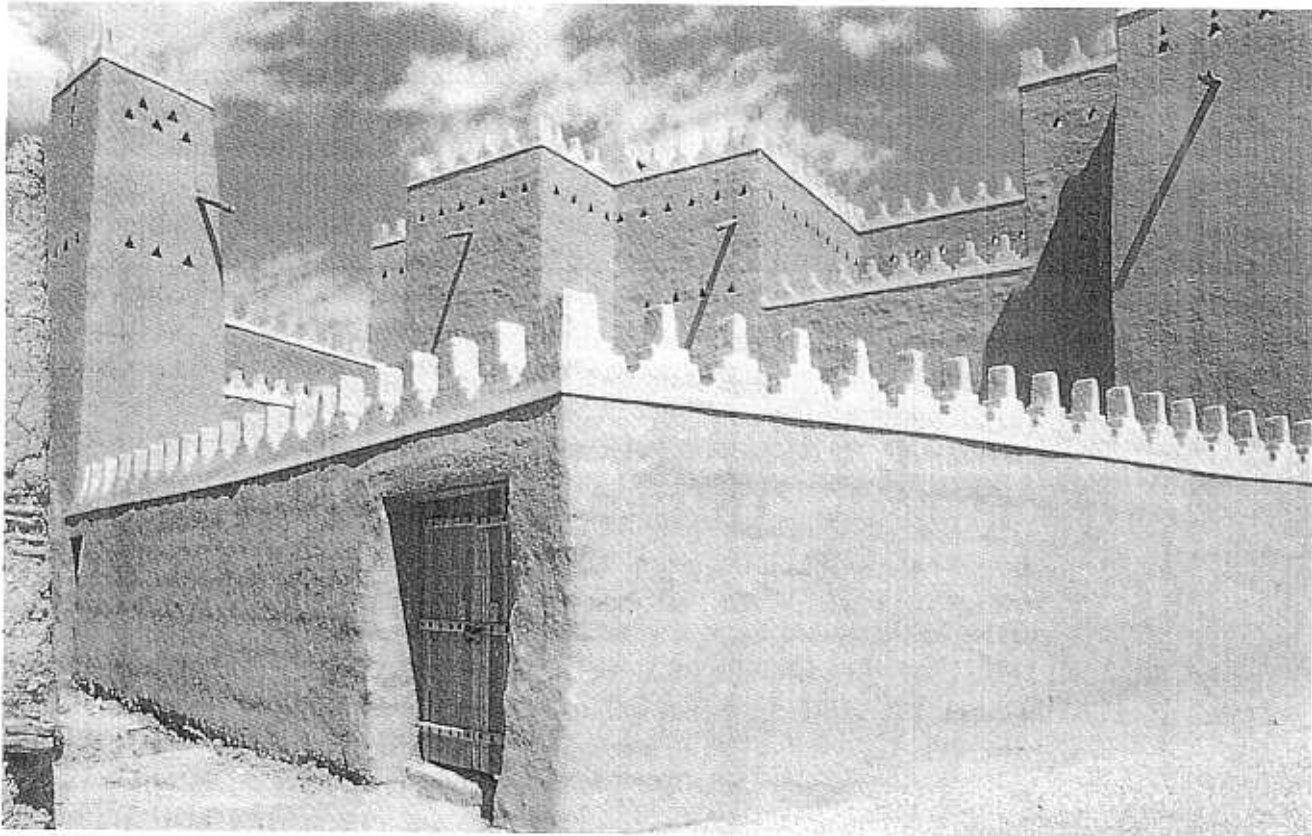
Restored Palace of the Sauds. (Turaif, Saudi Arabia).

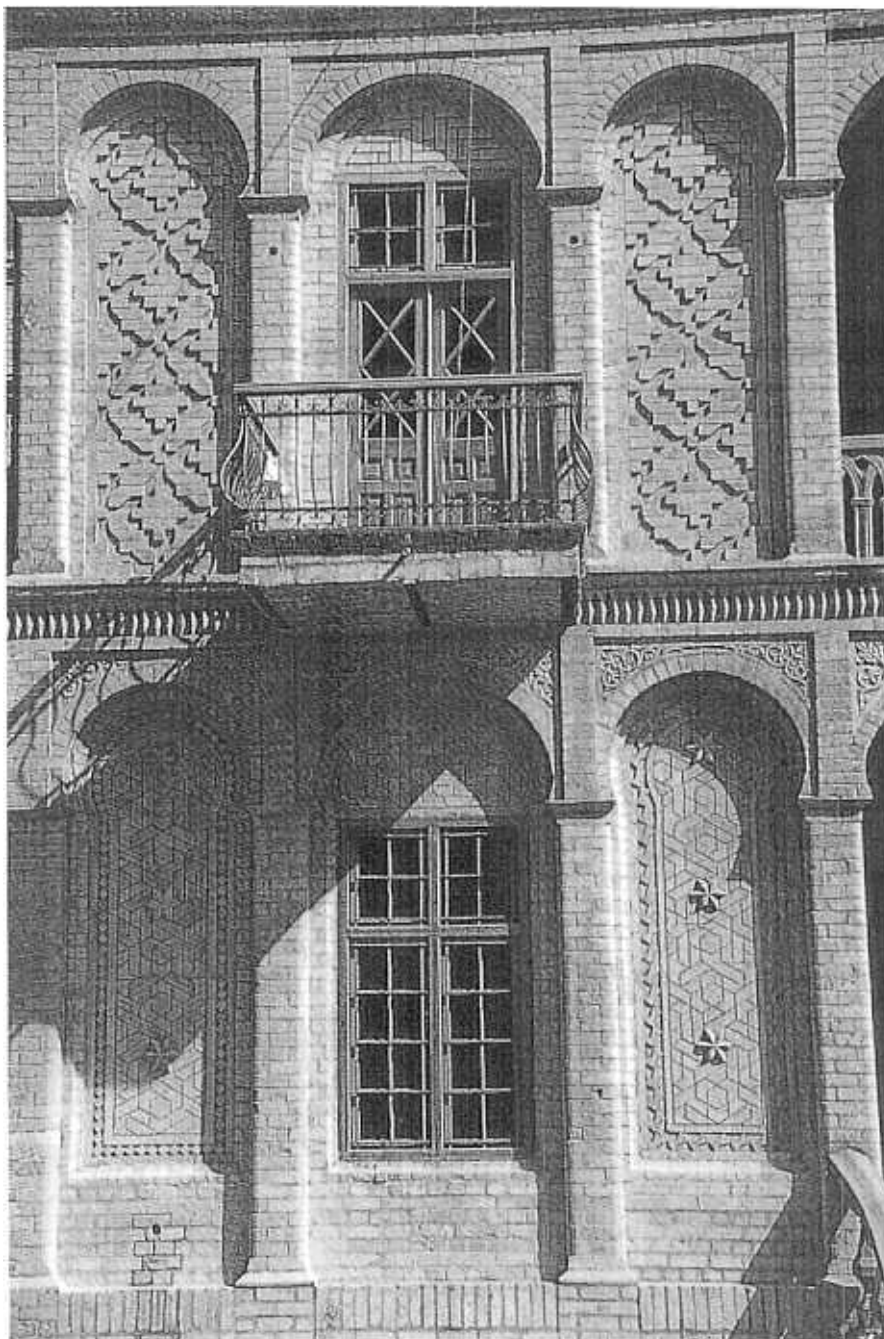
Street facade of a restored town house. (Resafa, Iraq).
