"From Material to Structure" MECHANICAL BEHAVIOUR AND FAILURES OF THE TIMBER STRUCTURES

Examination of corroded wood by ammonium phosphate and sulphate-based fire retardants – The results of the Prague Castle roof timber examination

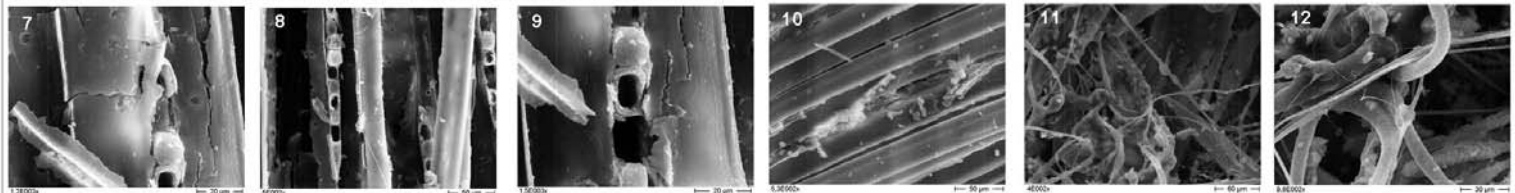
Figure 7,8,9 – A splinter from the House attic. Figure 10 – A splinter from the Vladislav Hall attic Figure 11,12 – Fibers sample from the All Saints Church attic.

Figures 7-12 show the observation of wooden samples by electron microscopy. On the anatomical structure level, some cells of the wood exhibited breakdown of the central lamella, which is predominantly formed by lignin (Fig. 8,9,10), while other cells exhibited breakdown of the cell wall, primarily composed of cellulose (Fig. 7,9). Figures 11 and 12 image the structure of fibers which originate from the wood surface corrosion (fig. 6). Indicates that the cell walls have disintegrated into the fibrous tangle. Microscopical research says that both of the main polymers are corroded – in some cases both of them and in other cases either cellulose or lignin only. Damage of the cell walls by mechanical agent can be considered as well.

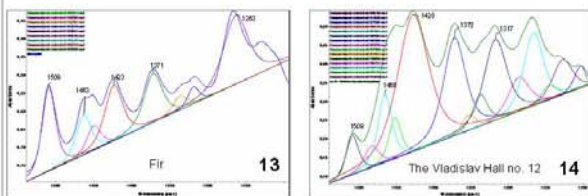
Figure 13,14 – Examples of bands isolation in absorption area 1200-1600 cm⁻¹

Analysis of wood samples was performed with FTIR spectrometer Bruker ISF 66v/S (Bruker, BDR) connected to a microscope Hyperion connected with Cassergrain lens for measuring transmittance spectra, detector MCT, beam splitter KBr. Measured parameters were: spectral range 4000-650 cm⁻¹, resolution 4 cm⁻¹, number of spectra accumulations 1028, apodisation Happ-Ganzel. The measured spectra were processed by a program Omnic 6.1 (Omnics Instruments Co., USA). Evaluation of changes in chemical structure was performed after bands isolation in absorption area 1200-1600 cm⁻¹ (fig. 13,14) and after relative comparison with areas of selected absorption bands of cellulose and lignin, which was calculated according to Gauss and Lorentz function. Table 2 gives information about the selected bands, which were used for the study of changes in chemical structure of wood. The relative changes in cellulose and lignin content are presented in table 3.

The results given there show there is a decrease of the lignin content in the samples which were taken from the wood surface (fibrous samples). Shifting of band position of CH₂ group bending vibration in cellulose to a higher wave number (from 1424 to 1430 cm⁻¹), is likely to indicate a relative increase of cellulose crystalline part as a consequence of a decrease of amount cellulose amorphous part. Creation of new bands was observed in the spectrum of sample no. 9 from the Vladislav Hall. The phenomenon may be related to oxidation of hydroxyl groups to carboxyl groups which are presented in the sample as a salt form.

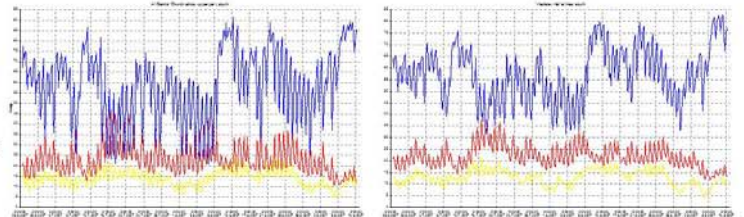
Relative humidity
Temperature
Dew point
Figure 15,16 – Records of climatic condition measurements

The highest temperature approx. 47 °C was measured in the upper part of the attic that was close to southern tiles. In this part of the attic the temperature arose to 40 °C 9 times in summer 2007. Maximal temperature was lower in the bottom part of the attics. This indicates that the temperature is not one of the main corrosion agents (fig. 15,15).
