## **Structural Failures of the Timber Structures in Arctic Climate**

**Johan Mattsson**  
Mycoteam AS, Norway

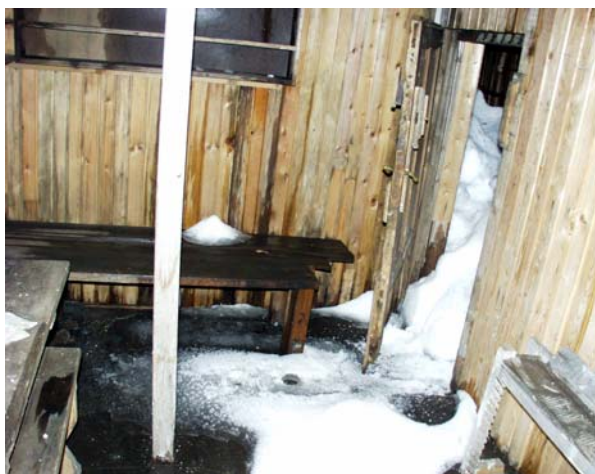
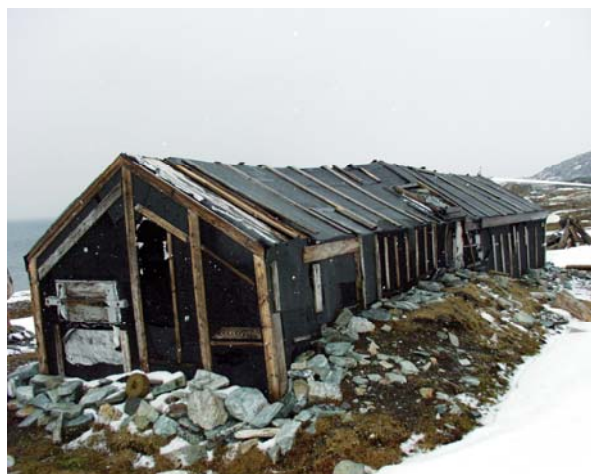
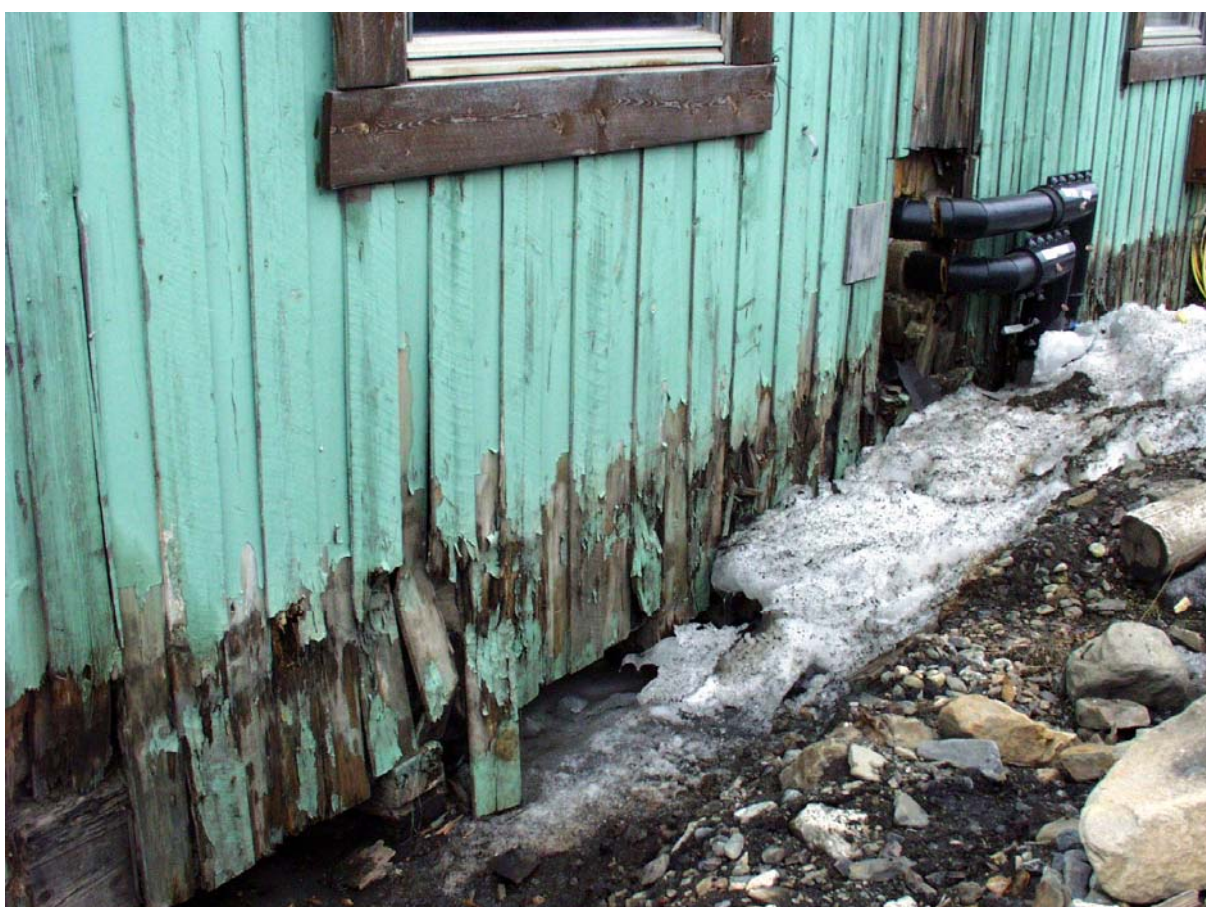
The traditional cabins at Svalbard were constructed by simple materials. The walls are normally without insulation, either by timber or a wooden frame. It is often an external bitumen layer in order to achieve an air tight construction. Some cases, where soil was shovelled up against the lower part of the walls were observed.

The floor is placed directly on the ground without any preparation. This is possible because a combination of relative stable ground conditions due to permafrost and a light, flexible building "floating" on the surface.

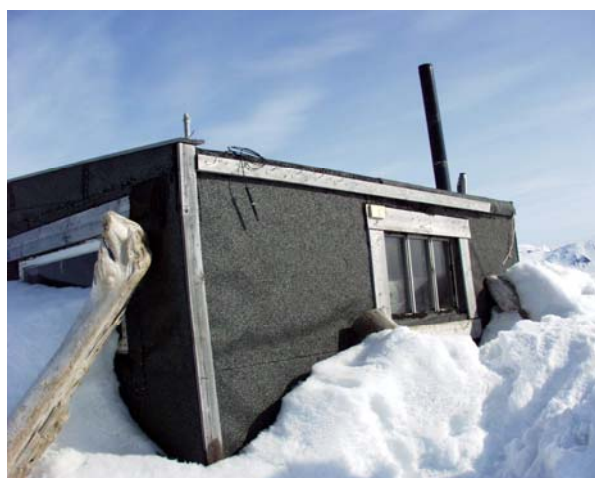
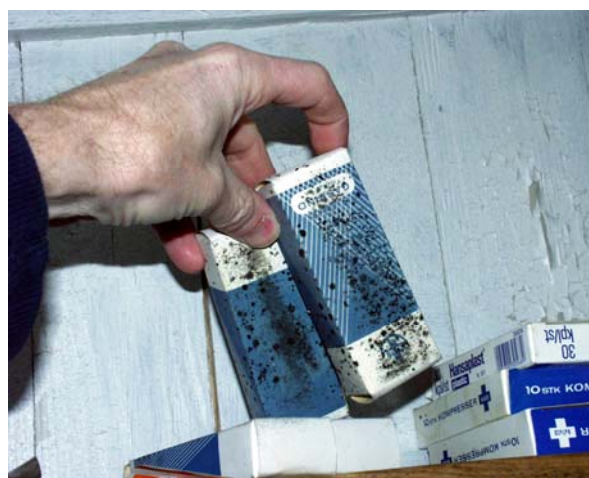
Decay fungi were generally found along the floor construction and lower part of external walls. Furthermore, all external wood had a grey discoloration, mainly caused by the blue-stain fungi *Aurobasidium pullulans*. External wood with horizontal exposure were also in several cases attacked by wood-decaying fungi, mainly *Leucogyrophana mollis*, but also occurring was *Gloeophyllum sepiarium*.

In totally 54 wooden samples, *Leucogyrophana mollis* was found in 34 samples, while softrot-damages were found in 29 of the cases. *Coniophora puteana* was found in two samples and an unidentified species in the family *Corticaceae* in one sample.

Several of the decayed materials were seriously damaged. The results of this were a severe technical failure of the timber structure. Due to continued climatic and humidity exposure, the rate of decay will increase in the future.

Our suggestion it therefore that during the repair work, the buildings should be permanently lifted somewhat up from the ground in order to ensure a better future service life of the building. This remedial action is of extra importance in case of a future global warming because such change could prolong the periods of favourable growth conditions due to increased temperature and access of water from the thawing permafrost.
