Failure is not always what it seems to be Timber Roof Trusses Behaving Badly

Richard I. Ortega, PE, AIA, FAPT

Senior Associate and Director of Preservation Technology, RMJM Hillier, Philadelphia, Pennsylvania, USA

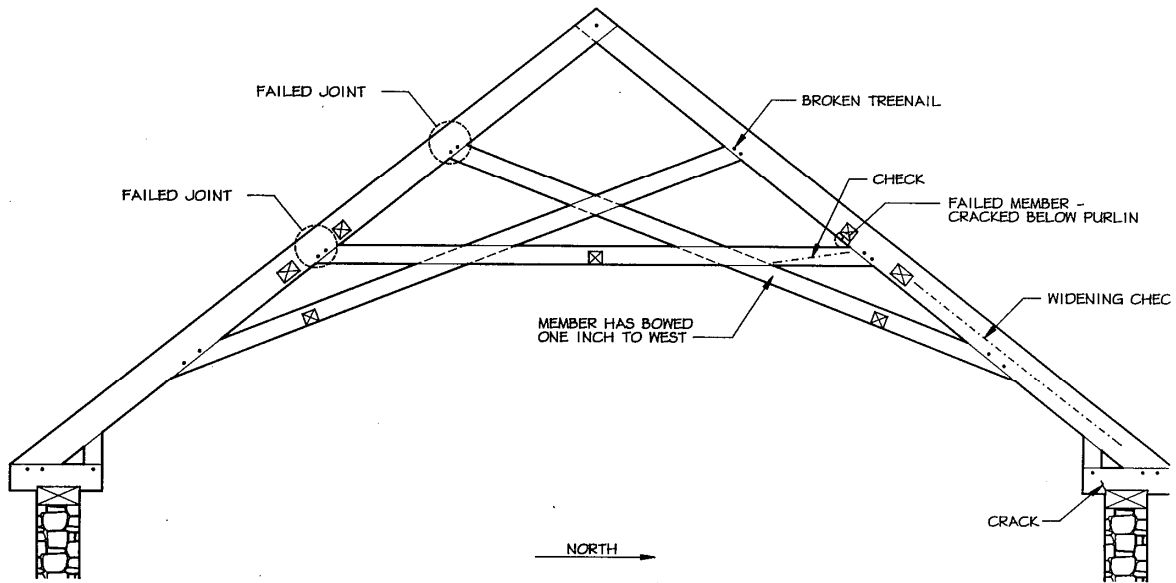
- All the trusses exhibited numerous failed pegged joints. In addition to the failed pegs, a few of the joints where the pegs were intact exhibited failure of the tenons.
- All the lapped joints of the trusses had rotated to some extent producing gaps at the far ends of the laps and localized crushing at the near ends of the joints.
- All of the top chords had failed.
- Several of the joints connecting the horizontal tie to the top chord had failed in tension.

E	ORTEGA CONSULTING	DRAWING TITLE: TRUSS #1 EAST ELEVATION	SCALE: 1/4" = 1'-0"
	Port Office Box 428 (215) 585-1131 Media, PA 19063	DATE: 3/12/92 DRAWN BY: RDN APPROVED BY: PROJECT #: 92-03B	NOTE: UNLESS OTHERWISE NOTED, JOINTS NOTED AS "FAILED" ARE DUE TO BROKEN TREENAILS &/OR TENON.

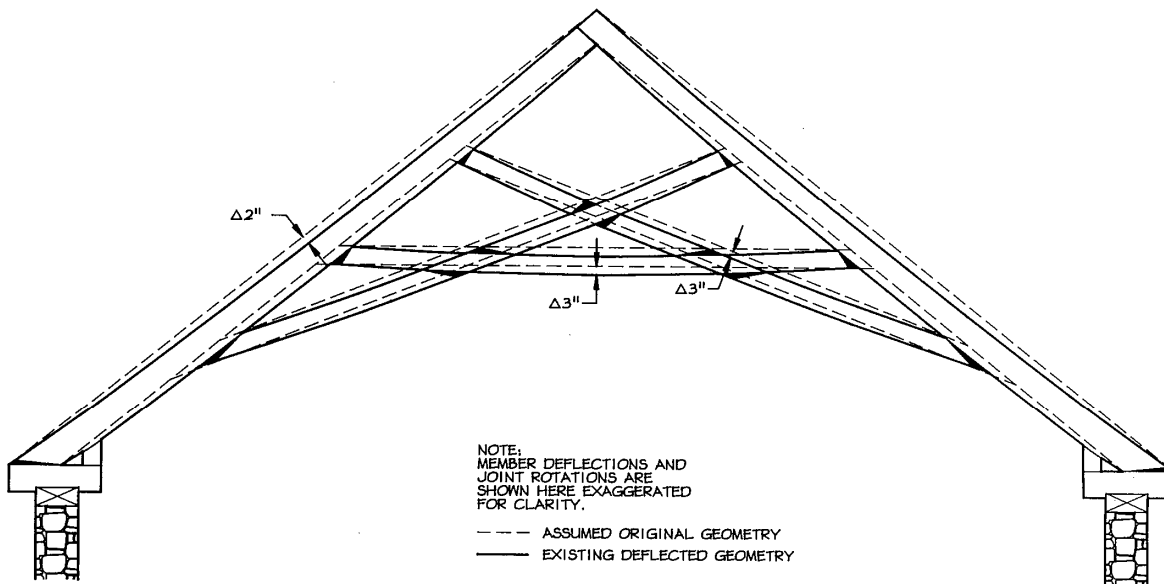
- The top chords had deflected approximately 2 inches.
- The diagonal scissor chord had deflected 2-1/2 to 3 inches.
- The horizontal tie had deflected about 3 inches.

We also closely examined the 20" thick masonry walls supporting the trusses and found that the tops of both walls had bowed outward as much as 6". This observation meant that our initial assumption that the masonry walls provided unyielding support for the trusses was not realistic. Thus, the same truss geometry was re-analyzed with one bearing end modeled as a roller so that spreading of the truss was theoretically permitted. The results of this analysis were consistent with the observed failures in the truss: the diagonal scissor chords go into tension to resist the spreading of the truss, and many of the truss members become overstressed.

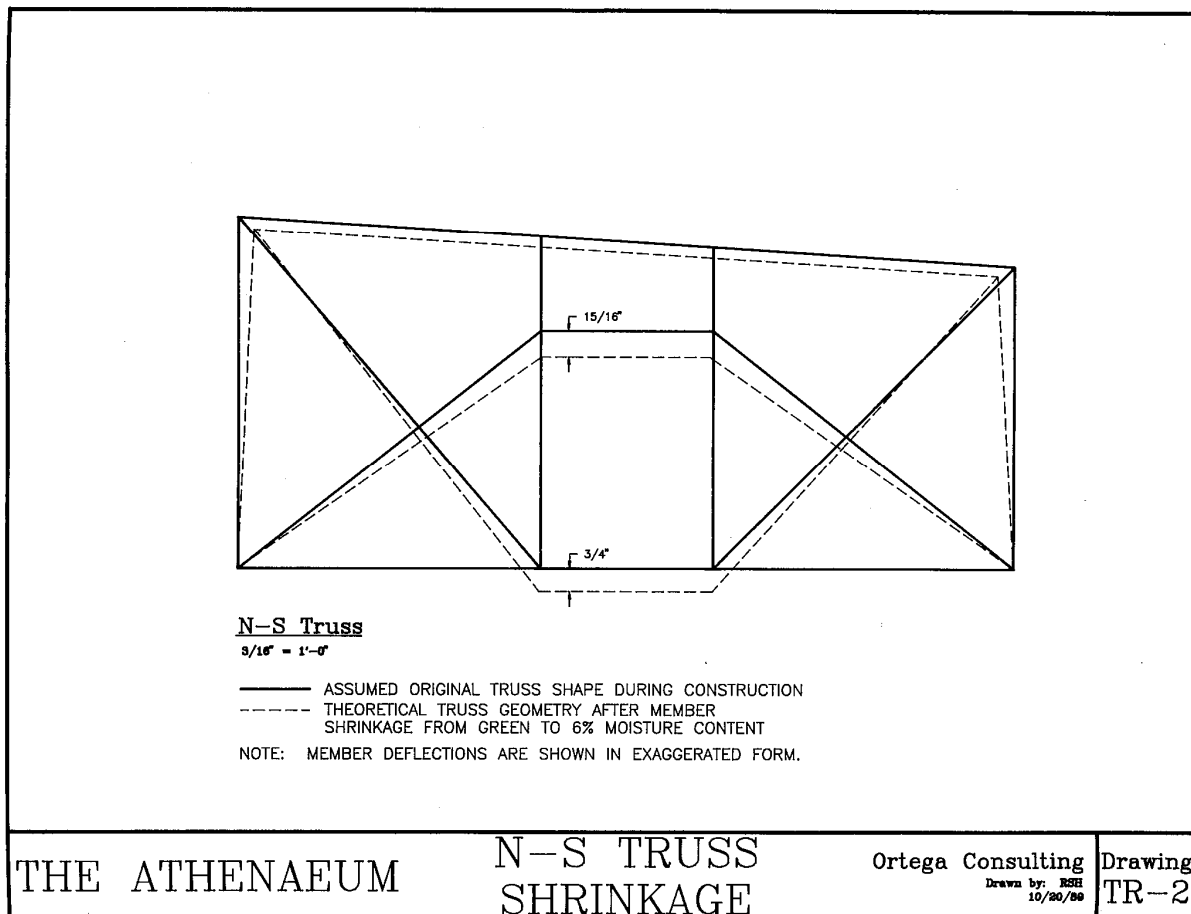
As part of our assessment we surveyed the floor levels throughout the building. For the most part the deflection patterns conformed closely to those anticipated for the deflection of joists. And except for the third floor, the magnitudes of the measured deflections were neither excessive nor substantially different from the calculated deflections. The glaring exception, however, was the deflection of the third-floor trusses. While deflection calculations of spanning wood members are notoriously approximate, the measured deflection of the trusses, at slightly more than one inch was well in excess of the calculated theoretical deflection of no more than 0.28 inches.

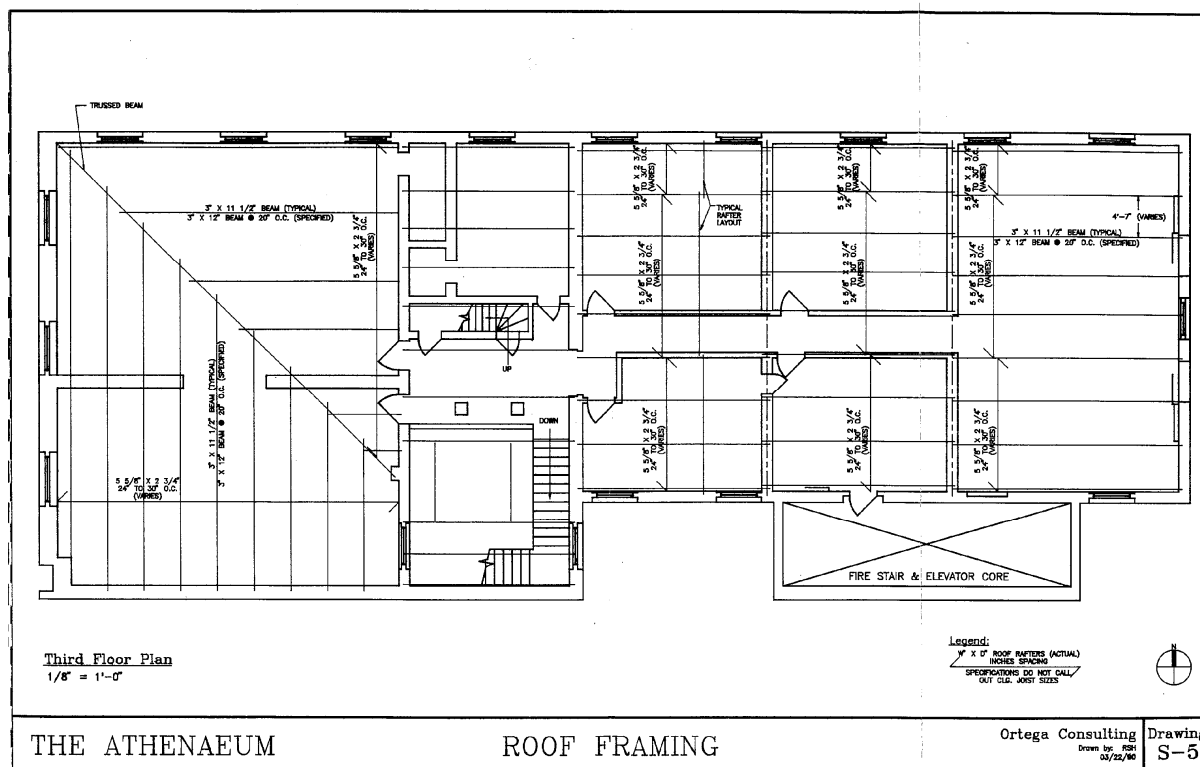
This sent us back to re-examine the trusses more carefully for damage which could have caused the excessive deflections. The joints appeared tight and there were no apparent failures of the connections. We had limited access to the heel joints, but saw no evidence of movement or shear block failure. The rods seemed reasonably tight. We found checking in most of the members, but no signs of failure. There seemed to be no mechanism to account for the excessive deflections.

While mapping the checking of the timbers we realized that they must have gone through a considerable change in moisture content since the time of original construction. Considering the sizes of the timbers, and assuming that it was unlikely that the timber was aged for several years before use, we concluded that they were probably green when the trusses were built – i.e. the wood had a moisture content approaching 30%. From readings taken during our survey we knew that the moisture content was about 6%.

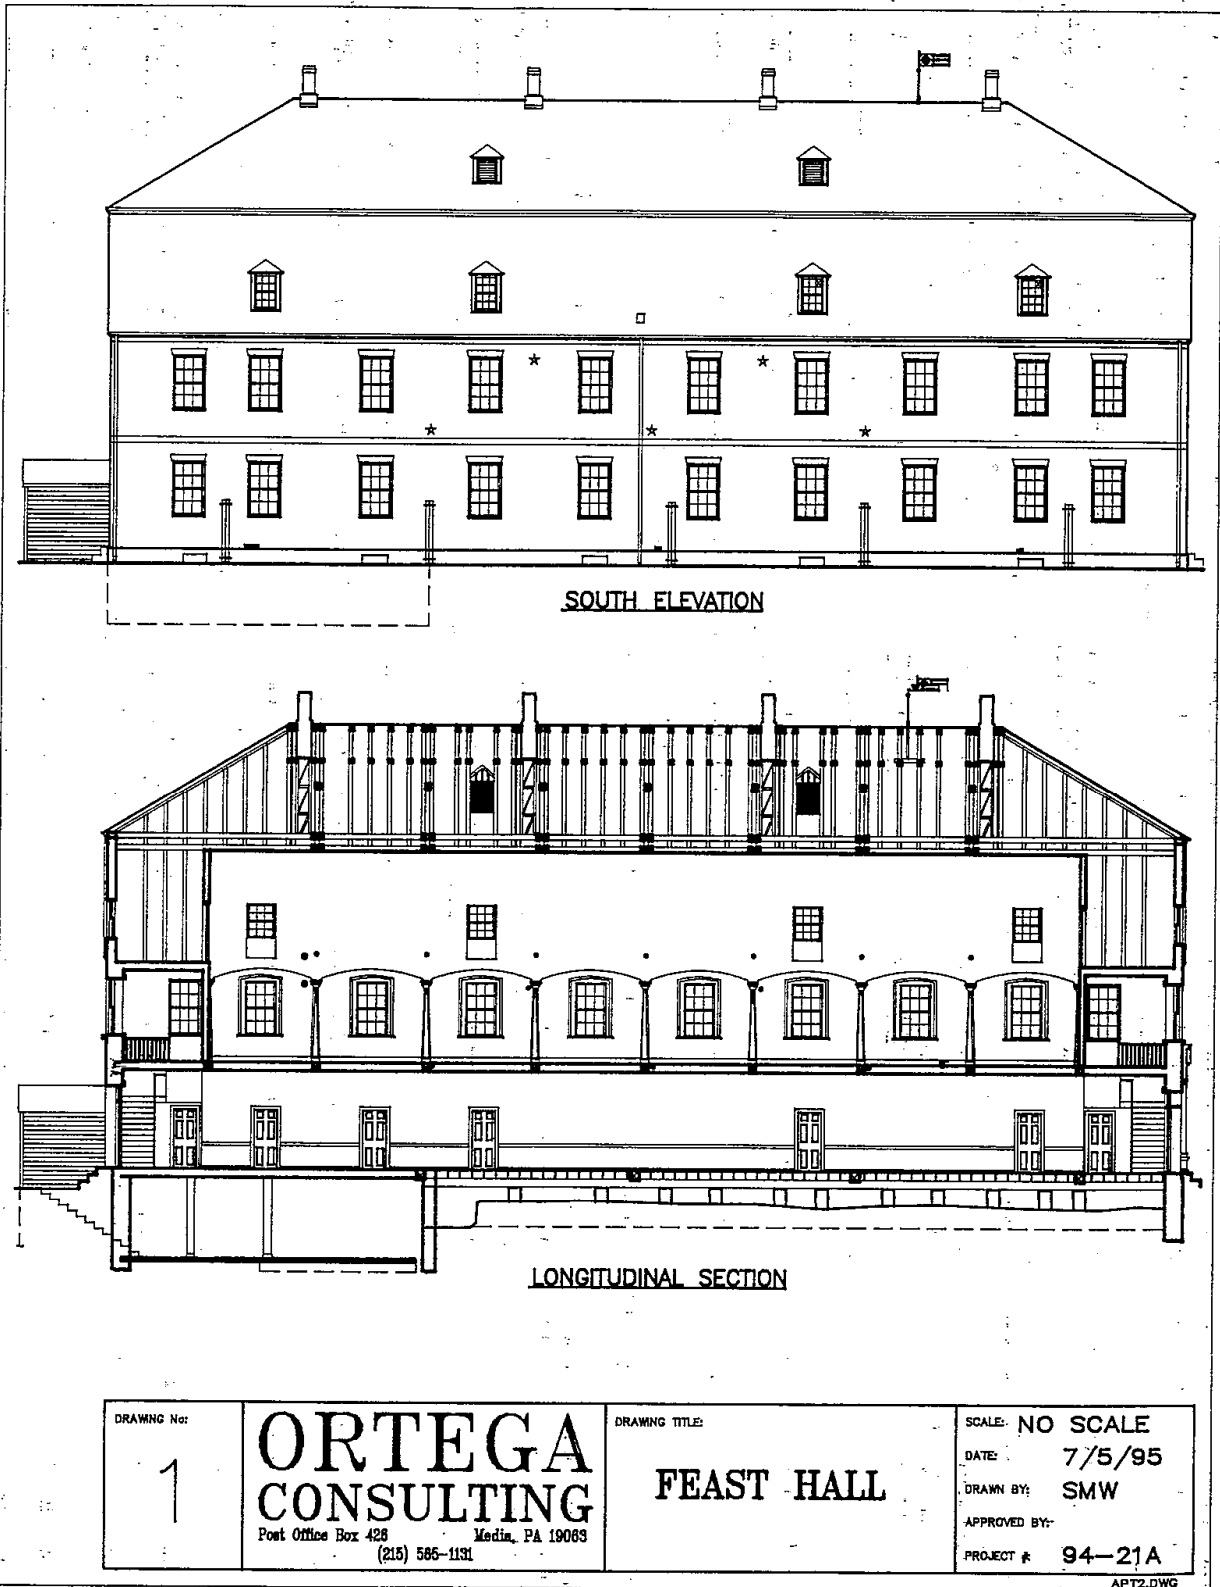
- The king-rod top chords were generally checked their entire length; for the most part the checking was more pronounced near the joints, such as at the apex of the 30° chords and at the intersection with the upper and lower horizontal ties.

- The joints between the king-rod chord and the horizontal ties have rotated. Where the rabbeted members intersect there are gaps between the chord and upper tie at the exterior shoulder and between the chord and the lower tie at the interior shoulder. At the opposite shoulder of each joint the intersecting members are tight against each other and in most cases exhibit localized crushing of the wood.

- Similar rotation was noted at the joint between the king-rod chord and the bearing member of the frame. In this joint the chord is shouldered to fit between the two frame members. At the upper face of the connection there are gaps between the members whereas the joint was tight at the bottom edge; but not generally to tight as to cause crushing of the fibers.

- At the connection between the knee brace and the bearing member there is a gap at the bottom of the mortised joint. At the opposite end of the brace, where it is morticed into the lower horizontal tie there is a similar gap. In both cases the opposing edge of the joint was tight. This situation also indicates rotation of the joints.

- There is a gap between the faces of the lower tie and the bearing member at the upper face of the joint where the former is morticed into the latter; the lower edge was tight, though not crushing.

- The maximum deflection of the upper tie, as measured at the mid-point of the top face relative to a string line between the two ends of the tie, was 2-5/8".
