THE PRESERVATION OF A GOTHIC CHURCH IN CZECHOSLOVAKIA

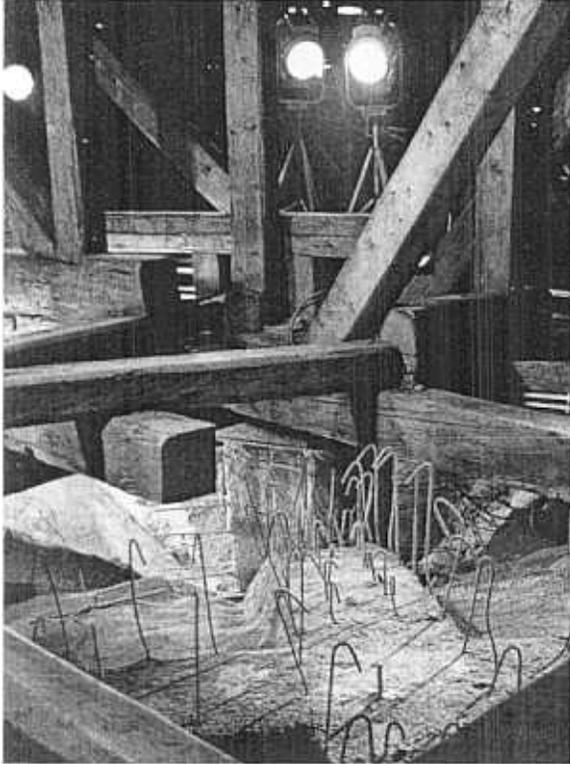
Fig Reinforcement of the vaults

bly, during the actual transfer. Two opposite alternatives were considered, i.e. either the erection of a rigid grillage structure guaranteeing the stability of form of the whole series of principal vaults, with, however, increased danger of overloading on the individual load-bearing members, or else flexible reinforcement of the vaults by means of a concrete shell on their rear face, while the position of their abutments was secured by an independent horizontal structure. Finally a compromise solution was adopted which combined the advantages of both alternatives, i.e. a flexible extrados shell reinforced with relatively rigid concrete ribs formed by placing concrete along the original masonry ribs. This structure was so designed as to be suitable for conversion, if necessary, into a rigid framework by the addition of concrete walls. In the transverse direction the outside wall masonry of both aisles on the vault abutment level was secured by prestressed ties whose prestressing force corresponded to the horizontal components of the vault reactions.

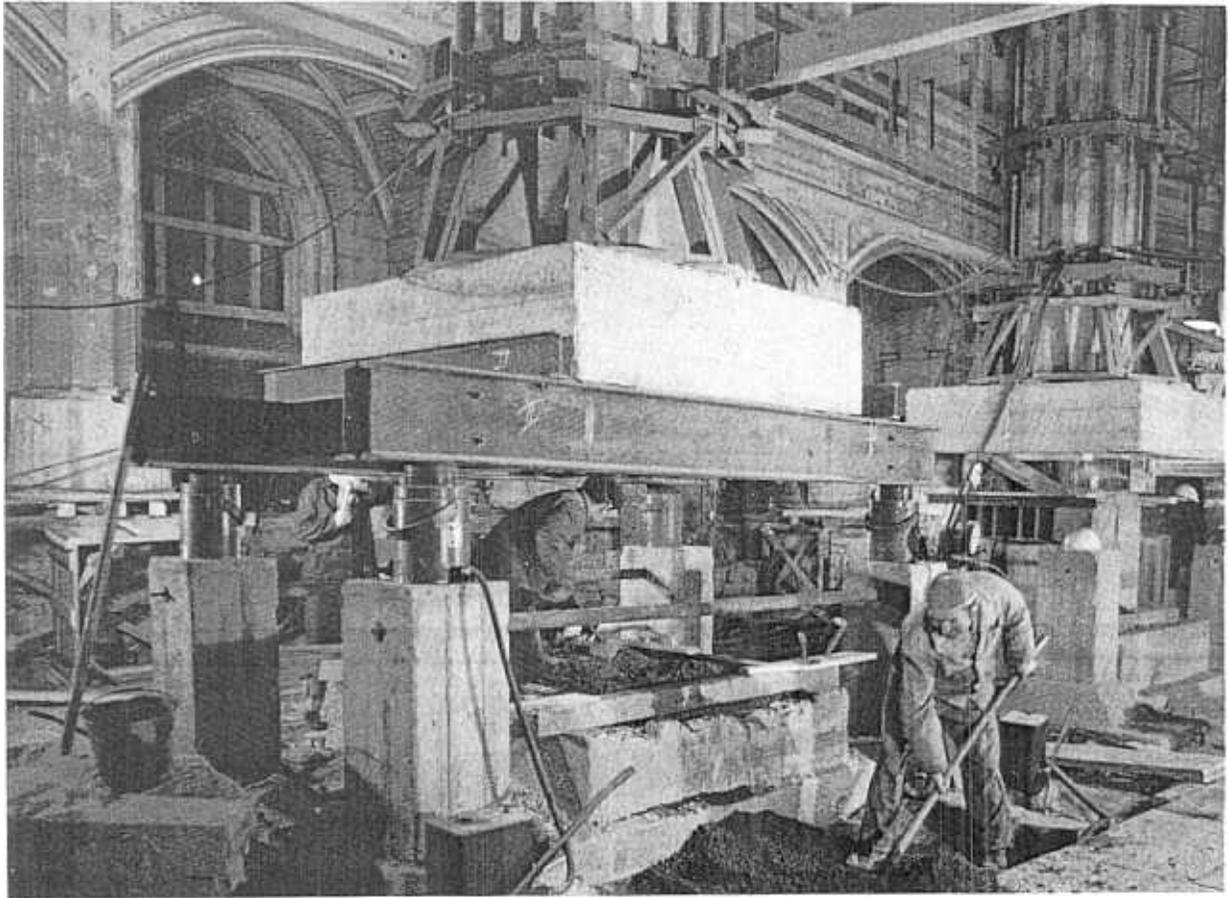
Fig. 2. - Column underpinning.

The slender stone piers were reinforced, both for loading and with a view to the transfer, with a prestressed steel structure which also served for underpinning purposes. The sleeve supporting this reinforcement was slowly lifted by four hydraulic presses until the reinforcing structure transferred the whole axial force of the pier by friction on to auxiliary foundations. It was then possible to replace part of the pier foundation with a concrete block with embedded steel beams, below which the main reinforcing structure was subsequently mounted.

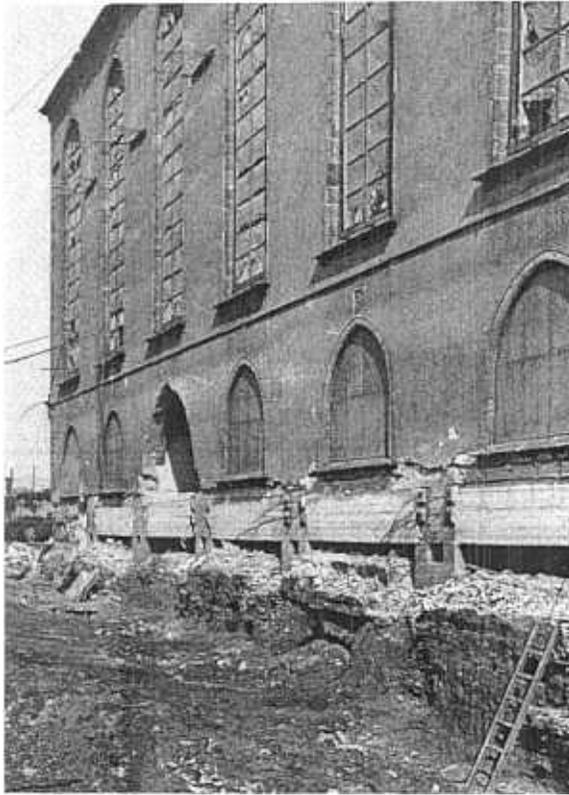
Fig. 3. The reinforcing ring beam.

Another interesting building operation was the construction of a ring beam of reinforced concrete and the underpinning of the piers and buttresses. The ring beam was progressively concreted, the replacement of the masonry with concrete beginning at the points where the buttresses linked up with the

outside walls. The core of the future ring beam thus formed was provided with all the necessary tensile and compressive reinforcement, corresponding to a load-bearing capacity designed for a maximum deformation of 10 mm. at midspan on a girder loaded by masonry over a span of some 10 m., as well as shear stress reinforcement capable of transmitting a reaction of 500 tons.

After these blocks had been concreted in all appropriate places the masonry in between them was progressively replaced by a concrete girder. The reinforcements of these intermediate parts were welded to those of the blocks. At particularly tricky points where the support reactions were at a maximum the contact surfaces between the block and the rest of the ring beam were given special treatment to improve their bonding.
