ICOMOS Sri Lanka

**Preliminary Survey of Tsunami-affected Monuments and  
Sites in the Maritime Region of Sri Lanka**

The Southern Maritime Region:  
from the Walawe Ganga to the Nilvala Ganga

March 2005

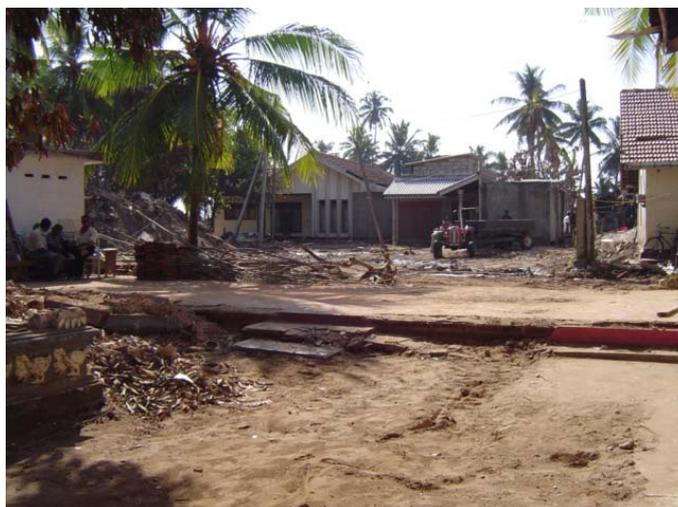
According to the chief priest of the temple, the oldest building in the temple is the *dharmasala*/the preaching hall which was totally destroyed due to tsunami tidal waves. He dates this preaching hall to 1897. However, no such antiquity could be established through the debris. Only the foundation of brick and cement remains. No apparent architectural or archaeological value is visible. No archaeological conservation is required as nothing can be saved.

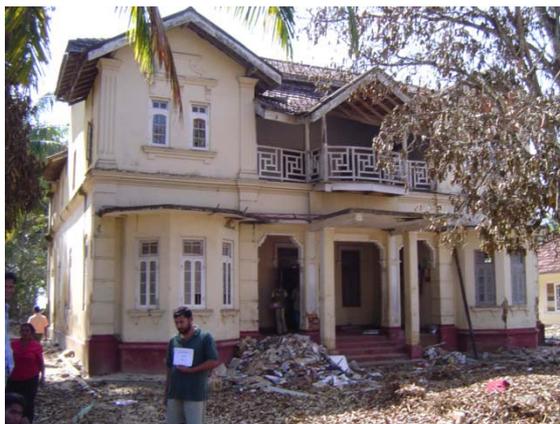
Constructed by a police officer named Don Jayawickrama Weerasuriya, this is a work of the later part of the 19<sup>th</sup> century. The roof tiles are said to contain a manufacturing date of 1867. As it is located about 75 meters inland from the sea at a very low elevation, this house is highly vulnerable to sea erosion. The garden around the house is badly eroded and the pavement and the foundation have sunk to the ground. This has led to cracks on the walls. Pre-tsunami cracks have also been aggravated. Cracks on the front side columns have made the structure somewhat unstable. In places the plaster has come off the walls.

The house is doubled storied by way of having a timber mezzanine. Its foundation is built of cabock while the walls are of both brick and cabock. The Calicut tiled roof is in a state of decay. Fungal impacts are visible on the plaster.

The doors and windows are timber paneled glass. About 60% of the doors have either been destroyed or damaged, while the windows too are damaged. The salt water impact can also be seen on the cement rendering floor. The boundary wall is completely demolished.

The rear – sea facing – kitchen, probably not of the same age as the house is badly damaged. Some furniture of antique value has also been damaged. Attention should be given to conserving this building.
