**RENOVATION OF THE ROMANESQUE CATHEDRAL
OF RODA DE ISABENA IN THE PYRENEES (PROVINCE OF HUESCA)
AND OF ITS URBAN SETTING**

Architect : Francisco Pons-Sorolla Y Arnau.

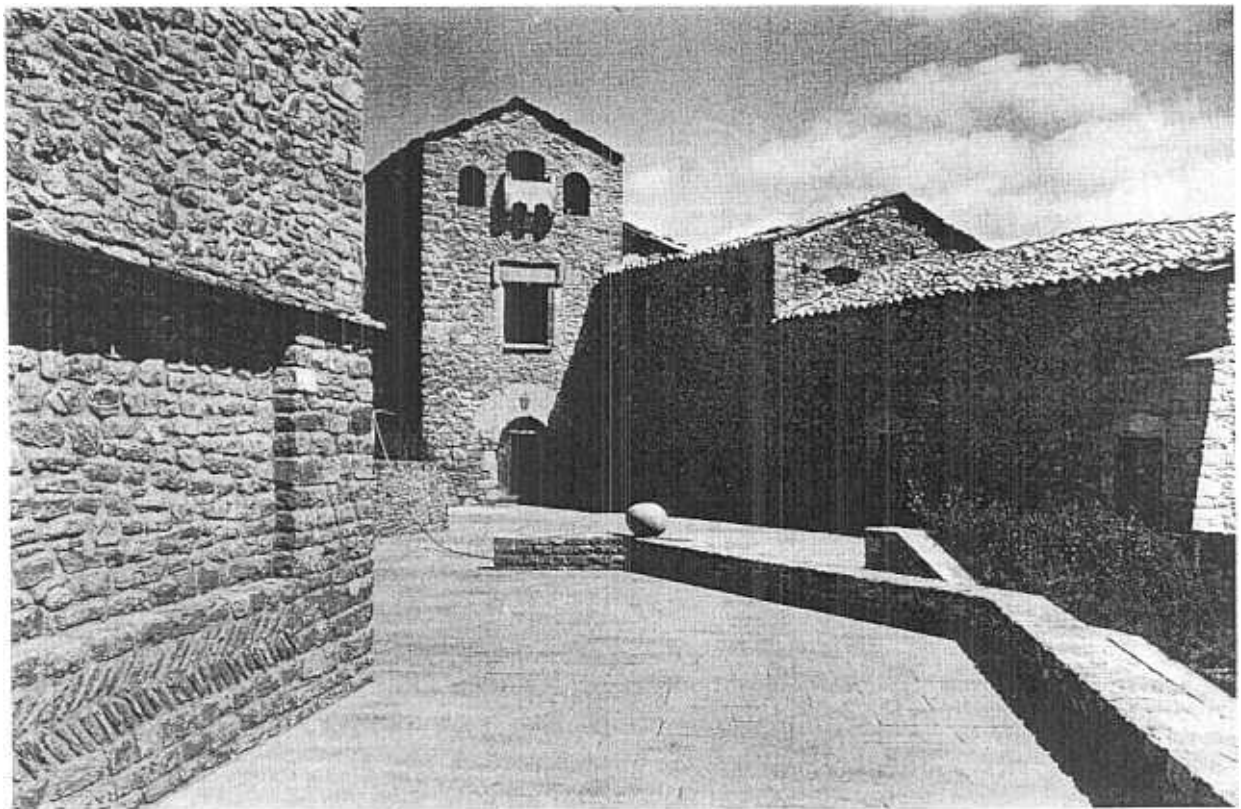
Fig. 1. — The Bishop's Palace with the area west of the Cathedral, after the renovation work.

Restoration work on the great tower of the Bishop's Palace has been confined to structural consolidation, cleaning and repointing; worthy additions dating from different periods — such as the 14th-century ashlar machicolations and the 16th-century window surrounds — have been retained.

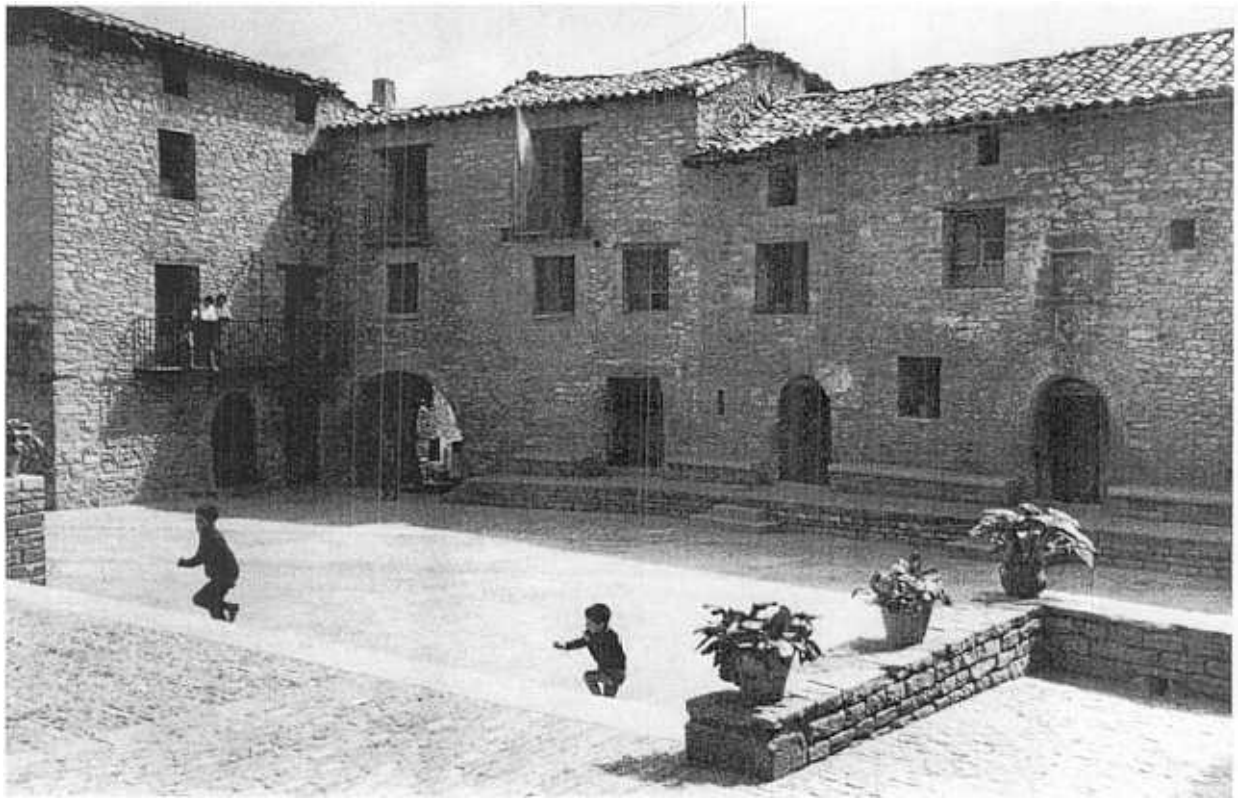
Fig. 2. — The Plaza de San Pedro. In the background, the archway giving access to the Cathedral precinct.

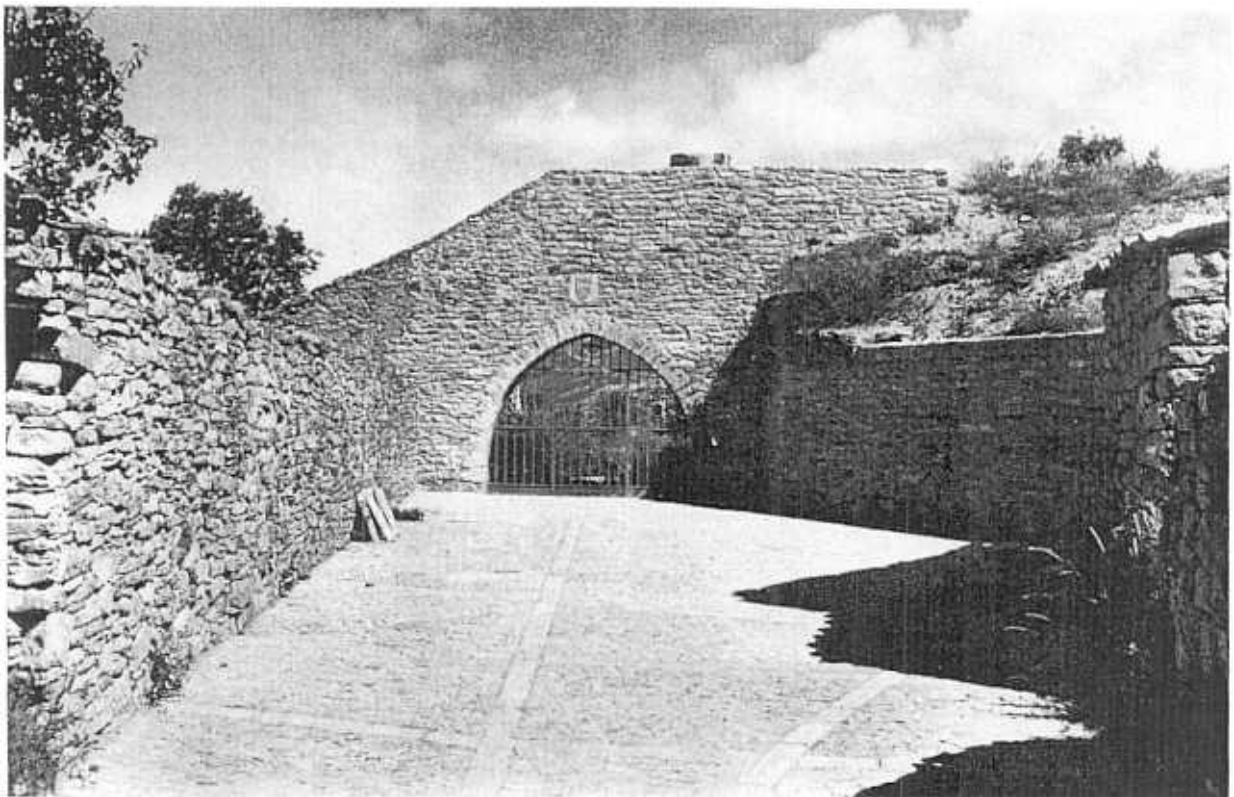
Fig. 3. — The entrance to the cemetery.

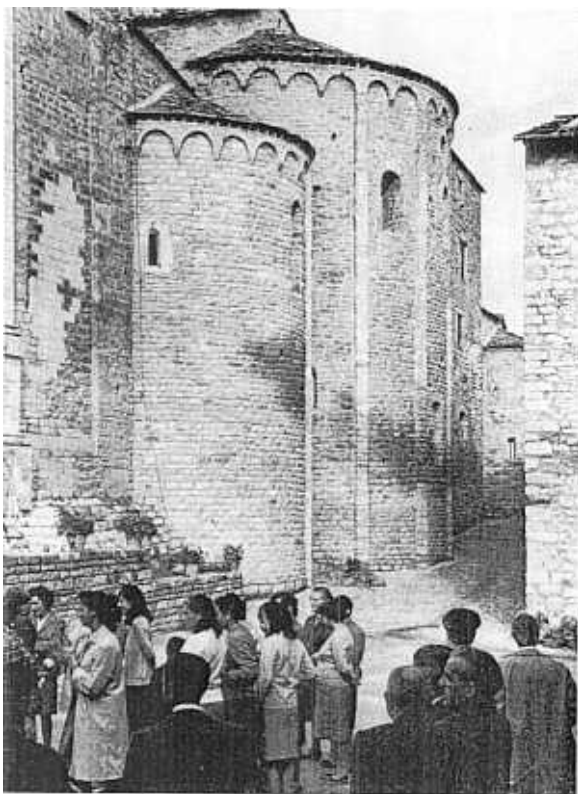
Fig. 4. — The Cathedral apses, restored.

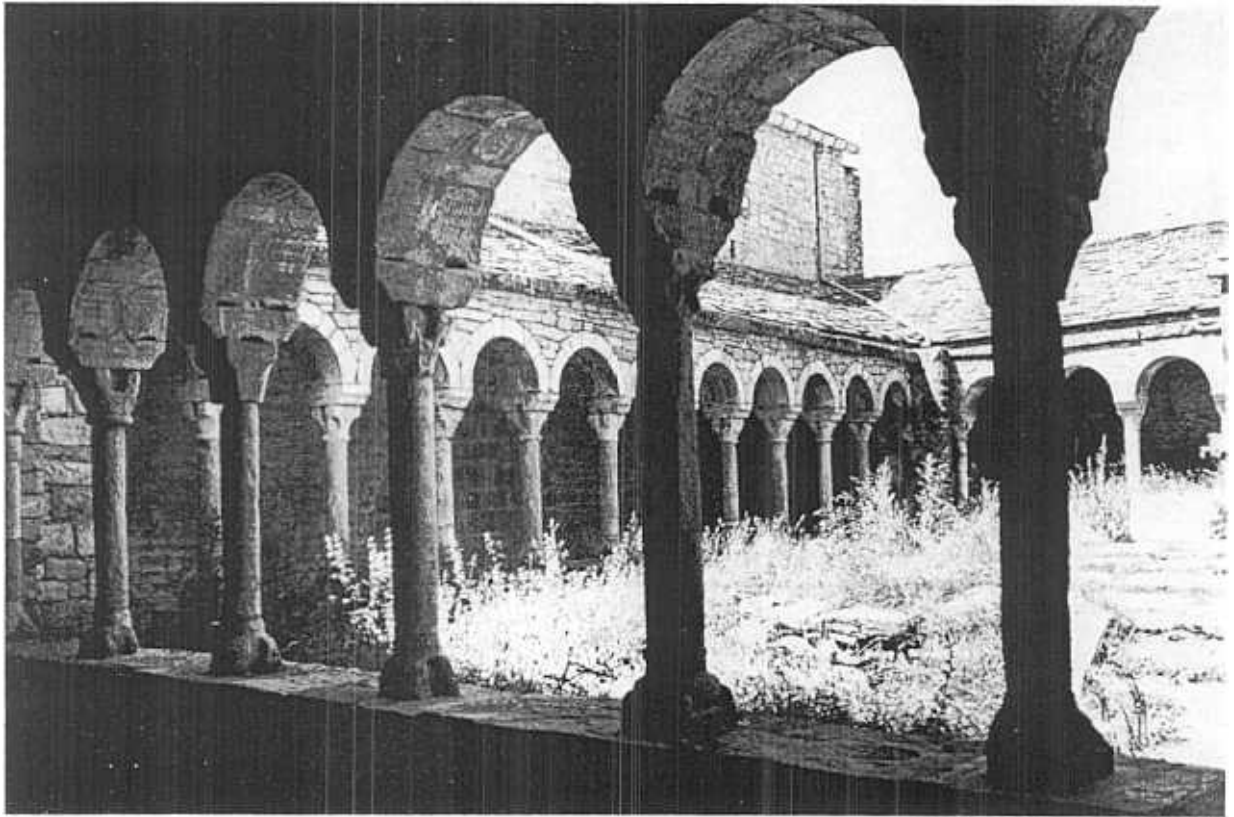
Fig. 5. — The cloister.

The modern additions to the northern part of the cloister have been removed, so that the facings of the

walls are once more visible, and these have been consolidated and repointed. The arcading has been preserved in its original condition.

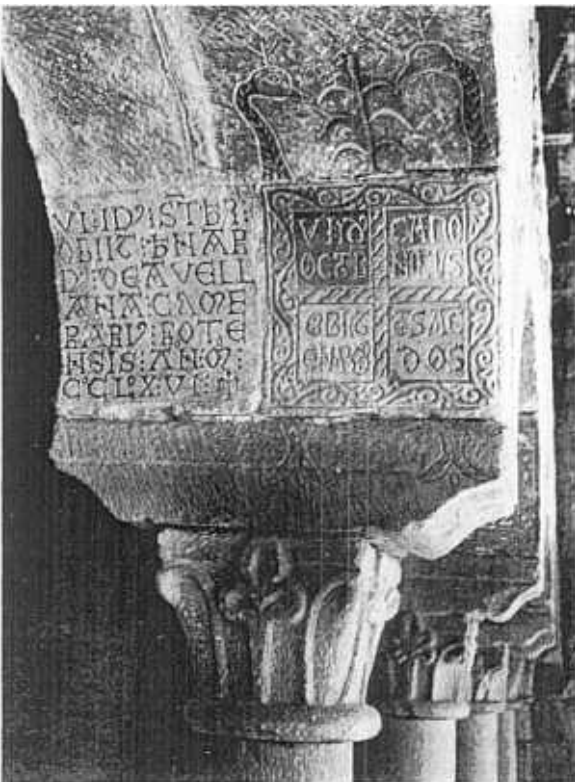
Fig. 6. — Detail of the cloister arcades, showing the mediaeval funerary inscriptions.

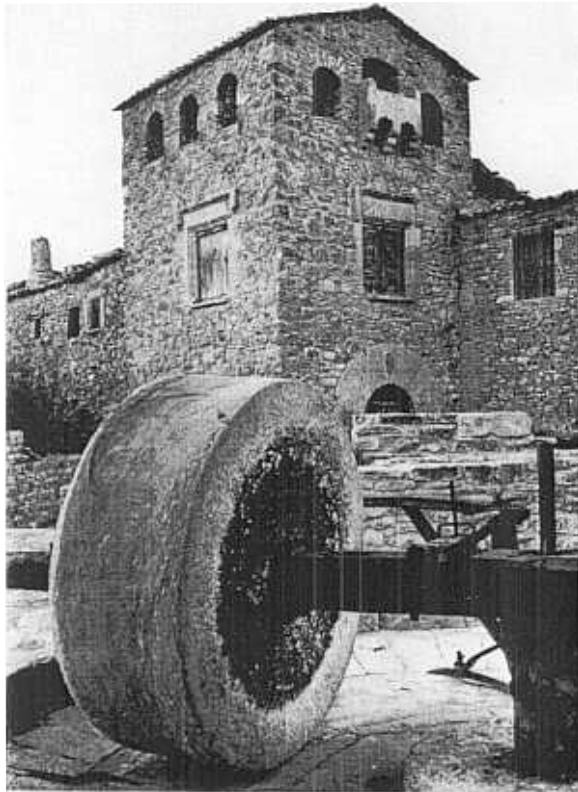
A work of fine vernacular craftsmanship is the oil-press adjoining the cloister on the north side; this was buried beneath a mass of unsightly structures but is now preserved in a completely uncovered state.

Fig. 7. — Area to the north of the Cathedral after renovation, with detail of the oil-press.
