## The Cathedral of Mexico and the Metropolitan Sacrarium

PEDRO RAMIREZ VAZQUEZ

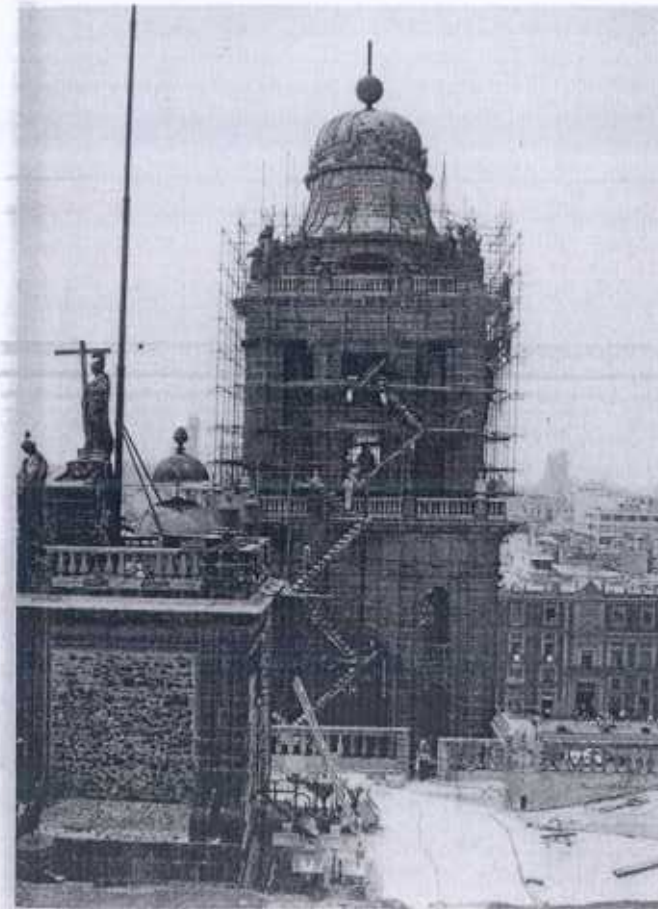
FIG. 1. Restoration being carried out on the West Tower.

Finally, the conservation of this important group of monuments is dealing with the decayed stone of the west tower (*Fig. 1*). Environmental pollution and lack of maintenance have caused serious deterioration to the carved masonry, some of which has been restored, consolidated or replaced according to its condition. Copies of the sculptures on the upper part of the tower have been made, so that they may be placed in position some time in the future, if and when that becomes necessary. By such means it is hoped to assure the future conservation of Mexico City's most important monuments.

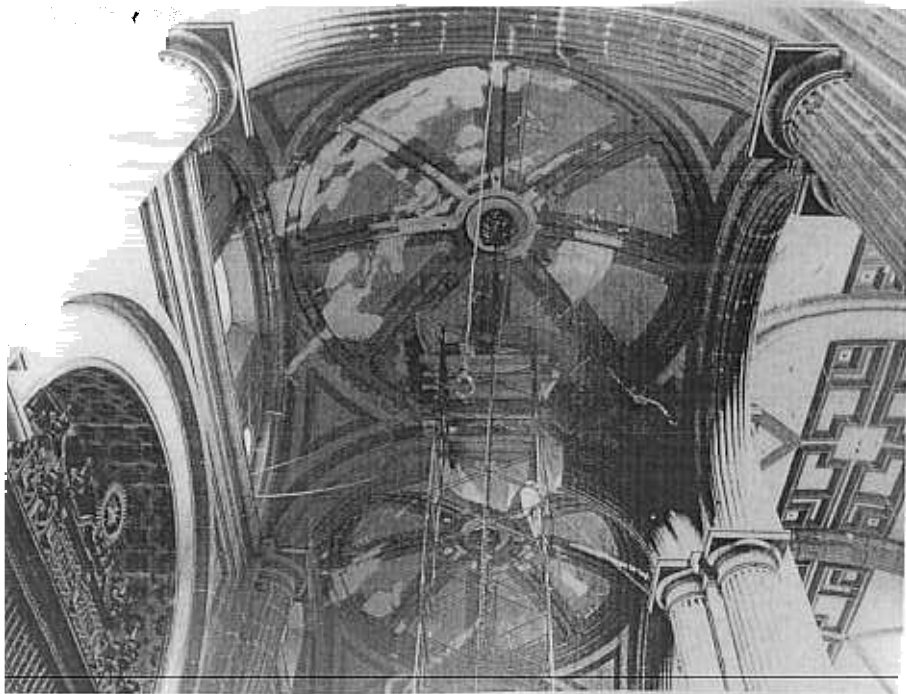
FIG. 3. Consolidation of the structure of the arch and injection under pressure into the fissures found in the side nave.

In restoring the vaults, the cracks in the *extrados* and *intrados* were located and their direction and magnitude were recorded in plans, diagrams and tables. The brickwork was then removed, revealing the flaws that did not appear on the surface, and the structural continuity in

the vaults was reestablished. The cracks were filled with injections of mortars prepared with expander additives (*Fig. 3*). Since 1977 the buildings have been stabilized, and periodic measurements are taken in order to diversify the transmissions of load to the stratum if necessary; this allows the possibility of controlling the settlement and subsidence of this important group of monuments.

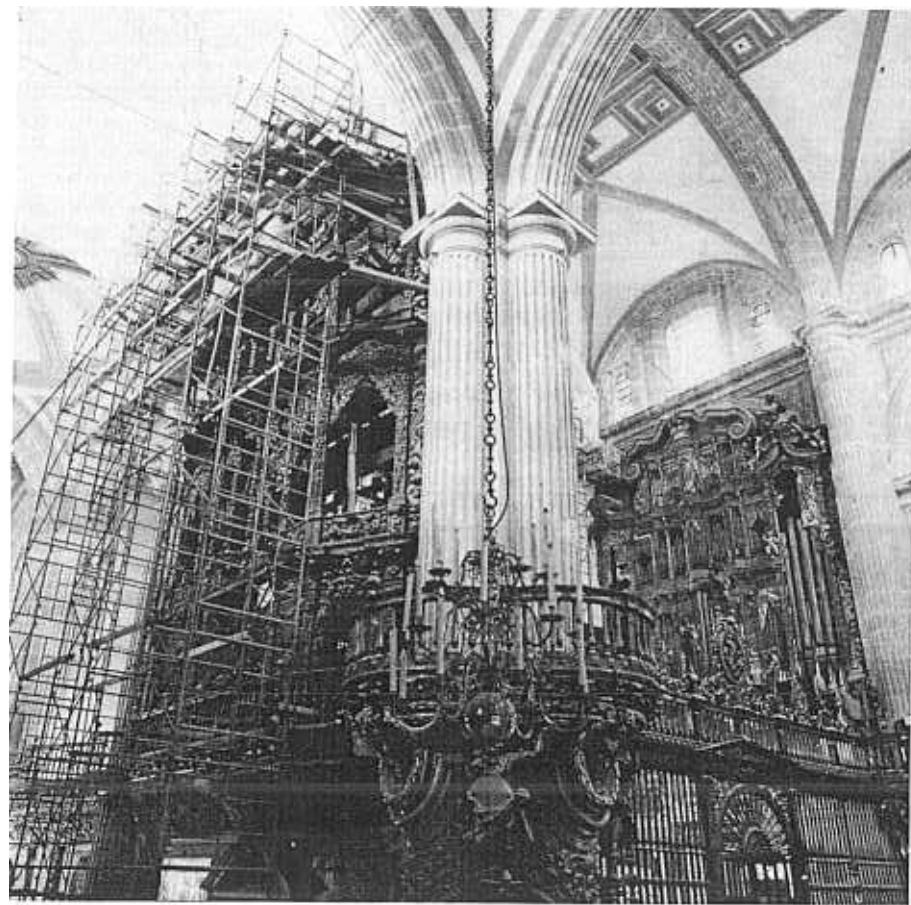
FIG. 4. The restoration of the pipe organ; work in progress on the Spanish organ constructed in 1695.

fifty-nine choir stalls by Juan de Rojas (1695), and a painting of the Apocalypse by Juan Correa were lost. The organ cases were seriously damaged, and the flutes and trumpets melted (*Fig. 4*).<sup>2</sup> The choirmaster's desk, brought from Manila in 1762, was partly destroyed, and so were the ivory figures decorating it. The flames destroyed the painting on the main cupola and severely damaged the upper part of the altarpiece made by Jeronimo de Balbas for the Capilla de los Reyes (1718–36) which was in the presbytery at the time. A completely new system has now been installed, including a substation fed by one single branch capable of taking a load of 960 kw. Separate switchboards have been provided for the different parts of the Cathedral and placed under the control of individual members of staff. The external lighting has also been reconsidered, in order to show the architectural quality to its greatest advantage (*Fig. 5*).

<sup>2</sup> The monumental organs, one built in 1695 in Spain by Jorge de Sema and the other in New Spain in 1735 by Jose de Nasarre, have been completely restored while respecting their musical properties. The technical restoration from a musical standpoint was undertaken by Flentrop B.V. de Zaandam, Holland under the supervision of Dr Kirk A. Flentrop. The restoration of the mechanism and pipe-work and the carving of the cases was done by Mexican craftsmen.

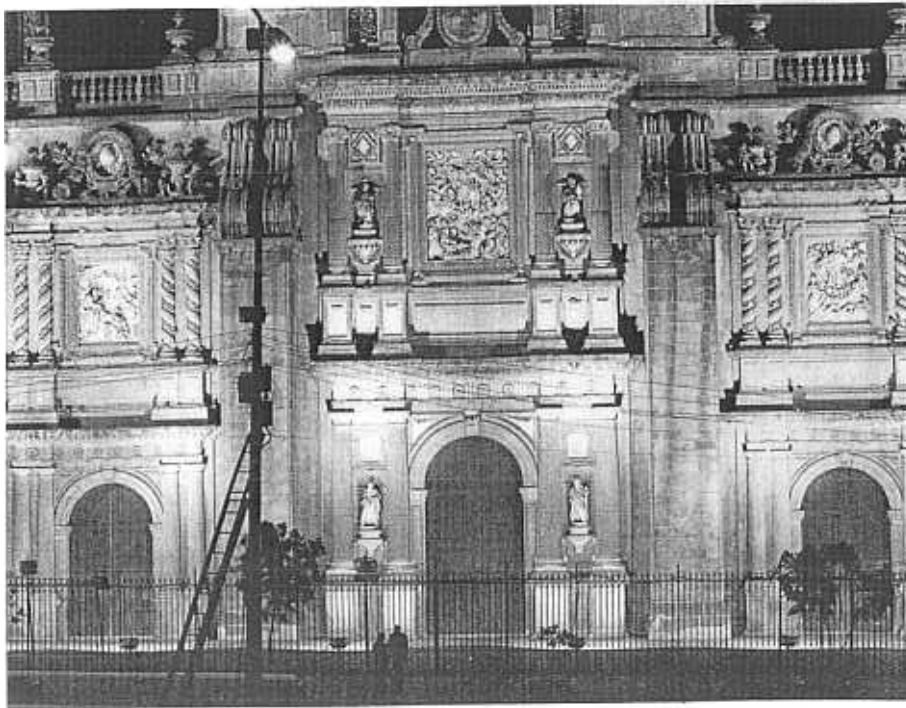
FIG. 5. Testing the external lighting of the main facade.
