The restoration of the *nirvana-stupa* of
the Buddha at Kusinara, India

R. SENGUPTA

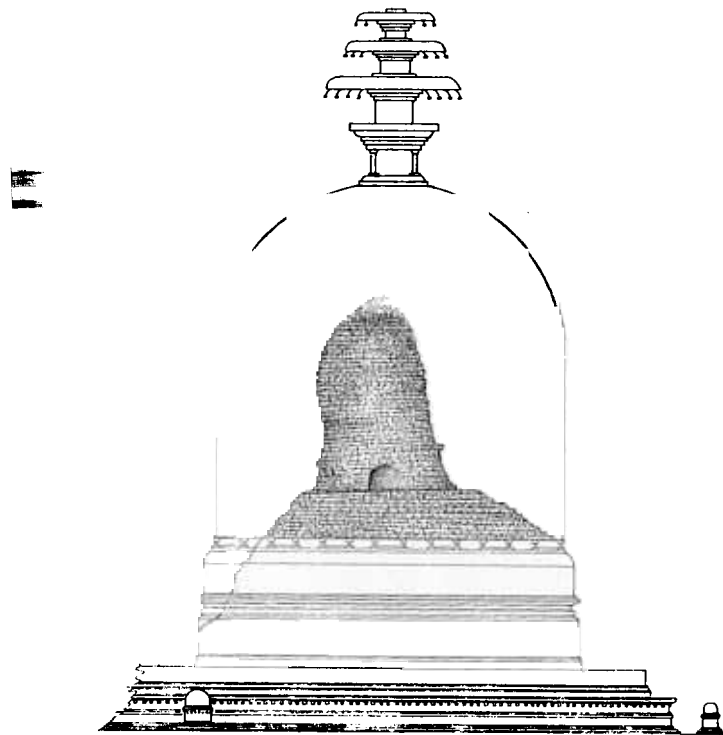
FIG. 1. The *nirvana-stupa* as
found in 1876, and the
outline of the hypothetical
renovation executed in
1927 with donations from
a devout Buddhist.

Among the ruins of the excavated monastic remains, a shrine and a *stupa* on a high platform were excavated in 1876 (*Fig. 1*). Some parts of the ruined *stupa* were cleared away or dismantled to lessen the top-weight,

since the monument overhung and leaned slightly towards the temple, on which it was in danger of falling. An account published in the Archaeological Survey's annual report for 1910-11 notes that the domed top had gone and the extant part of the drum was in a more or less dilapidated condition. After this dismantling a shaft was sunk from the top down the centre of the structure (*Fig. 2*) in order to ascertain if the *stupa* contained any relics, and at a depth of more than four metres a copper vessel and a copper plate were found. On the latter the Buddhist text, the *Nidanasutra* in Sanskrit was written in black ink with the first line only having been engraved. At the end of the inscription it was recorded that the donor was Haribala, the Chief Superintendent of the monasteries, and the plate was deposited in the *nirvana chaitya*. A colossal image of the Buddha in *mahaparinirvana* pose, housed in the adjoining shrine, had also been donated by the author of the copper plate.

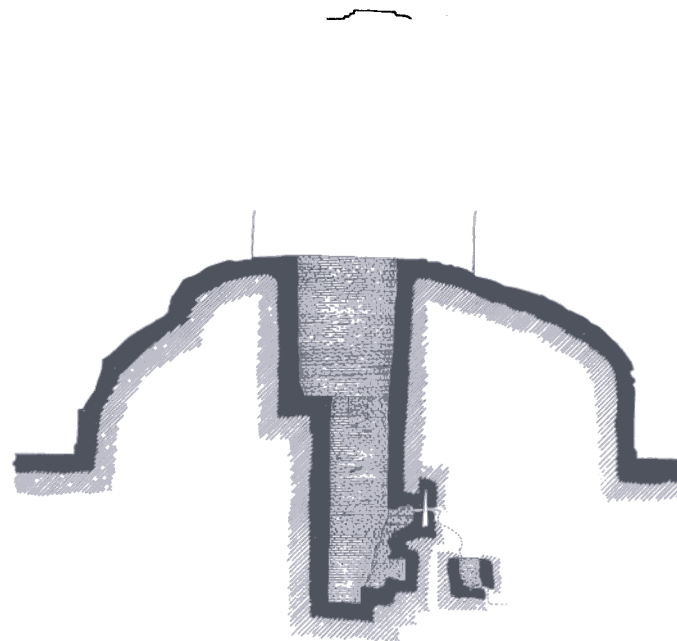
FIG. 2. The *stupa* in 1910, showing the 'excavation' in the form of a well sunk through the centre in a search for relics.

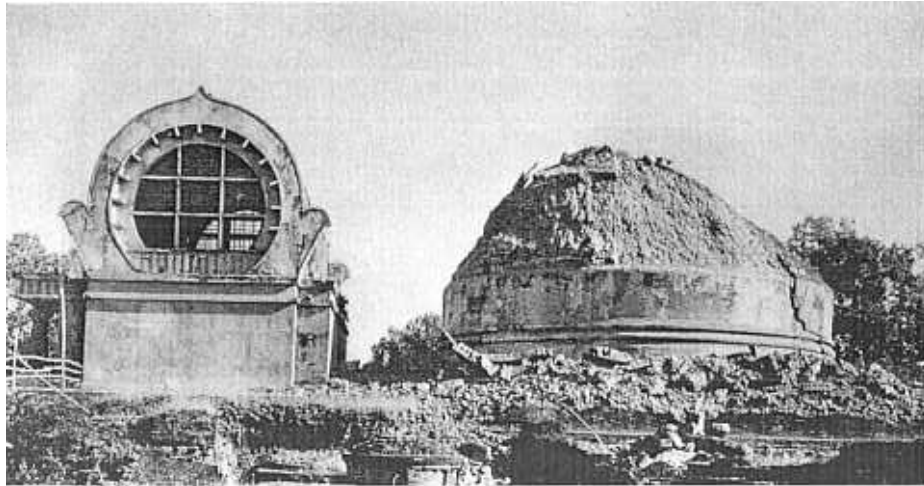
On 4 October 1963, following six days of incessant rain, the renewed *stupa* at Kusinara collapsed with a great noise (Fig. 3). Because of its extraordinary importance, this caused dismay and concern among Buddhists all over the world, and there was a demand that it should be restored to its earlier shape. An assurance was given in Parliament that this would be done, although it is not government policy to build a religious structure of an arbitrary design on an archaeological site. But as the earlier renovation dated from before Indian independence, nothing could be done to alter it even though the decision is one that is not likely ever to be repeated. The rebuilding of ancient monuments is strictly limited to anastylosis, i.e. restoring the fallen members. In this unusual case of the *stupa*, since a drawing of the earlier structure was available, it was decided to restore the original form. This was a departure from the accepted principles of archaeological conservation, and the exception was made specially in order to respect the religious susceptibilities of those who worship the great teacher.

The collapse appears to have been due to the earth filling which had become saturated and so greater in weight and volume; this had caused undue pressure on the enclosing wall, which had finally burst open. The area around the platform on which the *stupa* stands, having been excavated to expose the old structures, remained under water during the

FIG. 3. The *stupa*, after renovation in 1927, collapsed in 1963. The temple was restored in 1956.

rains and for some time after. The sub-soil water level rises high enough each year to permit capillarity, and this was to a large extent the cause of the saturated filling. The disappearance of the gilding on the outer surface is due to the same saturation of the fabric and a consequent rise in salinity. The heavy rains during the six days preceding the collapse only hastened the fall.

The earlier behaviour of the *stupa* is interesting. It seems that cracks appeared generally during the monsoons, with a consequent rise of the sub-soil water level and increased moisture through capillarity. The cracks used to widen gradually, but they were filled in regularly, as they had been before the collapse in 1963; at the time their width varied from 5 to 7 cm. After filling in, glass tell-tales were fixed in order to monitor any further movement. After two months it was observed that out of six repaired cracks, three very narrow ones reappeared on the surface of the drum. According to local officials of the Archaeological Survey, these remained unchanged without any further widening until the day before the collapse.

But there was no record of the construction and no reason to believe the cracks were danger signals; and after the increased saturation of the earth filling because of the six days of rain, nothing could save the *stupa* from collapse. The thin encasing wall—a defect in the original design—could not sustain the extraordinarily excessive thrust produced by the mass of wet earth.

Among the long-term measures, it was suggested that the area around the *stupa* should be kept water-free by draining the stagnant water through a channel connecting the excavated trenches with nearby streams. As for arresting the recurrence of the cracks, since filling in alone would not work, the recommendation was to open up and repair them after the monsoon. Any earlier action was out of the question, since the cracks could not be opened up during the rains without allowing even more water to percolate.

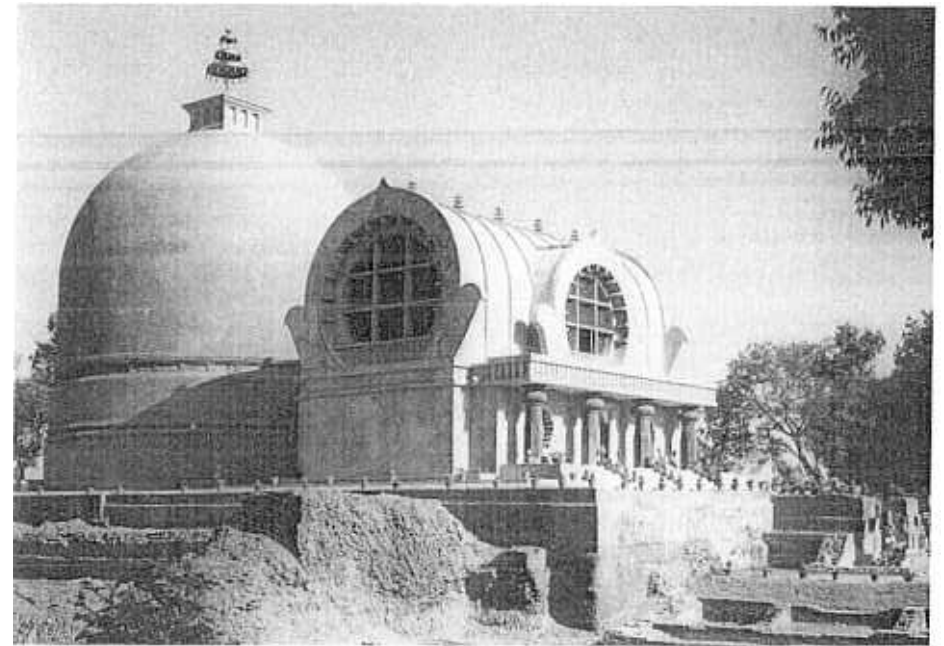
FIG. 5. The *stupa* after restoration and the restored temple of 1956, with the excavated ruins and trenches around them.

providing a reinforced concrete raft to guard against any differential settlement. A waterproofing compound was mixed with the concrete to prevent any rise of moisture through the brickwork of the platform, the base of which remains in contact with water for much of the year. It was decided to fill all the existing trenches to avoid the problem of stagnant water around the monument. The superstructure has been strengthened, especially that part which would be under circumferential tension, by providing reinforced concrete rings embedded horizontally in the brickwork at different levels. These are tied with mild steel stirrups placed vertically at intervals. In the earlier construction of 1927, the Public

Works Department had fixed angle-iron bands in the brick shell; but these did not take care of the tension and vertical cracks resulted. The surface of the brickwork has been plastered, and a waterproofed colour-wash has been applied to give protection (Fig. 5). Thus, the *stupa* which had collapsed was restored, and provision was made to counteract the potential causes which had led to its downfall.

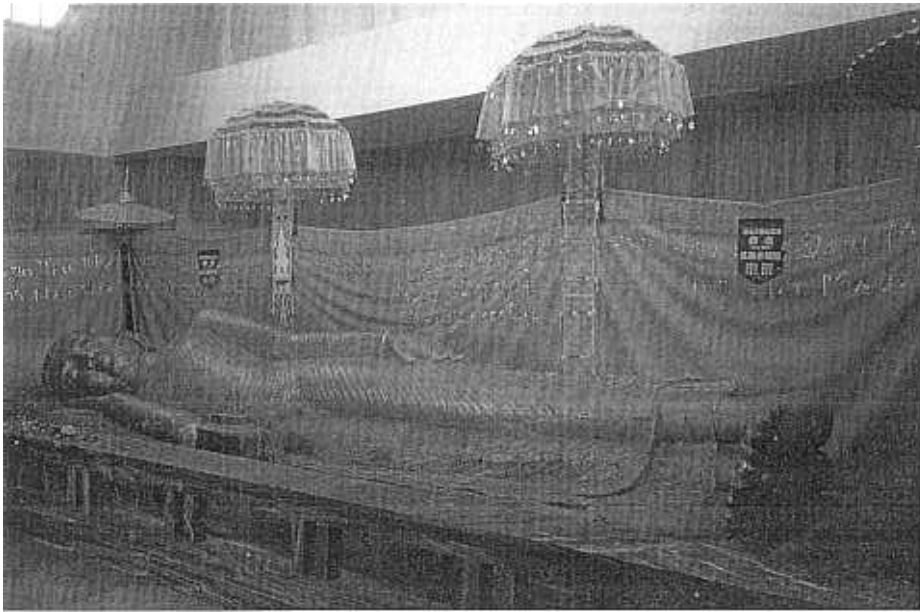
FIG. 6. The statue of the Buddha in *nirvana* pose enshrined in the temple.

so, several parts were missing. As recorded at the time, in 1876, the cavities were filled with a 'strong compound-like stucco, composed of a cement formed of various ingredients among which was Portland cement'. Having completed the repairs, the excavator then applied a coat of paint and coloured the face, neck, hands and feet with a yellowish flesh colour. The drapery was painted white, and the hair black. Fortunately these colours are no longer there, and the image has been more appropriately gilded with gold leaf (Fig. 6).

In places, the plastered parts of the image make a hollow sound when tapped; in other places the stone has flaked off in thin layers, as usually happens when sedimentary sandstone is affected by salt or hydration. For protection, it is proposed to provide a horizontal waterproof membrane at the base; this will have to be placed below the floor level so as to remain concealed.²

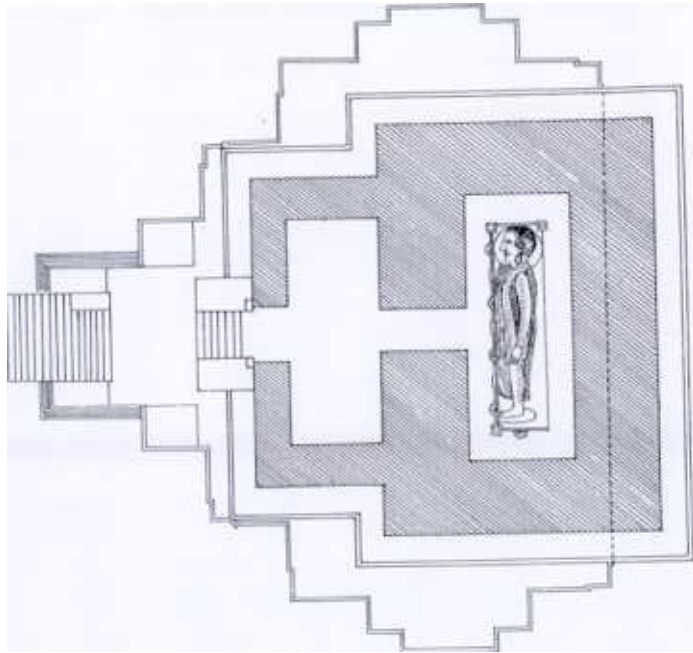
original layout, but erected a simple rectangular structure with a porch. The original form was supposed to have been covered with a vaulted roof, of which fragments recovered from the site were assumed to be part. It is difficult to understand why there was such a deviation from the known designs of contemporary structures, and why the plan of the temple should have been changed (Figs 9, 10). The image of the Buddha also seems to have been shifted from its original place without any justification. In Brahmanic temples, the reclining image of Visnu and the Seven Mothers are required to be enshrined in rectangular structures with vaulted roofs. In this particular case of a Buddhist temple, the ground plan also had to be rectangular because the statue is reclining; and as it is probably the only one of its kind in India, it ought to have been preserved by careful restoration. But the 1876 form has been retained, and there has not been any attempt in the recent restoration to revert to the original design despite the availability of some old drawings and some evidence on the site.

FIG. 9. Plan of the original *nirvana* temple exposed by excavation. The superimposed hatched plan shows the alterations made during the 1876 restoration.

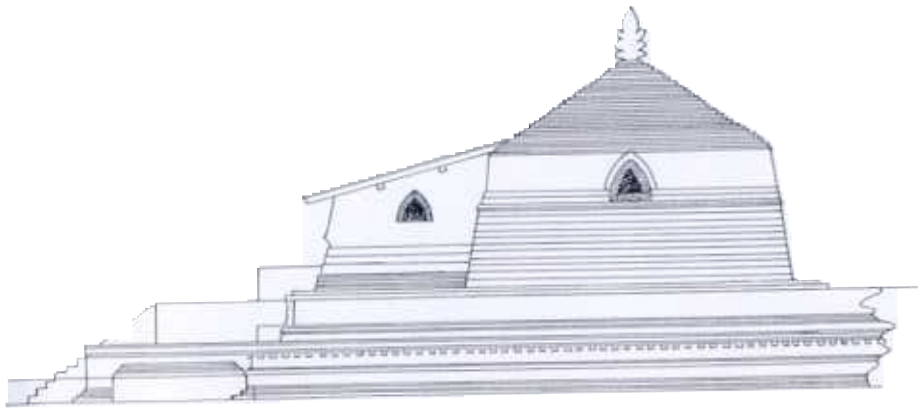
FIG. 10. Elevation of the temple as restored in 1876.
