CONSERVATION OF PAINTED LIME PLASTER ON MUD BRICK WALLS
AT TUMACACORI NATIONAL MONUMENT, U.S.A.

ANTHONY CROSBY

JULY, 1980

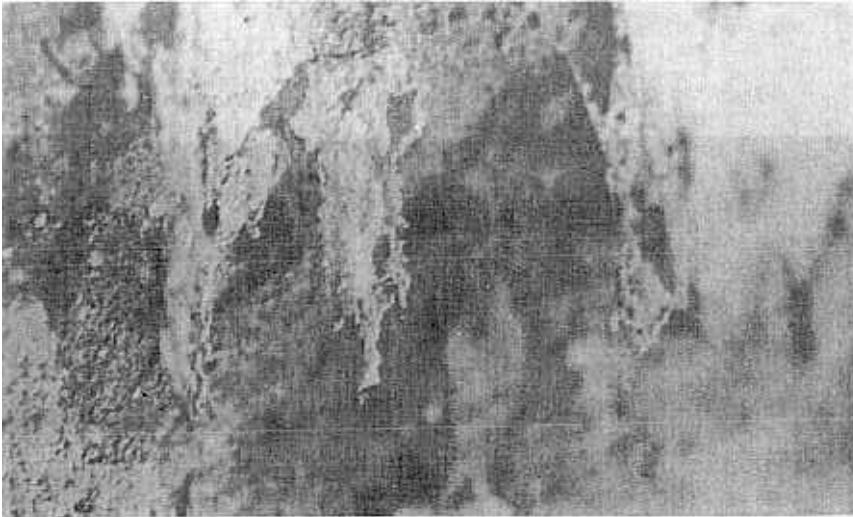
A recent evaluation of this work has clarified the knowledge of both the techniques of application and the performance of the PVA. The application, as described, was accomplished with a spray technique that often resulted in incomplete coverage. In some of the areas where the plaster wash or paint was covered by the PVA, penetration was not achieved and the adhesive material remained only on the surface. In other areas, particularly on the interior surface of the Sanctuary's dome, the PVA penetrated through the first layer of paint only to concentrate on the surface of the next layer. On other areas of high soluble salt concentrations the PVA remains only as a thin, extremely friable film that often hangs down like a thin net from the plaster surface (Figure 3).

Figure 3: Deteriorated dome plaster with FVA applied in 1949 hanging from the surface in thin net. NPS photograph, 1979.

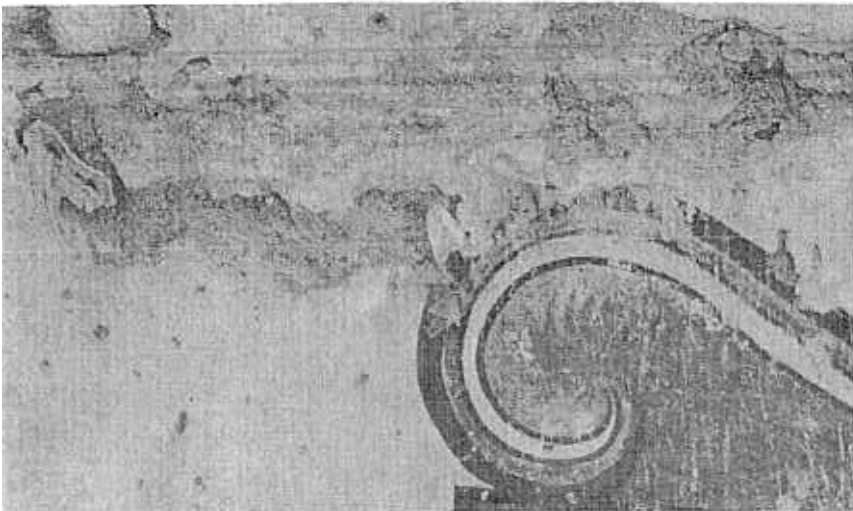
An attempt was made to reattach a few square inches of paint by Mr. Nitkiewicz in March of 1976. This was done in an area where the paint had lost its adhesion to the plaster (Figure 4). The treatment was not successful as the paint in the treated area soon became detached. This was the result of a significant amount of moisture moving through the plaster from the interior of the wall.

Figure 4: Painted plaster in Sanctuary. Note the paper along the top edge of the painted volute that was used in an attempt to temporarily reattach the paint film to the plaster ground. NPS photograph, 1976.

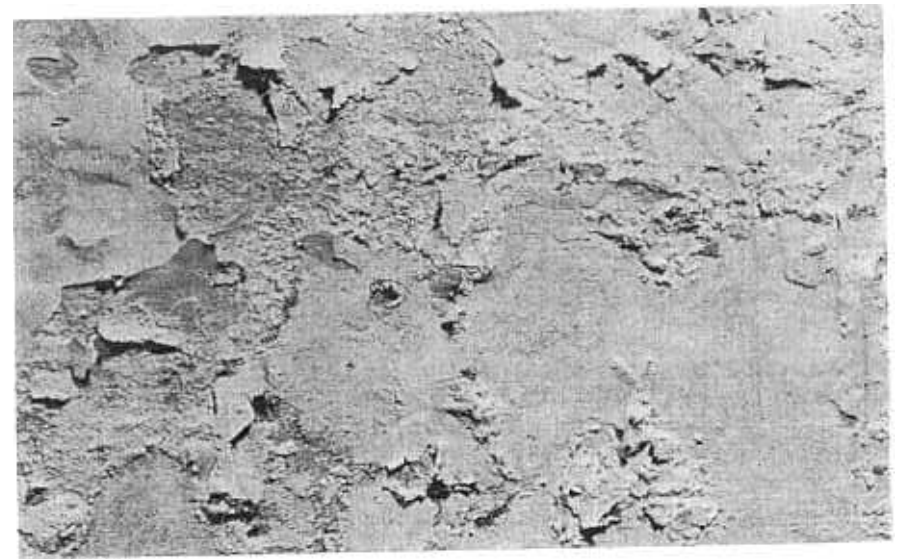
Flaking paint that occurs without an accompanying deterioration of the plaster ground was limited primarily to the area around the northwest pendentive, above the cornice on the west side of the dome, and a small area over the transverse arch between the Sanctuary and the nave. The paint film is thin and after it pulled away from the plaster, even a slight breeze would cause it to fall to the floor. Efflorescence that formed on the plaster in much of these same areas, often pushed the paint film away from the wall (Figure 5).

The source of the problem of course was moisture. Moisture migrated through the dome transporting soluble salts which recrystallized in the form of efflorescence and subflorescence. In the case of efflorescence,

the salts recrystallized on the surface of the plaster, forcing the paint film away from the wall. In the case of subflorescence, the salts recrystallized in the plaster, creating pressures which fractured the plaster causing it to simply fall as it became friable. The recrystallized salts also acted hygroscopically resulting in more ambient moisture being drawn to the area of salt concentration. During the time of the accelerated loss of paint from the northwest pendentive, heavy efflorescence would reappear in a small cleaned area in only two or three days. The efflorescence appeared as recrystallized salts with chloride and nitrate anions.

Figure 5: Plaster surface with extensive deterioration by efflorescence forming on the surface and immediately beneath the paint film. NPS photograph, 1979.

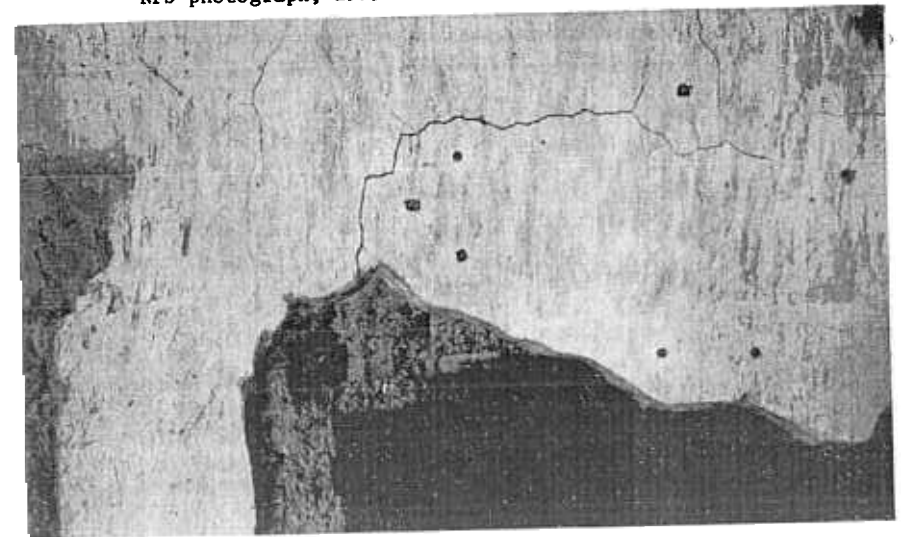
The problem has been dealt with in the past at Tumacacori in two ways. The most prevalent method was to apply a cement bead around all the exposed edges attaching this bead to the walls by some mechanical device such as pins. Much larger steel pins were also used in one section of plaster to replace the effects of original plaster keys that were feared to be of questionable integrity (Sudderth, 1973). Holes were drilled through the plaster and into the mud brick walls. The exterior edge of the hole and the plaster itself were grouted in an attempt to attach the head of the steel pin to the plaster (Figure 6).

The results of this work have been ineffective. In addition, several adverse side effects have arisen and contributed to the deterioration of the plaster. Initially, there was a separation between the steel and the grouted plaster, probably because of the difference in the coefficients of thermal expansion of the two materials. The second and the most

deleterious effect was the deterioration of the plaster in an area approximately 10 centimeters in diameter around the head of the pin. This was caused by the condensation of internal wall moisture on the steel and its concentrated movement from the inside of the wall to the plastered wall surface.

Figure 6: Plaster on interior surface west of the nave wall. Small dark spots are the locations of the steel pins used to secure the plaster to the mud brick walls.

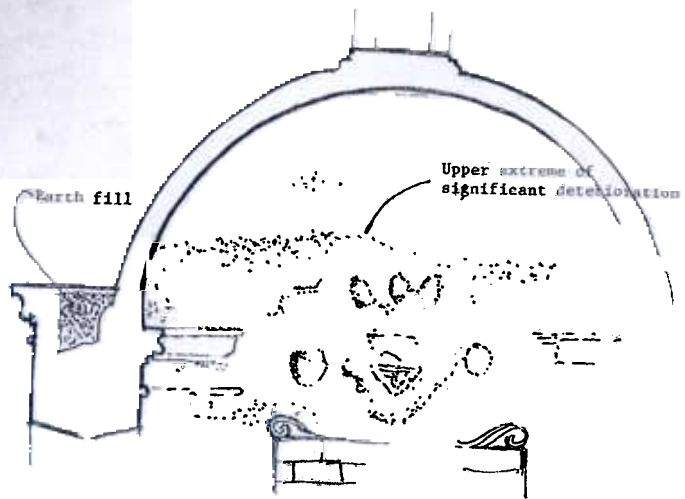
Further investigation after the removal of non-historic cement stucco on the exterior surface of the dome indicated the source of the anionic nitrate salts. A substantial part of the building mass originally constructed to receive the thrust from the dome consisted of earth fill. This fill contained a significant amount of decaying, or decayed organic matter relatively high in concentration of nitrates. The cracked exterior cement stucco allowed moisture to penetrate down to this earth fill material and then, eventually to surface on the interior of the dome.

Figure 7: Partial section through the dome showing the location of the earth fill.

The cement stucco on the dome was removed and replaced with the same lime-sand plaster used on the wall surfaces. The earth fill which proved to be the source of the nitrate anions was removed and replaced with low fired bricks set in lime mortar (Figure 7).

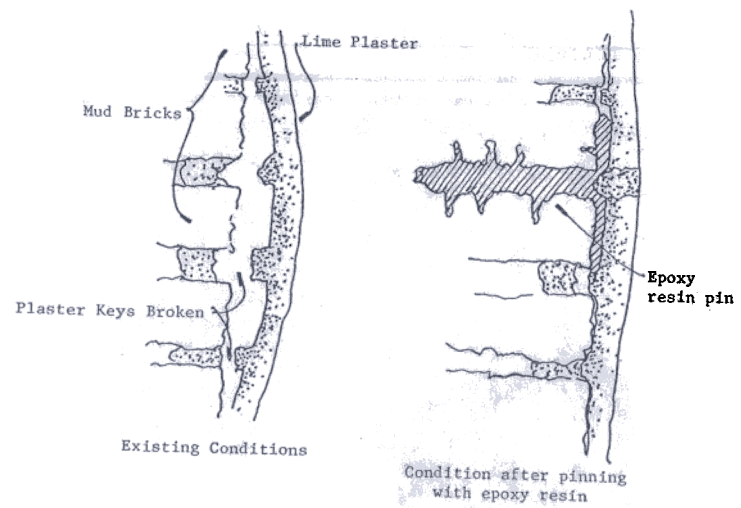
Figure 8: A typical use of an epoxy resin pin to reattach lime plaster to the mud brick wall.

Epoxy resin pins of the formulation given above have also been used on an experimental basis. This seems to give the best promise for a permanent solution. The principal is to simply replace the effect of original plaster keys where they are missing, and to rely on the tensile strength of the plaster in the areas where the pins are not placed (Figure 8). The ability of the epoxy resin to consolidate both materials will make it possible for the resin itself to hold the plaster surface to the pin. If one does not exist, it will be necessary to drill a hole through the plaster and into the brick, but this hole can be filled with a lime grout or another appropriate material such as the cellulose filler.

The depth of the pins into the wall will vary depending on the integrity of the bricks near the surface. In some unusual cases it seemed necessary to extend the pins as much as 30-45 centimeters into the wall. However, in most situations a depth of 10-15 centimeters seems more appropriate. Of course the length of the pins and its depth in the wall will also depend somewhat on the amount of plaster that is being supported.
