THE EFFECTS OF MODERN RESTORATION TECHNIQUES ON THE PREHISTORIC TEMPLES OF THE MALTESE ISLANDS

Gennaro TAMPONE, Dipartimento di Storia dell'Architettura e di Restauro delle Strutture Architettoniche, Università di Firenze, ITALIA.

Sergio VANNUCCI, Istituto di Mineralogia e Petrografia dell'Università di Urbino, ITALIA.

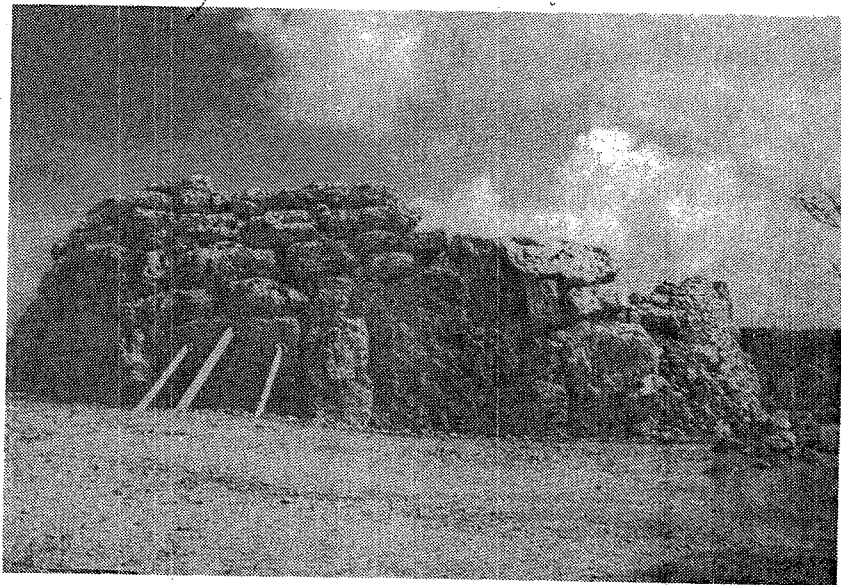
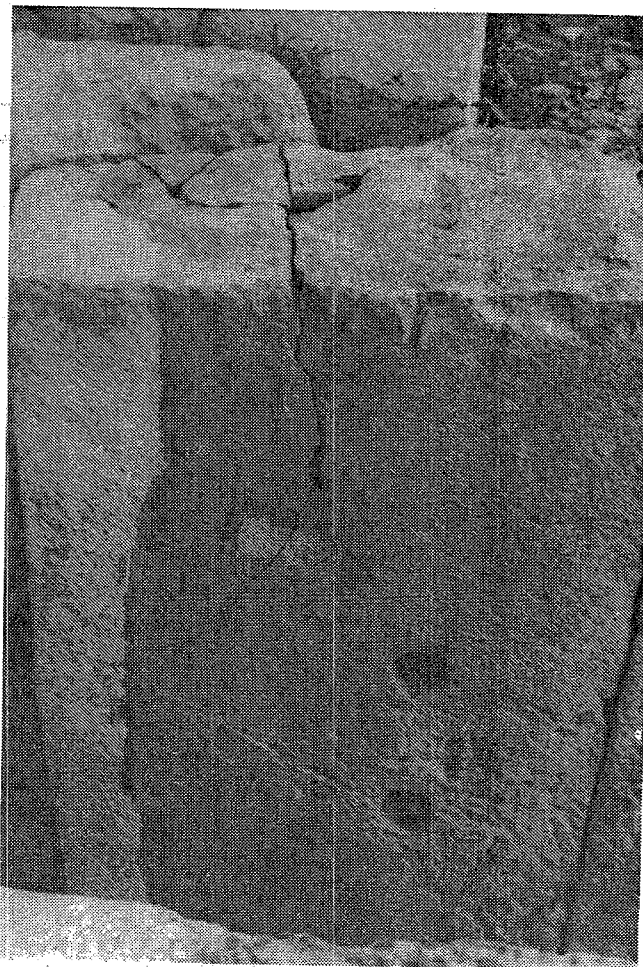
A very few examples of the insertion of swallow-tailed stone elements to connect blocks affected by cracks, which can seem a natural practi-

ce in the restoration of stone monuments, can be observed in the Tarxien temple. No records of them can be found but we may suppose that were done soon after excavation. In one case the device itself has broken owing to further movement and in another the crack later by-passed the device. In both cases, in fact, the cause of the cracks had not been removed.

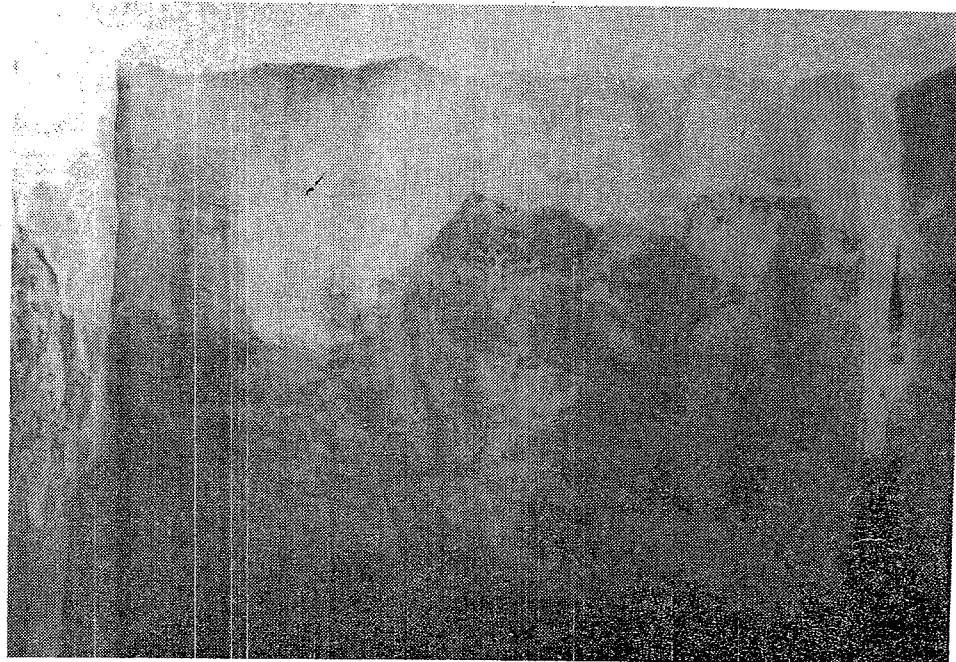
The most extensive repair work on the Maltese temples has been carried out with the ample funds provided by an American foundation. Caps of concrete (?) were put on the broken blocks in order both to prevent further degradation and, more importantly, to recover a partial image of the

construction. The Tarxien temples have been extensively submitted to this treatment which would be unthinkable today. A number of the problems which have to be faced today arise out of the great hardness of the concrete in comparison with the softness of the Globigerina Limestone. Furthermore, the free upper surfaces of the caps channel rainwater to flow down the vertical surfaces of the blocks. The huge block of Tarxien which carries the bas-relief of the sow and bulls is a dramatic example of the seriousness

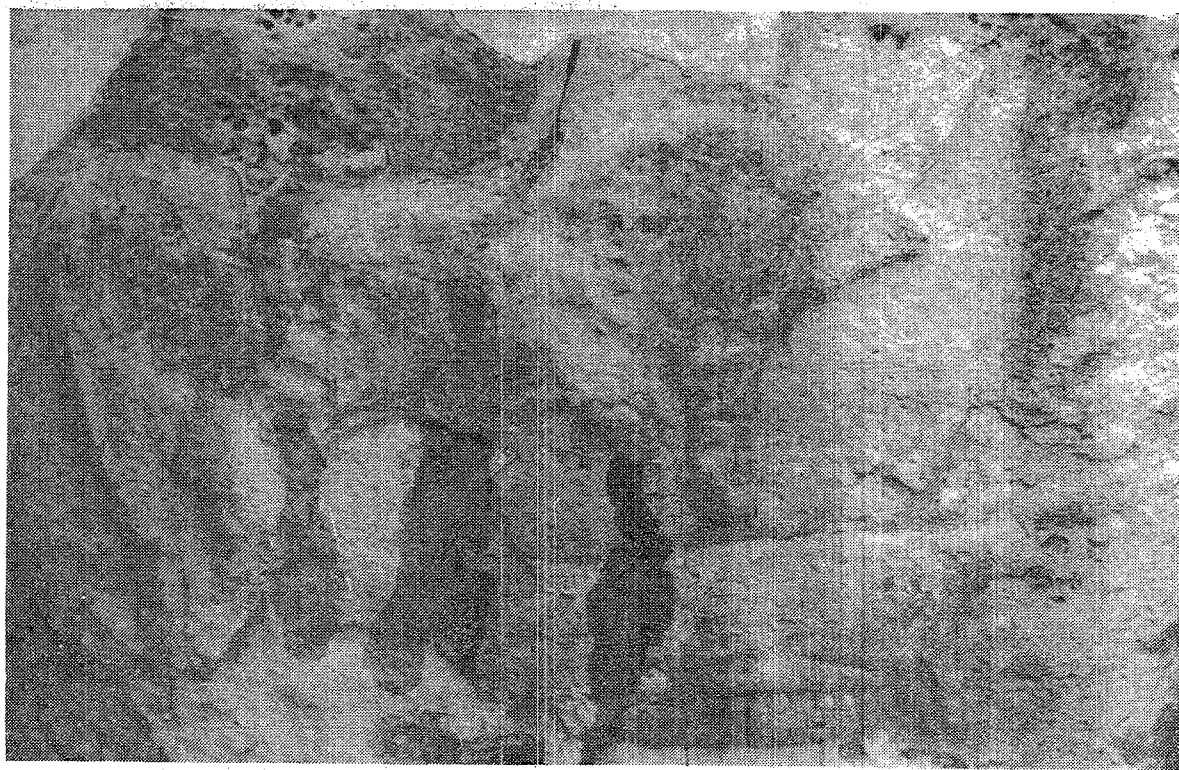
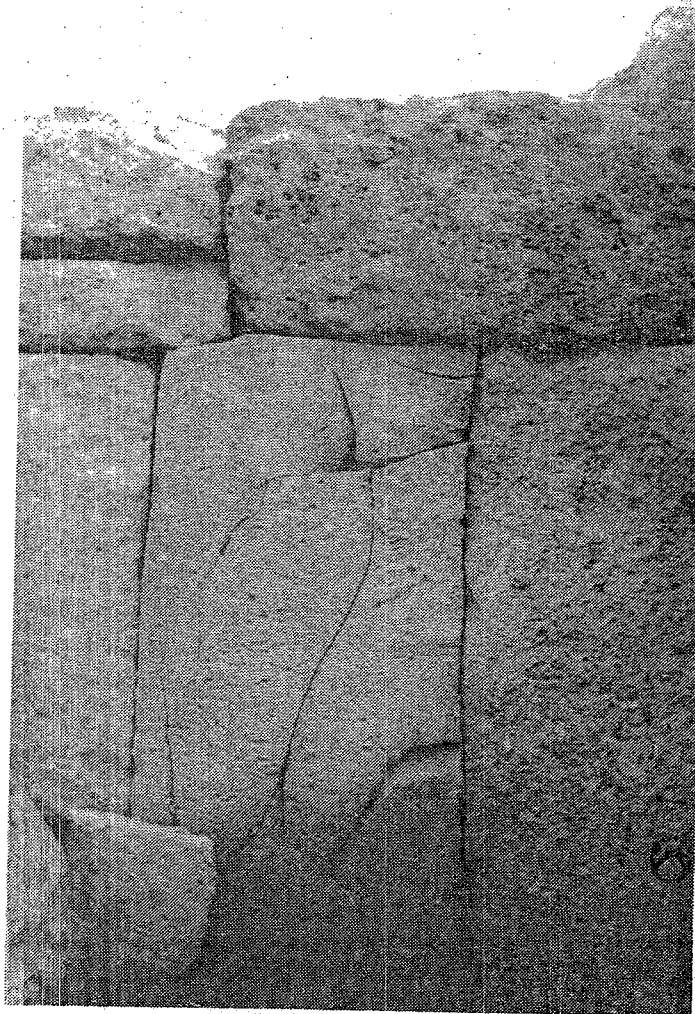
The condition of the bas-relief, which is already difficult to decipher because of missing parts and of the rough and chimsy sealing of cracks with grey cement, is precarious, and if it continues in this same condition it is likely to be completely destroyed within a few years. The part which includes the bull and sow has become almost completely detached and is virtually a huge flake held to the substratum at a few limited points as has been verified with internal water percolation tests (see plate). The phenomenon of detachment is favoured by the fact that the blocks have been worked with their major surface parallel to the original stratification of the rock, but there is no doubt that the modelling of the bas-relief

did, in itself, cause some damage in this respect. The surface with the three figures is severely decayed by "corrosion", desaggregation and the flaking off of minute particles.
