F.W.B. CHARLES:

Bredon Tithe Barn

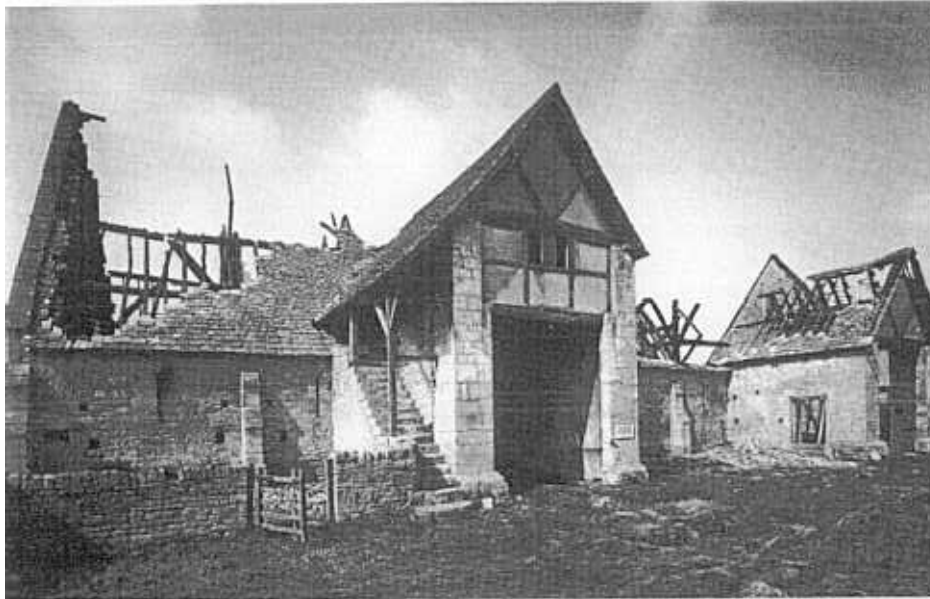
1. View from south-east a week after the fire
Vue du sud-est une semaine après l'incendie

how the heat had built up at the north end, where the fire started and, owing to the absence of ventilation until whole chunks of the roof had collapsed, swept through the length of the barn to the south end where the damage to the stone was the greater.

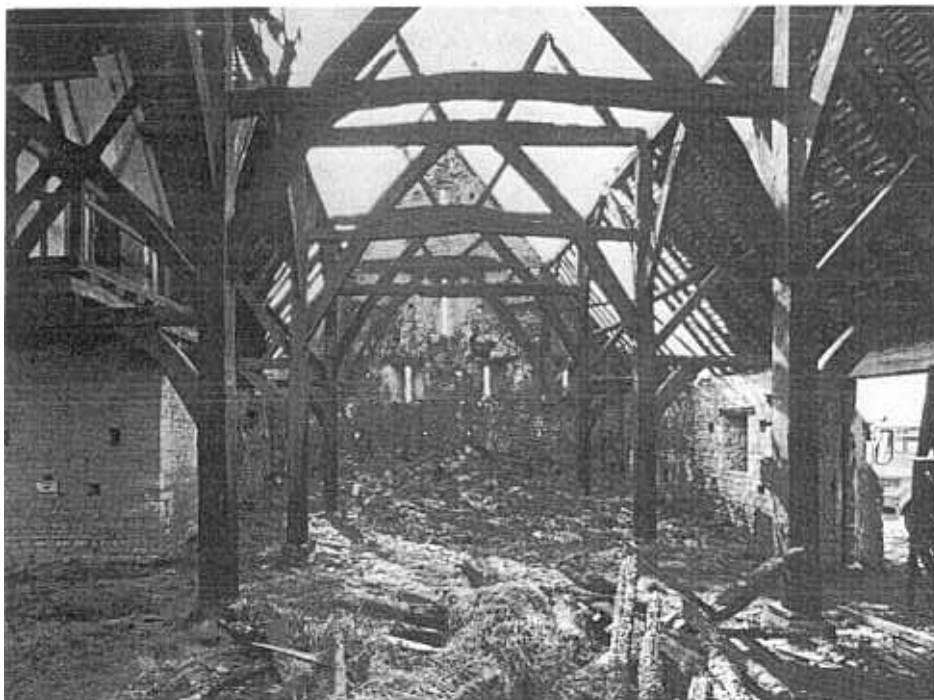
What remained at the end of the day was a hulk of reddened stone; blackened timbers with charring up to half-and-inch thick, either fallen or still standing in a series of nightmarish abstract sculptures, taking on more structural forms as one looked from either end to the trusses near the south-east porch; a few thousand slates, out of a total of

2. Interior looking south, after the fire
Intérieur vers le sud, après l'incendie
