**Preliminary Survey of Tsunami-affected Monuments  
and Sites in the Maritime Region of Sri Lanka**

**The Southern Maritime Region:  
from the Nilvala Ganga to the Gin Ganga**

Prof. S. Manawadu  
and  
The ACOMAS Unit of the Department of Architecture  
University of Moratuwa

March 2005

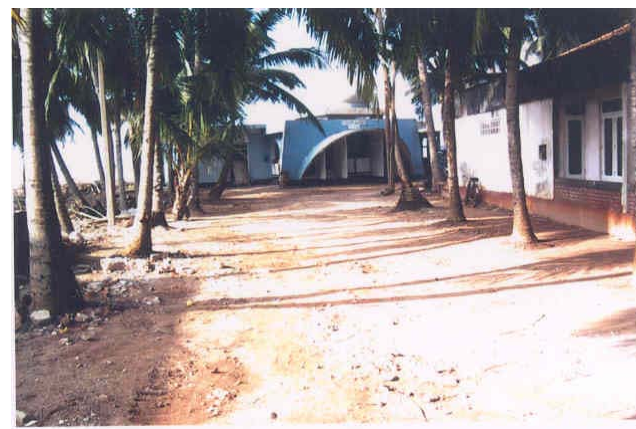
<b>Element</b>	<b>Material</b>		<b>Extent of Damage</b>		
<i>Roof</i>					
<i>Walls</i>	Masonry		30%		
<i>Doors</i>	Timber		80%		
<i>Windows</i>	Timber		80%		
<i>Floor</i>	Cement		30%		
<i>Foundation</i>	Rubble				
<i>Site</i>					
<i>Other</i>

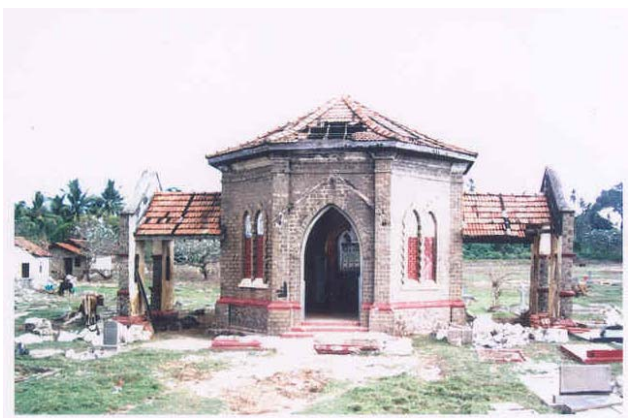
<p>Chapel Cemetery Colombo - 50 Miles road</p>

<b>Element</b>		<b>Material</b>		<b>Extent of Damage</b>	
<i>Roof</i>		Calicut tiles		50 %	
<i>Walls</i>		Dressed stone		10%	
<i>Doors</i>		Timber		100%	
<i>Windows</i>		-			
<i>Floor</i>		Cement		10%	
<i>Foundation</i>		Rubble		-	
<i>Site</i>		Damaged			
<i>Other</i>		Tombs in cemetery damaged 50%

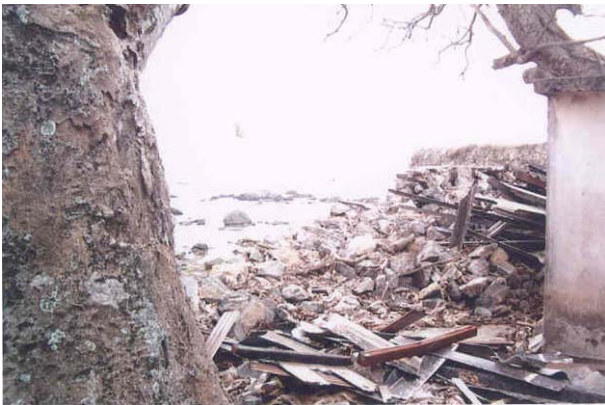
<b>Element</b>		<b>Material</b>	<b>Extent of Damage</b>		
<i>Roof</i>		<p>Parts of the rampart behind the Old Kachcheri have been damaged in three places.</p>			
<i>Walls</i>					
<i>Doors</i>					
<i>Windows</i>					
<i>Floor</i>					
<i>Foundation</i>					
<i>Site</i>					
<i>Other</i>

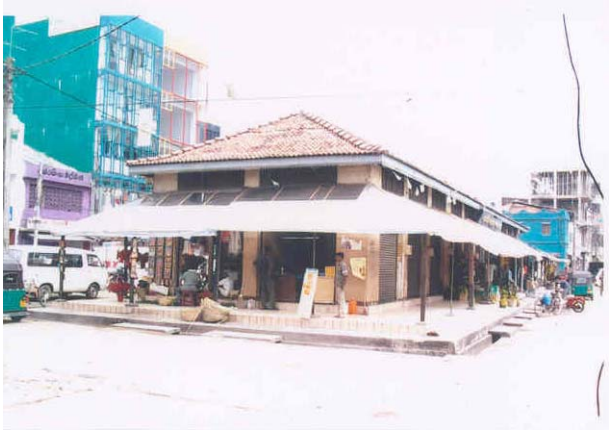
<b>Element</b>		<b>Material</b>		<b>Extent of Damage</b>	
<i>Roof</i>		Tiles		100% of verandah roof	
<i>Walls</i>		Timber pillars		75%	
<i>Doors</i>		Aluminium		20%	
<i>Windows</i>					
<i>Floor</i>		Cement		10%	
<i>Foundation</i>					
<i>Site</i>					
<i>Other</i>

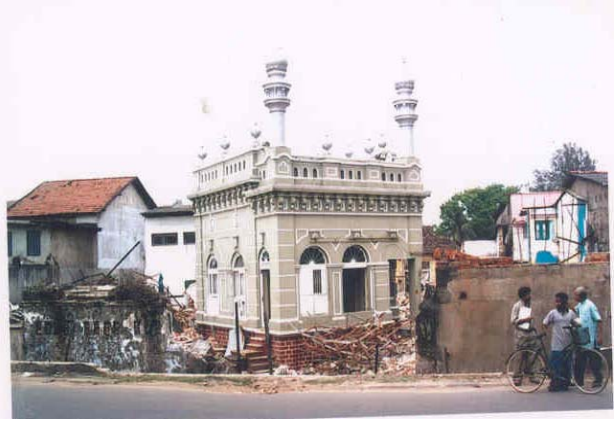
<b>Element</b>		<b>Material</b>	<b>Extent of Damage</b>		
<i>Roof</i>		Except for the middle part, all the structures were completely destroyed.			
<i>Walls</i>					
<i>Doors</i>					
<i>Windows</i>					
<i>Floor</i>					
<i>Foundation</i>					
<i>Site</i>					
<i>Other</i>		Only the centre of the building remains, other structures have been destroyed.

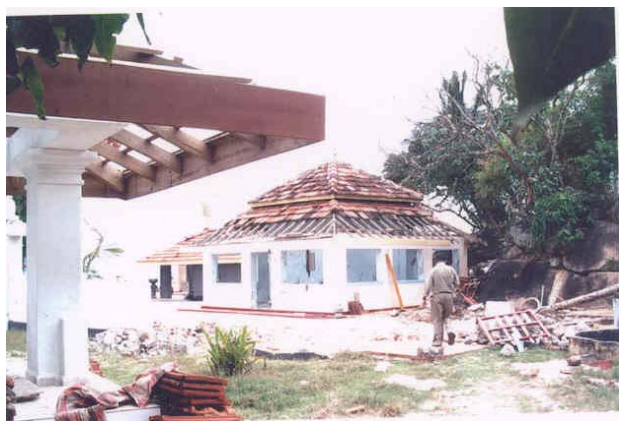
<b>Element</b>	<b>Material</b>	<b>Extent of Damage</b>		
<i>Roof</i>	Calicut tiles	100%		
<i>Walls</i>	Masonry	60%		
<i>Doors</i>	Timber	100%		
<i>Windows</i>	Timber	100%		
<i>Floor</i>	Cement	50%		
<i>Foundation</i>	Rubble	10%		
<i>Site</i>				
<i>Other</i>	Complex of three buildings (all damaged), interior structures partially damaged. Water level above the roof.

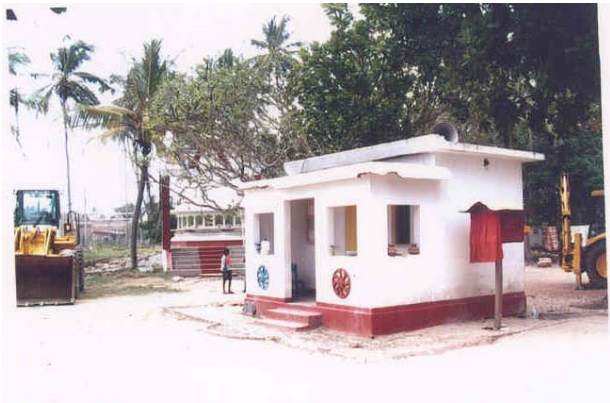
<b>Element</b>	<b>Material</b>	<b>Extent of Damage</b>		
<i>Roof</i>	Tiles	Preaching hall (modern building), entirely (100%) destroyed.		
<i>Walls</i>	Masonry	100%		
<i>Doors</i>	Timber	100%		
<i>Windows</i>	Timber	100%		
<i>Floor</i>				
<i>Foundation</i>				
<i>Site</i>				
<i>Other</i>

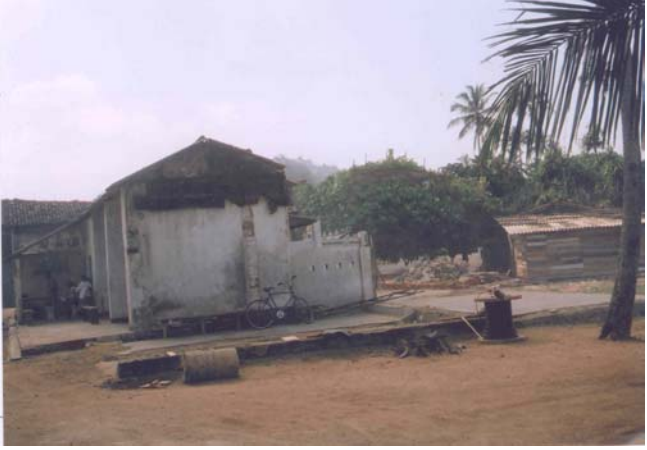
<b><i>Element</i></b>	<b><i>Material</i></b>	<b><i>Extent of Damage</i></b>		
<i>Roof</i>	Timber, asbestos and half round tiles	40%		
<i>Walls</i>	Rubble, lime	30%		
<i>Doors</i>	Timber	40%		
<i>Windows</i>	Timber	30%		
<i>Floor</i>	Cement	30%		
<i>Foundation</i>	Rubble	10%		
<i>Site</i>	Sandy			
<i>Other</i>	Former Hospital for Lunatics. Buildings are more than 100 years old.

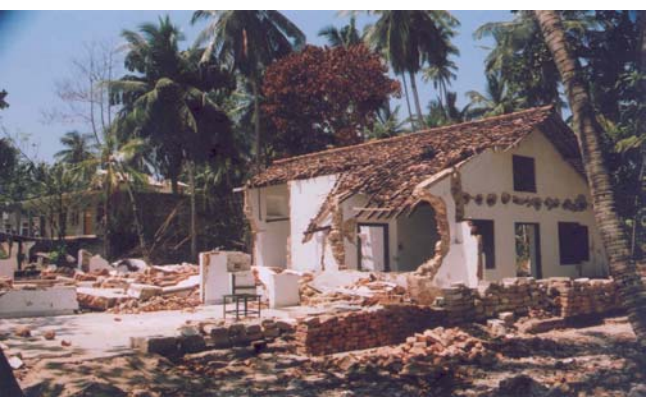
<b>Element</b>		<b>Material</b>		<b>Extent of Damage</b>	
<i>Roof</i>		Half round tiles		70%	
<i>Walls</i>		Lime stone, clay		70%	
<i>Doors</i>		Timber		90%	
<i>Windows</i>		Timber		90%	
<i>Floor</i>		Cement		80%	
<i>Foundation</i>		Rubble		10%	
<i>Site</i>		Sand		10%	
<i>Other</i>

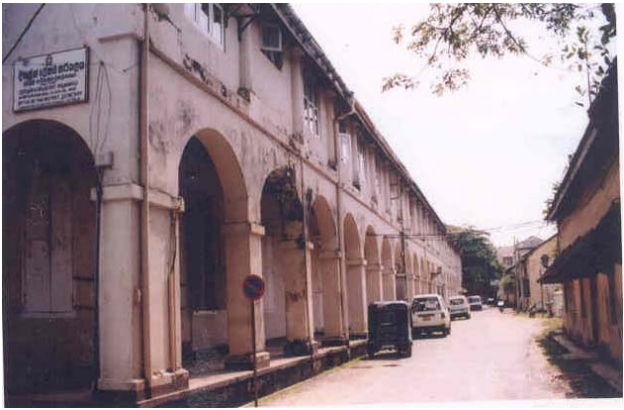
<b><i>Element</i></b>		<b><i>Material</i></b>		<b><i>Extent of Damage</i></b>	
<i>Roof</i>					
<i>Walls</i>		Caboock		10%	
<i>Doors</i>		Timber		20% (Ground Floor)	
<i>Windows</i>		Timber		20% (Ground Floor)	
<i>Floor</i>		Cement		10%	
<i>Foundation</i>		Rubble			
<i>Site</i>					
<i>Other</i>

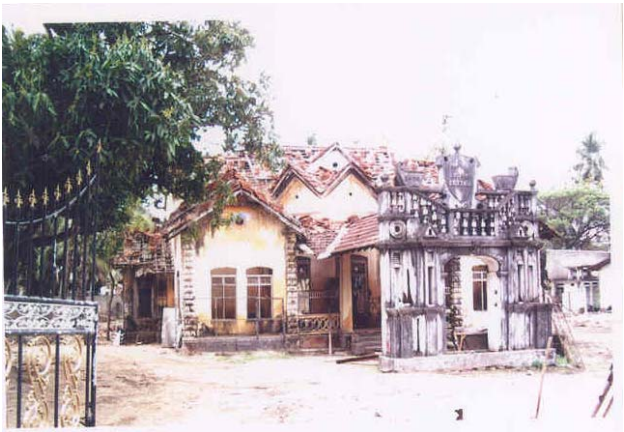
<b>Element</b>		<b>Material</b>		<b>Extent of Damage</b>	
<i>Roof</i>		Calicut tiles		20% (lower roof 50%)	
<i>Walls</i>		Cabock		30%	
<i>Doors</i>		Timber		GF - 100%	
<i>Windows</i>		Timber		GF - 100%	
<i>Floor</i>		Cement		30%	
<i>Foundation</i>		Rubble			
<i>Site</i>					
<i>Other</i>		Water level at the site had been 7'.0

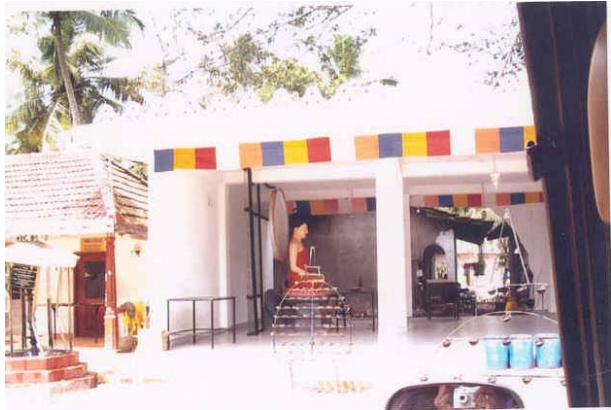
<b>Element</b>		<b>Material</b>		<b>Extent of Damage</b>	
<i>Roof</i>		Calicut tiles and R.C.C.		No damage	
<i>Walls</i>		Masonry		10%	
<i>Doors</i>		Timber		No damage	
<i>Windows</i>		Timber		No damage	
<i>Floor</i>		Cement		No damage	
<i>Foundation</i>					
<i>Site</i>					
<i>Other</i>		4'.0" water level

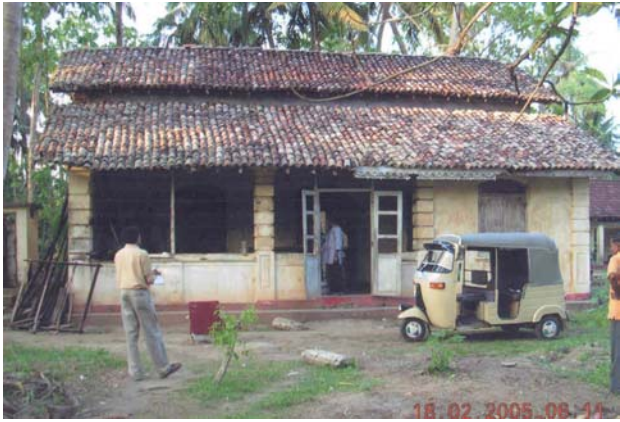
<b><i>Element</i></b>	<b><i>Material</i></b>	<b><i>Extent of Damage</i></b>		
<i>Roof</i>	Half round tiles	2%		
<i>Walls</i>	Limestone	2%		
<i>Doors</i>	Timber	30%		
<i>Windows</i>	Timber	25%		
<i>Floor</i>	Cement	-		
<i>Foundation</i>	Limestone	-		
<i>Site</i>				
<i>Other</i>

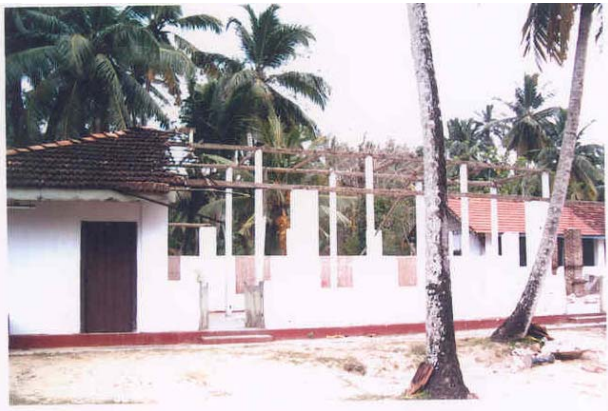
<b><i>Element</i></b>	<b><i>Material</i></b>	<b><i>Extent of Damage</i></b>		
<i>Roof</i>	Calicut tiles	100%		
<i>Walls</i>	Masonry	50%		
<i>Doors</i>	Timber	50%		
<i>Windows</i>	Timber	50%		
<i>Floor</i>	Cement			
<i>Foundation</i>				
<i>Site</i>				
<i>Other</i>	Preaching hall damaged, old <i>avasage</i> slightly damaged.

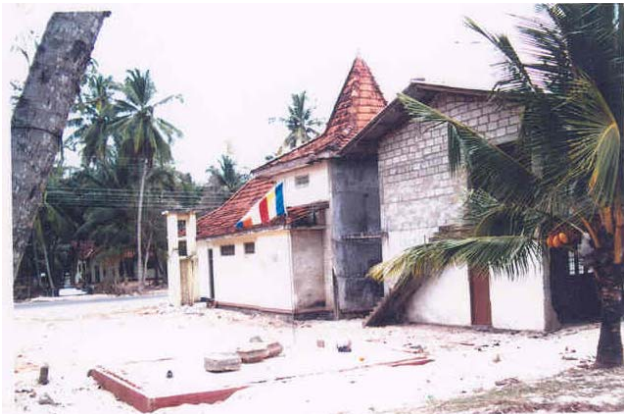
<p>Photograph of the Subadraramaya building, a traditional structure with a tiled roof and a flag.</p>		
<b>Element</b>		<b>Material</b>		<b>Extent of Damage %</b>	
				Preaching Hall	Avasage
<i>Roof</i>	Tiles		100%	50%	
<i>Walls</i>	Masonry		100%	31%	
<i>Doors</i>	Timber		100%	5%	
<i>Windows</i>	Timber		100%	50%	
<i>Floor</i>	Cement		100%	30%	
<i>Foundation</i>	Rubble		100%	-	
<i>Site</i>					
<i>Other</i>

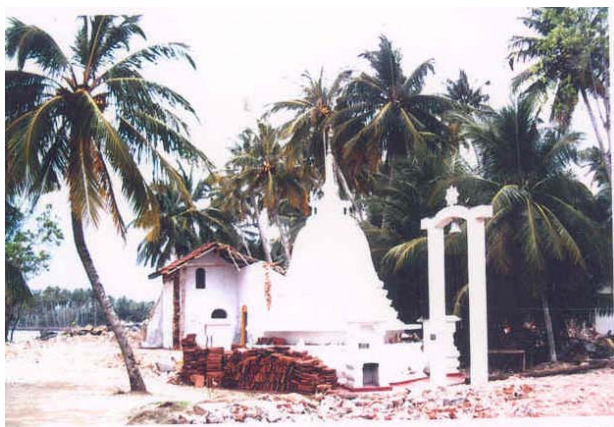
<b>Element</b>		<b>Material</b>		<b>Extent of Damage</b>	
<i>Roof</i>		Tiles		100%	
<i>Walls</i>		Brick		100%	
<i>Doors</i>		Timber		100%	
<i>Windows</i>		Timber		100%	
<i>Floor</i>		Cement		100%	
<i>Foundation</i>		Rubble		100%	
<i>Site</i>					
<i>Other</i>		The monument on the island is partially damaged.

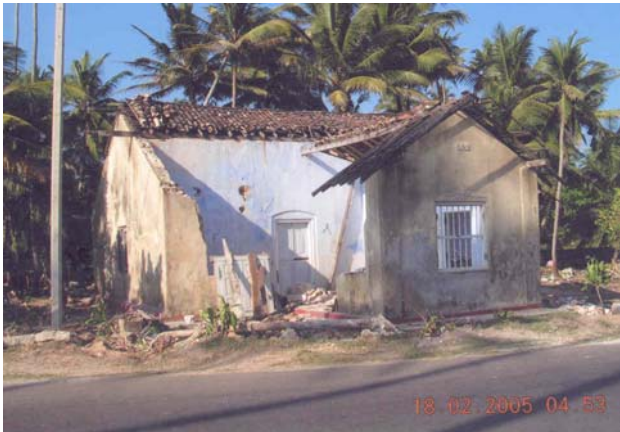
<b><i>Element</i></b>		<b><i>Material</i></b>		<b><i>Extent of Damage</i></b>	
<i>Roof</i>		Half round tile		35%	
<i>Walls</i>		Limestone, mud and sand		30%	
<i>Doors</i>		Timber		40%	
<i>Windows</i>		Timber		40%	
<i>Floor</i>		Cement (1500 sq.ft)		30%	
<i>Foundation</i>		Brick		-	
<i>Site</i>		-		20%	
<i>Other</i>

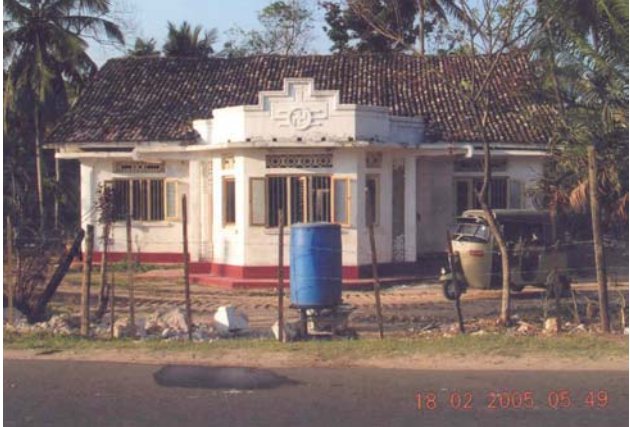
<b><i>Element</i></b>		<b><i>Material</i></b>		<b><i>Extent of Damage</i></b>	
<i>Roof</i>		Half round tile		10%	
<i>Walls</i>		Limestone		15%	
<i>Doors</i>		Timber		75%	
<i>Windows</i>		Timber		80%	
<i>Floor</i>		Cement		5%	
<i>Foundation</i>				5%	
<i>Site</i>					
<i>Other</i>

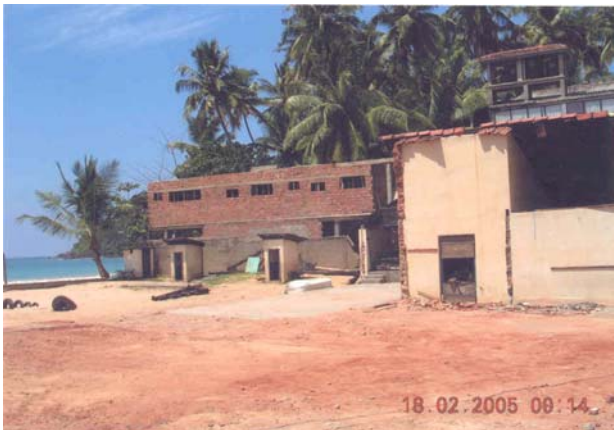
<b><i>Element</i></b>		<b><i>Material</i></b>	<b><i>Extent of Damage</i></b>	
<i>Roof</i>		Calicut tiles	50%	
<i>Walls</i>		Brick and limestone	50%	
<i>Doors</i>		Timber	50%	
<i>Windows</i>		-	-	
<i>Floor</i>		Cement	50%	
<i>Foundation</i>		Limestone	20%	
<i>Site</i>		-	-	
<i>Other</i>		-

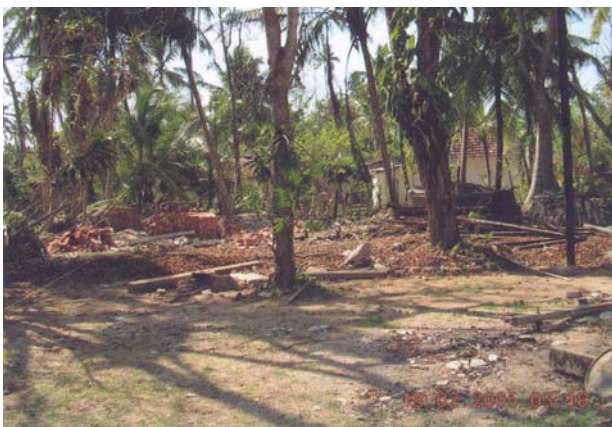
<b>Element</b>		<b>Material</b>		<b>Extent of Damage</b>	
<i>Roof</i>		Half round tile		100%	
<i>Walls</i>		Clay brick		100%	
<i>Doors</i>		Timber		100%	
<i>Windows</i>		-		100%	
<i>Floor (600Sqft)</i>		Cement		100%	
<i>Foundation</i>		Masonry		-	
<i>Site</i>		-		-	
<i>Other</i>		-

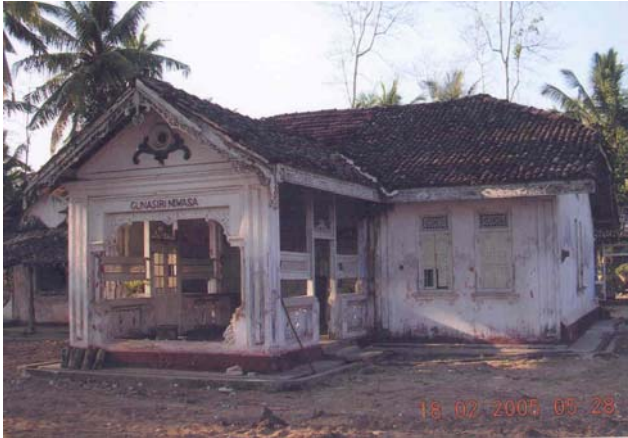
<b>Element</b>		<b>Material</b>		<b>Extent of Damage</b>	
Roof		Half round tile		10%	
Walls		Limestone		5%	
Doors		Timber		60%	
Windows		Timber		50%	
Floor		Cement floor 2500sqft		5%	
Foundation		Limestone		-	
Site		-			
Other

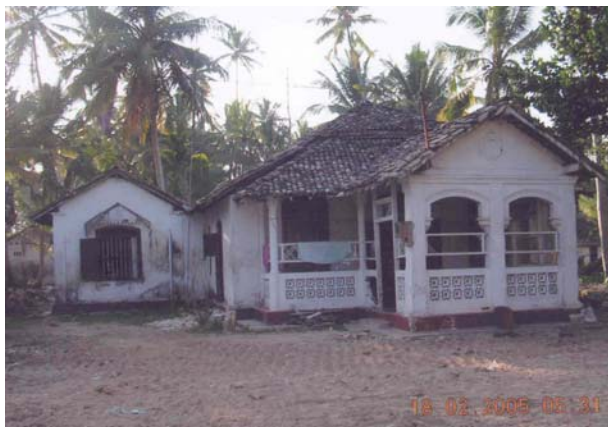
<b>Element</b>		<b>Material</b>		<b>Extent of Damage</b>	
<i>Roof</i>		Half round tile		40%	
<i>Walls</i>		Limestone. Sand and lime		20%	
<i>Doors</i>		Timber/glass (double shash)		25%	
<i>Windows</i>		Timber		10%	
<i>Floor</i>		Cement		-	
<i>Foundation</i>		Limestone		-	
<i>Site</i>		-		-	
<i>Other</i>

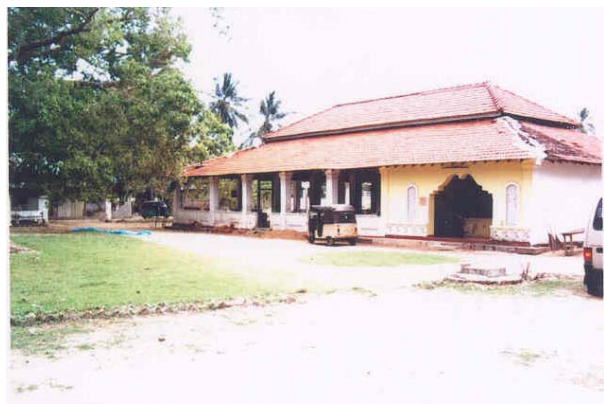
<b>Element</b>		<b>Material</b>		<b>Extent of Damage</b>	
<i>Roof</i>		Tiles		No damage	
<i>Walls</i>		Masonry		Preaching hall 10% Bo-tree shrine, Boundary wall 100%	
<i>Doors</i>		Timber		No damage	
<i>Windows</i>		Timber			
<i>Floor</i>					
<i>Foundation</i>					
<i>Site</i>					
<i>Other</i>

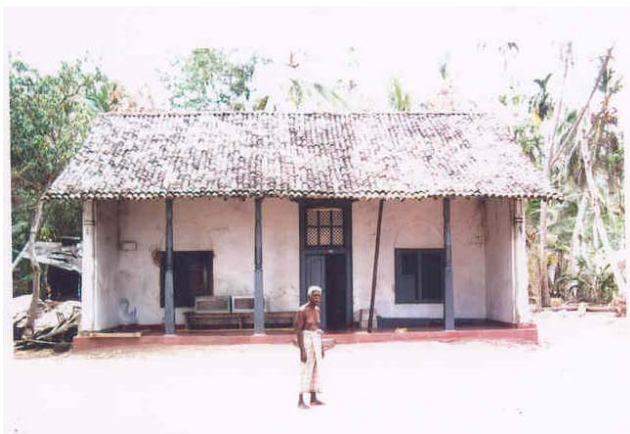
<b>Element</b>		<b>Material</b>		<b>Extent of Damage</b>	
<i>Roof</i>		Half round tiles		10%	
<i>Walls</i>		Limestone Timber columns		10% 20%	
<i>Doors</i>		Timber		30%	
<i>Windows</i>		Timber		30%	
<i>Floor</i>					
<i>Foundation</i>					
<i>Site</i>					
<i>Other</i>		New kitchen totally damaged.

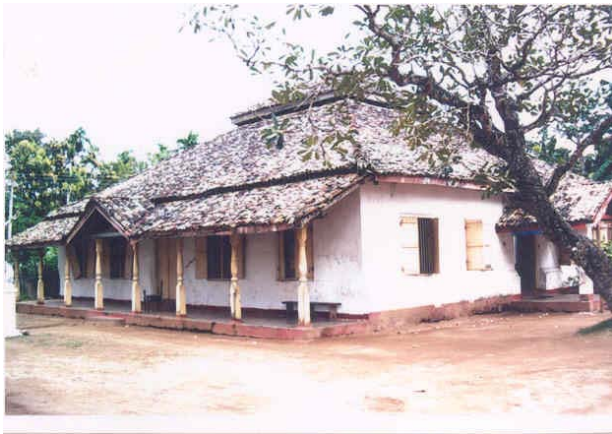
<b>Element</b>		<b>Material</b>		<b>Extent of Damage</b>	
<i>Roof</i>		Half round tiles		No damage	
<i>Walls</i>		Limestone		Paintings of image house could be affected due to flooding outside	
<i>Doors</i>		Timber		5%	
<i>Windows</i>		Timber		5%	
<i>Floor</i>		Cement		-	
<i>Foundation</i>		Rubble		-	
<i>Site</i>					
<i>Other</i>

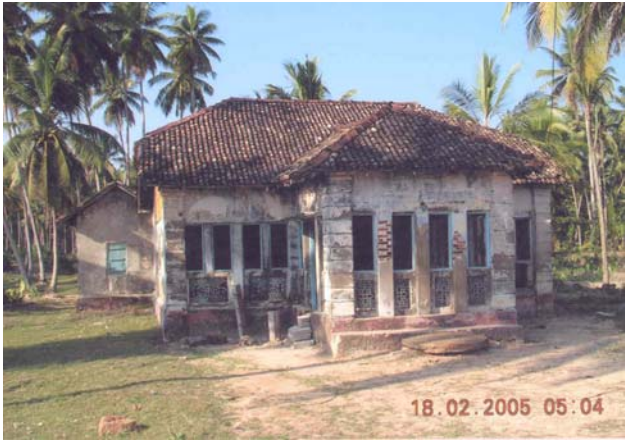
<b>Element</b>		<b>Material</b>		<b>Extent of Damage</b>	
<i>Roof</i>		Half round tiles		15%	
<i>Walls</i>		Limestone		5%	
<i>Doors</i>		Timber		10%	
<i>Windows</i>		Timber		10%	
<i>Floor</i>		Cement			
<i>Foundation</i>					
<i>Site</i>					
<i>Other</i>

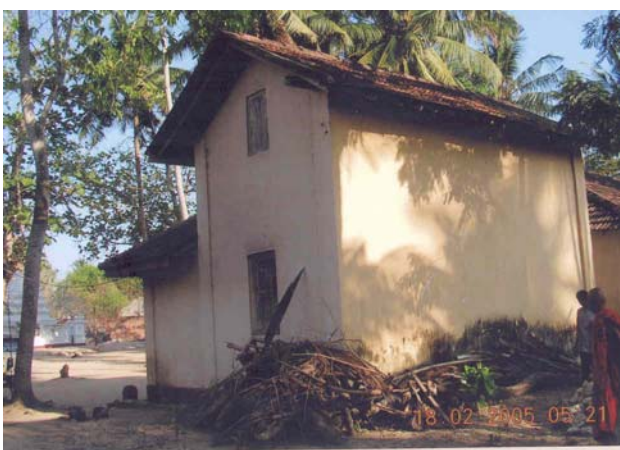
<b><i>Element</i></b>	<b><i>Material</i></b>		<b><i>Extent of Damage</i></b>		
<i>Roof</i>	Clay tiles		-		
<i>Walls</i>	Limestone		15%		
<i>Doors</i>	Timber		-		
<i>Windows</i>	Timber		-		
<i>Floor</i>	Cement		-		
<i>Foundation</i>					
<i>Site</i>					
<i>Other</i>

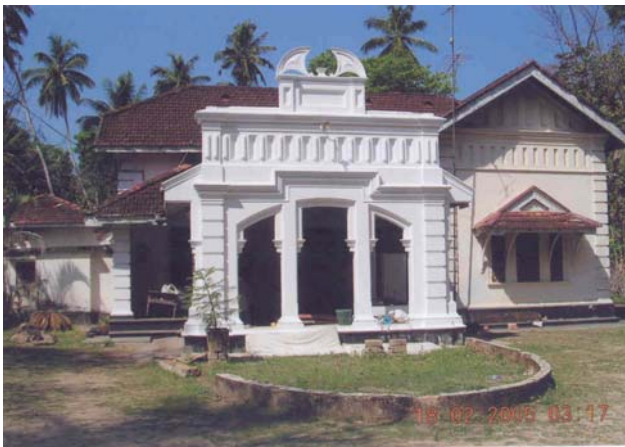
<b>Element</b>		<b>Material</b>		<b>Extent of Damage</b>	
<i>Roof</i>		Half round and Calicut tiles.		5%	
<i>Walls</i>		Limestone		-	
<i>Doors</i>		Timber		10%	
<i>Windows</i>		-		-	
<i>Floor</i>		Cement		-	
<i>Foundation</i>		Brick		-	
<i>Site</i>					
<i>Other</i>

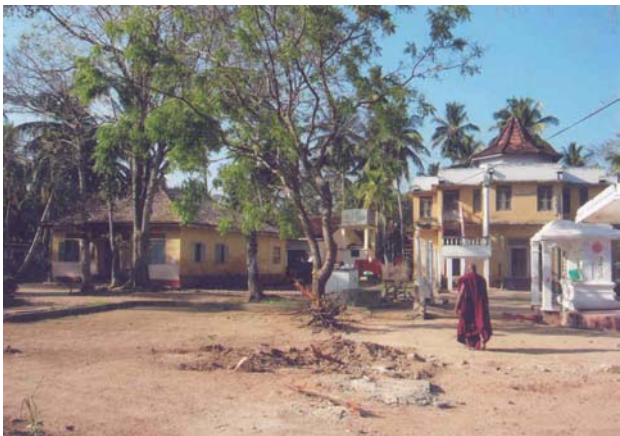
<b><i>Element</i></b>		<b><i>Material</i></b>		<b><i>Extent of Damage</i></b>	
<i>Roof</i>		Half round tile		10%	
<i>Walls</i>		Clay and cabock		25%	
<i>Doors</i>		Timber		5%	
<i>Windows</i>		Timber		5%	
<i>Floor</i> (Area 2500 Ft 2)		Cement rendered		5%	
<i>Foundation</i>		-		-	
<i>Site</i>		Boundary wall (9000 Sq.ft) damaged.			
<i>Other</i>

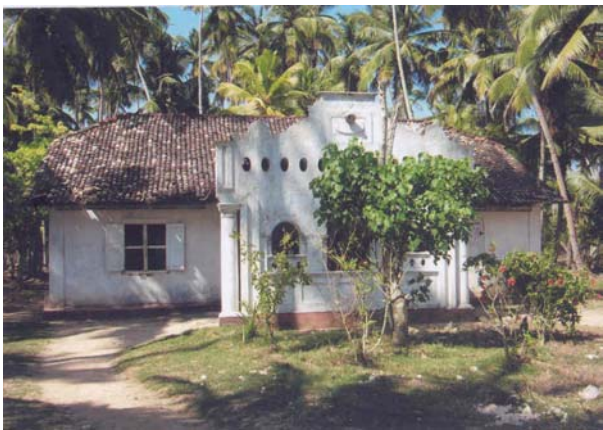
<b>Element</b>		<b>Material</b>		<b>Extent of Damage</b>	
<i>Roof</i>		Half round tiles and timber		10%	
<i>Walls</i>		Limestone and lime mortar		5%	
<i>Doors</i>		Timber		5%	
<i>Windows</i>		Timber		5%	
<i>Floor (area 1800 sq.ft)</i>		Cement rendered		10%	
<i>Foundation</i>		Rubble		15%	
<i>Site</i>		-		5%	
<i>Other</i>

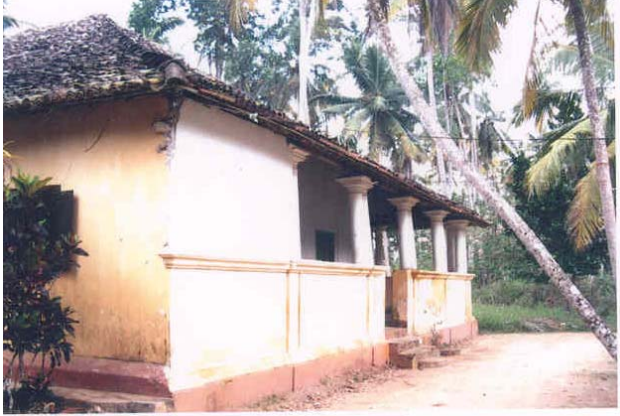
<b>Element</b>		<b>Material</b>		<b>Extent of Damage</b>	
<i>Roof</i>	Half round tiles		Archeological - Protected Monument		
<i>Walls</i>	Clay brick		Not directly affected. But due to close proximity to the river, the defects in old structures have increased. Preaching hall settlements have increased.		
<i>Doors</i>	Timber				
<i>Windows</i>	Timber				
<i>Floor</i>					
<i>Foundation</i>					
<i>Site</i>					
<i>Other</i>
