In Situ Site Stabilization: The William Salthouse Case Study

Mark Staniforth

Department of Archaeology
Flinders University
Australia

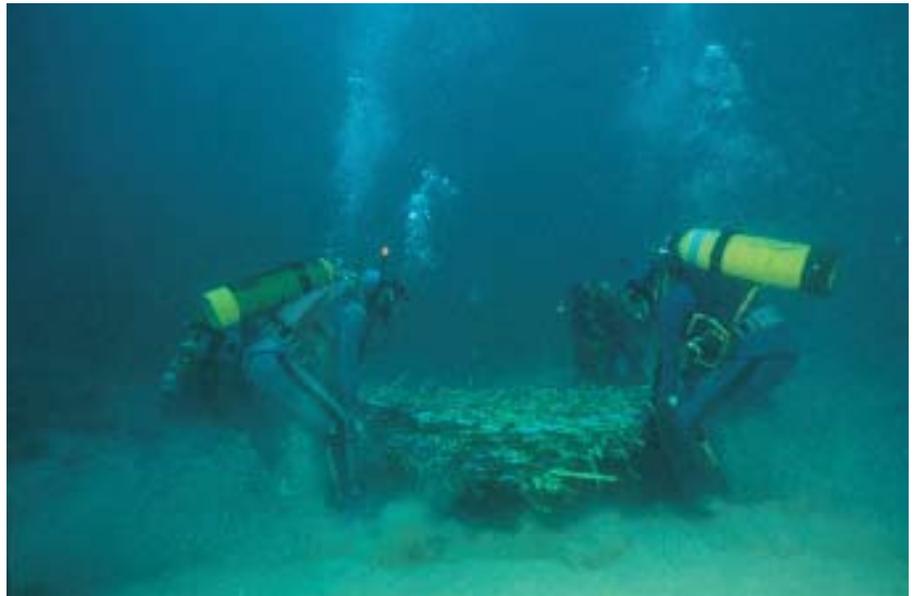
Figure 1: Moving sea grass matting into position (M. Staniforth)

Artificial sea grass matting made from closed-cell foamed polypropylene (Cegrass Erosion Control System) was purchased from Cebo UK Ltd based in Aberdeen, Scotland. Twenty-four strips (each 1.6 cm wide by either 90 cm, 120 cm or 150 cm long) were attached to a plastic clip and then to an iron reinforcing rod mesh (6m by 2.4 m with a 0.2m square mesh size) to create an artificial sea grass mat. The mats were weighted with 30 cm lengths of railway iron and a

total of 42 mats were deployed around (but not over) the site of the *William Salthouse* in 1990.

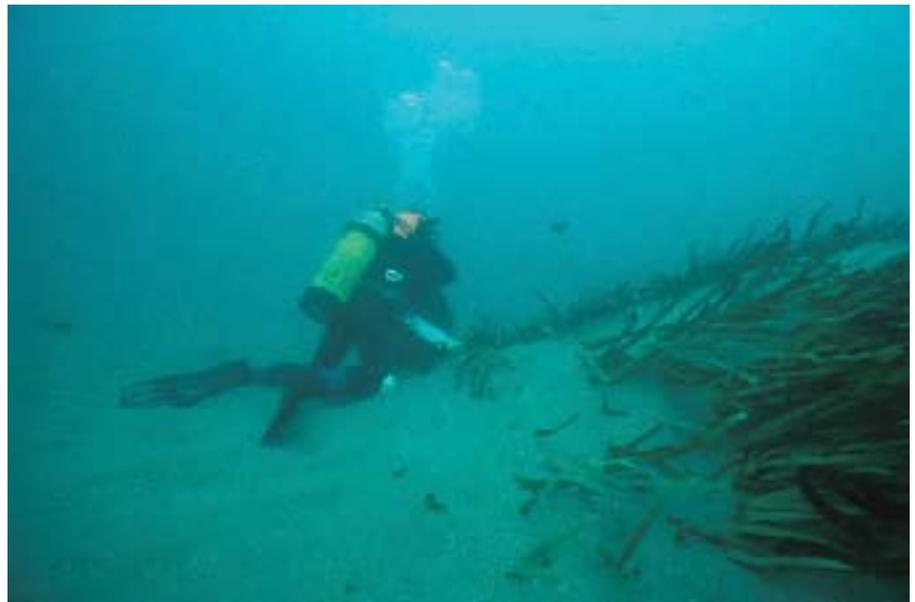
Figure 2: Build up of stabilised sand following placement of artificial sea grass matting

Sediment deposition around the wrecksite increased immediately. Even over the site where no sea grass matting had been placed, sand began to build up. Minor adjustments to the placement of sea grass mats to eliminate the remaining problems with scouring and a regular monitoring program took place over the next three years to ensure the stability of the site. Public access via the permit system was reinstated in 1993.

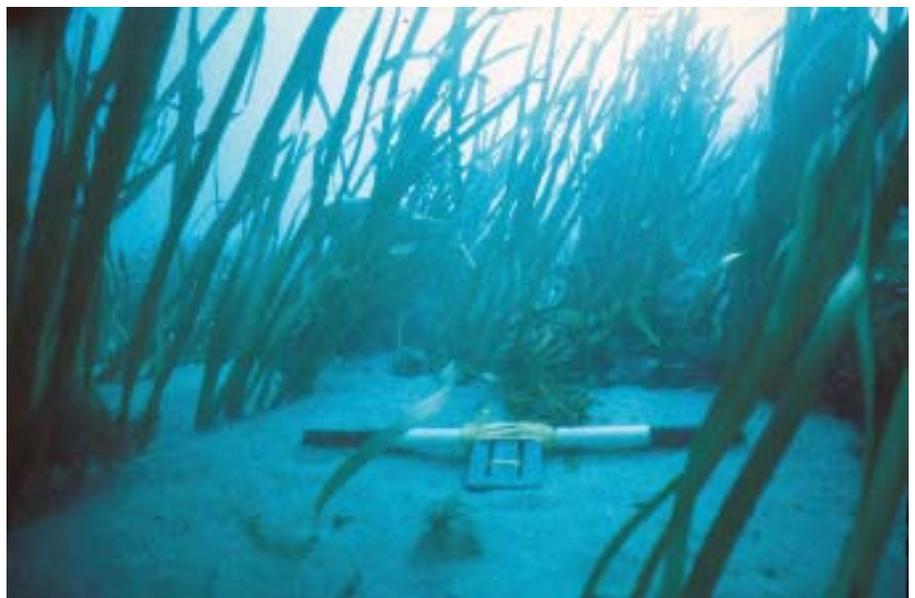
Figure 3: Close-up of accumulated sand and artificial sea grass fronds
