Structural Diagnosis of the Roof Structure of the Apollo Gallery in the Louvre

Philippe Galimard¹ Alain Cointe¹ Emmanuel Maurin²

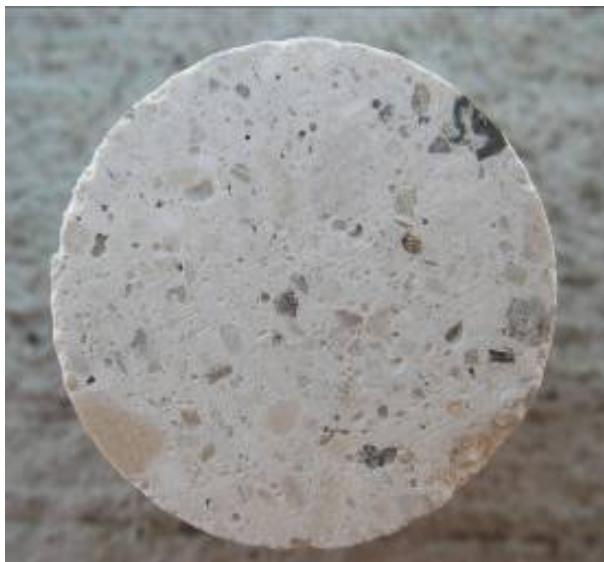
Stress/strain measurement
core sample N°7 compression test

The plaster characteristics can only be approximate as, in fact, the plaster of the vault is very heterogeneous and includes a lattice. Its resistance could only be measured using a core sample taken from the superior part of the vault. This sample does not allow to take the lattice into account and is not orientated along the down load path. The obtained values can only provide an approximation of the Young Modulus and of the plaster resistance.

➔ Young Modulus $E = 365 \text{ MPa}$

➔ Failure stress = 6 MPa

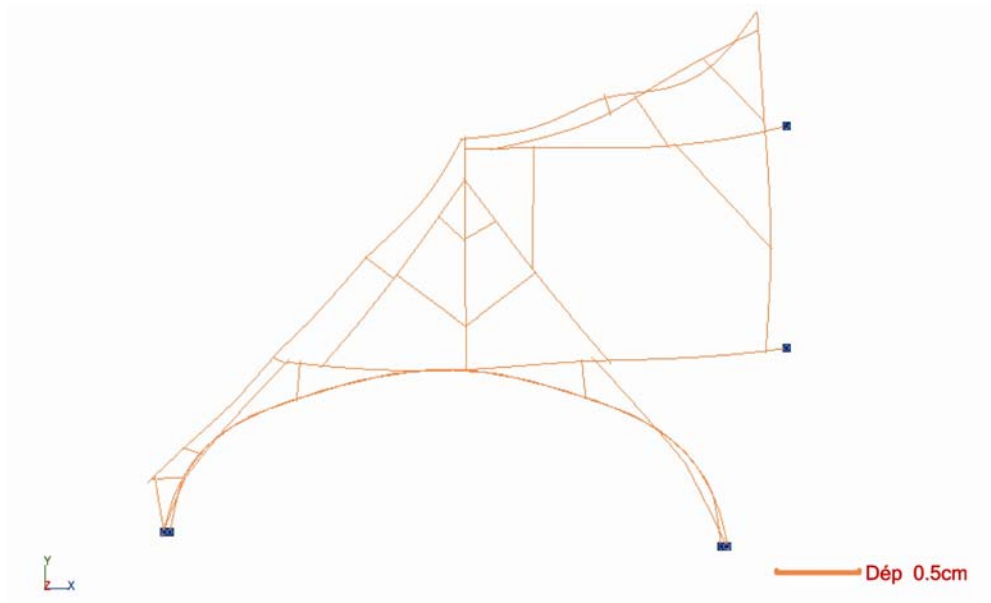
2 Deformation appearance

The most critical data concern the plaster vault, it is in fact the most distortable part, and also the part on which we do not want to intervene.

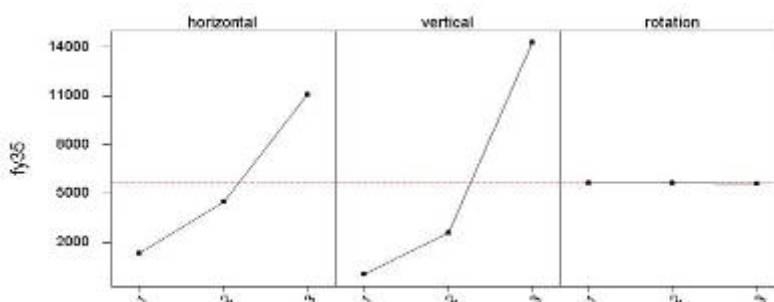
The design of experiment can help define, for example, the influence of the rigidity of the bottom timber beam on a variable representing the behaviour of the structure as a whole. The sensitivity of three factors must be determined: the horizontal rigidity of the bottom timber beam, its vertical rigidity and its rotational rigidity. Each factor can have three values (called modalities), a low value, a mean value and a high value. So, after 27 tests and a statistical analysis, it appears that only the vertical and horizontal rigidities of the bottom timber beam have an impact on the structure.

The most influential factor on the vertical reaction of the bottom timber beam is the vertical rigidity coefficient.

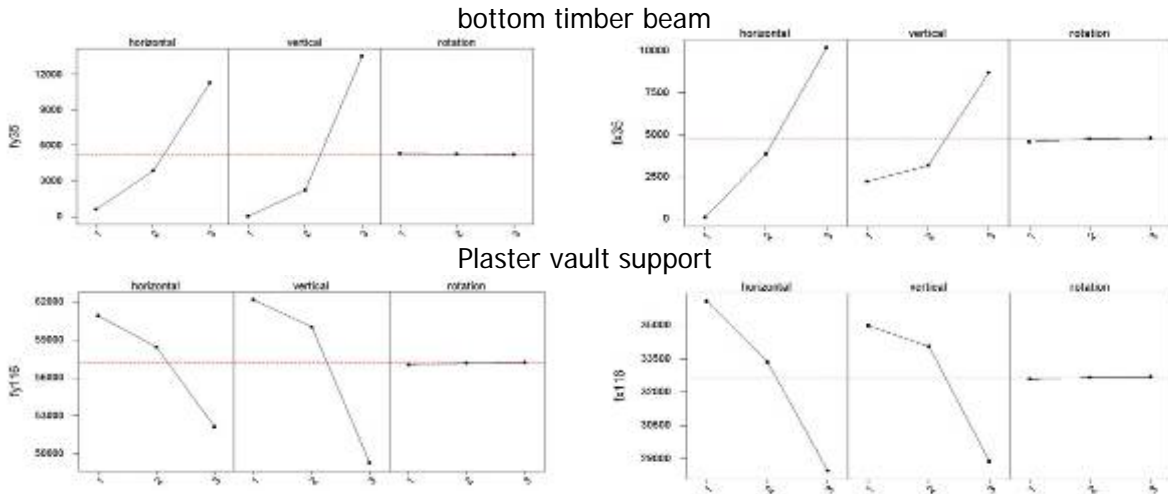
By applying a design of experiment on the rigidity of the sandstone /// sablière and by observing the variations of the reaction values, it can be observed that as the rigidity of the bottom timber beam increases, the loads which do not go through the bottom timber beam anymore go through the plaster vault.

➔ Load transfer from the bottom timber beam to the plaster vault

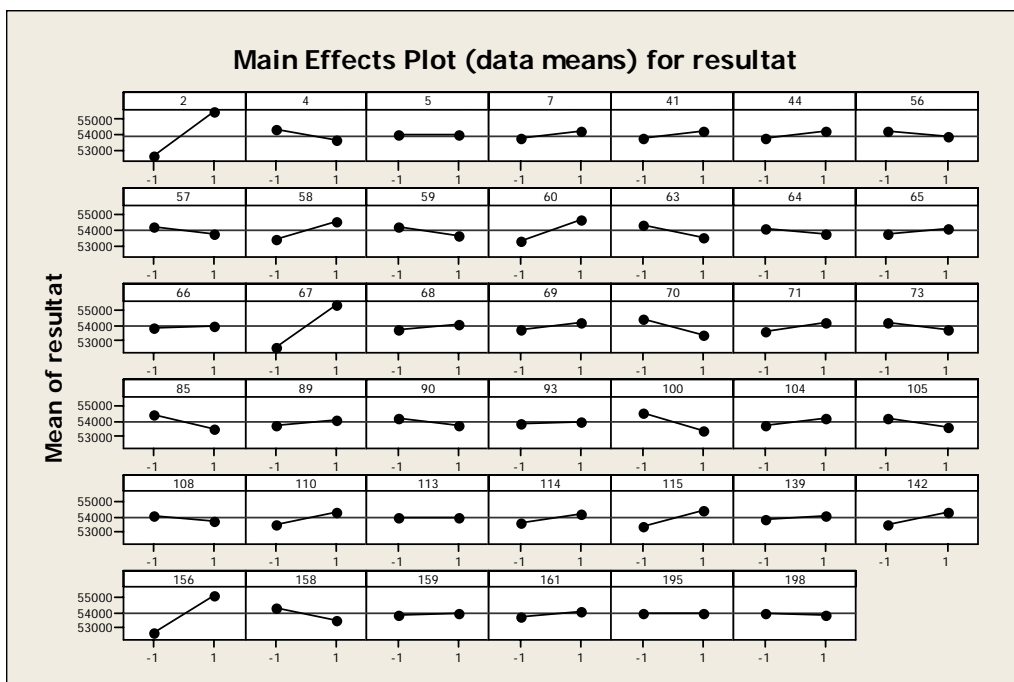
The designs of experiment that have been used are the Plackett-Burman designs, they enable the use of a great number of factors, but impose two modalities. In this case, depending on the models, there are about forty assemblies (and therefore factors) and, during the design of experiment, assembly rigidities only have two values (modalities): either a STRONG rigidity (functional assembly) or a very weak rigidity (open assembly). Once the design of experiment was carried out, the results were analysed:

It can be noticed that certain assemblies have very little impact on our output variable (113 195...). Once the most influential assembly has been determined (bar 2), it is given rigidity values in order to minimise the loads from the plaster vault to the side of the rotted bottom timber beam (it would therefore be a low modality for the bar 2 assemblies). Once this is achieved, the down load path is not the same anymore, a new design of experiment must be carried out to determine the most influential assembly of this new structure, and so on until the set limit is reached (which would here be a maximal reaction at the foot of the plaster vault on the side of the damaged bottom timber beam).

A limit must therefore be determined; this limit can only be set with a greater knowledge of the plaster at the level of the support.
