THE EXTERIOR RESTORATION OF THE WALNUT STREET THEATRE IN PHILADELPHIA

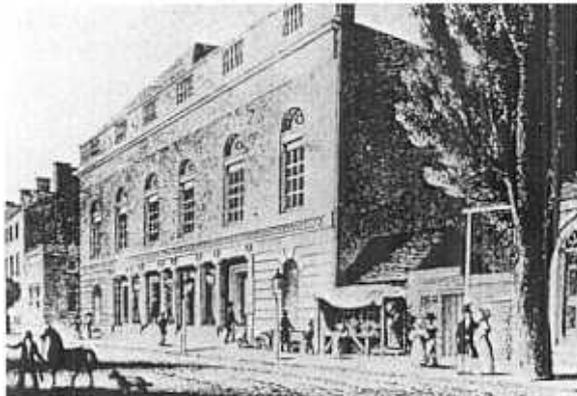
Fig. 1. - Walnut Street Theater, Engraving by Fenner Sears and Co. from a drawing by Charles Burton. Published July 15, 1831, by J. T. Hinton and Simpkin and Marshall, London. Courtesy of the Free Library of Philadelphia.

specifications and a description of the theatre⁴. There is an excellent engraving printed in 1831 by Fenner, Sears, and Company (Fig. 1) and a ca. 1859 photograph, the only one known that shows Haviland's façade before it was remodelled in 1865 (Fig. 2). The engraving and the c.1859 photograph of the theatre are in agreement on almost all details of the structure. There are several photographs that show the building after its renovation in 1865 and a substantial number of late nineteenth century and early twentieth century photographs which show the gradual evolution of the building as portions of Haviland's façade were removed or altered by successive owners of the building (Fig. 6-11).

Aside from this description, the only other information about the lamps are the 1831 engraving (Fig. 1) and the ca. 1859 photograph (Fig. 2). Apparently they were removed in the 1865 renovation, since the spaces between the paired columns are empty in the ca. 1865 photograph (Fig. 6). The design for the reconstructed lamps drew on a number of sources and proved to be the most conjectural part of the restoration. The initial decision required was whether to reconstruct the lamps shown in the 1831 engraving (Fig. 1) or the lamps shown in the ca. 1859 photograph (Fig. 2). Most details in the engraving were unusually accurate compared to the photograph, but the lamps differed substantially. It was decided to reconstruct the lamp in the photograph because it was known to have existed, while the lamp shown in the engraving in all likelihood was an imaginative visualization by the artist of an element that remained to be installed.

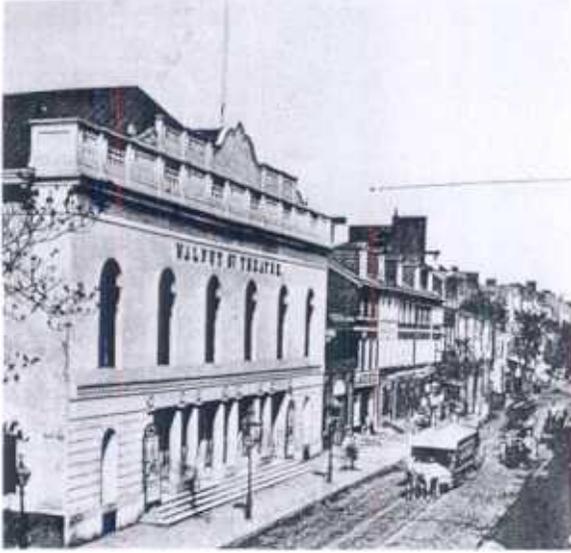
Fig. 6. - Walnut Street Theatre after the 1865 renovation. The Ninth Street wall has been raised, the cornice on Walnut Street has been replaced, the standing lamps have been removed and the porch floor has been lowered. Courtesy of The Library Company of Philadelphia.

was modified and the restrained neo-classic cornice built by Haviland on the Walnut Street façade was replaced with one that was far more Baroque. The floor level was lowered and two of the original steps in front of the theatre were removed (Fig. 6).

Due to the evolution of the building, there were several external features of the building that could not be restored. The wall on Ninth Street had been raised in the 1865 renovation and the pitch of the roof had been changed to meet the new wall level. In order to satisfy the spatial requirements of the interior of the theatre it was necessary to maintain the existing roof line. The existing roofing material, however, is similar to that which was used in the 1860's. In 1828 the theatre floor was six steps above the sidewalk. During the 1860's renovation, the floor of the theatre had been lowered by two steps (Fig. 6). During the 1920's renovation the

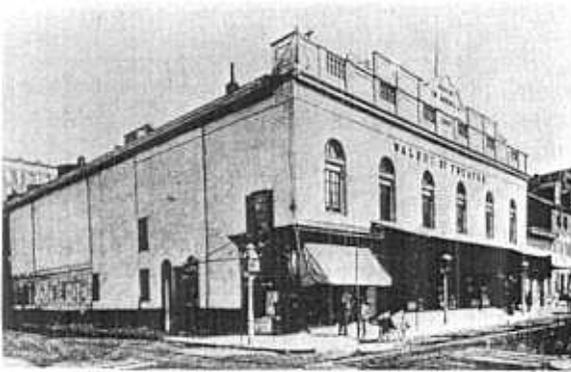
Fig. 7. - Walnut Street Theatre. Late nineteenth-century rusticated marble veneer and the niches at each end of the building have been replaced by storefronts. Courtesy of the Free Library of Philadelphia.

By the end of the nineteenth century, the chaste quality of the façade had been destroyed by renovation and the accretions of contemporary elements. The major alteration to the Walnut Street façade was the removal of the niches and the rusticated marble veneer on the first floor and the installation of iron and glass store fronts (Fig. 7). Plans were announced in 1903 for a complete renovation of the theatre by architect Willis Hale³. The architect's design would be an adapta-

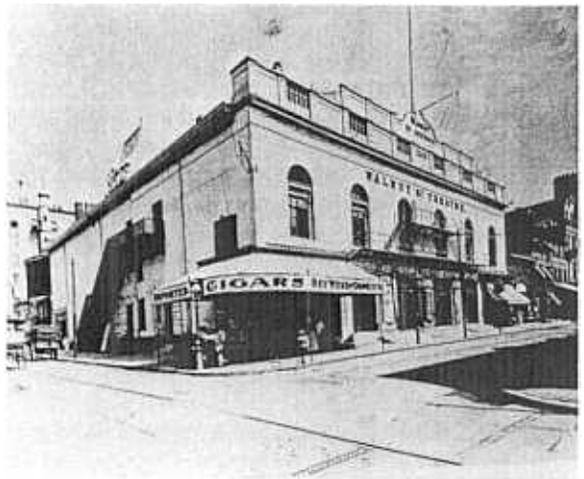
Fig. 8. - Proposed design for the Walnut Street Theatre, 1903, Willis Hale, Architect.

tion of the façade created by Haviland. The storefronts at each end of the building would have been replaced with a rusticated wall. Instead of the niches used by Haviland, there would be entrance doors opening into the lobby. The fire escape on the front of the building was to be removed along with the 1865 cornice. The Walnut Street façade would be raised in order to install a row of attic windows. Inside the theatre, the existing balconies supported on cast iron columns were to be replaced by a cantilevered balcony (Fig. 8). Subsequent photographs of the theatre reveal that none of the plans were carried out.

Fig. 8. — Projet pour le théâtre de Walnut Street 903, Will Hale, architecte.

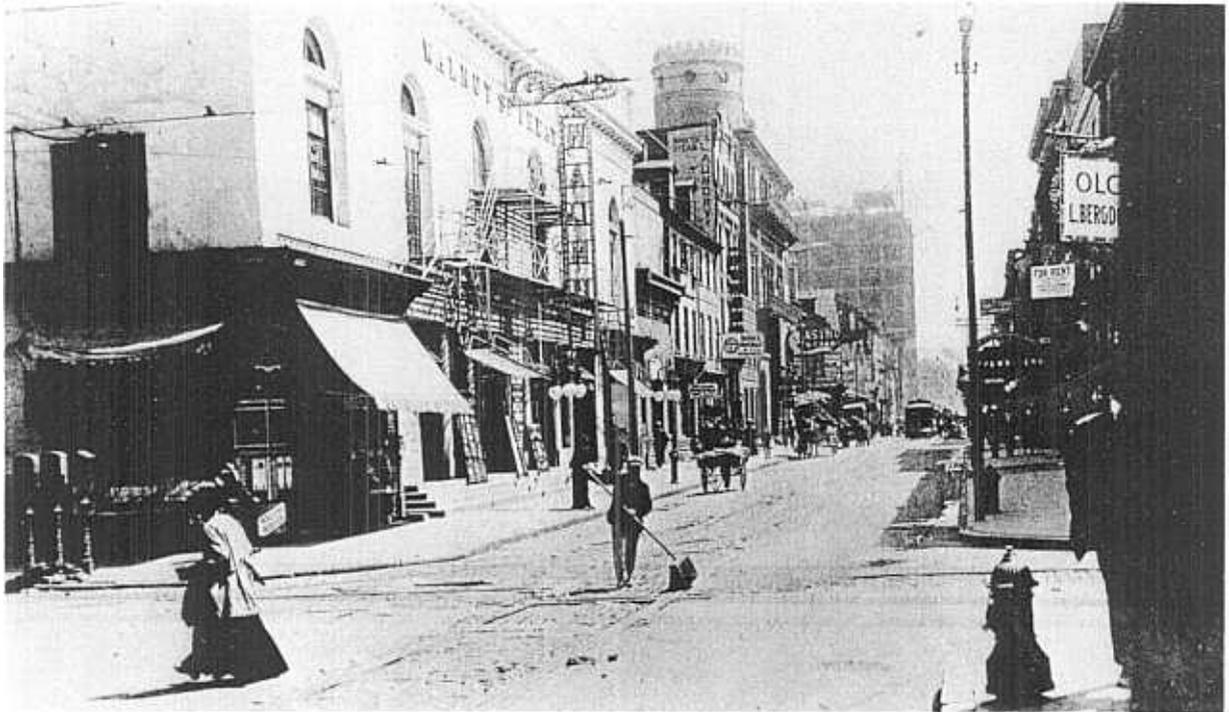
Fig. 9. - Walnut Street Theatre, ca. 1903. Fire-escapes have been added to both façades of the theatre. Courtesy of the Free Library of Philadelphia.

wall and a new stage house was erected on the roof (Fig. 9). With the introduction of electricity to Philadelphia, the façade of the theatre was overwhelmed by a new glittering electric marquee that projected over the front doors (Fig. 10). By 1913 the French window on the east end of the Walnut Street façade had been removed and replaced with four small windows. The fire escape had been rebuilt, which only caused greater clutter to the face of the wall (Fig. 11).

Fig. 9. — Théâtre de Walnut Street, vers 1903 — Des échelles à incendie ont été installées sur les deux façades du Théâtre (Bibliothèque Municipale, Philadelphie).

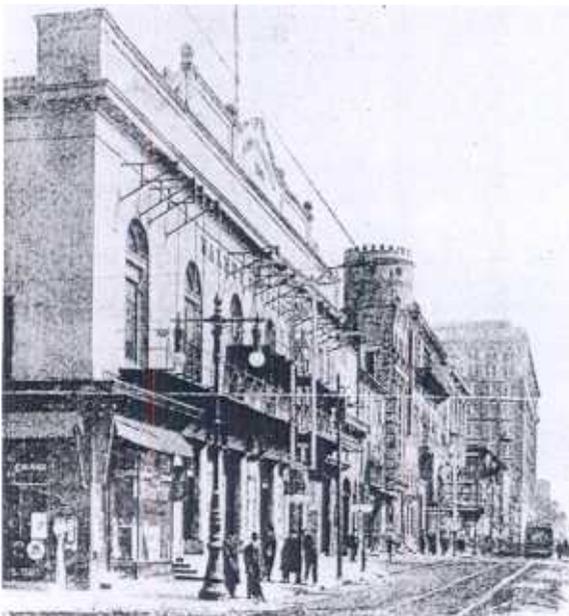
Fig. 10. - Walnut Street Theatre, ca. 1905-1913. An electric marquee is the latest addition to the front of the theatre. Courtesy of the Free Library of Philadelphia.

Fig. 10. — Théâtre de Walnut Street, vers 1905-1913. Une marquise électrique est la dernière addition apportée à la façade du Théâtre.

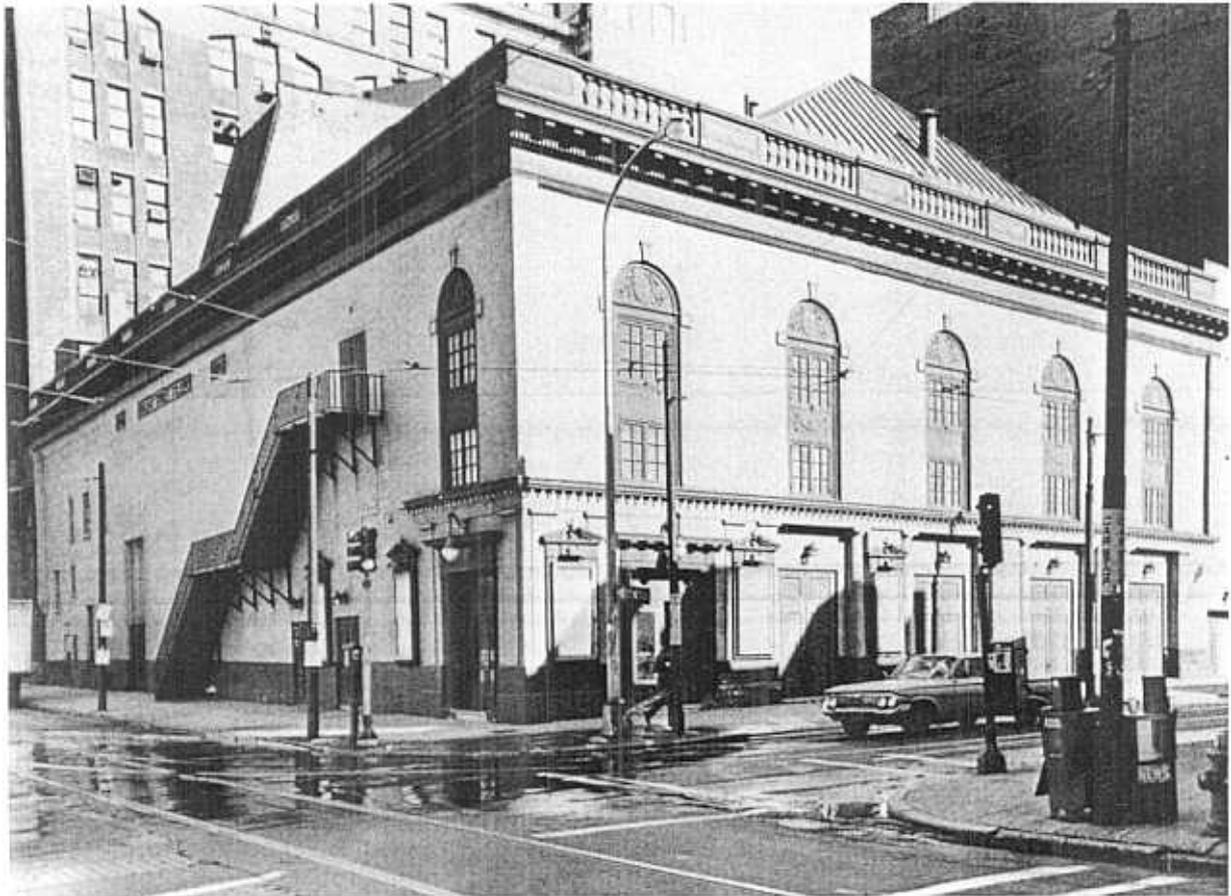
Fig. 12. - Walnut Street Theatre, renovated by architect William Lee, in 1920 (photo: Jack Boucher).

The major structural repairs were required on the front wall in order to restore the exterior appearance. When Haviland renovated the theatre in 1828, the balconies he installed were primarily carried by the cast iron columns inside the theatre. The front wall of the theatre only had to carry the load from the roof and partial loads from the balconies. Because these loads were relatively light, the six free standing marble columns were able to support the central portion of the front walls. When the theatre was remodelled in 1920, Haviland's light balconies were replaced by a massive steel and concrete balcony that was virtually cantilevered from the front wall (Fig. 16). The marble columns at the entrance were then unable to support the load and it was necessary to add brick piers between the columns (Fig. 12).

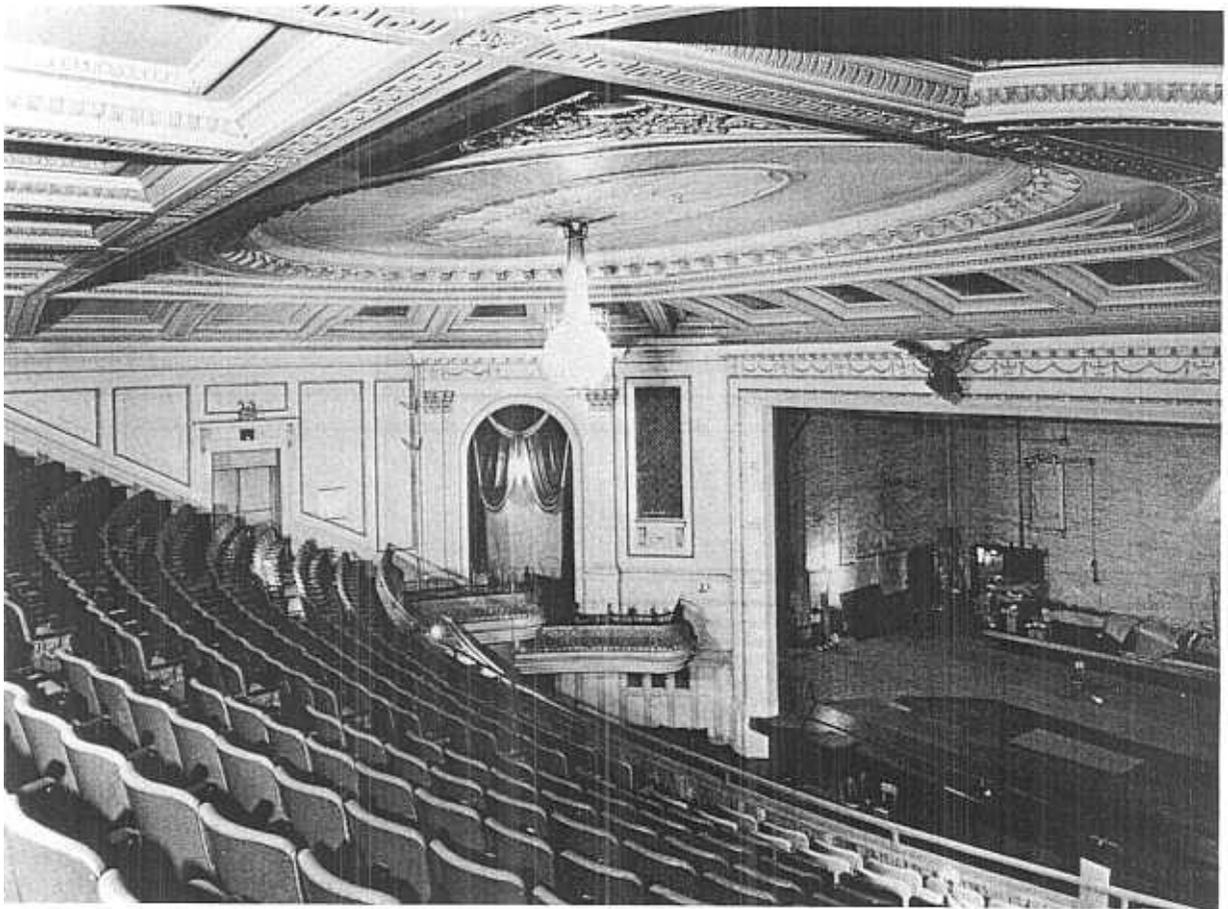
Fig. 13. Auditorium, Walnut Street Theatre, renovated by architect William Lee, in 1920 (photo: Jack Boucher).

The only remnant of the nineteenth century that survived was the wooden eagle over the proscenium arch and the wooden stage machinery in the fly space (Fig. 13, 14 and 15). The layout of the auditorium was completely changed. The horseshoe-shaped balconies supported by cast iron columns were replaced by a single balcony cantilevered from the back of the theatre, which placed the new mezzanine floor directly in front of the second storey windows (Fig. 16). The floor level of the theatre was dropped to street level, and a new concrete floor was added. The walls and ceiling were replastered and new appointments were added throughout the theatre.

Fig. 13. — La Salle du Théâtre de Walnut Street, après les remaniements par l'architecte William Lee, en 1920.

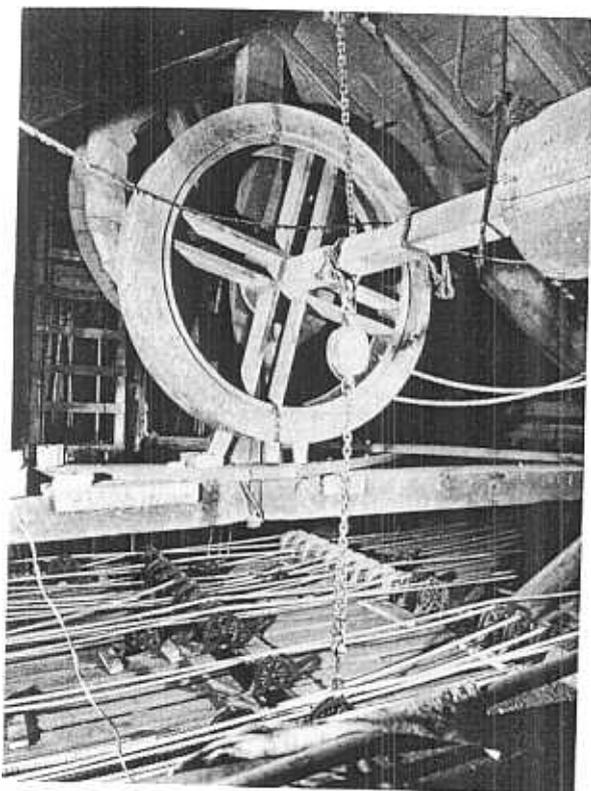
Fig. 15 - The fly space with the nineteenth century stage machinery (photo Jack Boucher).

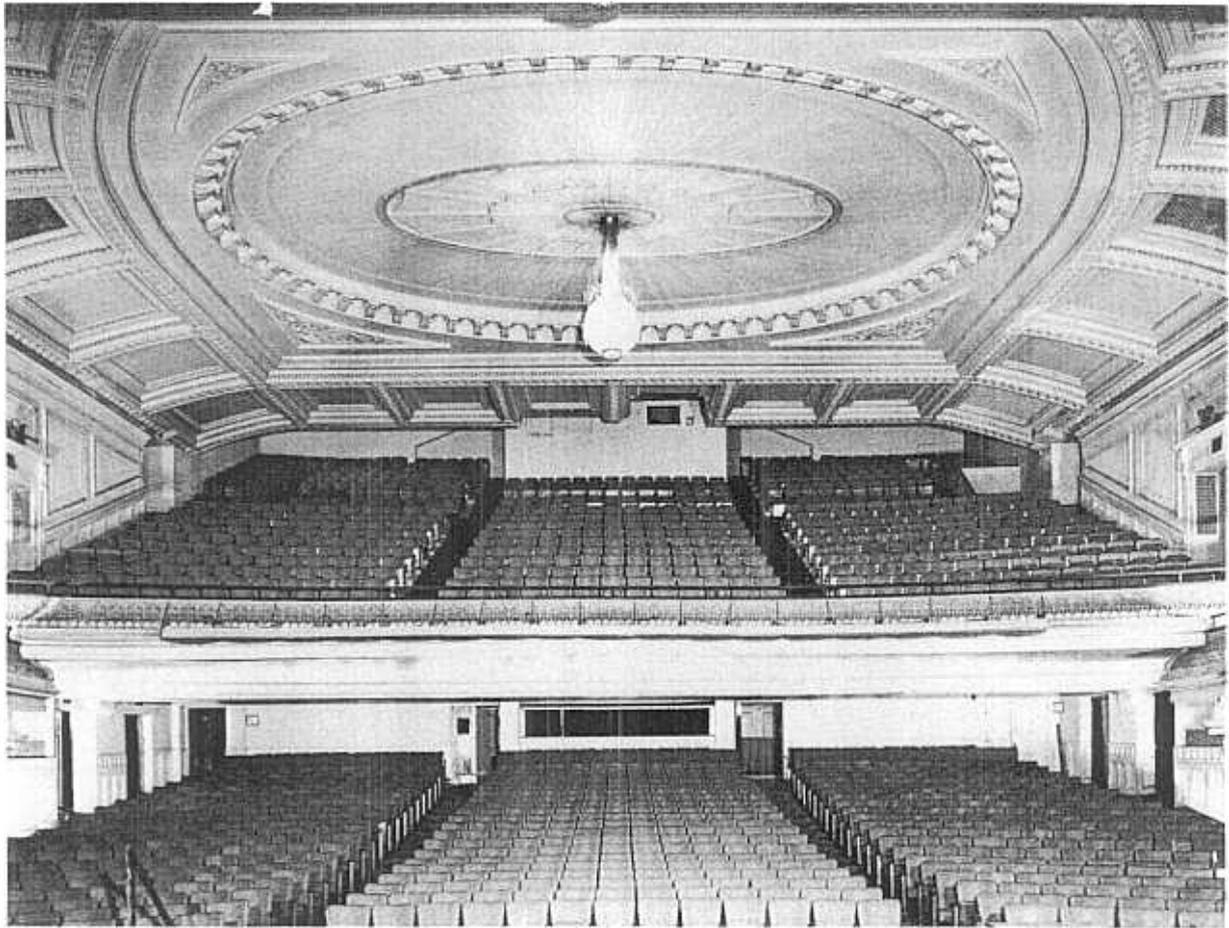
Fig. 16 The new cantilevered balcony built in 1920 replaced the 1828 balconies supported by cast iron columns (photo: Jack Boucher).

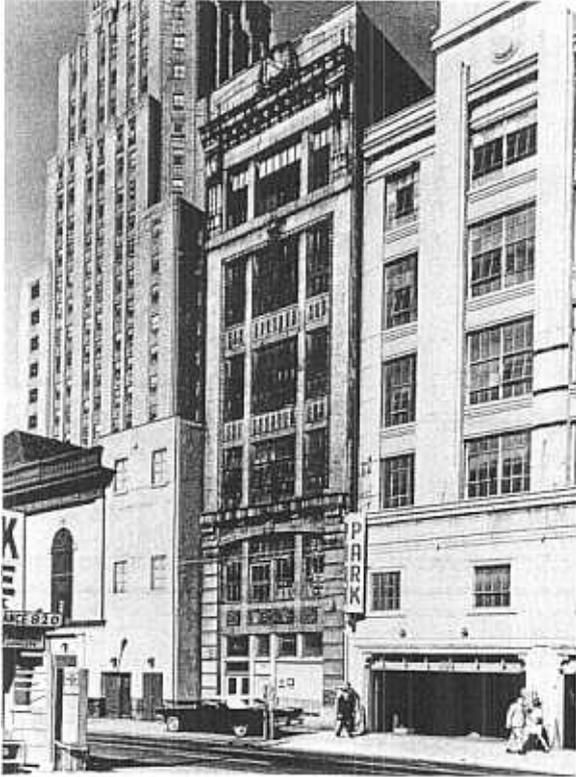
Fig. 19 - The restored façade of the Walnut Street Theatre, 1971 (photo: Jack Boucher).

In order to restore the colonnade that Haviland had designed it was necessary to remove the brick piers and the front wall on the first floor. However, before the piers could be taken down, a new structural system was installed to carry the front wall and the balcony, since the load could not be carried by the marble columns alone. A new steel beam supporting the upper wall was cantilevered from steel columns that were set into new front wall (Fig. 19).

Fig. 19. — Façade du Théâtre de Walnut Street, après la restauration de 1971 (Photo: Jack Boucher).

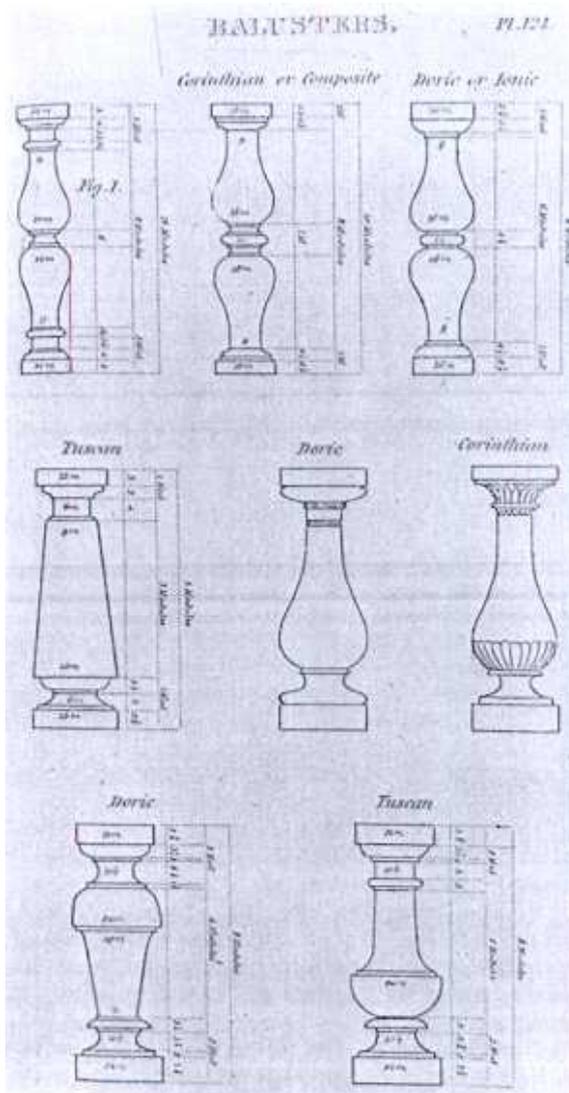
Fig. 20 - Doric or Ionic Balusters, from John Haviland's *Builder's Assistant*, 1819, vol. 3, pl. 124.

even they were somewhat different from the photographs of the Walnut Street Theatre. The final design was based primarily on the photographs of the building, and several sources from Haviland's books. The balustrade designed and built by Haviland was removed by 1865. The design for the reconstructed balustrade was based on the «Doric or Ionic Balustrade», from his book published in 1819: *The Builder's Assistant* (Fig. 20).

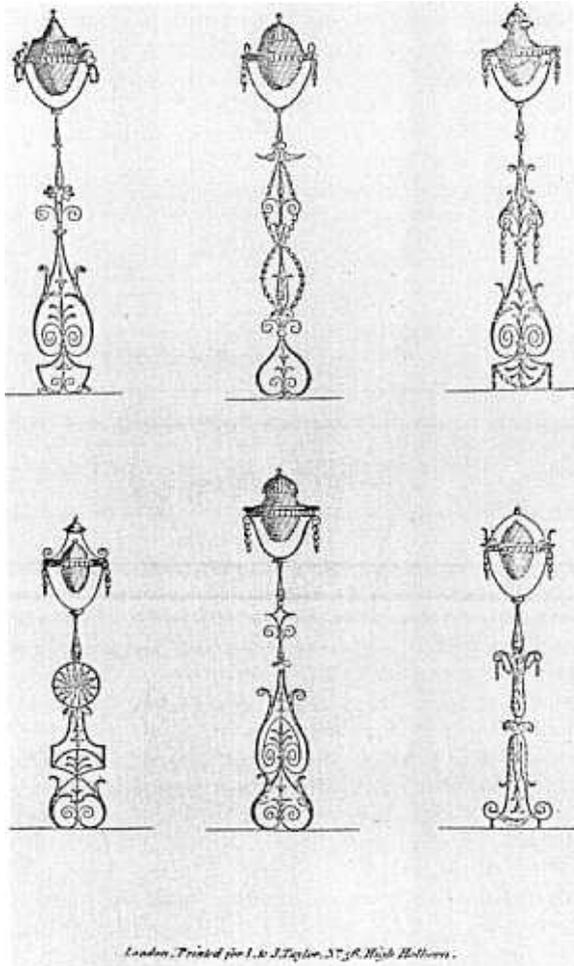
Fig. 21. - Lamp Irons, I & J. Taylor, *Ornamental Iron Work*, 1795, Pl. 12.

The design of the reconstructed lamp was an amalgamation of two style periods. The upper portion of the lamp is related to many English late eighteenth-century designs. Numerous examples of lamps mounted on a standard were shown by I & J Taylor in their 1795 catalogue *Ornamental Iron Work* (Fig. 21). However, similar designs appear twenty years earlier in views of the Adelphia and the bridge for Syon House in Robert and James Adam's *Works in Architecture*.

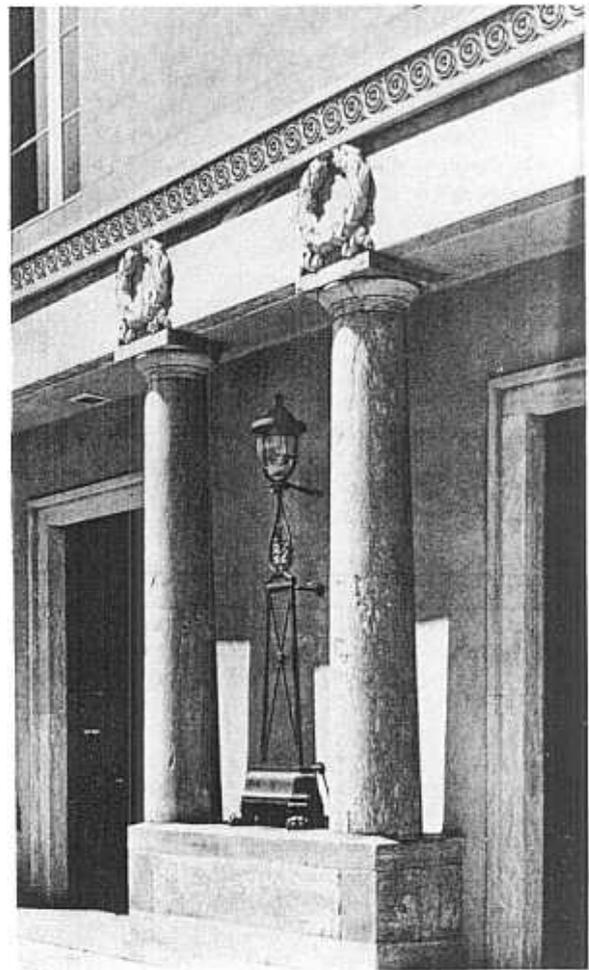
Fig. 22. - Reconstructed Standing Lamps, Walnut Street Theatre (photo: Jack Boucher).

While most of the English designs show a lamp mounted on a wrought iron standard, the standard in the theatre photograph appears to be a cast iron double volute in the Grecian manner. The model for this portion of the lamp was based on the cast iron braces that support the fence surrounding St. Peter's Church, Philadelphia. The lower half of the standard appears to be a trapezoidal stand made up of wrought iron bars. The design was a common motif of the new Greek Revival, and is illustrated by Thomas Hope and George Smith in England and Percier and Fontaine in France. An unusual feature is that the stand is virtually two-dimensional. The final design was based on several sources; the shape of the standard was based on the photograph, the rosette was copied from a design in Haviland's *Builder's Assistant* and the feet were based on the carved wooden lion's paws found in numerous pieces of furniture in America from 1815-1845.

The light source for the lamps caused some concern, since neither the photograph, Taylor's catalogue, nor Adam's design showed the mechanism for burning fuel. Although gas lighting had been used experimentally in Philadelphia since 1816, there was widespread fear of gas lighting, and it was not until 1833 that the City Council allowed the creation of a public gasworks. In 1828, oil was the most common lighting fuel in Philadelphia, and it seems likely that the standing lamps in front of the Walnut Street Theatre originally burned oil. While it might have been interesting to burn oil in the reconstructed lamps, the maintenance would have been excessive, and since a natural flame was required, it was decided to use gas as a fuel.

It was possible to bring the gas line into the lamp without modifying the globe or changing the elements of the burner (Fig. 22).
