**Preliminary Survey of Tsunami-affected Monuments and
Sites in the Maritime Region of Sri Lanka**

An Archaeological Survey of Tsunami Affected
Historic Structures in the Municipality of Galle,
Sri Lanka

Ranjith M. Jayasena & Kim Spijker

PGIAR, Colombo, February, 2005

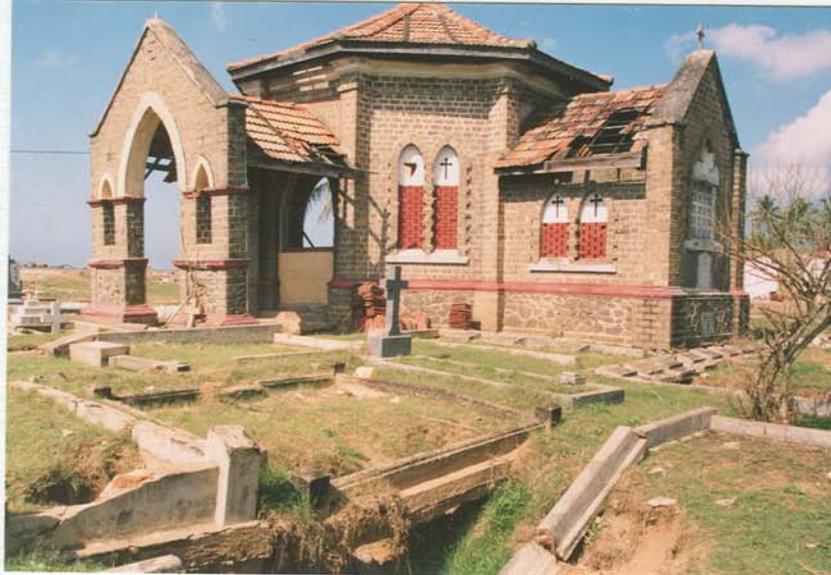
DADALLA CEMETERY (RMJ-I-0)

- 1) Colombo Road, Dadalla Cemetery.
- 2) Chapel and Cemetery.
- 3) Late 19th/20th Century (the oldest grave noticed dates from 1895).
- 4) The graveyard was formed around an octagonal brick build chapel with four additions, which give the chapel a cross-shape.
- 5) A: chapels like these are not very common. The graveyard serves as a familiar landscape.
- 6) III: the wall surrounding the cemetery is gone. The east portal of the chapel is damaged. Most tombstones are damaged. Some graves have caved in. No skeletons were exposed.
- 7) It is advised to restore the chapel and organize the cemetery.
- 8) The cemetery was still in use.
- 9) RMJ - I - 09+10.

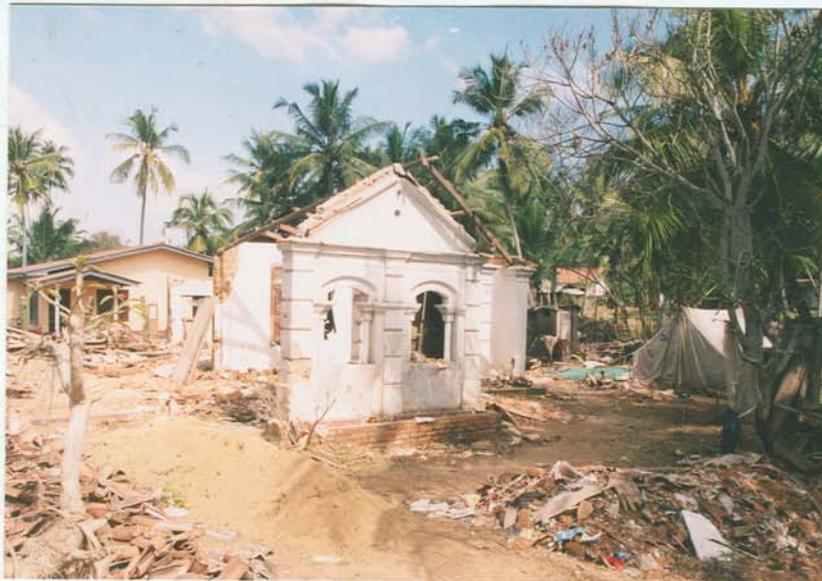
5. 406 COLOMBO ROAD (RMJ-I-13)

- 1) 406 Colombo Road.
- 2) Residential.
- 3) Early 20th century.
- 4) The building was a brick house with a verandah.
- 5) C: when in perfect condition the house should be classified as A status, because this type of house is not very common.
- 6) V: only the two short end walls are partly standing.
- 7) Restoration is impossible.
- 8) If possible some more detailed measurements can be taken before complete demolition of the building.
- 9) RMJ - I - 13.

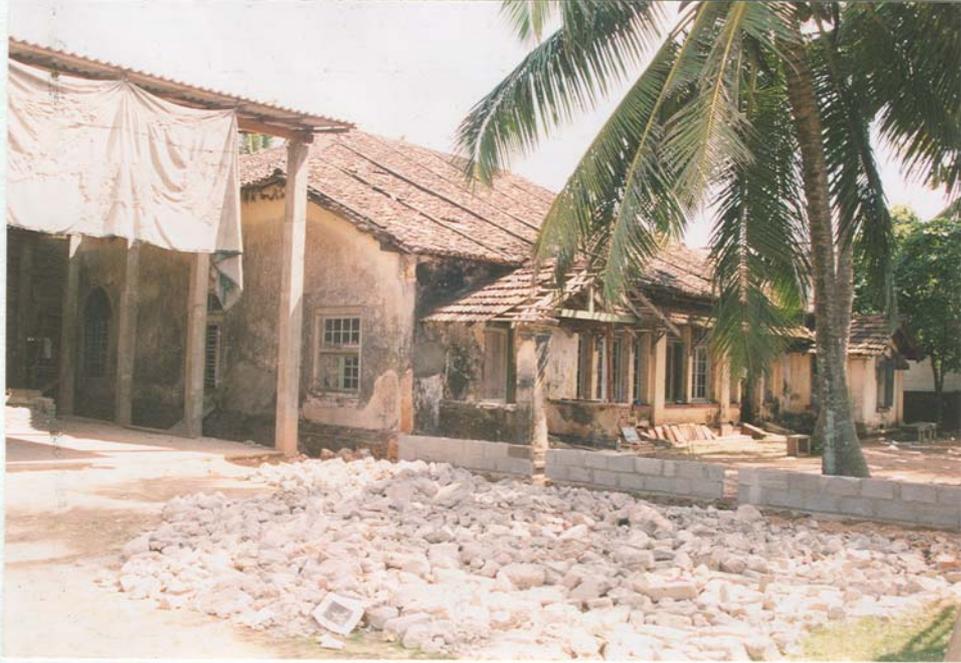
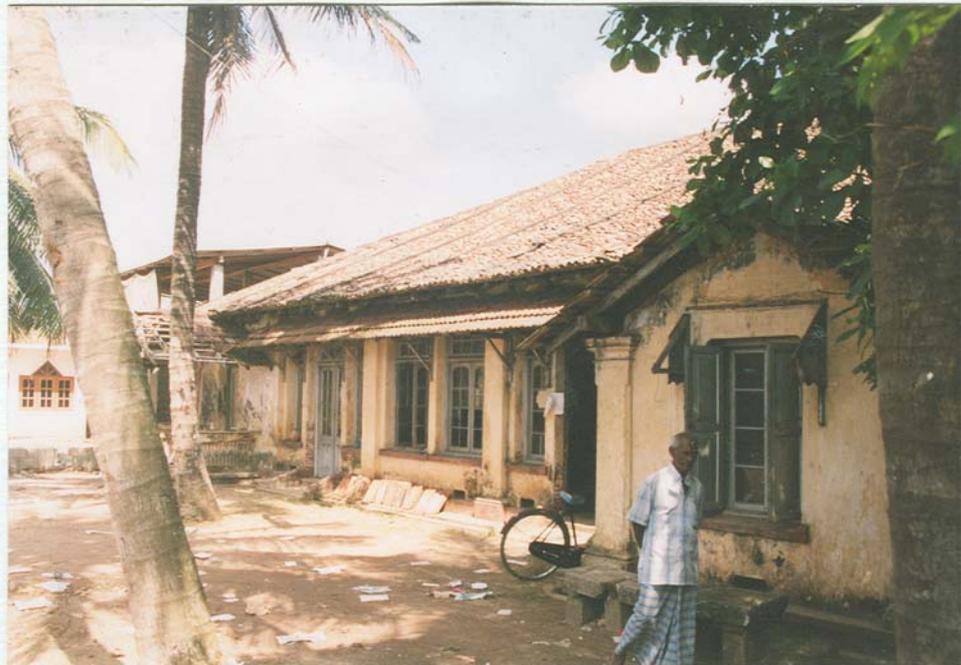
6. 236 COLOMBO ROAD (RMJ-I-19)

- 1) 236 Colombo Road.
- 2) Residential.
- 3) Early 20th century.
- 4) The brick and coral stone structure consists of a big complex house with a kitchen and courtyard at the back. The verandah has been closed. The elaborate fanlights and the floor tiles are original. Has Portuguese roofing tiles.
- 5) A: even though the verandah has been altered the structure is mainly original.
- 6) II: water level up to 1.20 meters, some of the external walls have been damaged and the interior was washed away.
- 7) Restoration advised.
- 8) The building is currently inhabited.
- 9) RMJ - I - 14 + 15.

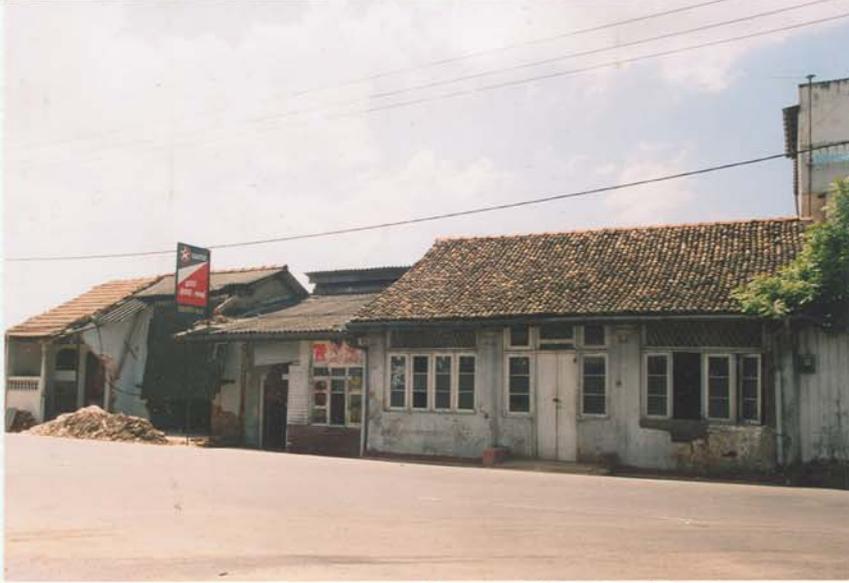
9. 259-261 COLOMBO ROAD (RMJ-I-22)

- 1) 259 + 261 Colombo Road.
- 2) Residential.
- 3) Early 20th century. (neighbours claim it was built in the 1950s)
- 4) 259 has a verandah, brick and coral stone columns along side the doors, elaborate fanlights. In # 261 the verandah has been closed. The columns remain visible.
- 5) A: mainly because of the elaborately detailed verandah.
- 6) IV: 259 the facade is severely damaged. In 261 the back of the building is severely damaged.
- 7) Almost impossible to restore.
- 8) -
- 9) RMJ - I - 22+23+24.

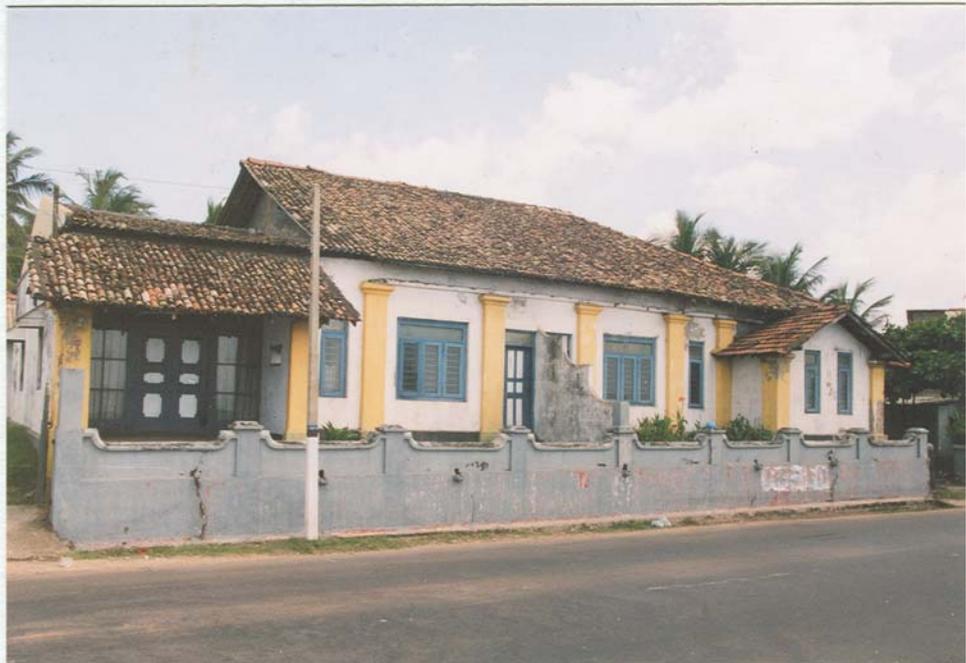
10. 106 COLOMBO ROAD

- 1) 106 Colombo Road.
- 2) Residential.
- 3) Early 20th century.
- 4) Rectangular building with closed verandah and square columns. Portuguese roofing tiles.
- 5) C: the building was altered.
- 6) I: the exterior bares no visible damage from the tsunami impact.
- 7) Preservation advised.
- 8) The building is currently inhabited.
- 9) RMJ - I - 25.

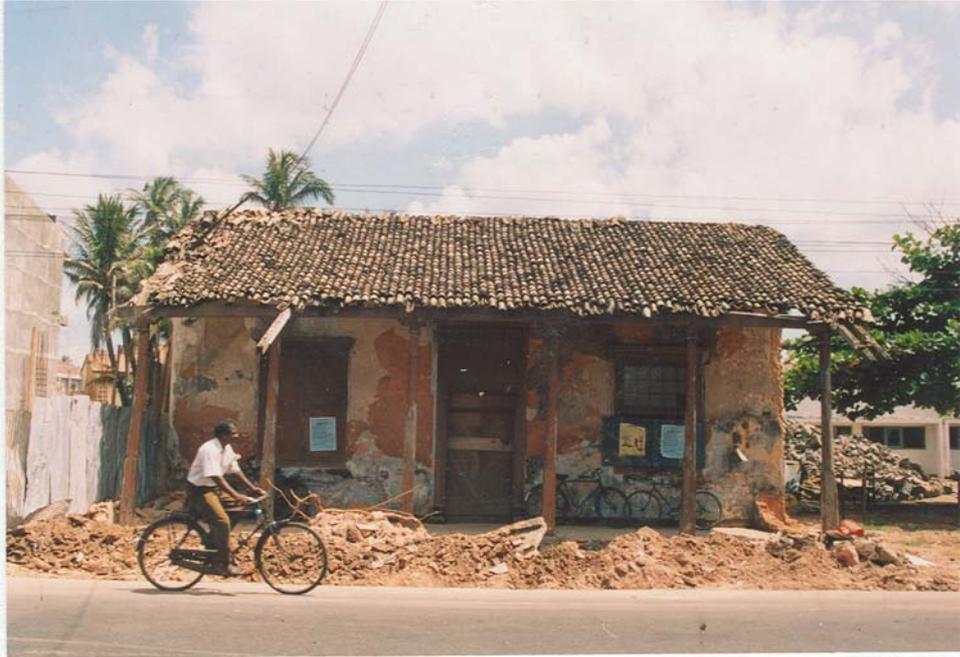
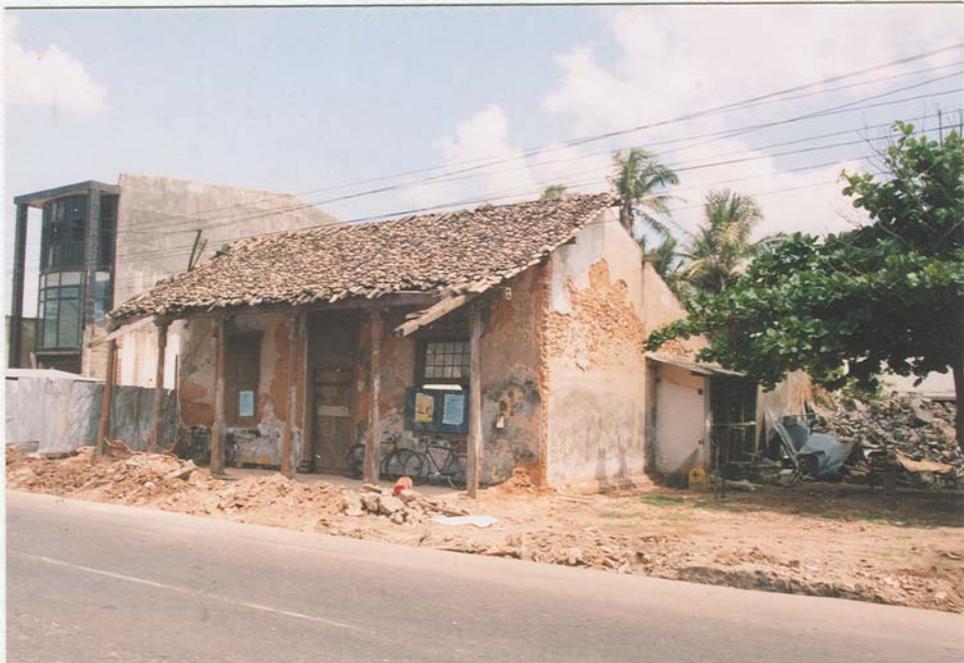
11. WEST OF COLOMBO ROAD 70A (RM3-I-26)

- 1) Colombo Road, west of 70A.
- 2) Residential.
- 3) 19th century.
- 4) A simple rectangular house. With a high fanlight, walls of coral stone and brick, wooden columns on the open verandah and Portuguese roofing tiles.
- 5) A: because the structure belongs to a very early date and the original wooden elements make it unique.
- 6) II: the verandah wall is gone. The back of the building is severely damaged.
- 7) Restoration when possible.
- 8) -
- 9) RMJ - I - 26+27.

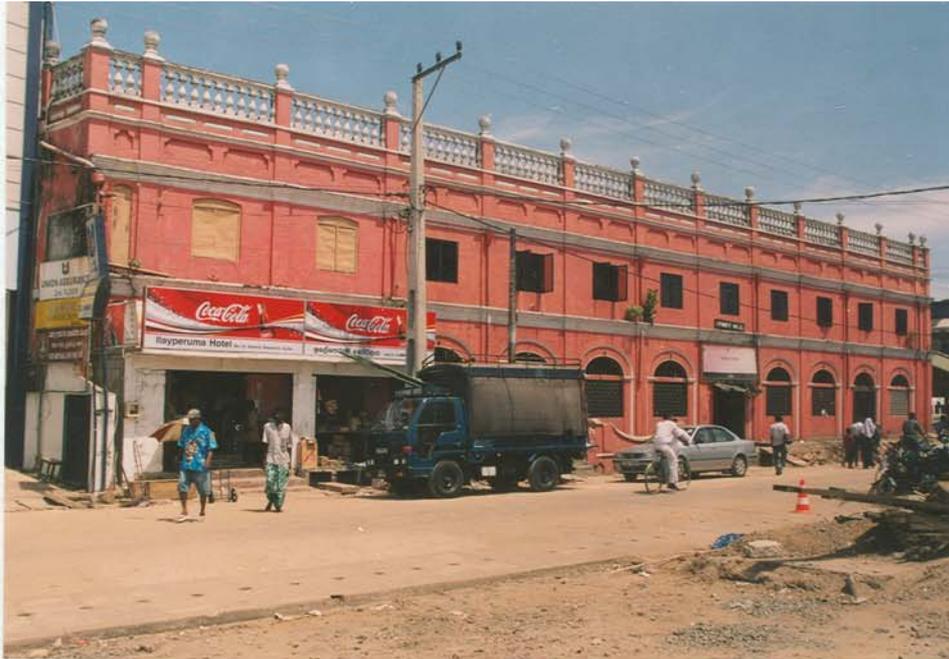
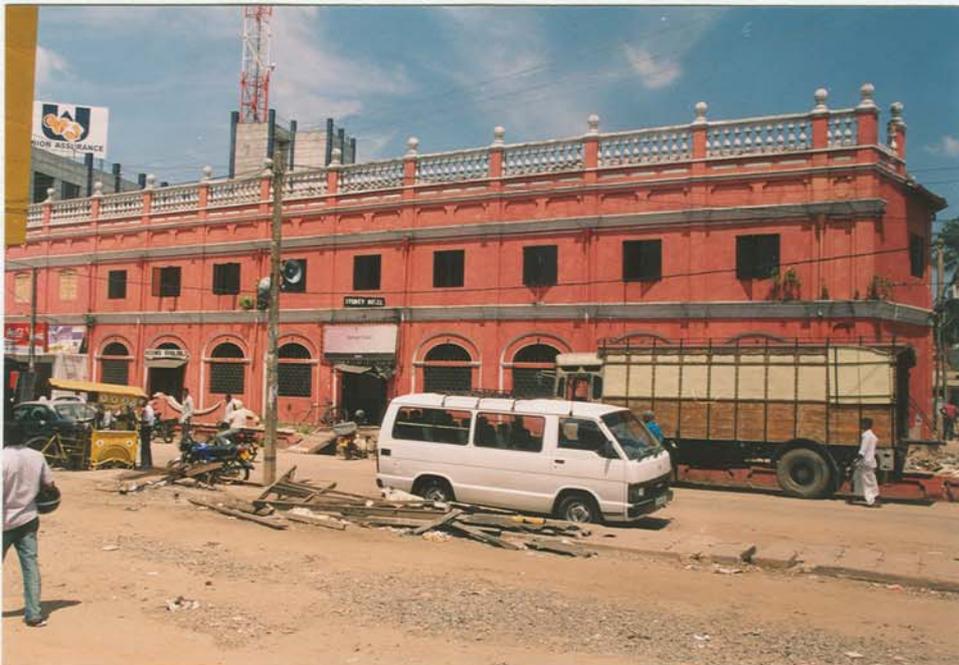
16. 10.12.12A GAMONI MAWATHA (RMJ-VI-07)
SYDNEY HOTEL

- 1) 10, 12, 12A Gamini Mawatha, Sydney Hotel.
- 2) Hotel/ commercial.
- 3) 1900s.
- 4) A large two-storey brick complex.
- 5) A: by its appearance it is a landmark, showing typical early 1900s architectural characteristics.
- 6) II: water level up to 3 meters, the surrounding wall collapsed and at the back of the building part of the kitchen was damaged by the tsunami.
- 7) Restoration advised.
- 8) The hotel is in use again.
- 9) RMJ - I - 36/ RMJ - VI - 06+07.

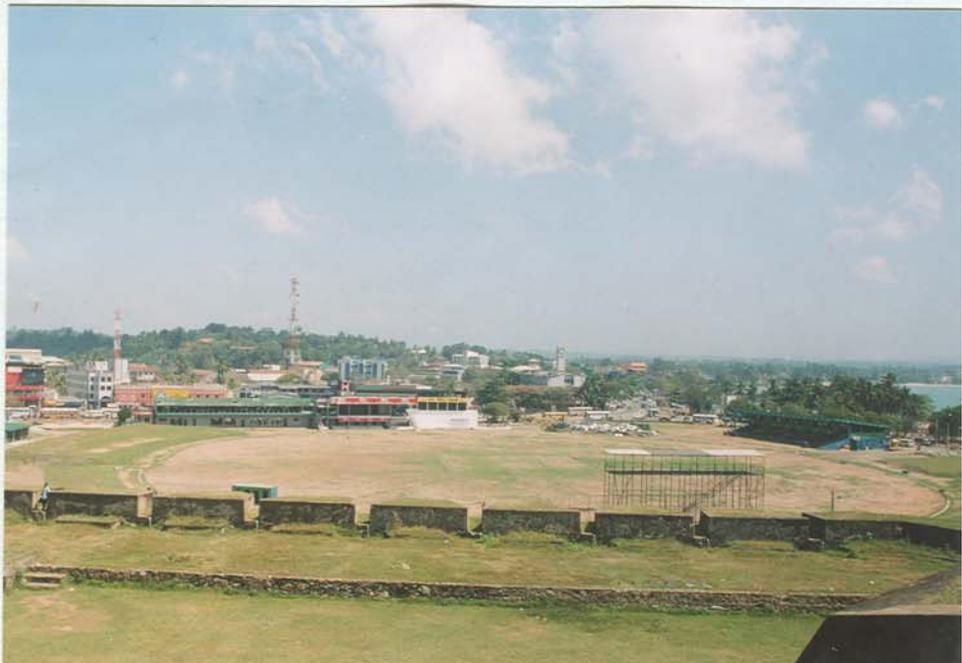
21. GALLE INTERNATIONAL CRICKET STADIUM
(RMJ-III-33)

- 1) Galle International Cricket Stadium.
- 2) Sports complex.
- 3) 20th century.
- 4) Oval-shaped stadium on the Esplanade.
- 5) A: familiar sight, because of its setting on the Esplanade in front of Galle Fort
- 6) II: The main structures have been damaged.
- 7) Rebuilding the stadium would recreate what is sometimes rated as one of the world's finest cricket stadiums.
- 8) –
- 9) RMJ-III-33.

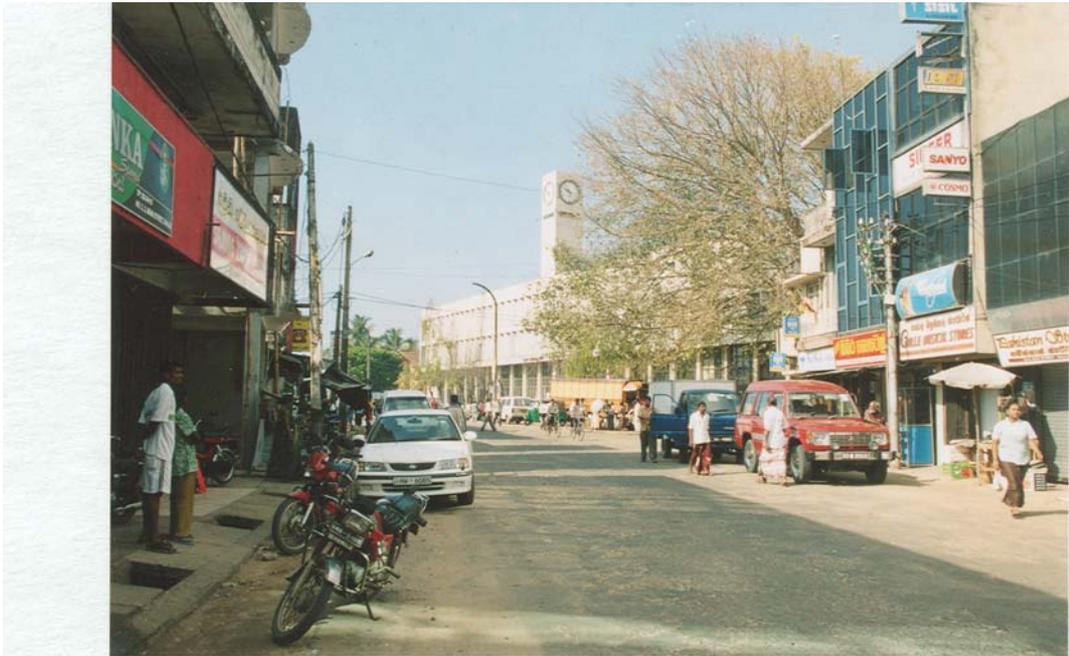
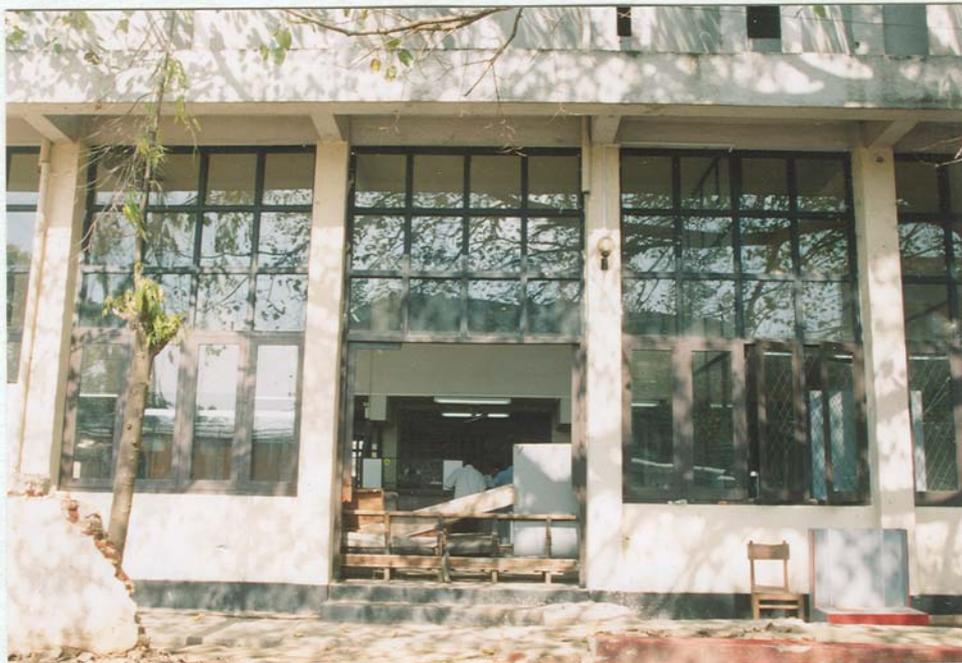
27. MAIN STREET WITH POST OFFICE (CRM-IV-14)

- 1) Main Street, General Post Office, Galle
- 2) Post Office.
- 3) 1960s.
- 4) Three-storey brick building with a clock tower.
- 5) C: no historical value.
- 6) II: ground floor is mostly damaged.
- 7) -
- 8) Building is back in use and the ground floor will be cleared soon.
- 9) RMJ - III - 14+15.

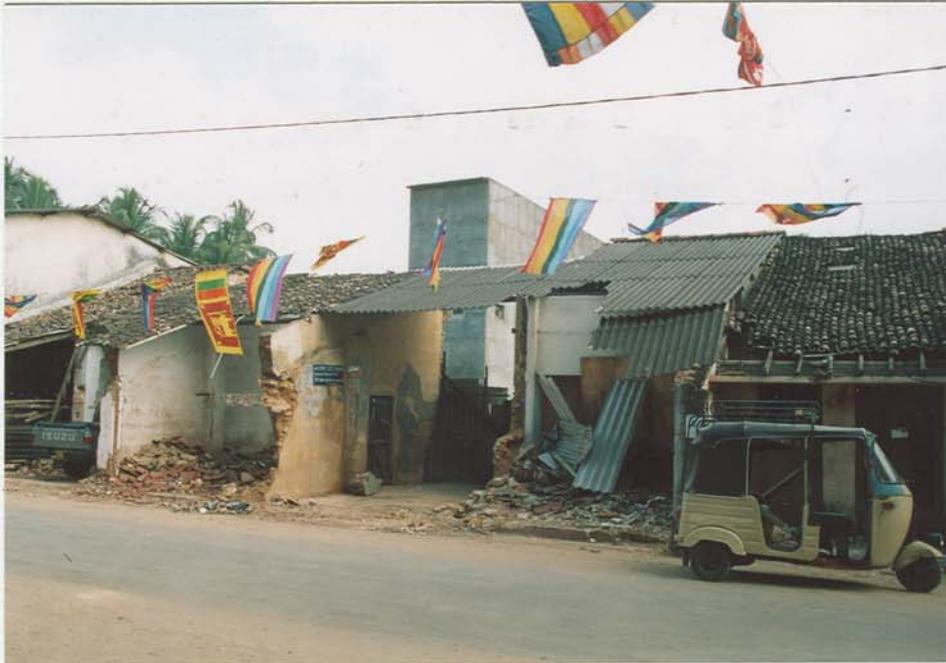
28. MAIN STREET 75-76 (RM)-II-12)

- 1) 65/67 Main Street.
- 2) Residential/commercial.
- 3) 20th century.
- 4) A square two-storey building divided into two houses or shops. The top floor has a verandah with a raster of woodwork.
- 5) A: architectural rareness of the verandah with closed woodwork on the top floor.
- 6) II: water level up to 1.50 meters. The entrance has been damaged.
- 7) Restoration advised.
- 8) Currently not in use/uninhabited.
- 9) RMJ - III - 13.

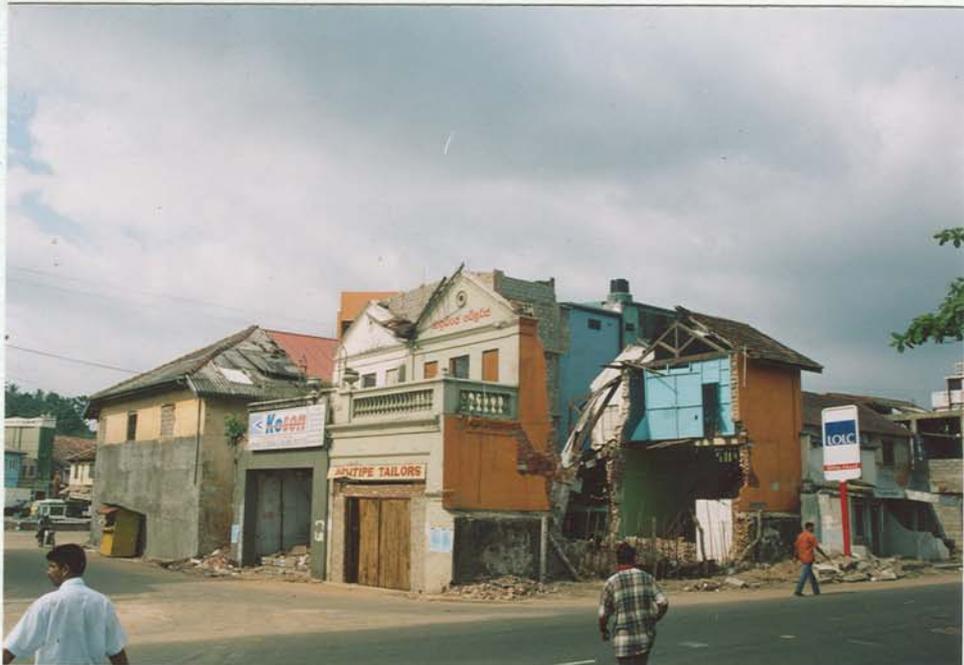
29. SEA STREET 426 (RM)-II-29)

- 1) 426 Sea Street.
- 2) Residential/ commercial.
- 3) 1911.
- 4) Two-storey house with balcony.
- 5) B: average significance.
- 6) IV: tsunami waves went right through it.
- 7) Restoration recommended but maybe impossible.
- 8) Further investigation is required before breaking it down.
- 9) RMJ II – 29+30+31.

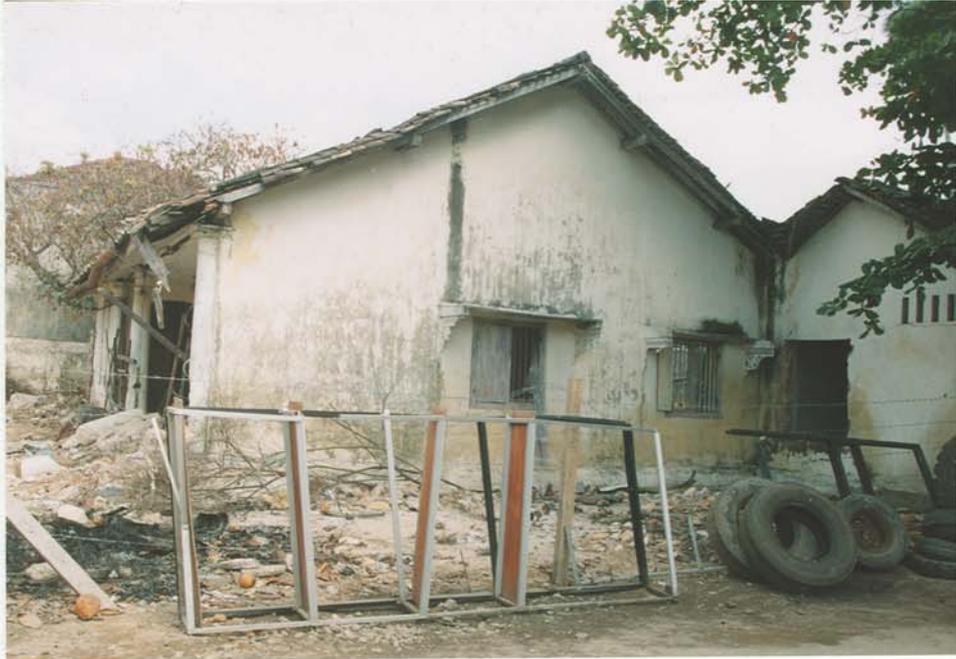
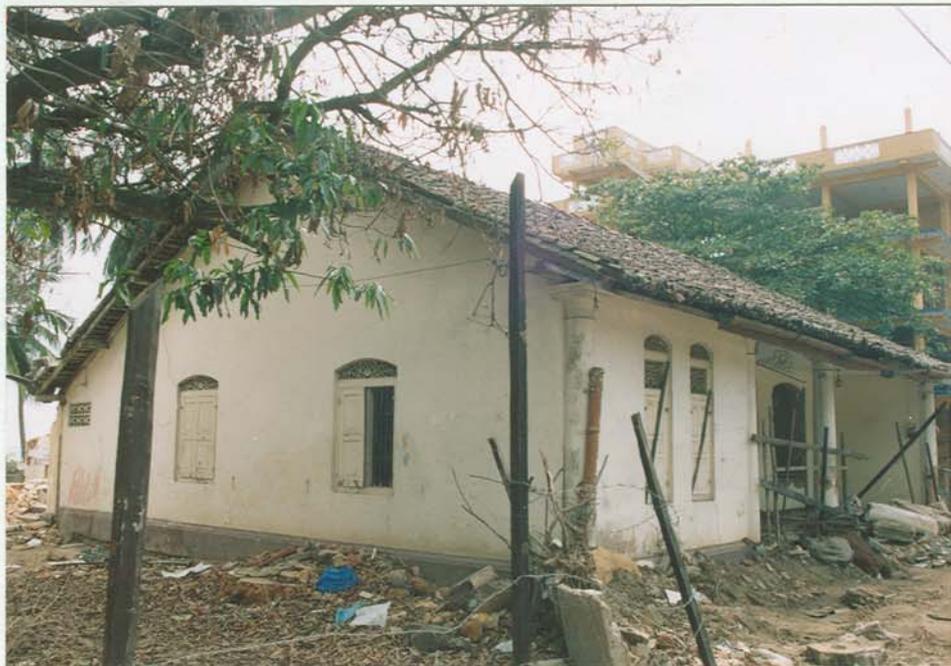
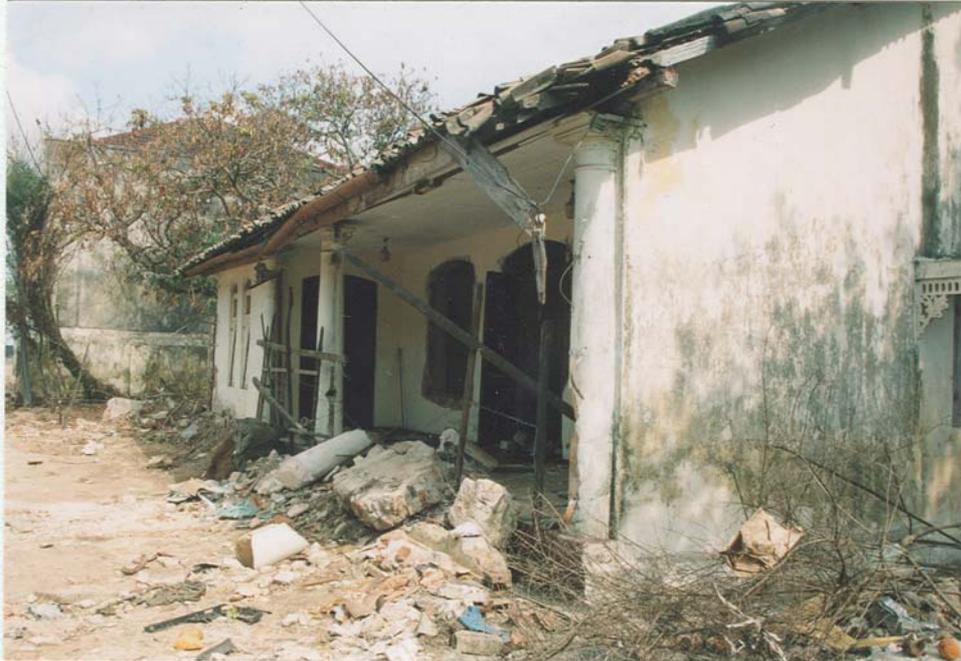
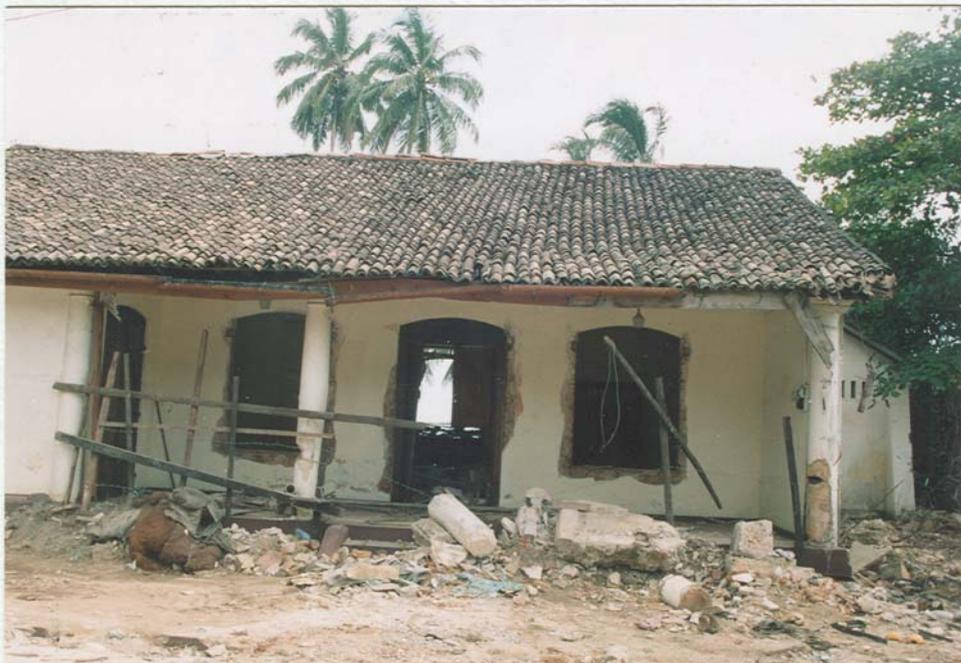
32. 124 OLD MATARA ROAD, PITTIGALAWATTA
(RM)-II-13

In Pittigalawatta, 124 and 165 Old Matara Road represents two typical examples of late 19th century residential buildings with colonnaded verandahs. The interior of No 124 has been destroyed, but since the structure itself is still standing restoration is highly recommended.

- 4) Building shows typical 18th-19th century architectural traditions. It is rectangular in construction with a colonnaded verandah at the front. There are original wooden doors and elaborate fanlights. The roof has Portuguese roofing tiles and a ceramic drainage system. The walls are made of brick and coral stone.
- 5) A: the building has not been altered - note the ceramic roof gutter and the open verandah (most verandahs have been closed).
- 6) III: Floating debris has damaged the front; at the back the walls are severely damaged. The interior is completely ruined by the soaring water.
- 7) Restoration recommended.
- 8) The owner is an antique dealer and therefore very interested in returning the house to its original state, provided there is money available.
- 9) RMJ – II – 13 till 21 / RMJ – III – 05 + 06.

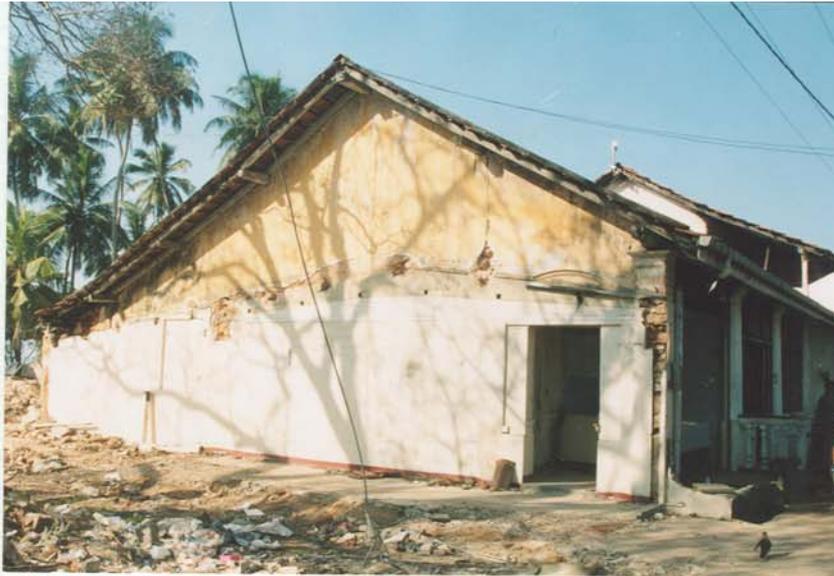
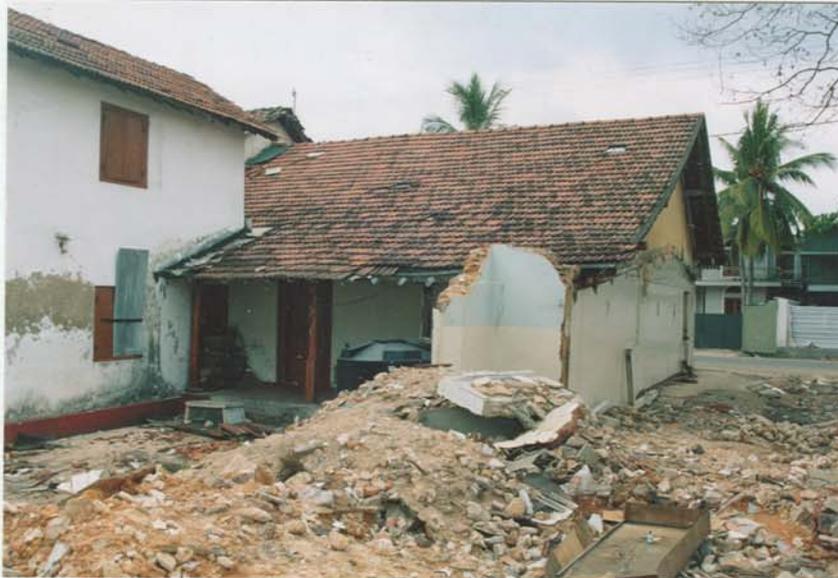
33. 160 MATARA ROAD

- 1) 168 Matara Road, Pittigalawatta.
- 2) Residential.
- 3) Building shows typical 18th-19th century architectural traditions.
- 4) Verandah with row of double columns, well-preserved decorated fanlights.
- 5) B: Some alterations to, for example, the verandah.
- 6) IV: only main structure remains.
- 7) Restoration recommended.
- 8) –
- 9) RMJ-II-27 / RMJ-III-1.

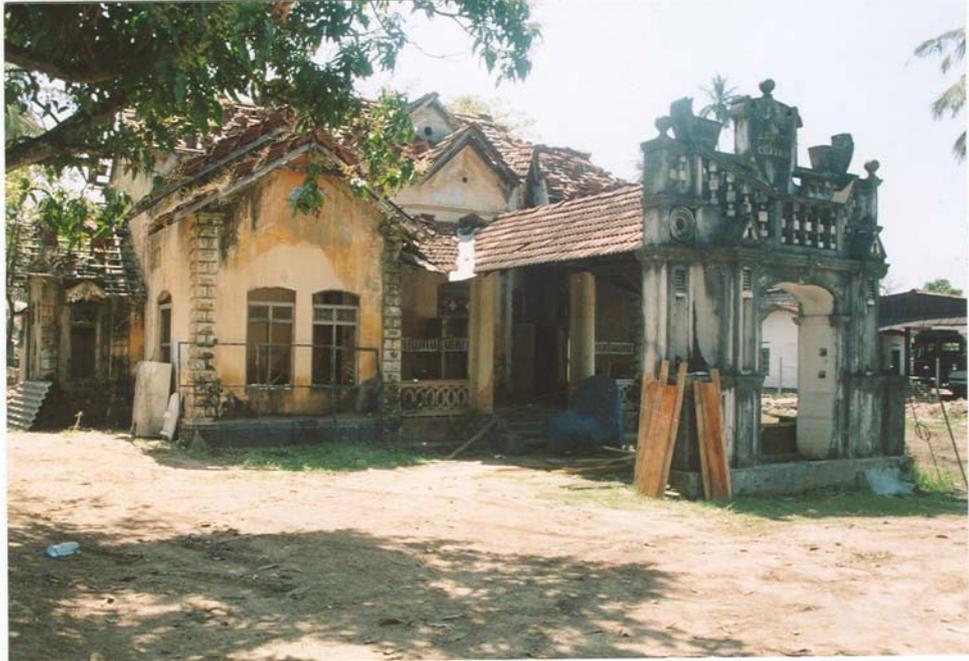
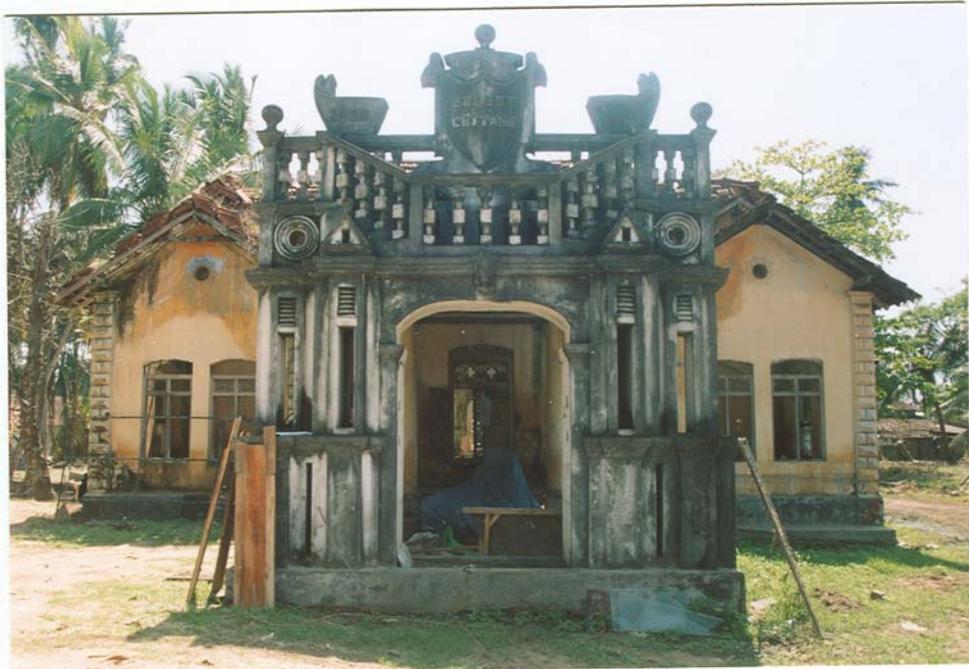
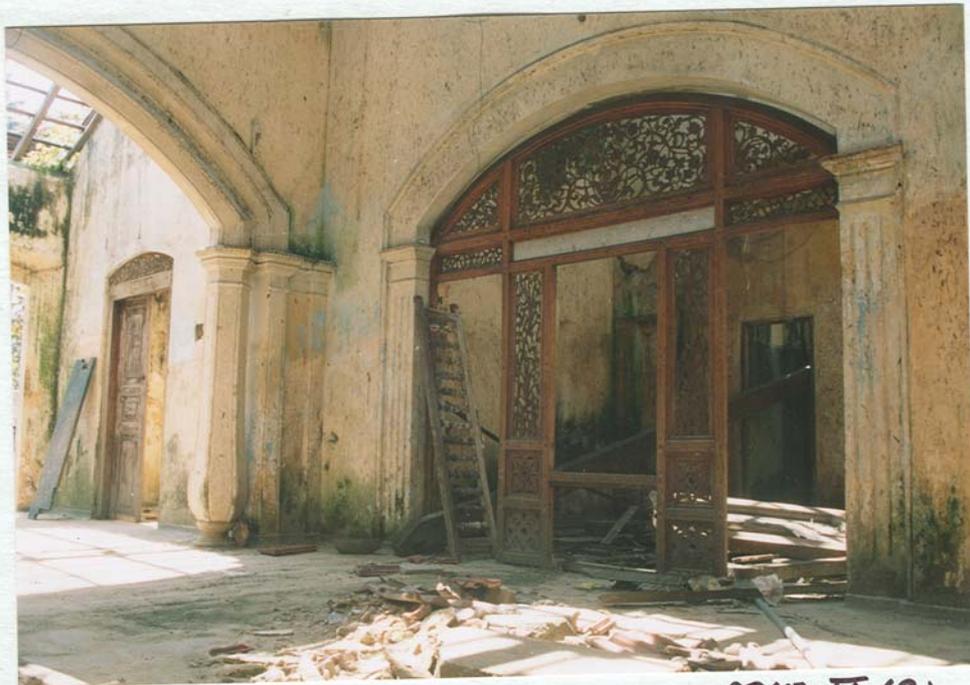
36. MATARA ROAD, „ERNEST COTTAGE“ (RMJ-IV-16)
IV-16

East of Pittigalawatta lies the Magalle area. Here a few architecturally significant structures are located. A typical example of a 19th or early 20th century residence is Ernest Cottage on Matara Road. The tsunami left the building in ruins. Even though in a fragile condition, the architecture, and the fact that Ernest Cottage is a familiar sight in the area, makes restoration desirable.

- 2) Residential.
- 3) Early 20th century.
- 4) Large rectangular villa with front porch.
- 5) A: characteristic house, as well as a familiar sight in its surroundings.
- 6) III: major damage, however, the building was already in a bad state.
- 7) Restoration recommended.
- 8) Uninhabited.
- 9) RMJ-IV-14/16/18/19.

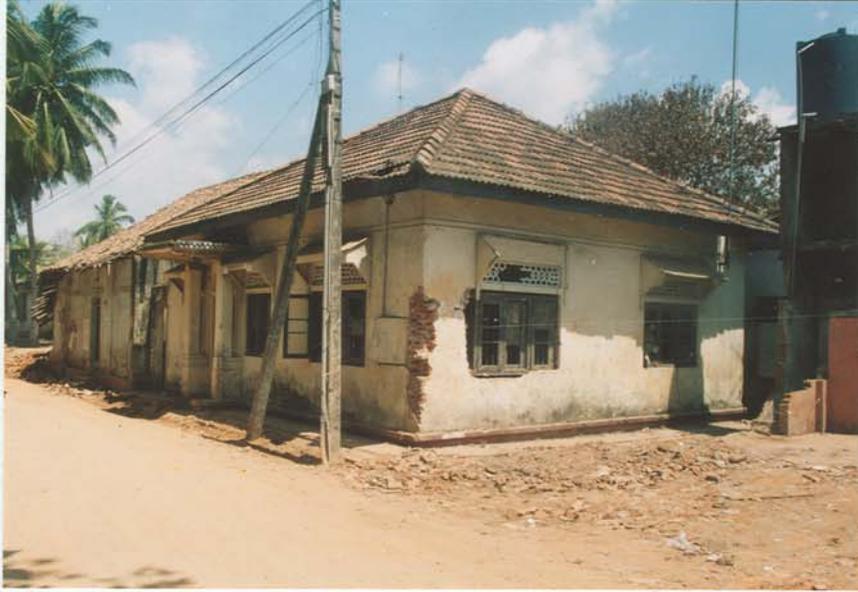
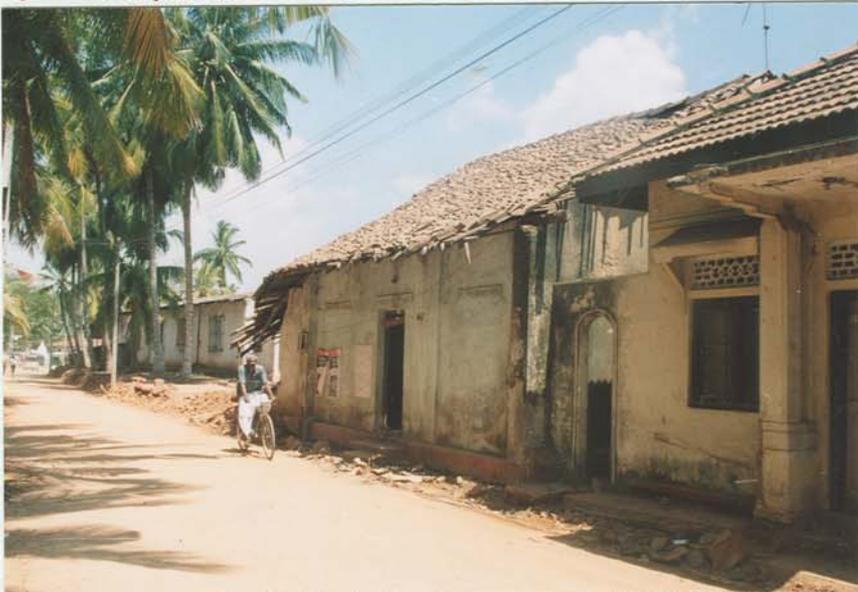
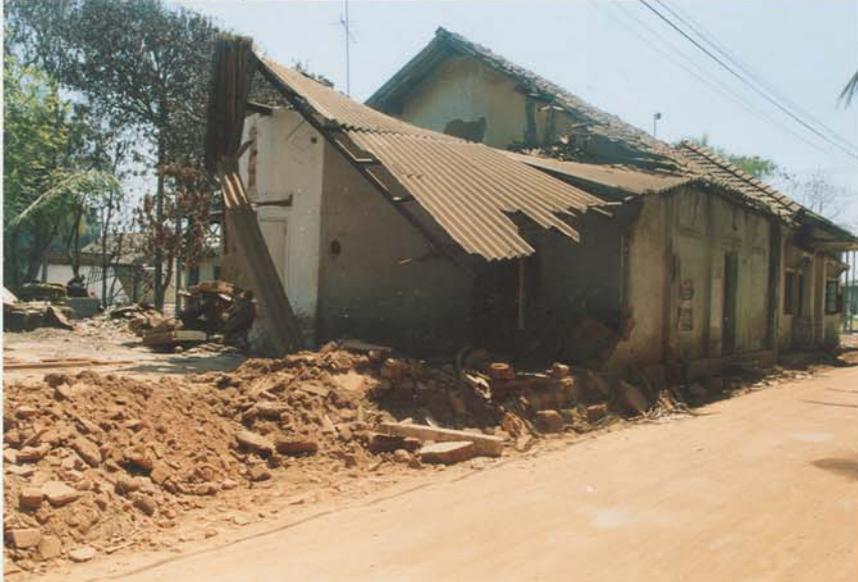
35. GANGARAMA ROAD (RMJ-IV-01)

- 1) 2-4 Gangarama Road, Magalle.
- 2) Residential.
- 3) 20th century.
- 4) –
- 5) C: minor historical value.
- 6) 2: II; water came up to 1.20m and caused little damage, 4: IV; rear side of the house has been completely destroyed.
- 7) Restoration of No 2 seems feasible, No 4 can be considered beyond restoration.
- 8) Uninhabited.
- 9) RMJ-IV-01, RMJ-IV-02, RMJ-IV-03.

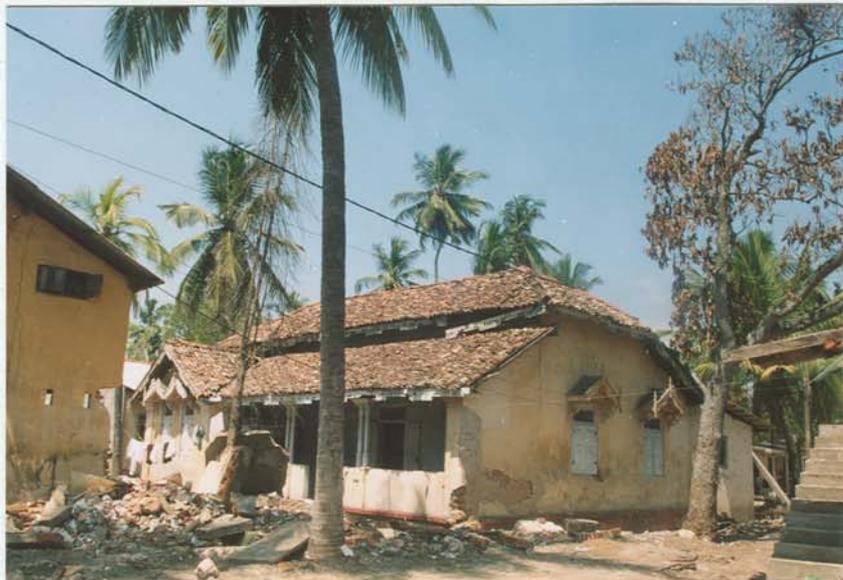
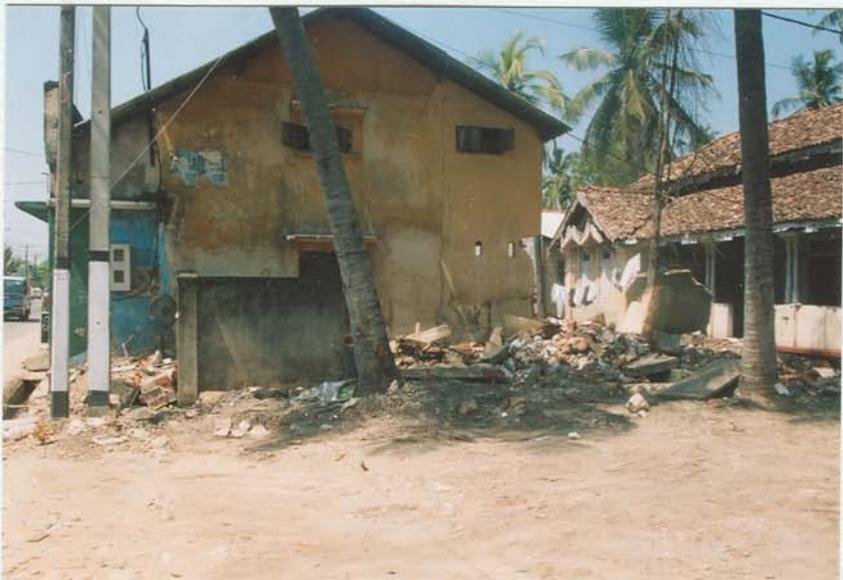
38. 215 MATARA ROAD

- 1) 215 Matara Road.
- 2) Residential.
- 3) First half of the 20th century.
- 4) Brick walls (plastered), verandah, and Portuguese roofing tiles.
- 5) A / B: typical structure with 19th century architectural characteristics.
- 6) III: Rear side severely damaged, front shows minor damage.
- 7) Restoration recommended.
- 8) –
- 9) RMJ-IV-06 / 07.

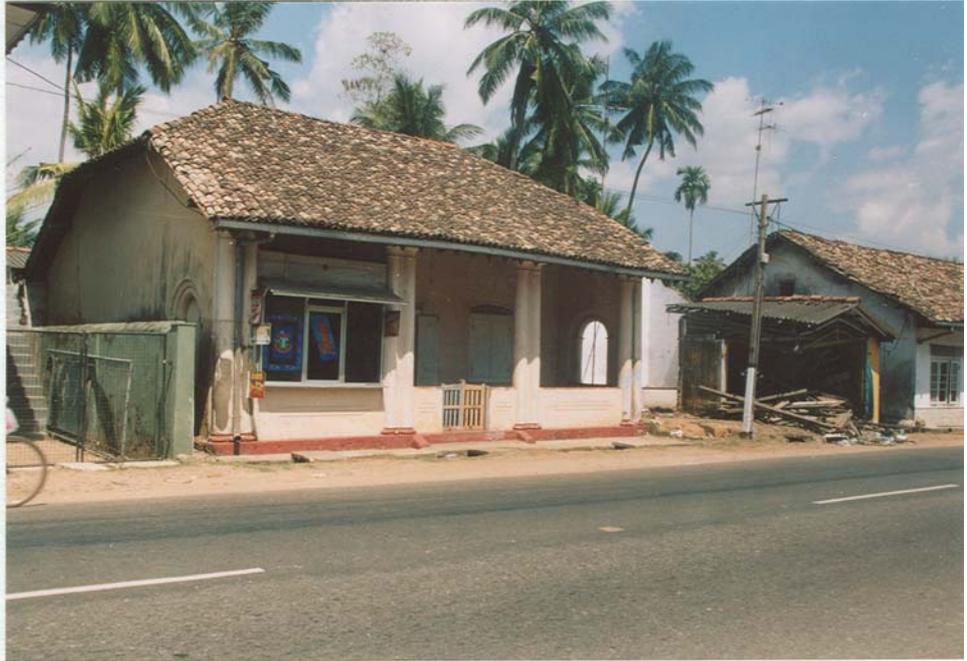
39. 267 MATARA ROAD, MAGALLE (RMJ-IV-21)

- 1) 267 Matara Road.
- 2) Residential.
- 3) 19th century.
- 4) Brick walls, colonnaded verandah, Portuguese roofing tiles.
- 5) A; built in the typical 18th – 19th-century style.
- 6) I: sea waves flooded the building up to a level of 1.60m, but did not damage it.
- 7) –
- 8) The building is in good condition and inhabited.
- 9) RMJ-IV-21.

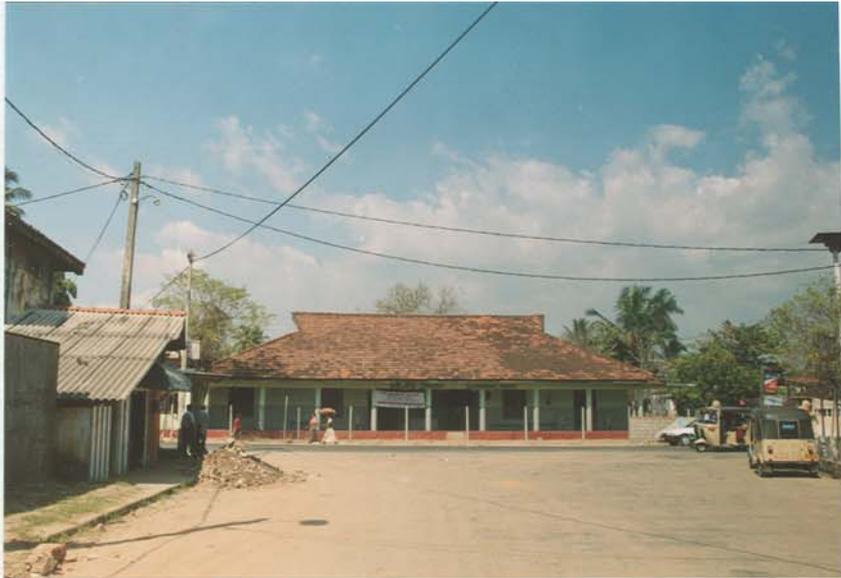
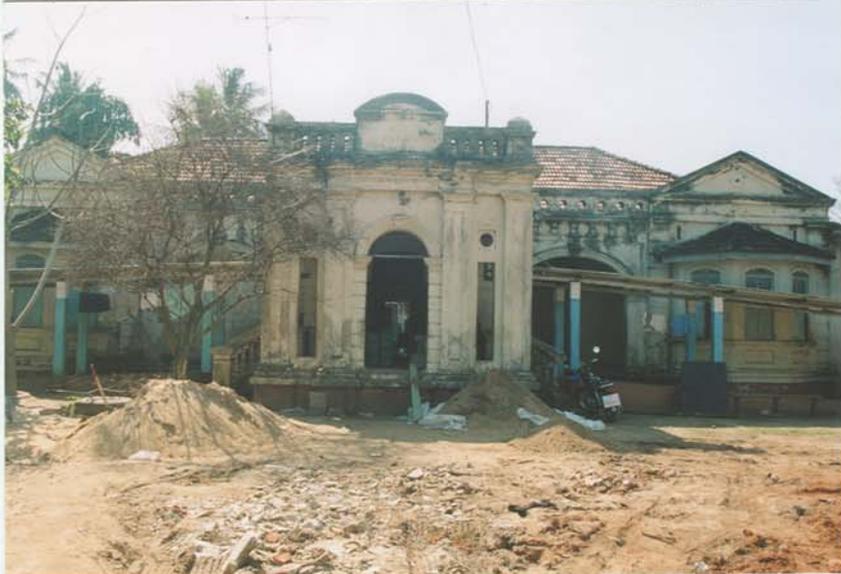
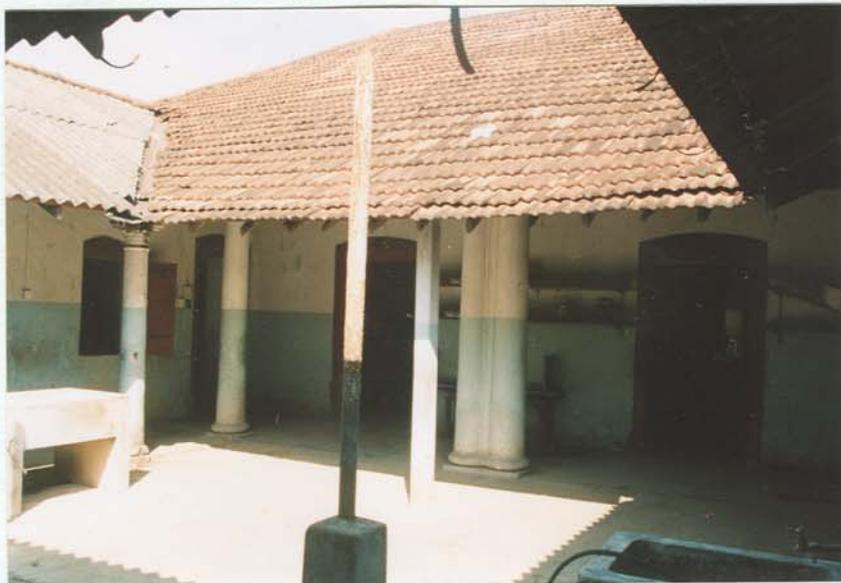
41. 277 MATARA ROAD, "SAMBODHI HOME" (RMJ-V-02)

Situated at the Matara Road – Udugama Road junction is the Sambodhi Home, a home for the disabled. The tsunami flooded the complex, causing many casualties. The Sambodhi home consists of two, probably 19th century buildings. The main structure faces Matara Road, while the building at the back, that bears the name "Siri Madura", faces Udugama Road.

- 7) Restoration is highly recommended.
- 8) The tsunami caused 40 casualties in the “Sambodhi Home” however; it is still in use. It is not unlikely that due to the (minor) damage to the buildings, and to create a better living environment for the people living there; a new complex might replace the historic complex.

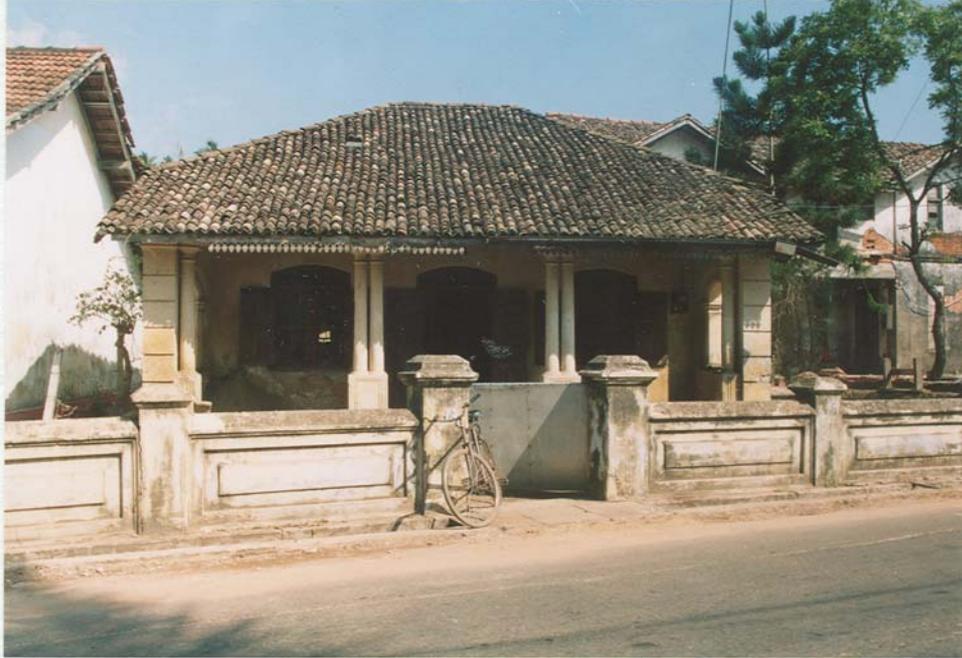
42. 305 UDUGANA ROAD

- 1) 305 Udugama Road.
- 2) Residential.
- 3) 19th - 20th century.
- 4) Small building with verandah, brick plastered walls and Portuguese roofing tiles.
- 5) A: built in the 18th – 19th century tradition, the house is in good condition.
- 6) I: water came up to a level of 1.50m, but there is no visible damage.
- 7) Preservation recommended.
- 8) –
- 9) RMJ-V-08.
