**Preliminary Survey of Tsunami-affected Monuments and
Sites in the Maritime Region of Sri Lanka**

An Archaeological Survey of Tsunami Affected
Historic Structures in the Municipality of Galle,
Sri Lanka

Ranjith M. Jayasena & Kim Spijker

PGIAR, Colombo, February, 2005

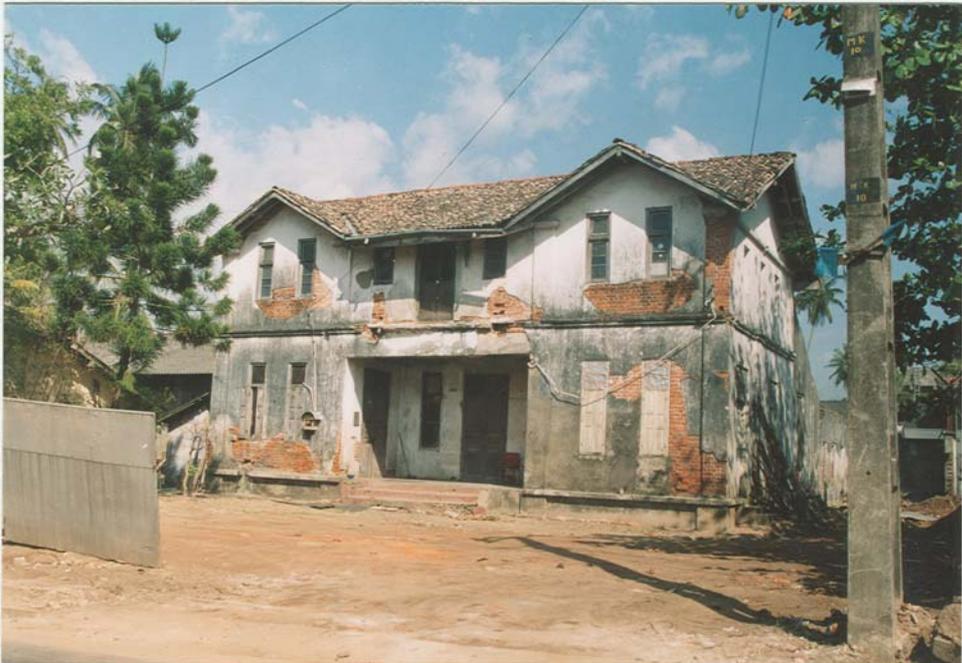
43. 307 UDUGANA ROAD

- 1) 307 Udugama Road.
- 2) Residential.
- 3) Early 20th century.
- 4) Rectangular two-storey building, brick walls and Portuguese roofing tiles.
- 5) B: a familiar sight, dominating its surroundings.
- 6) I: water came up to 1.50m.
- 7) Restoration recommended.
- 8) Although the building seems to be in good condition, no information could be gathered about the interior.
- 9) RMJ-V-10.

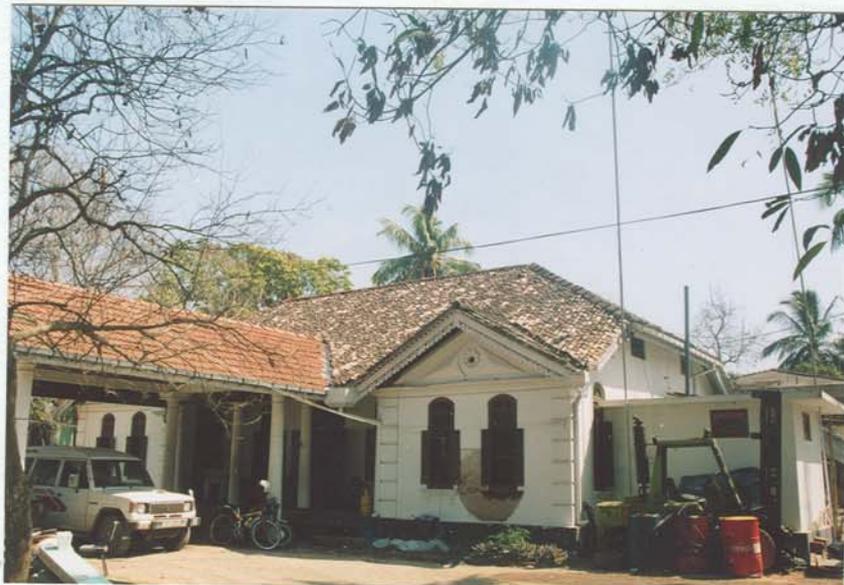
45. 6 CLOSENBERG ROAD (RMJ-VI-00)

- 1) 6 Closenberg Road.
- 2) Residential.
- 3) Early 20th century.
- 4) –
- 5) B.
- 6) II.
- 7) Restoration recommended.
- 8) –
- 9) RMJ-V-00.

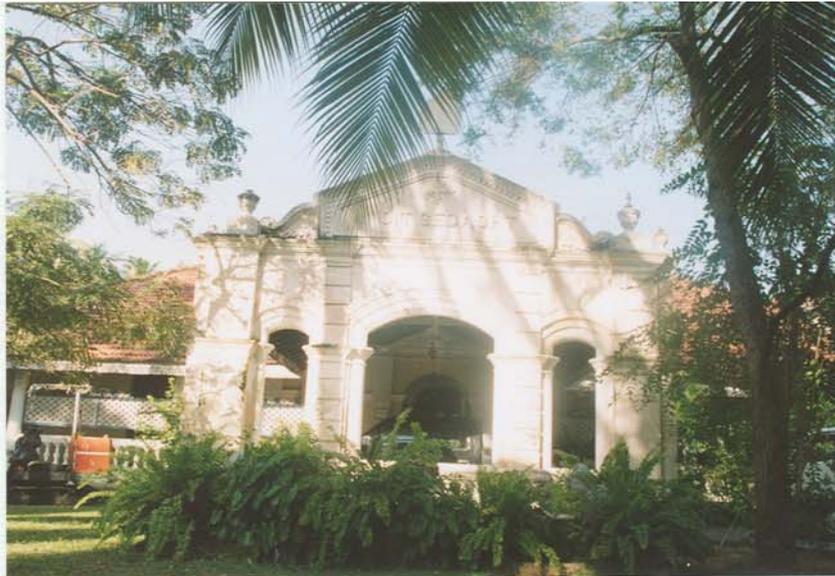
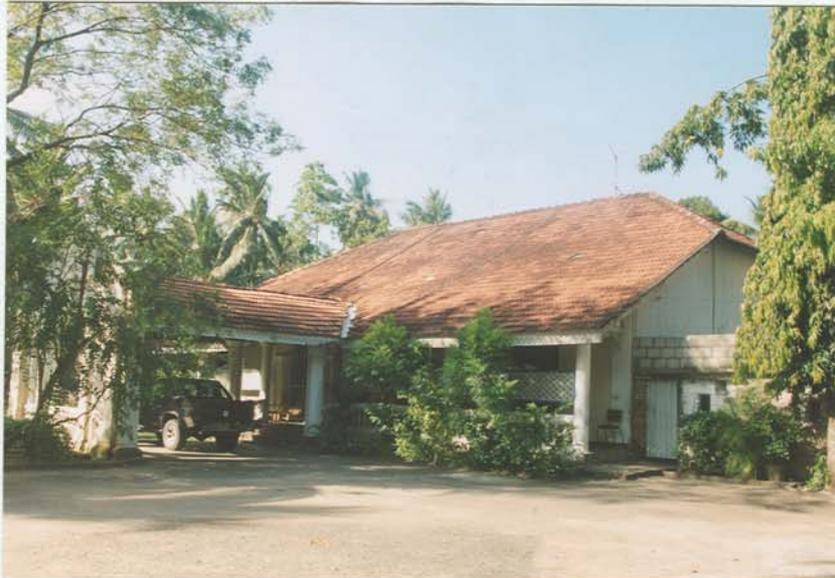
46. „NOOIT GEDACHT“, UNAWATUNA (RM)-V-14)

- 1) Matara Road, Unawatuna, “Nooit Gedacht”.
- 2) Hotel.
- 3) 18th century house.
- 4) –
- 5) A: Typical 18th century building in excellent condition.
- 6) Not affected by the tsunami since it is located just behind an elevated strip of land.
- 7) –
- 8) The building is well maintained since it houses a hotel.
- 9) RMJ-V-14 / 16.

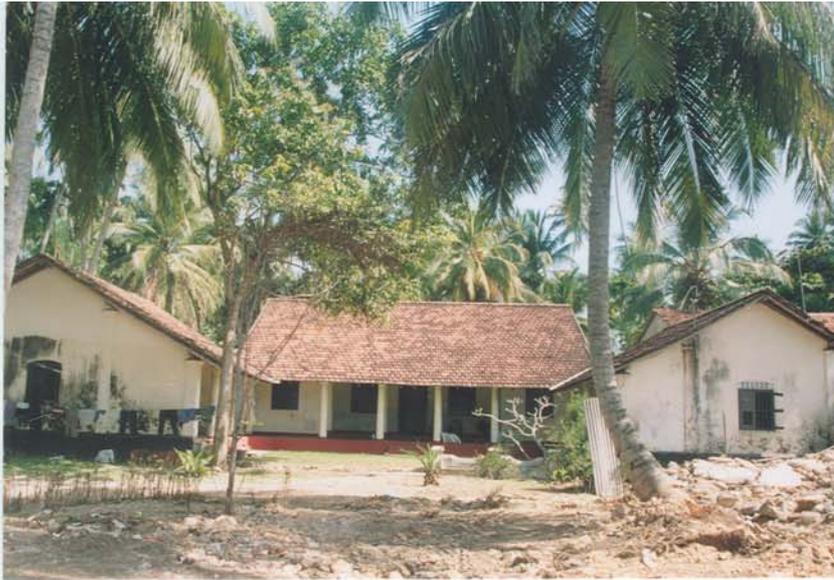
48. 403 MATARA ROAD, GANAHEMA. (RMJ-V-28)
UNAWATUNA

- 5) B.
- 6) II: flooded up to 2.00m, damage to doors and windows.
- 7) Restoration recommended.
- 8) –
- 9) RMJ-V-28.

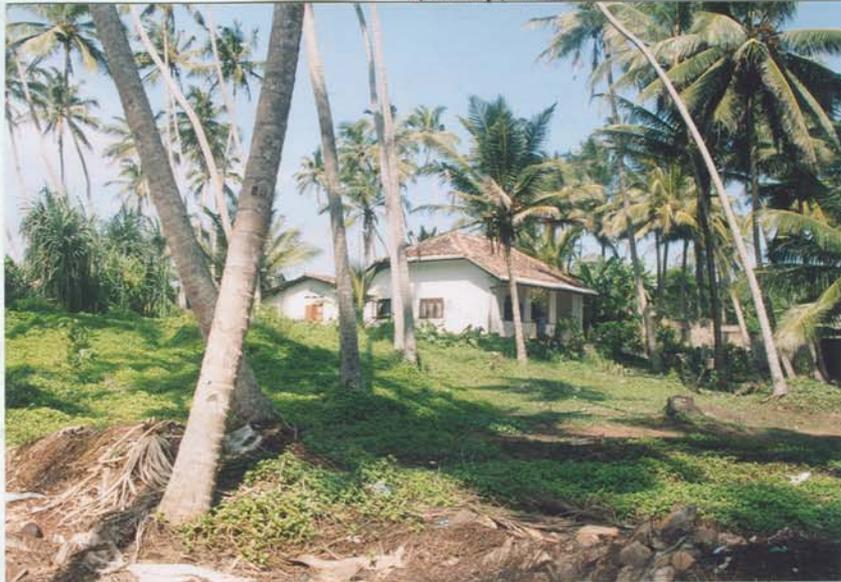
49. (RMJ-V-36)

- 1) Matara Road, Dalawalle, Unawatuna.
- 2) Residential.
- 3) 19th – 20th century.
- 4) Small house in 19th century tradition.
- 5) B.
- 6) I: only water damage.
- 7) Restoration recommended.
- 8) –
- 9) RMJ-V-36.

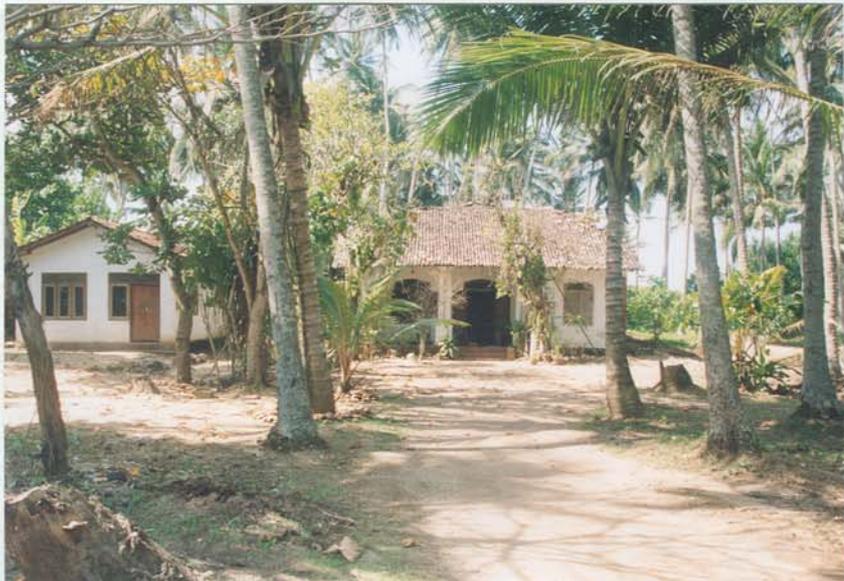
50. "RED LOBSTER", MATARA ROAD (RMJ-V-29)

- 1) “Red Lobster”, Matara Road, Dalawalle, Unawatuna.
- 2) Residential.
- 3) 19th – 20th century.
- 4) Small building with verandah.
- 5) B.
- 6) I: only water damage.
- 7) Restoration recommended.
- 8) –
- 9) RMJ-V-29.
