# **ICOA1371: SAFEGUARDING AN IDENTITY CARVED IN STONE: HERITAGE CONSERVATION OF THE ‘OAMARU HISTORIC AREA’ IN OTAGO, NEW ZEALAND**

## **Subtheme 01: Integrating Heritage and Sustainable Urban Development by engaging diverse Communities for Heritage Management**

**Author:** Stacy Vallis, Caroline Orchiston, Jason Ingham

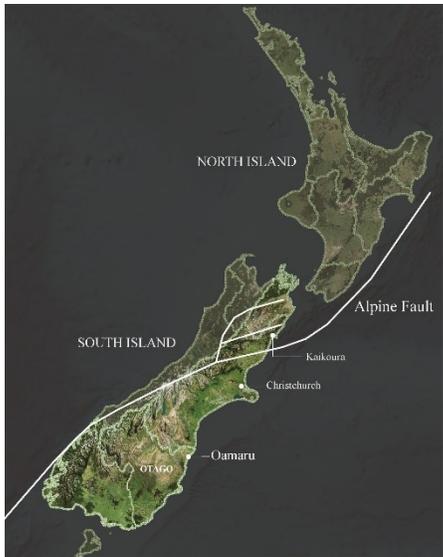
Fig.1- New Zealand Seismicity

(b) Illustrating earthquakes greater than M 4.0 since 1970 (Data extracted from [quakesearch.geonet.co.nz](http://quakesearch.geonet.co.nz))

(a) Location of Oamaru in South Island

In recent years the Oamaru Victorian Precinct has attracted increasing numbers of visitors, as a consequence of the resurgence of interest in New Zealand's heritage, provoking various changes in use within the building stock. In the year ending April 2017 (April 1, 2016 – March 31, 2017), total visitor arrivals generated a revenue of \$175 million in the Waitaki region.<sup>12</sup> The recent rapid growth in tourism activity across New Zealand over the past two years, resulting in more than 3.5 million international visitor arrivals per year for the first time, is also reflected in Waitaki tourism growth.<sup>13</sup> The following analysis highlights an example of tourism-related conservation and adaptive reuse within the Victorian Precinct (*Fig.1*).

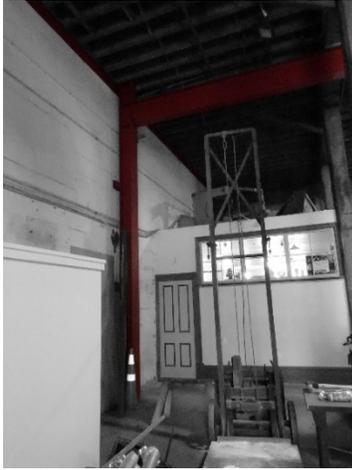
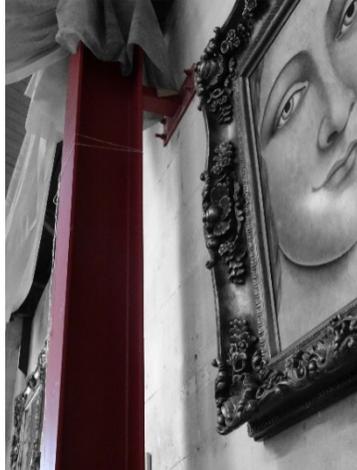
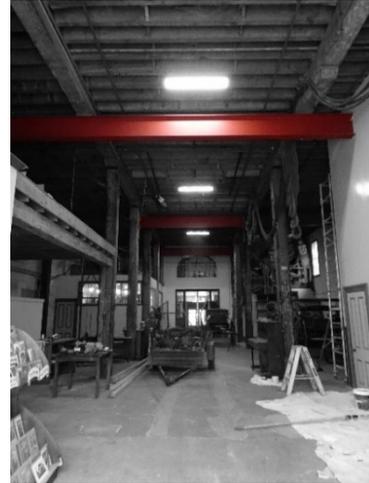
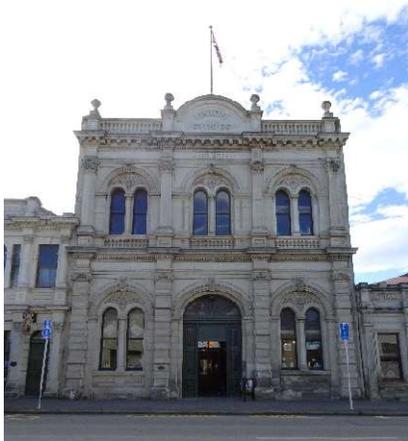
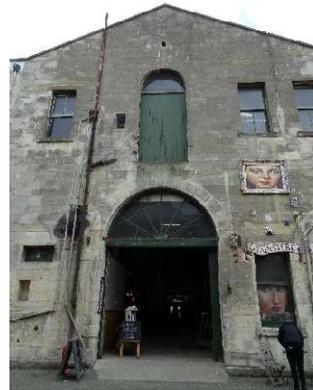
Fig.3- Expressed steel portal frames in Smith's Grainstore (Oamaru Victorian Precinct)

(a) Wall-First Floor Connection

(b) Wall Connection Detail

(c) 3 Steel Cross Beams

(c) Tyne Street Elevation

(d) Harbour Street Elevation

Site inspection revealed an expressive, interventionist approach to the undertaken structural conservation works. The proposed engineering solutions were implemented with three “goal post type”/ “H-shaped” steel frames, along with additional securing of structural elements to the exterior masonry walls.<sup>21</sup> The introduction of new red painted steel frames which are visible from ground to roof level and consists of new steel columns and cross beams eschews concealment and reflects the attitude presented by the 1993 ICOMOS New Zealand Charter (

*Fig.3a-c*).<sup>22</sup> Despite contrast in material and colour, the overall form, scale and mass remains consistent with the original timber structural matrix of columns and beams, seen at ground level. While installation involved the removal of three timber posts and replacement with steel columns, compatibility with the building’s historic internal plan configuration is retained.<sup>23</sup> The proposed works were undertaken in conjunction with a wider scheme for redevelopment.<sup>24</sup> From a stakeholder perspective, a key logistical challenge faced by building tenants and business owners during seismic strengthening work is described as:

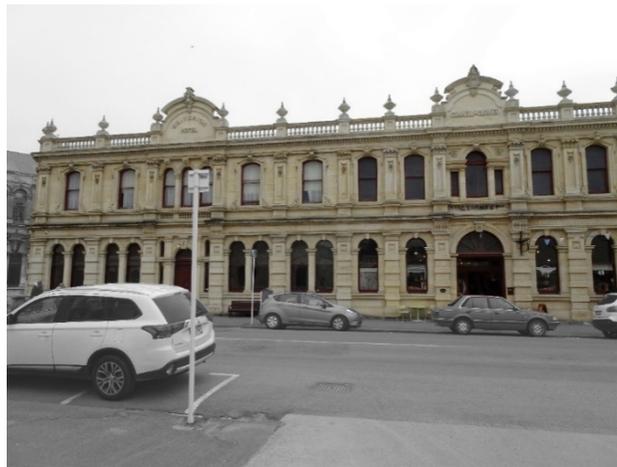
(a) Visible colour variation in Oamaru limestone parapet, indicating recent reconstruction works

where the original parapet finials were removed from the building, the parapet was readdressed during the 1990s conservation scheme. Archived working drawings reveal a process of dismantling the original and constructing a bond beam and stone parapet, that is perceptible from street level visual inspection (*Fig.4a*).<sup>28</sup> The procedure of works entailed reinstating new parapet finials with concealed carbon fibre rods, and fixed with epoxy resin grout.<sup>29</sup> The parapet demanded full reconstruction, potentially reusing any remaining good stone.<sup>30</sup> This procedure related to the 1993 ICOMOS Charter's process of reconstruction.<sup>31</sup> Partial reconstruction is addressed, although clarification of whether this process involves additional new stone or other remaining materials lie outside the Charter scope, remaining to be defined on a case-by-case basis.<sup>32</sup> Similarly, the subject of workmanship is addressed through the use of surviving evidence or knowledge of form, design, technology and craftsmanship for the purpose of reconstruction.<sup>33</sup> Authenticity is defined for the first time in the 2010 Charter.<sup>34</sup>

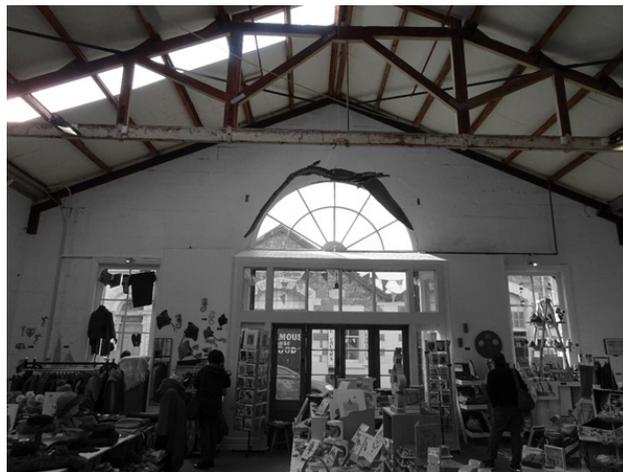
(b) Painted steel profile improving wall-roof connection (Connell and Clowes Building)  
Fig.4- External and internal structural modifications to the Criterion Hotel and Connell and Clowes Building  
(Oamaru Victorian Precinct)

facings portion of the Connell and Clowes Building features a visible painted steel profile evident in the building interior, providing improved wall-roof connections. Minimal invasion is an advantage of expressing the required structural upgrading solutions as compared with concealing new structural elements within the historic masonry building fabric. Article 6: Minimum Intervention is included as a specific definition within the 2010 Charter, for clarity of use and perhaps further reflecting the more conservative approach to new work.<sup>35</sup>

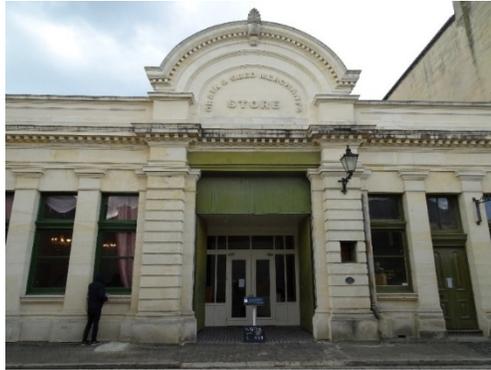
Fig.5- Neill's Building (Oamaru Victorian Precinct)

(a) Harbour Street elevation/New parapet

Lastly, Neill's Building is an example of intervention via removal, replacement and adaptation. Proposed seismic strengthening works entailed the removal, reproduction and reinstatement of the original building's parapet. In contrast to drilling carbon fibre rods into the parapet balustrade, archival drawings of Neill's Building featured replacement with concrete blocks sheathed in Oamaru stone and additional strengthening using stainless steel dowels grouted into the original Oamaru stone building wall.<sup>36</sup> Visible securing bolts along the Harbour Street elevation gable suggest the use of additional steel braces. Site inspection also revealed a less elaborate parapet form compared with other precinct examples, perhaps enabling the adoption of the aforementioned parapet replacement design solution, using concrete blocks. The same method for wall-roof strengthening is adopted, as seen in the Connell and Clowes Building, using a painted black steel gable profile and steel truss fixings.

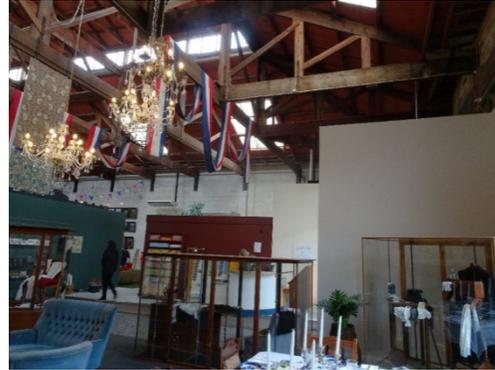
(b) 'Whitestone City' Museum inside Neill's Building
