ARE BUDDHA STATUES IN REMAINS LIVING HERITAGE FOR LOCAL BUDDHIST PEOPLE?

- CASE STUDY ON THE CONSERVATION OF THE GIANT BUDDHA STATUE AT SUKHOTHAI HISTORICAL PARK IN THAILAND -

Conservation of the Giant Buddha Statue at Sukhothai Historical Park in Thailand

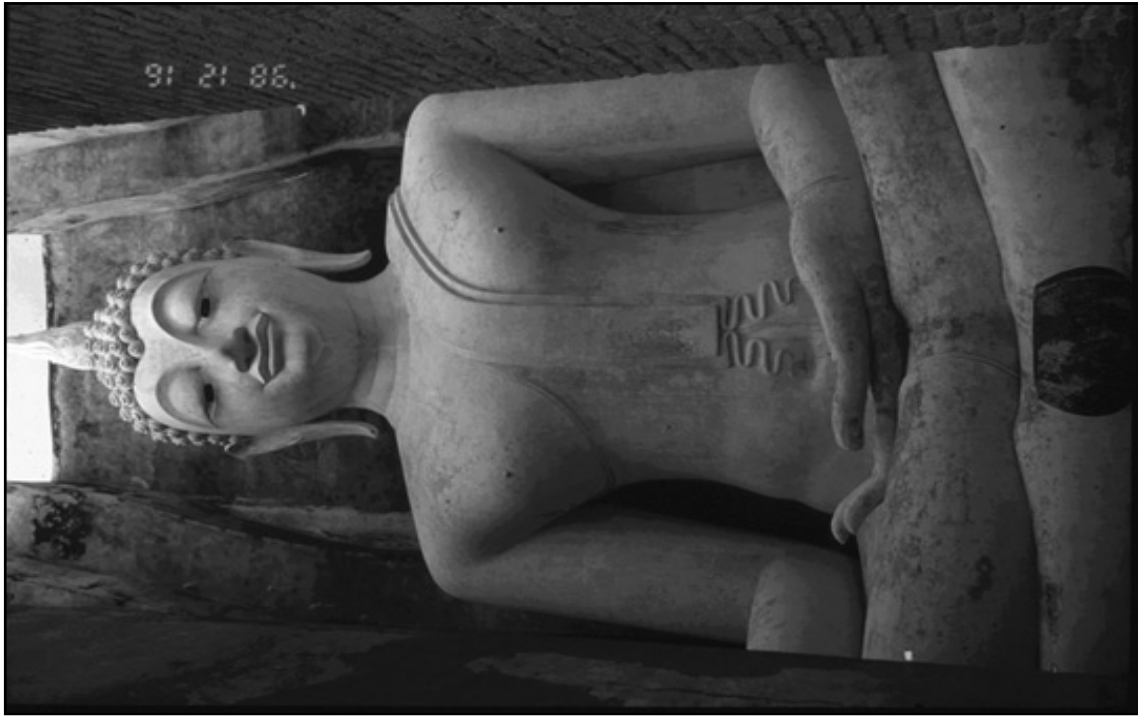
After the conservation treatment, its color changed from greenish black to slightly grayish white. And, it should be noted that the face of the Buddha changed to be merciful with the change of the color.[Photo.2]

Photo.2
Giant Buddha After Conservation Work

Dry deposit of mosses, algae and lichens was carefully removed by mechanical means with small scrapers, scalpels, soft brushes and synthetic fiber abrasives. Neither chemical nor water was used in the cleaning process. The cleaning process was accomplished by nine conservators and eight workers within 37 days.

The deteriorated plaster was removed and restored by using traditional lime plaster consisting of slaked lime, sand and paper fibers. These materials were well mixed and thoroughly pounded until it reached the desired consistency. This process yields stronger and less porous lime plaster. It also improves the plasticity and workability of the plaster. The portland cement which had been partially used in the previous restoration was also removed and replaced by this mixture.

About 300kg of the silicone resin solution (SS-101) was transported to the site from Japan. The silicone resin solution was applied to the statue in the order from the higher part to the lower part by pouring and/or brushing.

The solution penetrated well into the deteriorated part which had suffered from tremendous growth of microorganisms, while it penetrated a little into the sound part which had not suffered from growth of microorganisms. So, the amount of impregnated (applied) solution varied from 2 - 3 kg/m² down to 500 g/m² depending on the deterioration degree and the average amount was about 1 kg/m².

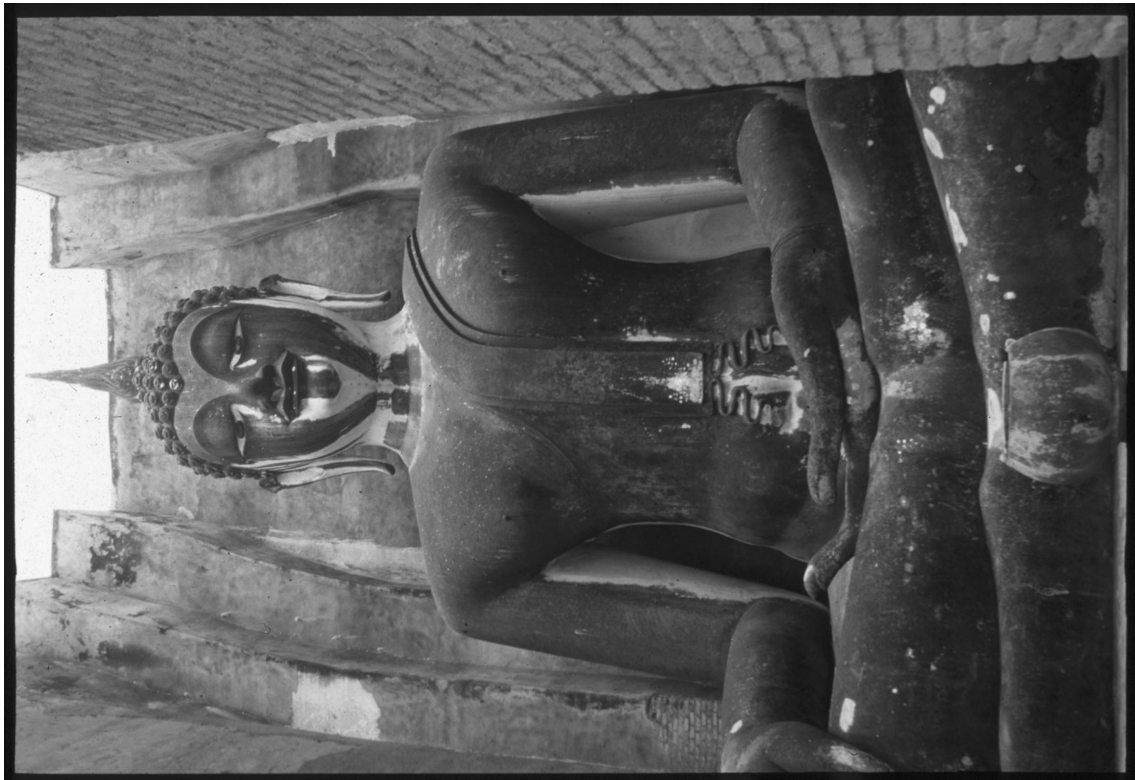
Tremendous microorganisms (mosses, algae, lichens, etc.) were growing on the surface of the statue. In the rainy season when enough water drenches the statue, the microorganisms got active and the surface looked a green carpet. In the dry (photo 1) season when little water is supplied, the microorganisms got into a state of suspended animation and blackened. Thus, the statue was discolored into greenish black except its armpits, its back and some part of its face, and had a very strange appearance. And mechanical deterioration (fragilization of the surface, especially the horizontal surface) occurred by the growth of microorganisms.

Photo.1
Giant Buddha Before Conservation Work

Moist areas of the statue was covered with greenish black crust and patinas. The microscopic investigation revealed that these crusts and patinas consist of mosses and algae. Their presence was more apparent on the horizontal surfaces. Mosses developed rapidly on the surface that was rich in humus deposit. The principal sources of such deposit was the accumulation of airborne particles, dead microorganisms and bird droppings. The plaster surface underneath was badly deteriorated.
