RENOVATION OF THE MONUMENTS IN THE VILLAGE OF PEÑARANDA DE DUERO (PROVINCE OF BURGOS)

(Collegiate church, Palace of the Dukes of Peñaranda, Palace Square and Town Hall Square, "Rollo", or column marking an area of feudal jurisdiction; peasants' houses.)

Architect : Francisco Pons-Sorolla.

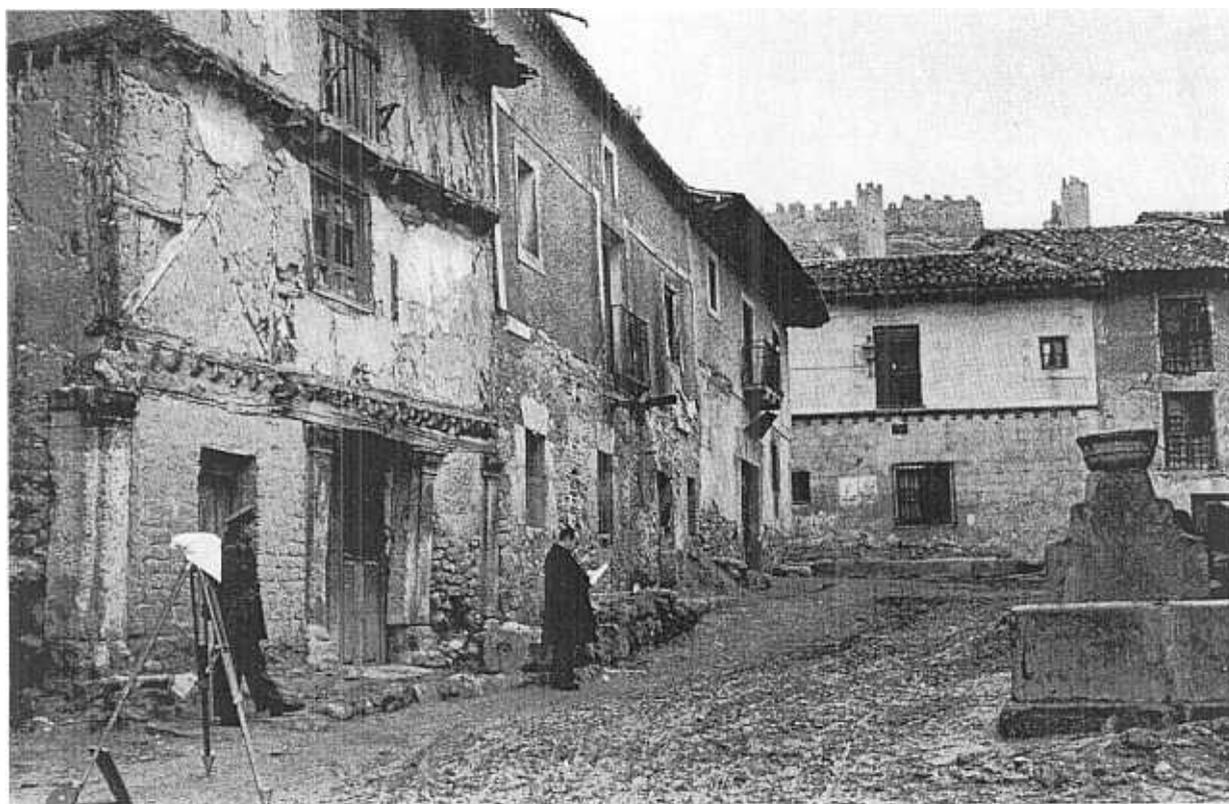
Fig. 1. — The Town Hall Square, condition when work started.

When work started, the whole of this handsome group of buildings was in an appalling state of neglect, aggravated by the presence of layers of earth washed down by torrential rains from the castle hill and the upper part of the town. As will be seen from the photograph taken at the time, the houses of the townsfolk with their wooden structures and wooden decorative features were largely in a ruinous condition, while some had been covered over with stuccoes or special renderings imitating other materials.

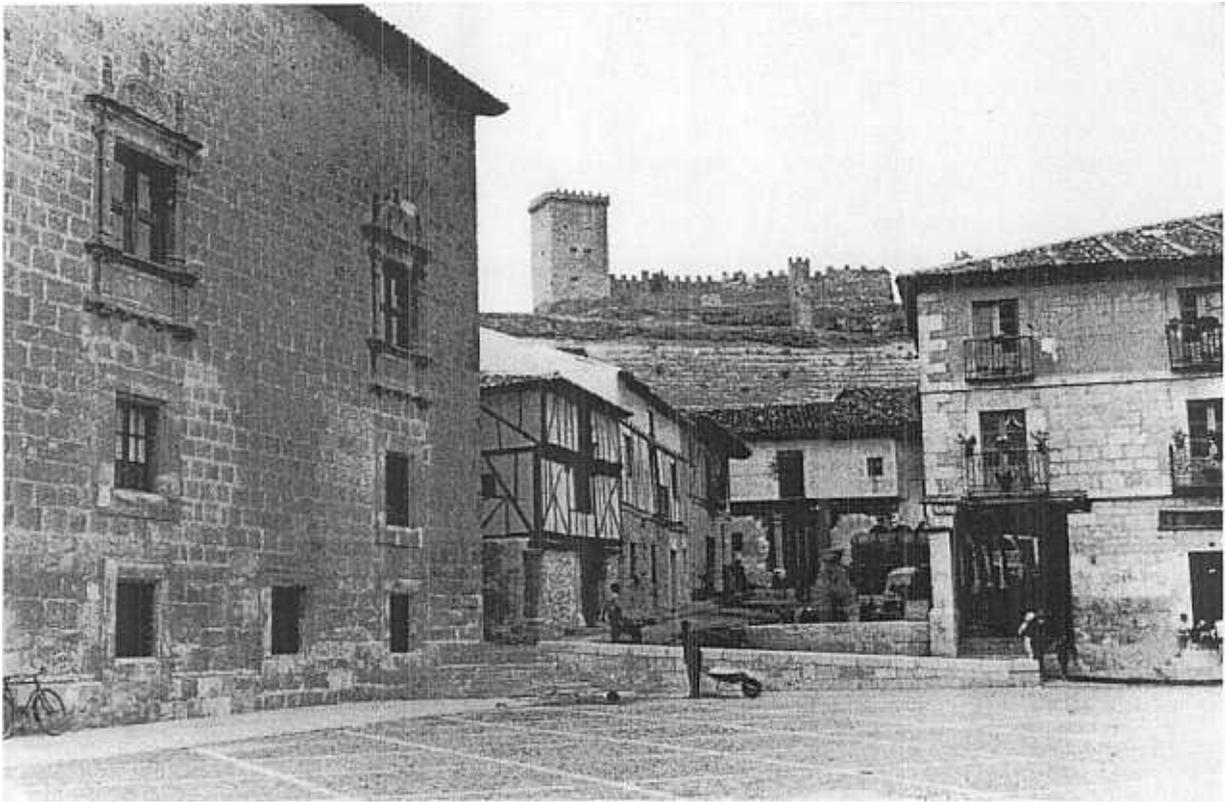
Fig. 2. — The monuments as they appeared during the renovation work. In the background, the Castle and the Town Hall with the porch of the latter partially uncovered.

J. The Town Halls has been consolidated and restored. In the course of this work its 16th-century pillared porch, which had been artificially covered up and walled in, was completely reinstated.

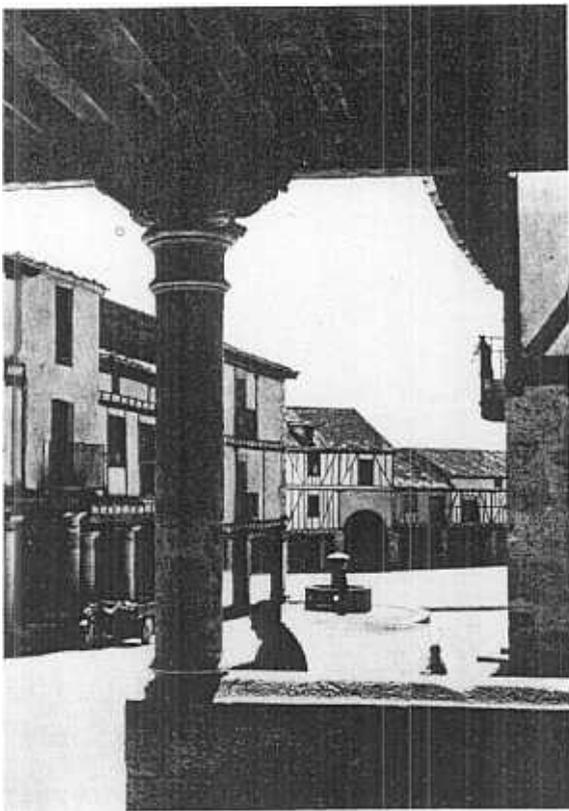
Fig. 3. — The squares as seen from the Town Hall porch.

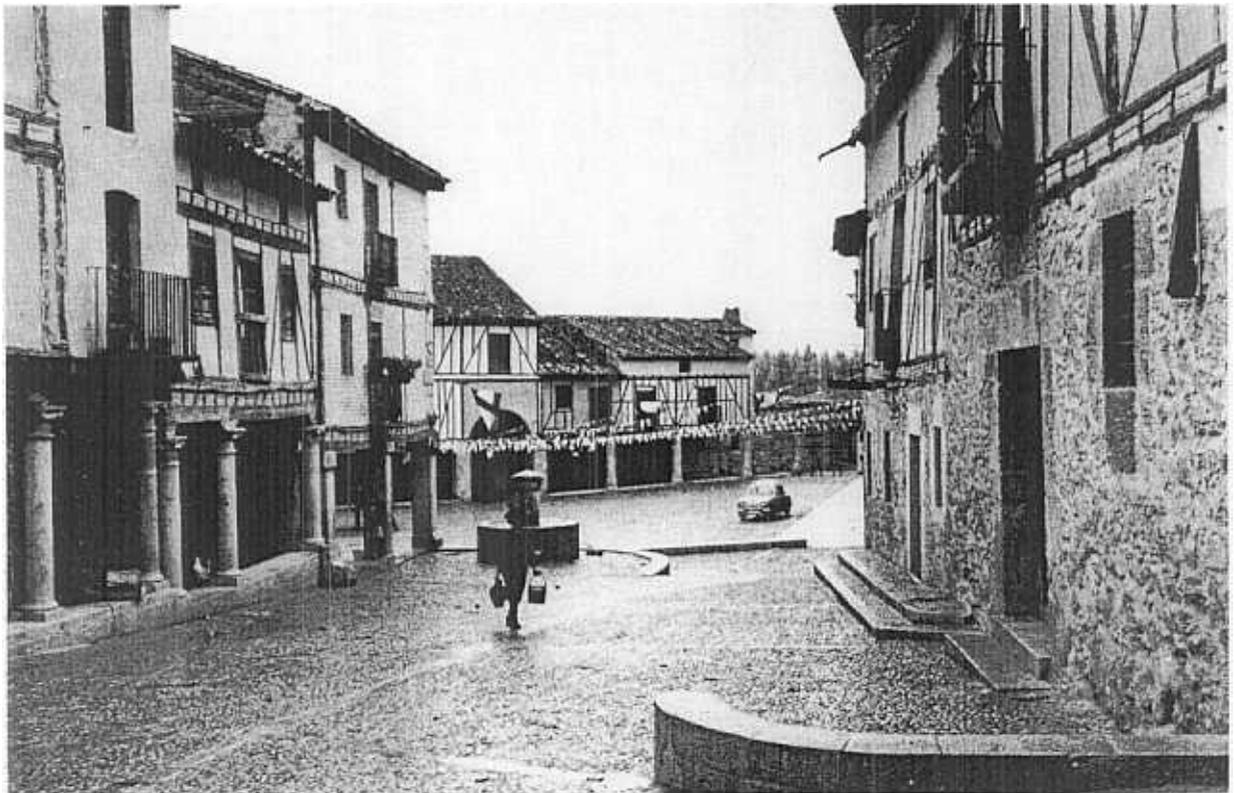
Fig. 4. — The squares on the completion of the work.

- A.* The difference in level between the two sections of the square has been emphasized so as to reduce the slope and make the ground in front of the Palace roughly horizontal.

- B.* A double traffic ramp has been built at the rear to link the upper part of the square with the streets leading to the rest of the town.
- C.* The character of the upper part of the square has been preserved; its paving is in a vernacular style, and the kerb running inside the arcade is reached by steps.

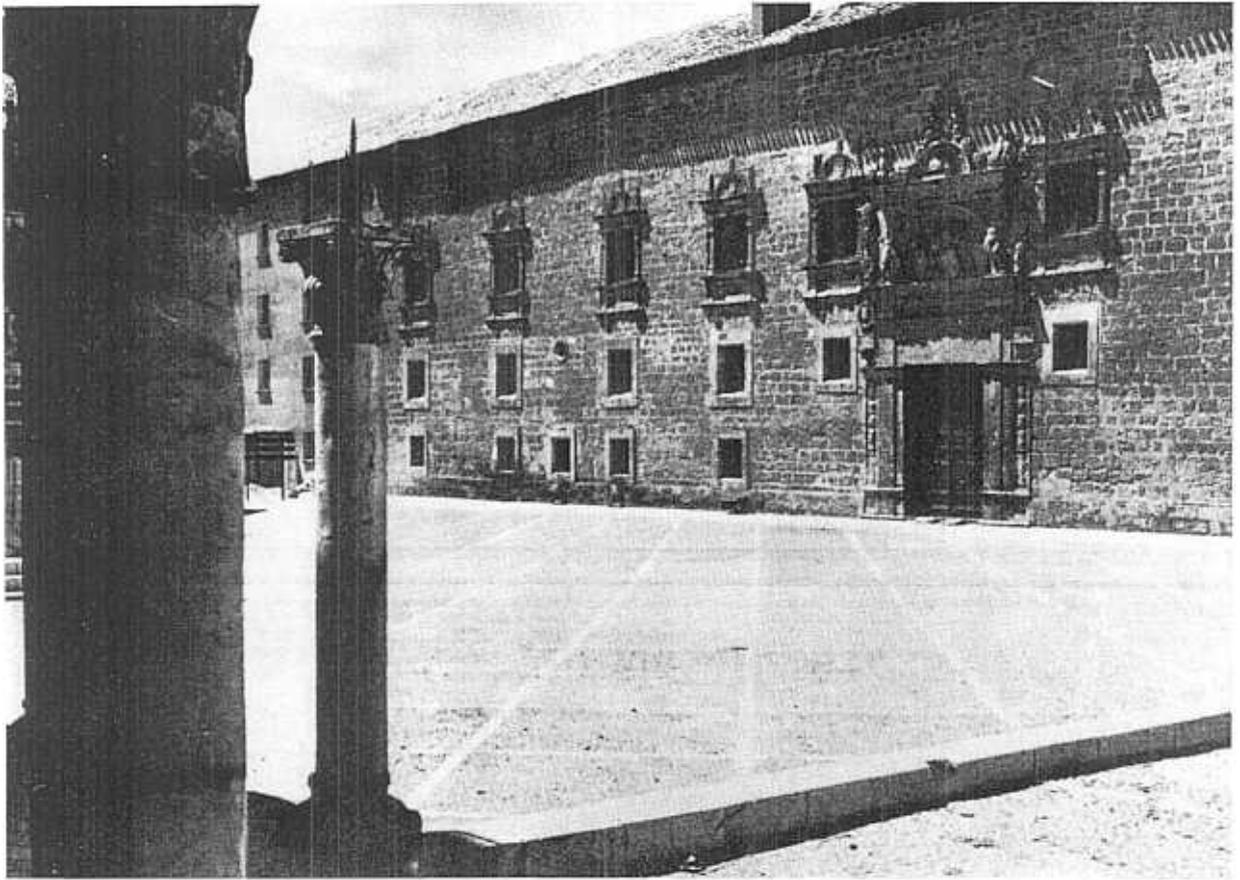
Fig. 6. — The square of the Dukes of Peñaranda with the 16th-century palace.

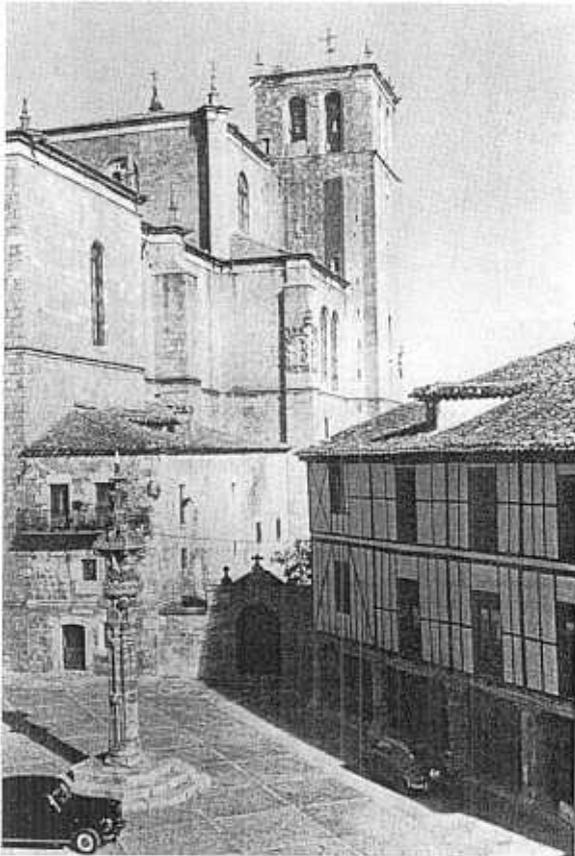
Fig. 6. — The Square of the Dukes of Peñaranda with the 16th-century collegiate church in the background.

- D.* The entrance porch to the church has been enlarged and renovated, while its columns of Italian marble have been retained.
- E.* The Gothic *rollo* has been brought inside the square and put up at a point carefully chosen with an eye to the maximum overall effect from the various angles from which it will be seen and to a harmonious balance of mass when it is looked at in conjunction with the other buildings.

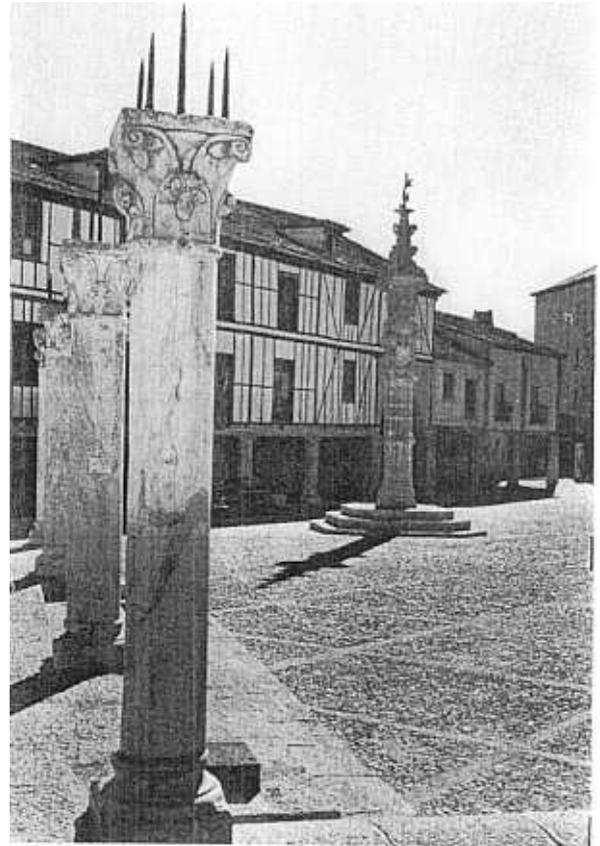
Fig. 7. — The Square as seen from the church porch. The "rollo" on its new site.

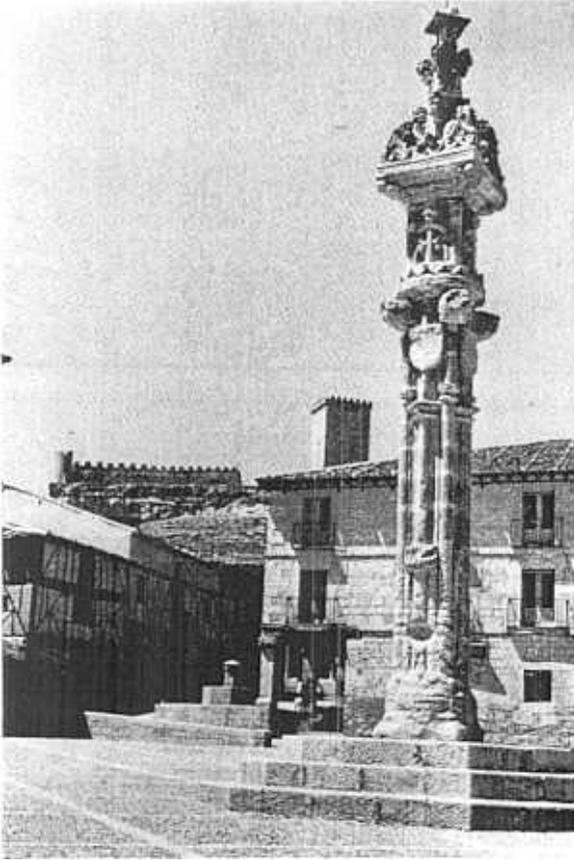
Fig. 8. — The squares as renovated, showing the "rollo".

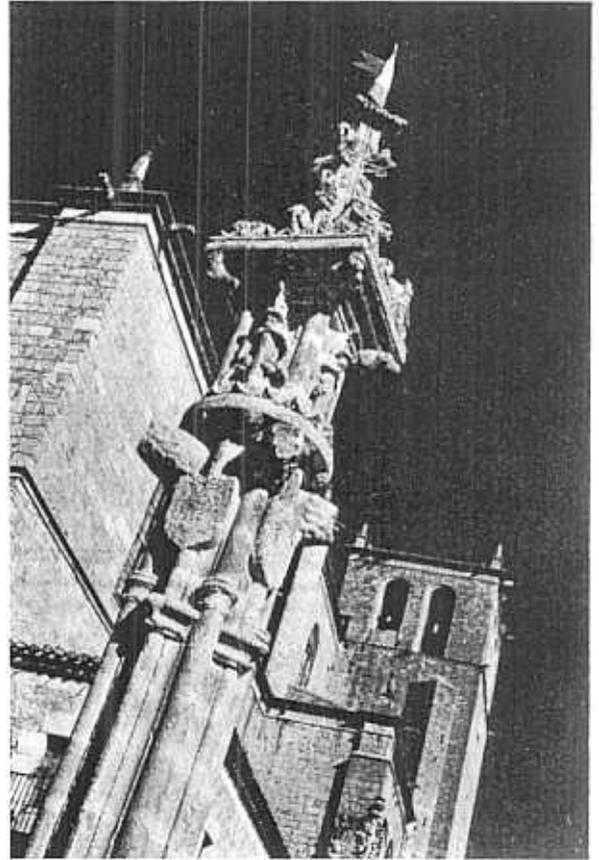
Fig. 9. — "Rollo"; detail.

Just outside the entrance to the square, directly on the main road and exposed to every sort of danger from passing lorries, there stood the late 15th-century *rollo* or column marking the area of feudal jurisdiction, scheduled as a National Monument and, as our illustrations show, one of the finest to be found in Spain.

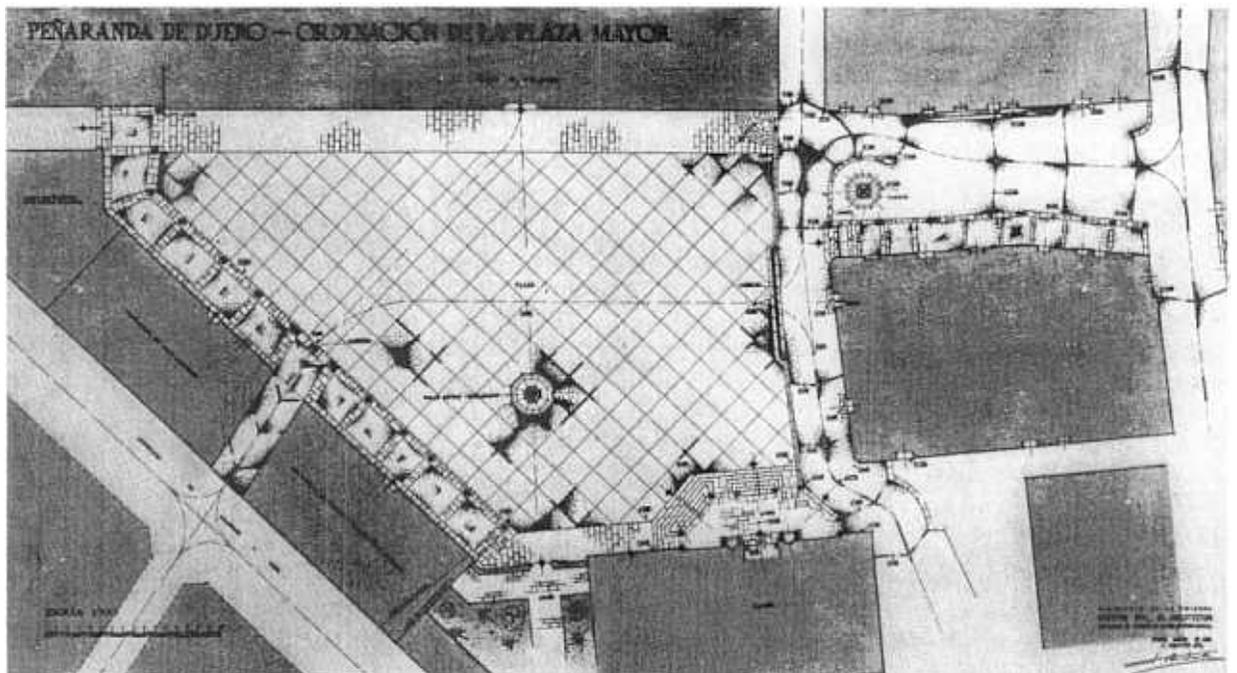
Fig. 10. — Plan of the renovated area.

- F.* The whole square has been laid with a traditional paving of cobbles and slabs on a concrete foundation, following a reticulated design suited to the size of the area and so oriented as to contribute, by a perspective effect, to the general impression of regularity, while emphasizing the itineraries in regular use and the main axial features of the monuments.

I. The vernacular paving of slabs and cobbles on a concrete foundation has been continued into the little square adjoining the northern face of the church and into the streets connecting this to the renovated area; problems arising out of differences in level have been solved by means of raised kerbs with steps leading up to them and by the introduction of green patches, in accordance with the plan completing the central scheme.
