## RECONSTRUCTION AT THE MAYA RUINS OF SEIBAL (\*)

#### EXCAVATION AND RECONSTRUCTIONS OF STRUCTURE A-3

#### EXCAVATION AND RECONSTRUCTION OF STRUCTURE 79

## MENDING AND RESETTING OF STELAE

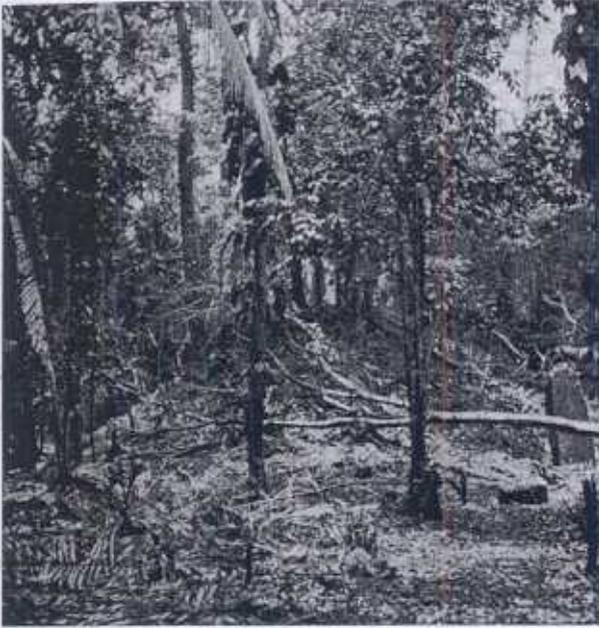
Fig. 1. — Northeast corner of Structure A-3 before excavation.

The excavation of Structure A-3 was started in February of 1965 and finished by the First of May of that year. However, before digging could be begun the mound had to be cleared of the tall trees that were found growing on it (fig. 1). Some of the trees were over 30 m high and great care had to be taken in guiding them with ropes when they fell so that they would not damage the stelae at the base of the mound. Once the trees were removed and a large area cleared around the base of the building, excavation was started. Pits were dug through the plaza floor at the base of Structure A-3 on its east and west sides to see if any floors were present that might indicate possible early constructions inside the mound. Several floors were found and although one 80 cm below the plaza floor continued under Structure A-3, no inner building was associated with it.

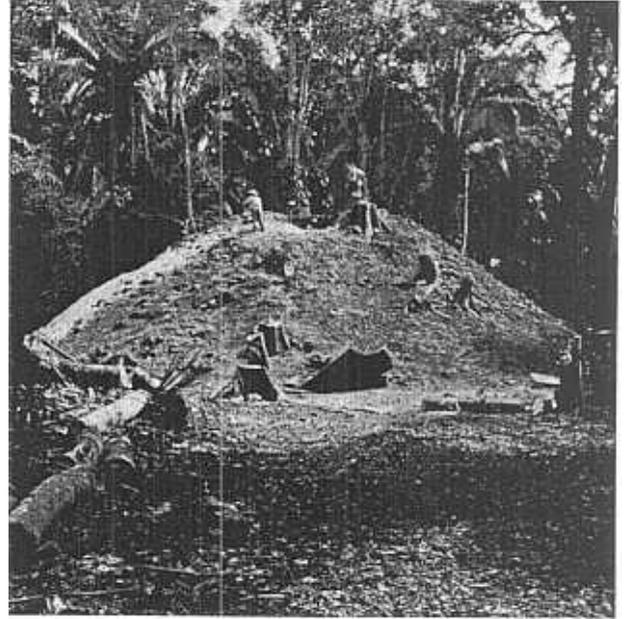
Fig. 2. — West side of Structure A-3 after clearing the mound. Excavation has just started.

Figures 2 and 3 show Structure A-3 at the beginning and end of excavation. It consists of a truncated pyramid supporting a temple. The pyramid rises in three vertical terraces to a height of 3.20 m above plaza floor. At its base it measures 17 m square; but an additional low platform was added which increased these measurements to 25 m on a side. Four projecting stairways, one on each side, lead from the base to the summit which supports a building platform 50 cm high and 11 m square. In front of each doorway into the

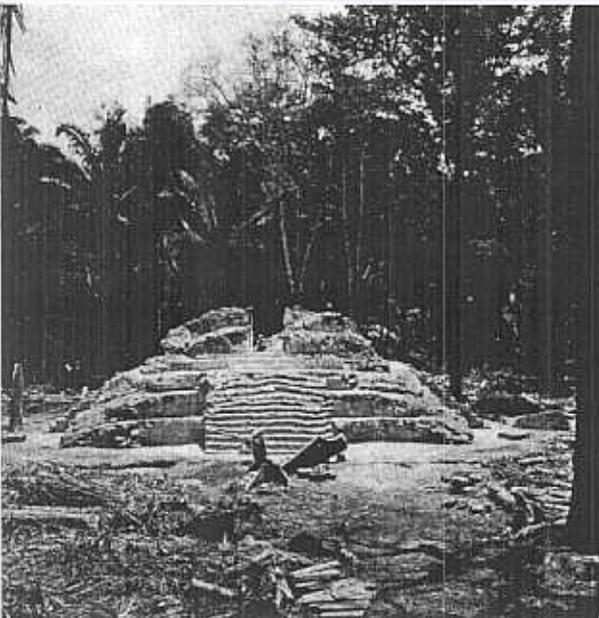
Fig. 3. — West side of Structure A-3 at end of excavation.

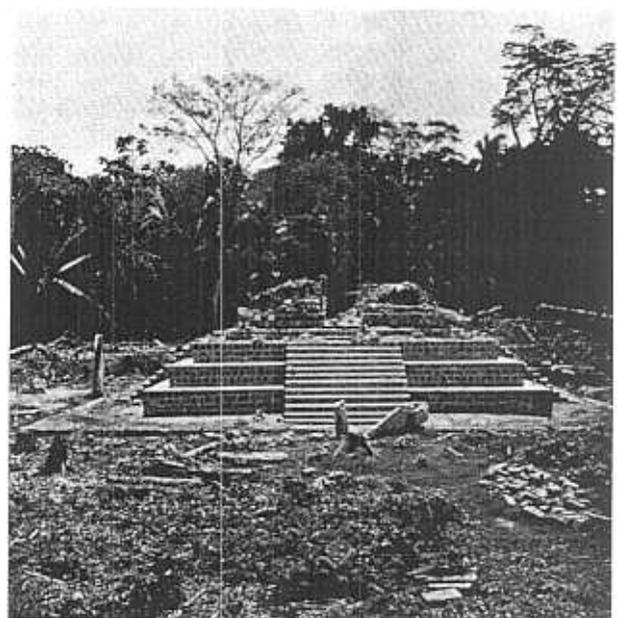
Fig. 4. — West side of Structure A-3 during reconstruction.

Reconstruction was started at the base of the building, that is the terrace of the pyramid. The stones in the walls had to be, for the most part, removed and re-set. The wall stones are almost all nearly square and nicely cut and faced. Although they vary in size, the average height and width is 30 cm and thickness 15 cm. They are slightly beveled on all four edges so that the inner face of the stone averages 24 by 24 cm. This leaves, when set on edge, space for mortar between each edge. Coursing was for the most part quite consistent. There was not much use of spalls, but bonding seems to have been quite haphazard. In rebuilding the terrace walls the stones were set in a mortar of lime and marl. This was no problem in rebuilding the terrace walls as we had their height and width. The bottom terrace being 1.35 m high and the two upper terraces being 90 and 95 cm. The two lower terraces were 50 cm wide and the top terrace 75 cm. When the terraces of the substructure were finished the four stairways were rebuilt. Again there was no problem as we knew the number of steps, 12 to each stairway, and how far the top step projected out from the top of the top terrace. The

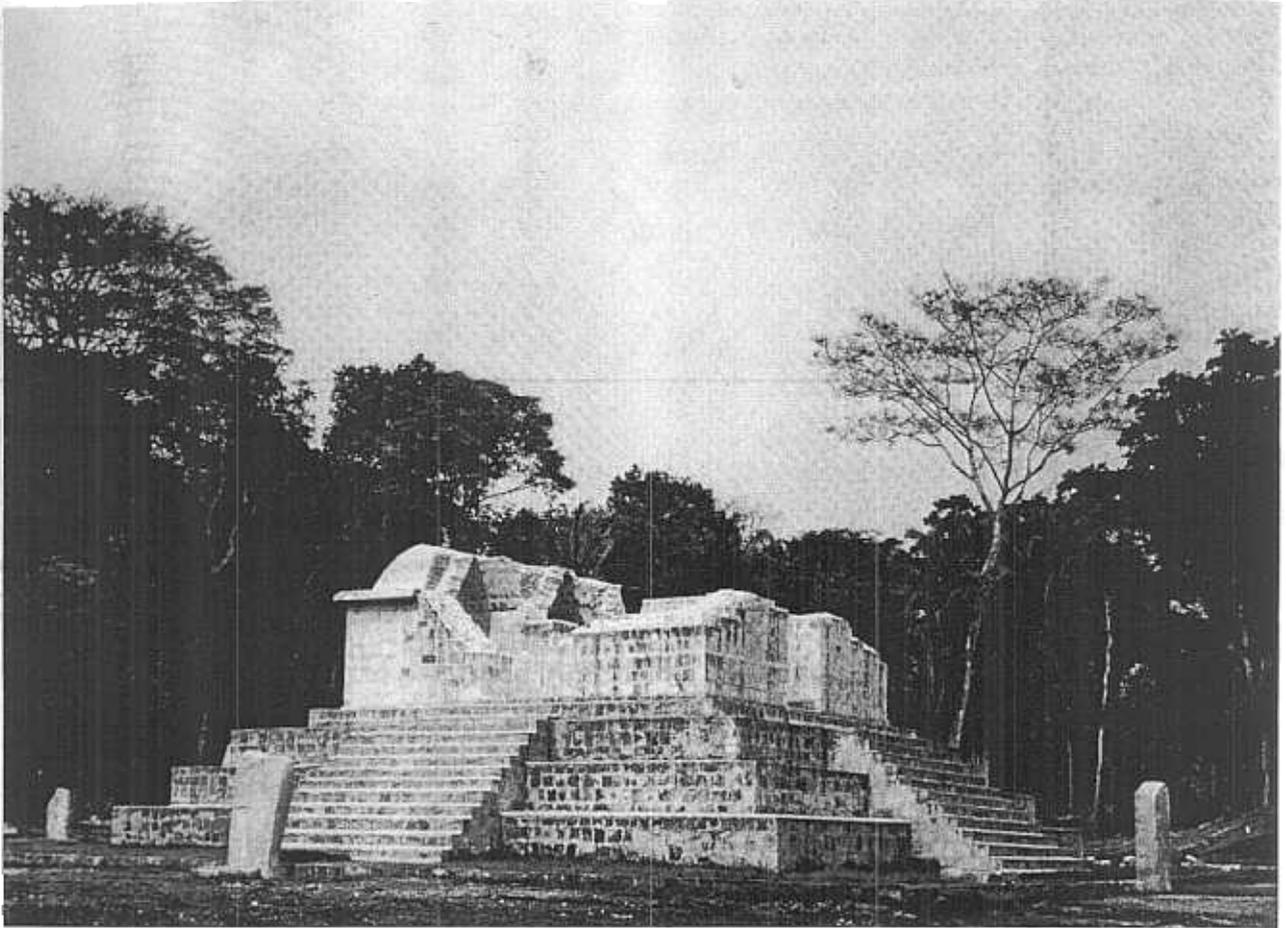
Fig. 5. — Southeast corner of Structure A-3, reconstructions having been completed.

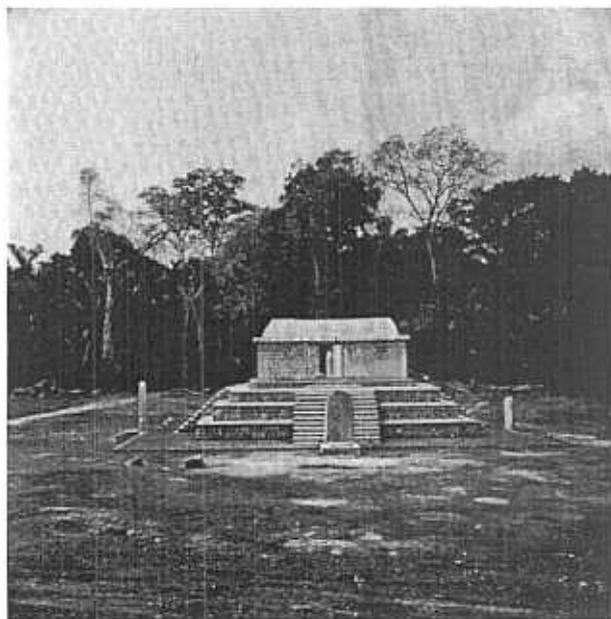
Fig. 6. — North side of Structure A-3 after reconstruction.

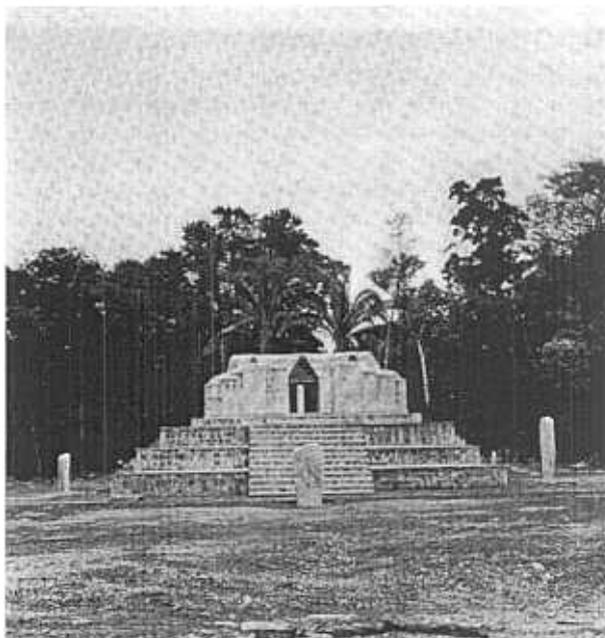
Fig. 7. — South side of Structure A-3 after reconstruction. Notice stela in central room.

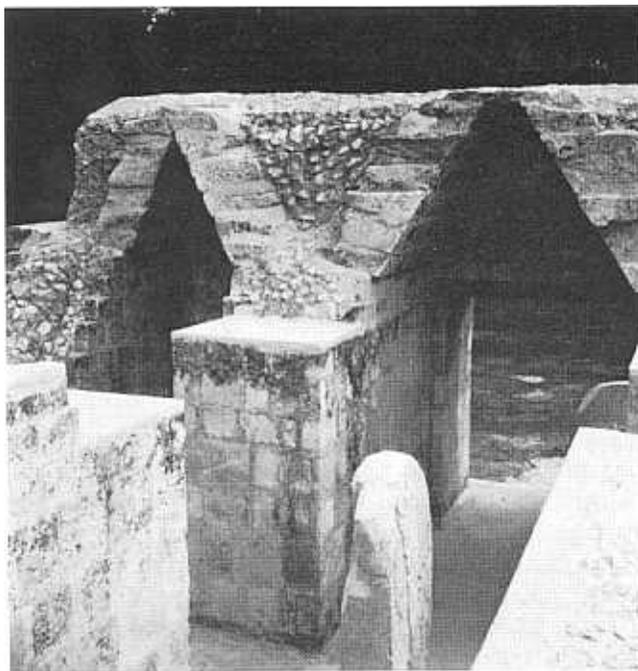
Fig. 8. — Structure A-3, north ends of central and west rooms showing construction of corbelled vaults. Notice stela in central room and sapote beam over doorway.

No vault stones or medial molding stones were found in place, however in one spot the whole side of the vault had fallen as a unit so that it was possible to estimate the original height of the walls, from floor to the spring of the vault, 2,55 m, and the height of the vault, 1,25 m, making a total distance of 3,80 m from floor to capstones. The corbelled or Maya vault is constructed of large overlapping stones deeply tailed into the hearting. In Structure A-3 these stones were long and tongue-shaped with the exposed surface beveled and nicely faced to form the soffit slopes. They were laid up in courses and held in place by a mortar of lime, marl and stones (fig. 8 and 9). Vault stones average 65 cm in length and 25 cm high and 22 cm wide on the exposed face. The bevel on the vault stones used in the end vaults was greater than those used in the vaults on the sides of the rooms giving a steeper soffit slope to the end vaults. As there were insufficient vault stones to complete the end vaults the extra side wall vault stones had to be re-cut to fit the end vaults. In building the vaults we used cement and sand instead of lime and marl to give extra strength to the construction. The soffit slopes of the two sides of the vaults were carried up to within 20 cm of each other and then capped with limestone slabs. These slabs average from 3 to 8 cm thick, 40 cm long and 25 cm wide. In one instance the plaster and red paint were still adhering to the exposed area.

The outside doorways of the temple measured 1,70 m across. As no stone lintels were found the lintels must have been wooden. Two kinds of wood were normally used by the Maya for this purpose, logwood and sapote. As sapote was more commonly used we decided on it. The only problem was that it is against the law to cut a living sapote and the dead ones were rotted and not

could use. One of our workmen, an excellent axeman, was sent to cut beams to span the north doorway of the temple. These were cut to specifications, 3 m long, 20 cm wide and 15 cm thick. Being freshly cut they were extremely heavy and took six men to carry each beam. Luckily our road was still open and we were able to bring them up to camp by truck. They were placed across the jambs of the doorway, being set back 5 cm from the edge of the inner and outer walls. Sapote is an incredibly strong and durable wood and when kept off the ground and dry will last indefinitely. Many of the buildings at Tikal still have their sapote and logwood beams.

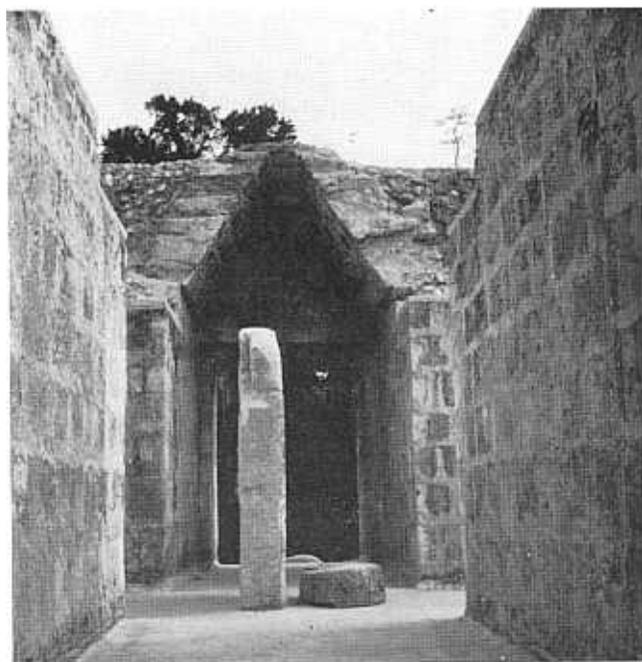
Fig. 9. — Structure A-3, north of central room showing vault construction. Notice stela and altar and sapote beam over doorway. See also fig. 23.

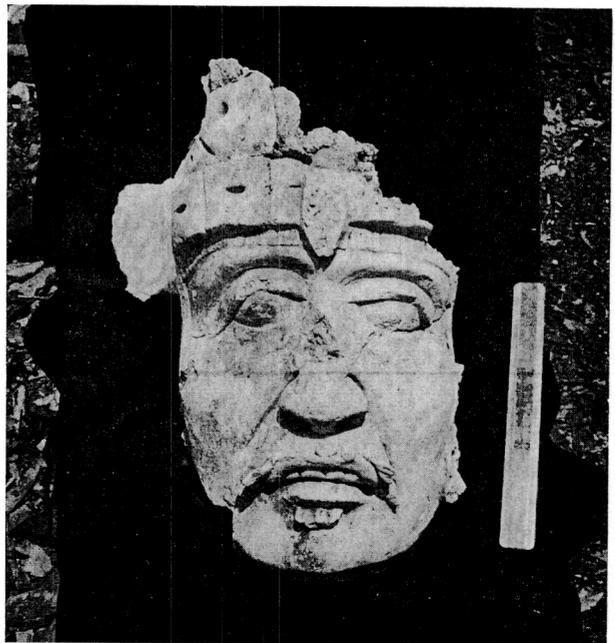
Fig. 10. — Head of large stucco figure. One of four such figures that formed part of the frieze that decorated the upper zone of Structure A-3, probably over the four doorways and above the roof of the building.

As we were not sure exactly what happened above the medial molding and the frieze could not possibly be replaced, the upper zone was not reconstructed. However, in the final publication on our work at Seibal, we are planing to have a reconstruction drawing of the north facade of Structure A-3 which will show a possible restoration of the frieze in the upper zone.

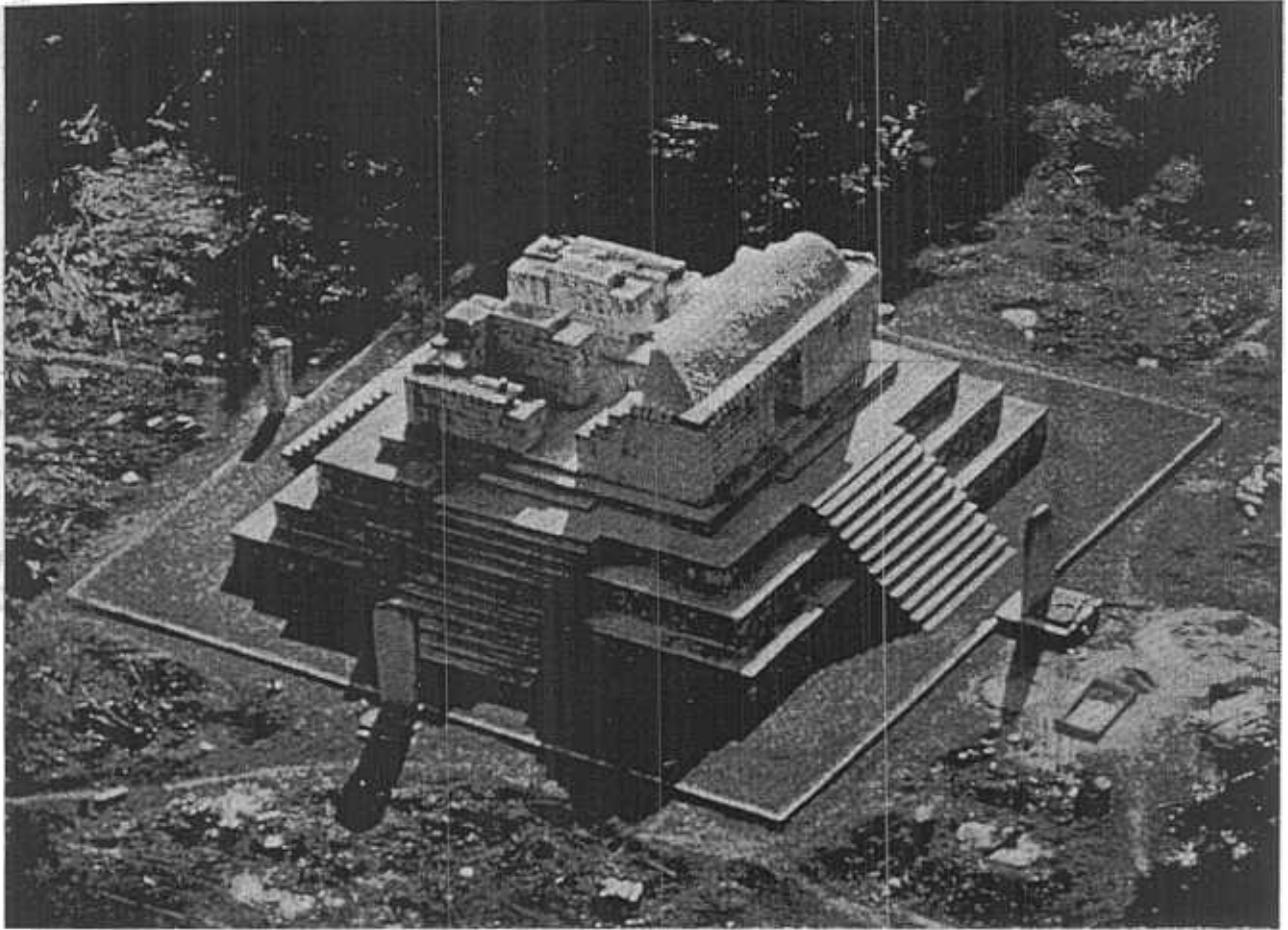
Fig. 11. — Looking southwest at Structure A-3 from the air. (Courtesy of A.D. Wood, National Research Council, Canada.)

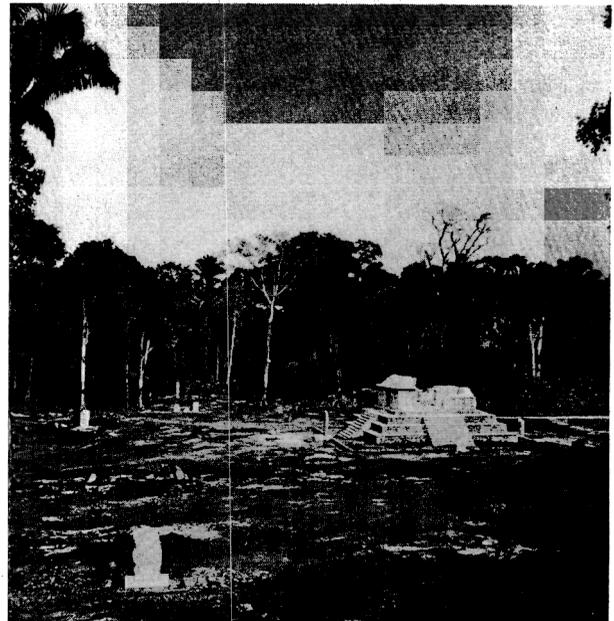
Fig. 12. — Looking east across the South Plaza, Group A. Structure A-3 is seen to the right.

Structure A-3, situated in the center of the South Plaza of Group A (fig. 12), although unimpressive in size, is the best known building at Seibal due to its association with the extraordinarily handsome stelae found at its base, one on each side. Discovered in the last century, both Artes and Maler mention this mound and the stelae at its base. The stelae are amongst the casts made by Artes and exhibited at the World's Columbian Exposition in Chicago in 1893. Maler described and illustrated them sixty years ago (Maler, 1908).

Fig. 12. — Vue vers l'est à travers la place sud, Groupe A. La Structure A-3 est à droite.

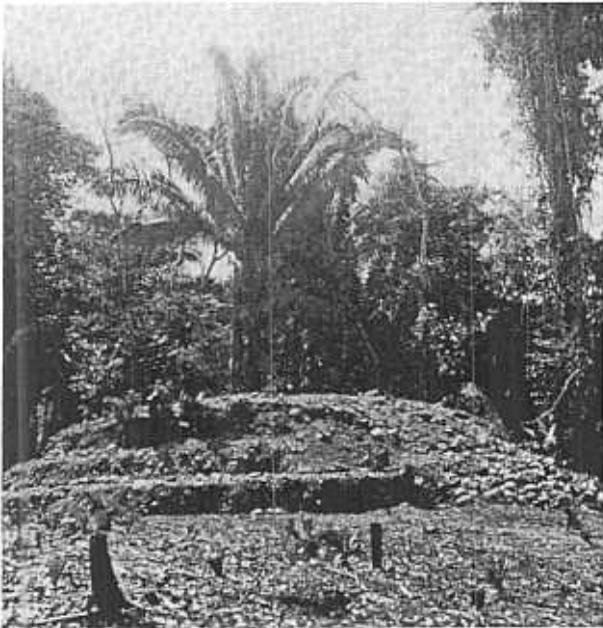
Fig. 13. — North side of Structure 79, the Round Structure, after excavation.

continued under Structure 79 indicating a possible early construction inside. The sherds below this early floor date to the Protoclassic Period (ca. 0 - 300 A.D.). Upon excavation the « Round Structure » was found to be 18 m in diameter and 3 m in height. It rises in three vertical terraces of equal height and 70 cm wide. The main stairway, extending out from the west side of the building, rose from the base to the top of the platform in a single flight. Only the bottom five steps remained. They had 20 cm treads and 15 cm risers which when carried up to the summit made 19 steps. At the foot of the stairway and centered on and built against the bottom step was a small stone box containing charcoal and sherds. It was undoubtedly used for burning « copal ». On the back, or east side, of Structure 79 is another stairway. This one is only 50 cm in width and it is placed so that the stairs rise parallel with the terraces rather than at right angles to them (fig. 15). On top of the « Round Structure » there was a low rectangular platform 30 cm high, 6 m wide, and 9,50 m long, its long axis being parallel to the main stairway. It very probably supported a temple built of perishable materials. Figure 13 shows Structure 79 after excavation.

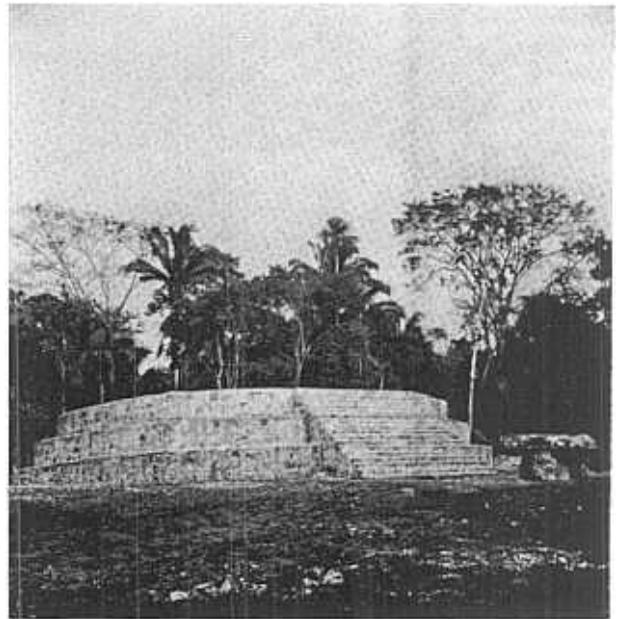
Fig. 14. — Looking southeast at Structure 79 after reconstruction. Notice jaguar altar in front of stairway.

roughly chipped and squared. In size they vary from 10 by 20 cm to 30 by 40 cm. No attempt had been made at coursing or bonding. The stones were usually laid with their long side horizontal and there was an abundant use of spalls. No plaster was found on what remained of the terrace walls but they probably were originally covered with plaster. We left them unplastered. In reconstructing the terrace walls and the stairways the same method was used as in Structure A-3. The terraces and stair treads were surfaced with a mixture of cement and sand as was the top of the platform. Figures 14 and 15 show the « Round Structure » after it had been reconstructed.

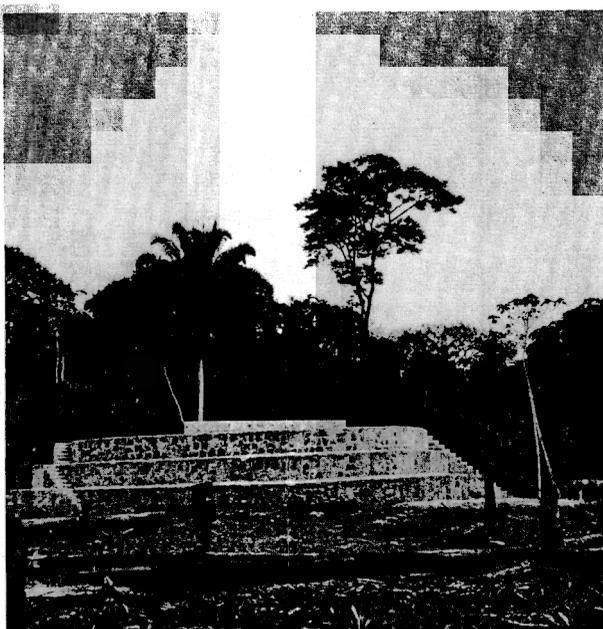
Fig. 15. — North side of Structure 79 after excavation. Notice small stairways at rear of building at left side.

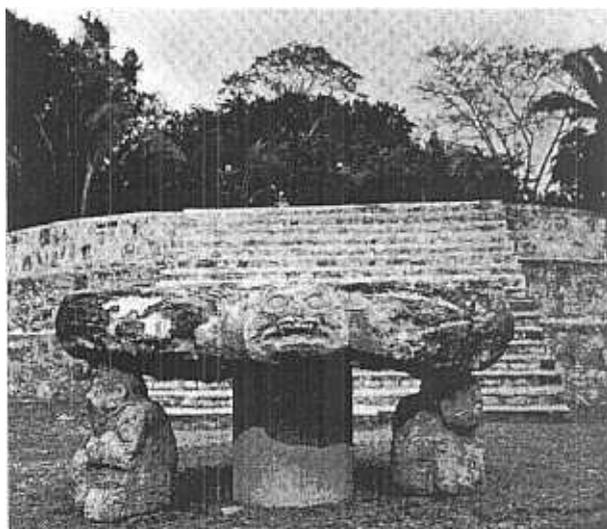
Fig. 16. — Jaguar altar in front of stairway on the west side of Structure 79. Notice two crouching figures supporting altar. Central column was put in as an additional support when the altar was reset.

The « Jaguar Altar », mentioned above as being out in front of Structure 79, and centered on the main stairway, had originally been supported by three legs (one plain and two carved as crouching men). It had slipped off the legs and had to be reset. It is a huge altar 2,20 m in diameter and 30 cm thick. To insure the preservation of the legs, which could, in their present condition, disintegrate under the great weight of the altar, a small central concrete column was added for additional support (fig. 16). A chain hoist had to be used to place the altar in position. To be sure that it could not be moved it was fastened to the central column and legs with epoxy.

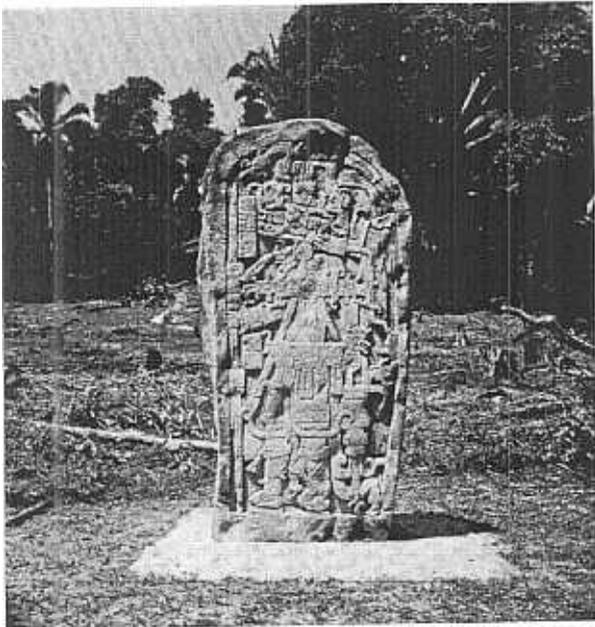
Fig. 17. — Stela 1. It was broken in three pieces and has been mended and its base set in concrete. It carries the calendar round date of 3 Ahau, 3 Ceh (?) which if interpreted as a period ending date would be 10.2.0.0.0 (A.D. 869).

Figures 17, 20, 22 and 23 show four of the monuments that were mended and reset. Figures 18 - 20, 21 and 22 show two stelae being put together and the final result <sup>(1)</sup>.

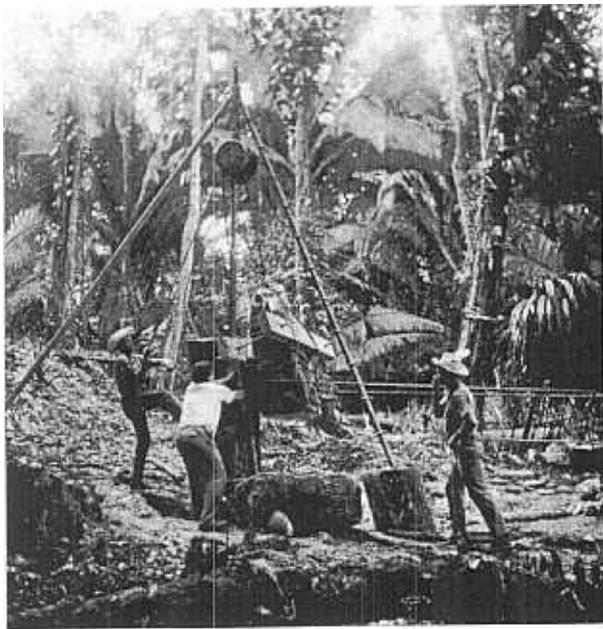
Fig. 18. — Erecting and mending Stela 2.

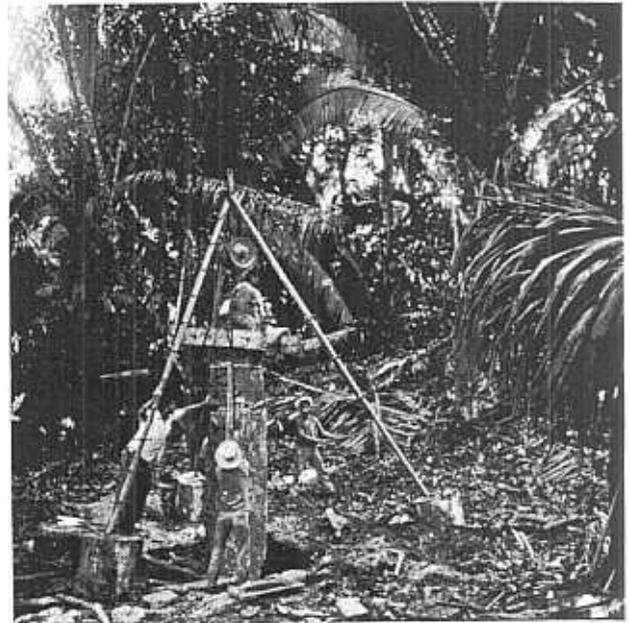
Fig. 19. — Putting the top part of Stela 2 in place.

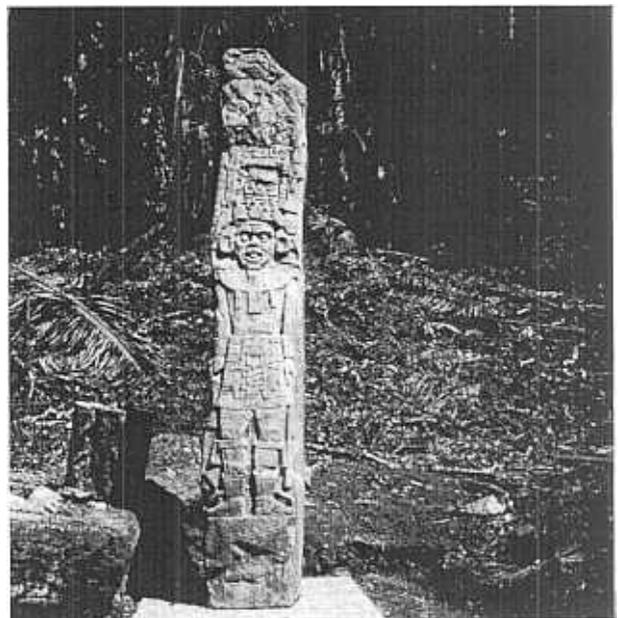
Fig. 20. — Stela 2 after it has been mended and set in concrete. It was broken into three major and three of four minor pieces. Stela 2 carries no date but stylistically is between 10.1.0.0 and 10.2.0.0 (A.D. 849-869).

« Epoxy » was used to mend broken stelae. However, before applying it the surfaces to be cemented together had to be thoroughly cleaned with a steel brush and absolutely dry. This having been done, and the desired surfaces covered with « Epoxy », fragments were lowered into position by means of the tripod and chain hoist (fig. 19 and 21). When all the fragments had been put in place any holes or cracks on the back or sides of the monument, as well as on the carved surfaces, were cleaned and filled with cement mixed with lime to match the color of the stone. This was done to prevent dirt accumulating in these openings which would invite growth of vegetation.

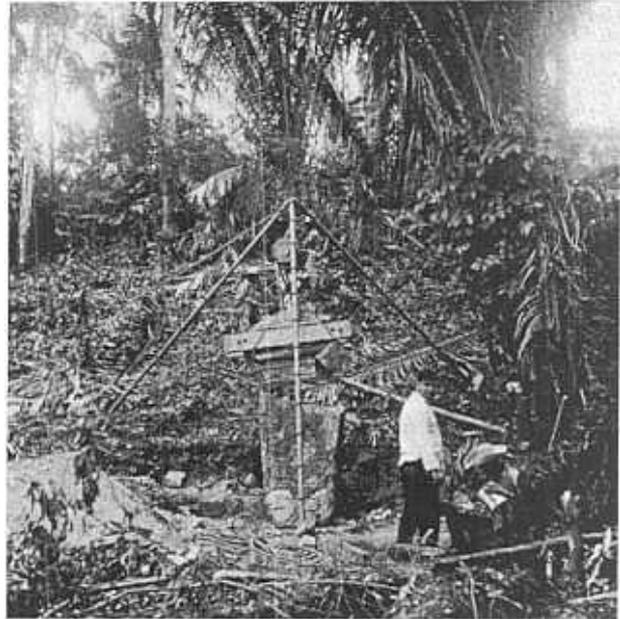
Fig. 21. — Placing the upper half of Stela 17 after setting the lower half in concrete in its altar platform.

varied, being anywhere from 20 cm to 1,50 m. This of course depended upon the size of the monument, normally the larger monuments having more underground. Until the mortar had hardened around the butt, it was still supported by the chain hoist.

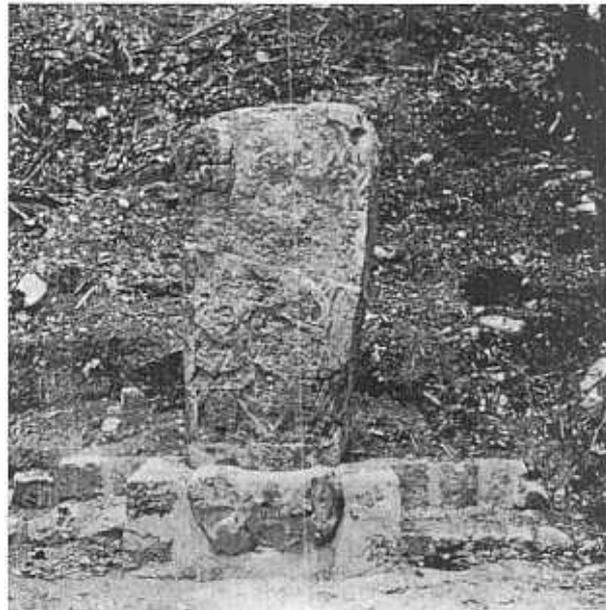
Fig. 22. — Stela 17 after it has been mended and erected. Notice prowling jaguar at base on altar platform. Stela 17 carries the calendar round date of 3 Ahau (?), as does the jaguar (A.D. 869).

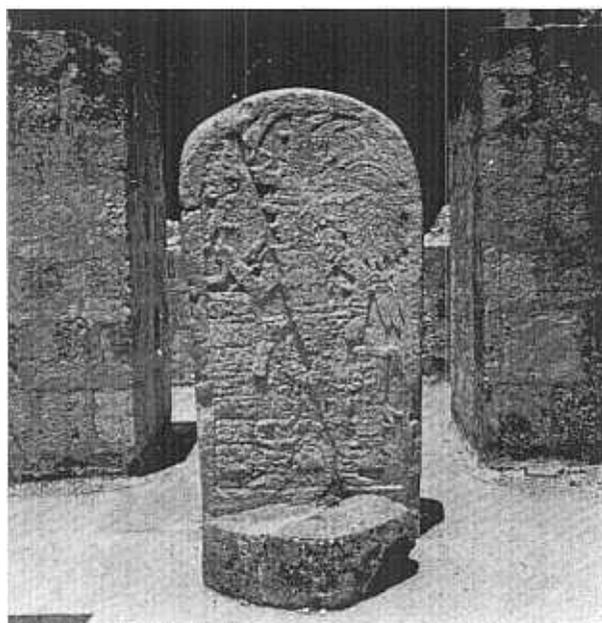
Fig. 23. — Stela 21 and altar. Stela 21 stands in the center of the central room of Structure A-3. It was found fallen and broken into five pieces. It carries the calendar round date of 5 Ahau, 3 Kayab (A.D. 849).

room up to the spring of the vault, rebuild the vaults of the three rooms at their north ends, and mend and reset the stela and altar in the center of the central room. Also the stelae at the base of the building had to be mended and reset and their altars mended and re-positioned. Figures 5 - 7 and 11 show Structure A-3 after all the above had been accomplished.
