## THE CHURCH OF THE BEGUINAGE OF ST. TRUIDEN. CONSERVATION AND RESTORATION OF THE ARCHITECTURE, INTERIOR AND FURNITURE: A CASE-STUDY

When the Province of Limburg acquired the mediaeval church of the Beguinage of St. Truiden with its important series of murals, the building and interior were in a state of dilapidation. The church had not been used as a place of worship for half a century and the maintenance work which was carried out in the 30's, through the intermediary of a special trust set up for the purpose, could only partly forestall the decay; detrimental attempts at restoration on the building, such as removal of cement and inexpert, exaggerated repairs to the murals in 1934 caused a more rapid deterioration and removed the church building even further from its original appearance.

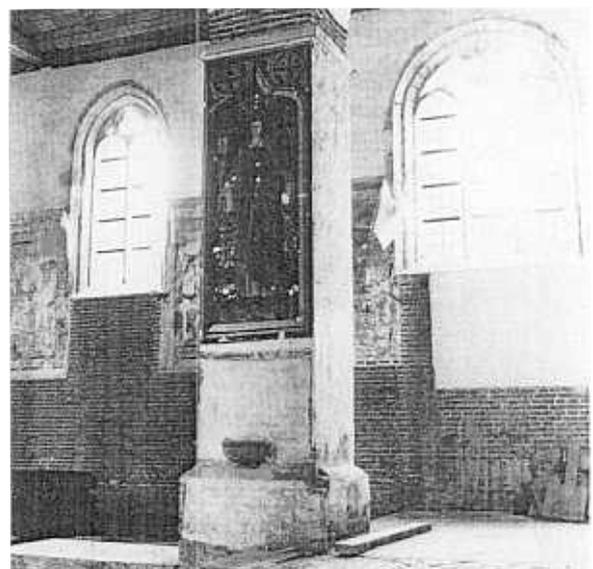
Fig. The Beguinage church, interior during restoration.

Fig. 1. - Eglise du Béguinage, intérieur pendant la restauration.

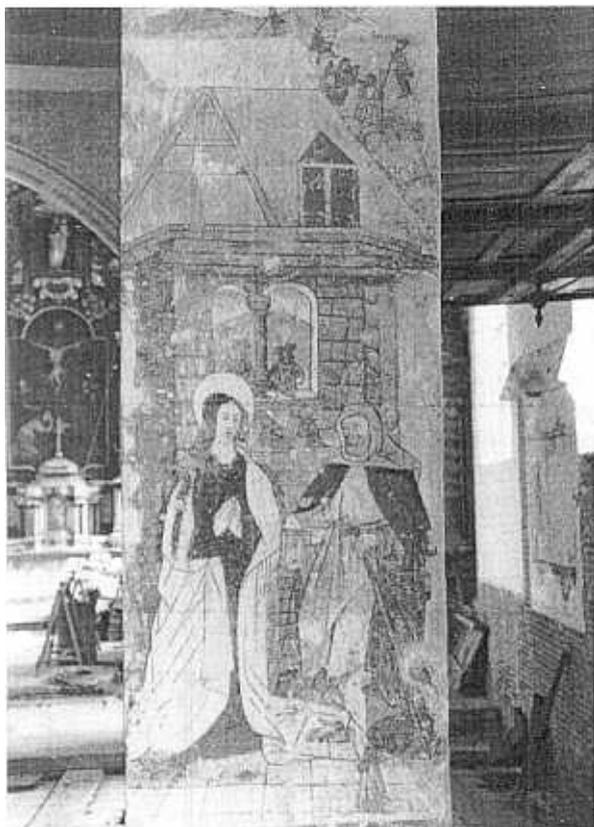
Fig. 2. The Beguinage church, «The Birth of Christ» (mural, 1490-1510).

Fig. 2. - Eglise du Béguinage, intérieur peinture murale, 1490-1510 « La naissance du Christ ».

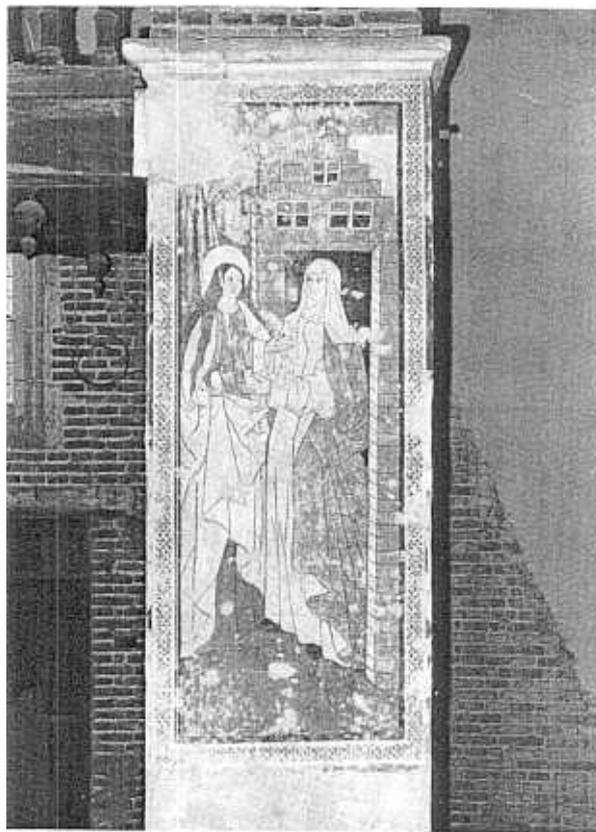
Fig. 3. - The Beguinage church, «Visit of Mary to her cousin Elisabeth» (mural, 1490-1510), during restoration.

The conservation of the murals posed a more complicated problem. The wall decoration as a whole must be viewed in its context with the interior to be restored. Through the natural aging process, the stripping of the building, the unsuitable restorative attempts and the incidence of alterations, especially the addition of pieces of furniture, the authentic expression of the whole was threatened with extinction. Also the value of each mural had to be repaired individually. A criterion had to be selected so that the historical and documentary value as well as the individual expression of each painting could

Fig. 3 - Eglise du Béguinage, intérieur peinture murale, 1490-1510 « Visite de Marie à sa cousine Elisabeth » pendant la restauration.

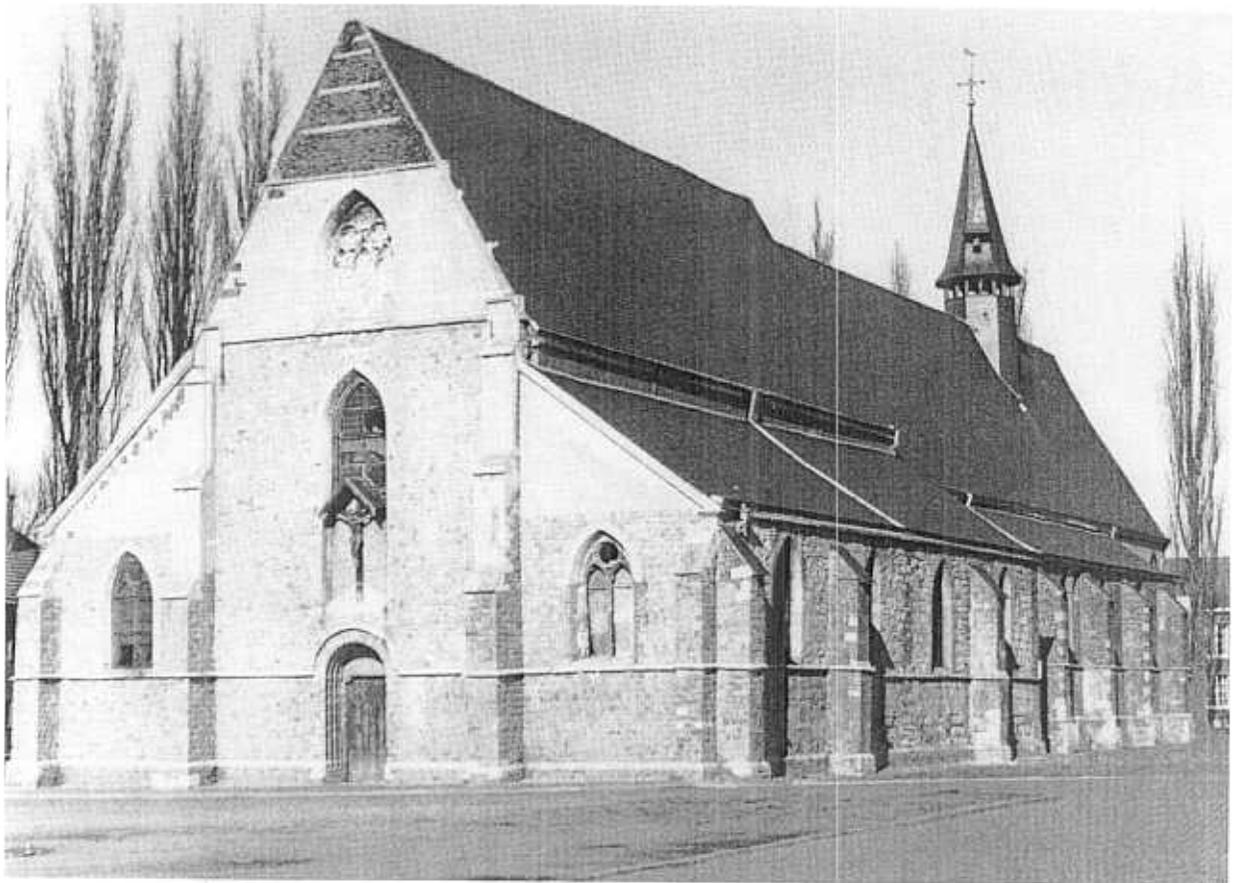
Fig. 4. - The Beguinage church before restoration.

Fig. 4. - Eglise du Béguinage, avant la restauration.

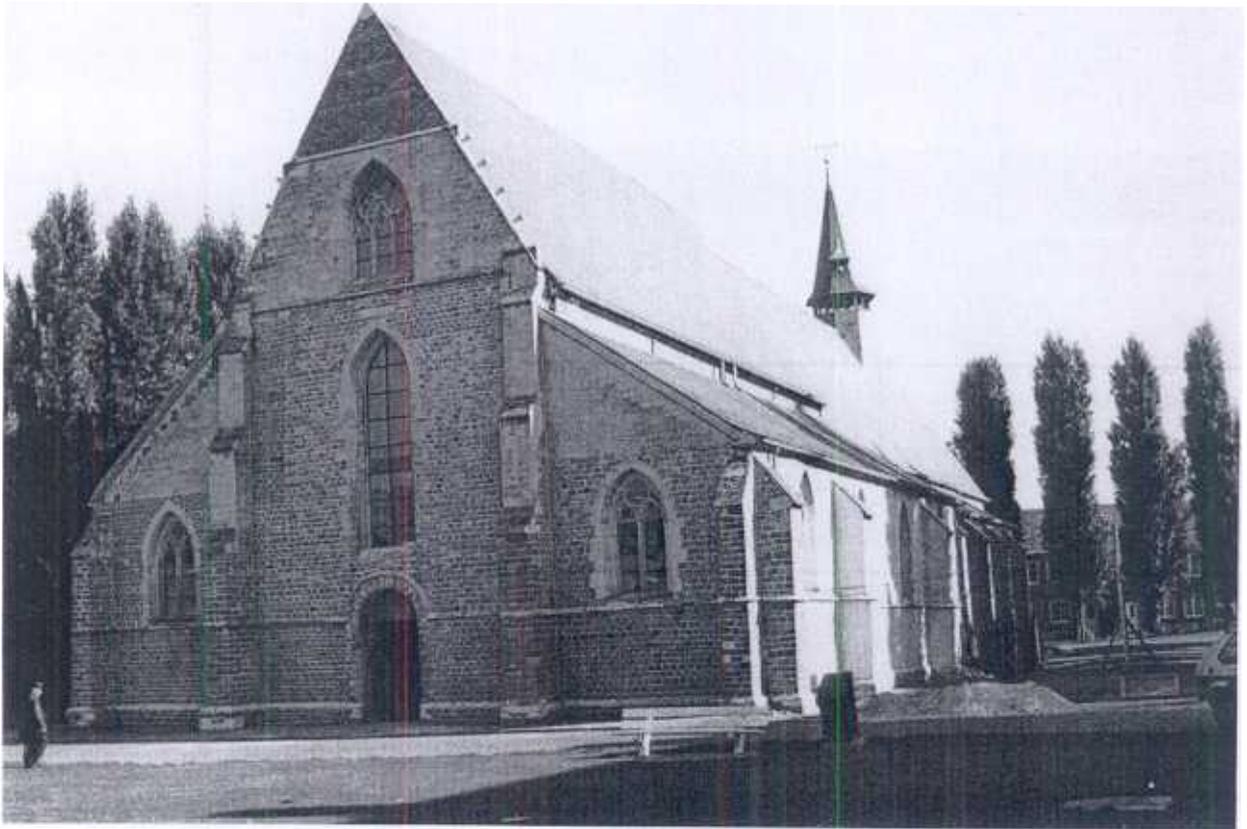
Fig. 6. The Beguinage church, restored.

The replastering of the pillars was an attempt to achieve the original aspect of the interior, and more specifically the presence of the murals gave an indication of the composition and shade of the types of plaster. The renewal of the plaster has made for more integration of the painted scenes and figures, which were brought into a lighter situation; it binds them into a coherent entity and brings them out more clearly in the total treatment of the wall, in the interplay between space and volume and in the architecture. The plastering of the wall is fundamentally significant for the support and dispersal of light, which in a pseudo-basilica can only enter through the side aisles and the choir windows. With the exception of such permanent fixtures as the high altar, the

Fig. 6. - Eglise du Béguinage, après la restauration.
