THE ARCHITECTURE OF THE BOYANA CHURCH

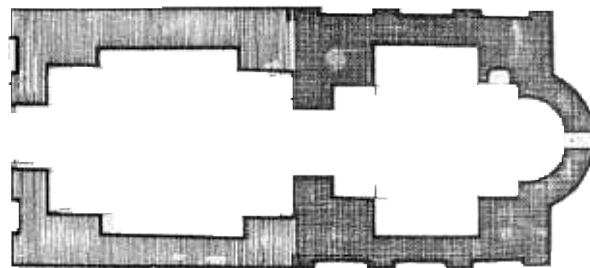
6. Presentation draft — option one:
top — longitudinal section; middle —
plan of the storey; bottom — plan of the ground floor

We worked out two options for conservation, restoration and presentation both with the aim of maximum exposition of the mediaeval churches. The first option suggests to get rid of the Late Revival annexe which lacks aesthetic worth and to create conditions to reveal the dynamically balanced total volume of the mediaeval churches. This option enables us to give prominence to the west façade of Kaloyan's Church which has an expressly monumental character. The second option keeps the Late Revival annexe but removes its inter-storey construction. The purpose behind it is to fully present the west façade of Kaloyan's Church. The preservation of the Late Revival annexe in this case favours the formation of a cushion volume which will facilitate air conditioning of the mediaeval churches.

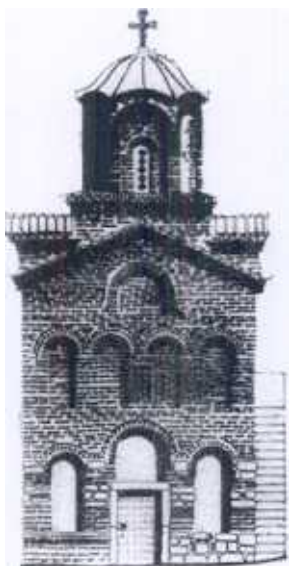
7. Presentation draft — option one: left — west façade; right — south façade

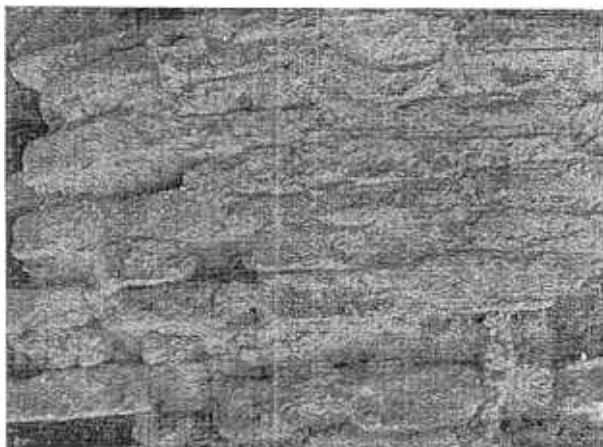
8. Original joining on the East Church dome

Investigation of the East Church shows that originally it had no plaster at all. All statements that there was stonework above the unplastered brick plinth, that the façades were initially plastered and that the cornices are original¹ turned out to be wrong. The entire East Church is made of brick, both the plinth and above it. There are two concentric brick rows above the blind arches with a wide band of white joining. It is an early ornamental form on the façades to which later decorative ceramics were added. The plastering of the façade starts at quite an accidental point and any attempt to find proportions between plastered and unplastered parts will lead to nothing, if of course, the façades are not idealised and the displacement of the ground around the monument is ignored. There is no stone masonry in the East Church except for a later patch deep in the west blind arch of the north façade. The patches acquired while Kaloyan's Church was under construction are clearly visible on the façades. The cornices belong to the Late Revival annexe. Sections with original joining on the drum of the dome have been discovered.

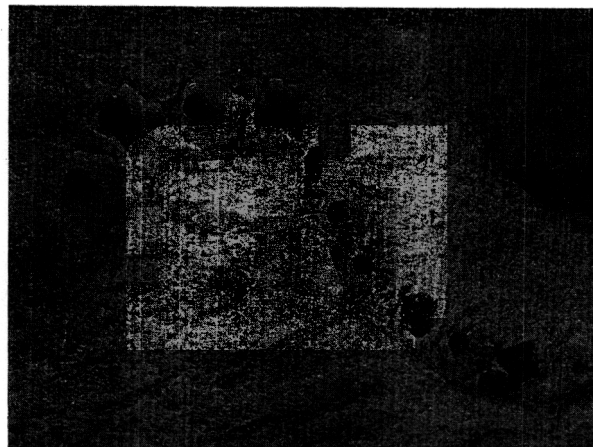
9. Original ceramic decoration on Kaloyan's Church

The most significant result of research on Kaloyan's Church was the discovery of original ceramic decoration on the south, west and north façades. That there was decorative ceramic was a fact known before¹ but now we saw that the decoration was ap-

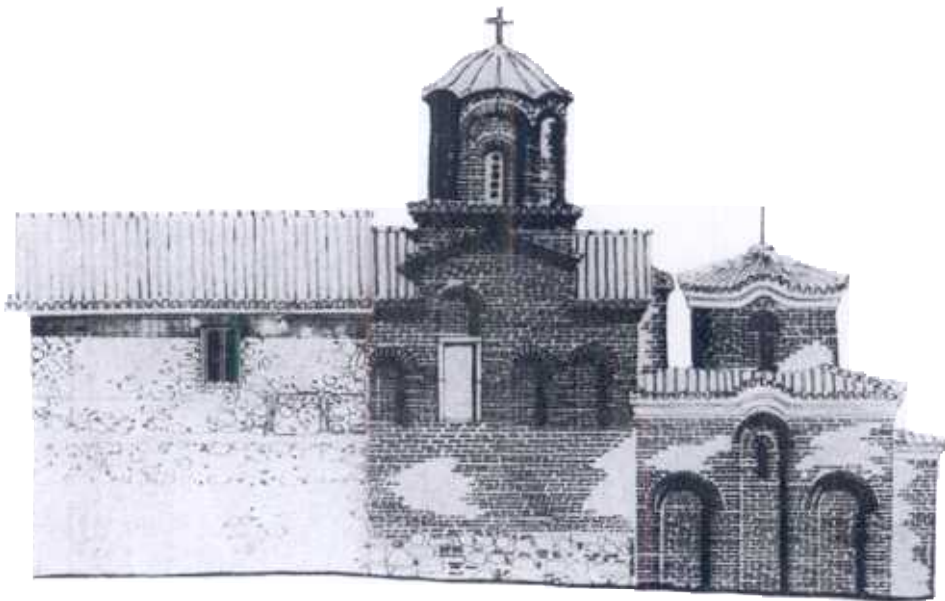
10. Presentation draft,
option two:

south façade

After consideration of the suggested options, appraisal of their positive and negative aspects, bearing in mind the importance of the monument, the necessity to put to maximum use the results obtained by investigation and recognizing that each part of the church has the value of an original and right to existence as representative of the period when it was built, an intermediate solution was reached: the Late Revival annexe is preserved as a volume, for it is the third stage in the history

of the monument, but the intermediate level is almost entirely done away with in order to present the west façade of Kaloyan's Church. Limited sections are left to mark the ceiling and storey levels. The west façade of Kaloyan's Church is restored according to the data provided by research. The south, east and north façades of the mediaeval churches are restored without plaster up to the cornices. Above, because of lack of data, we will keep the appearance assumed after the Revival reconstruction, the tent-like dome of Kaloyan's Church included.
