Conservation in action

The restoration of the small Buddha at Bamiyan

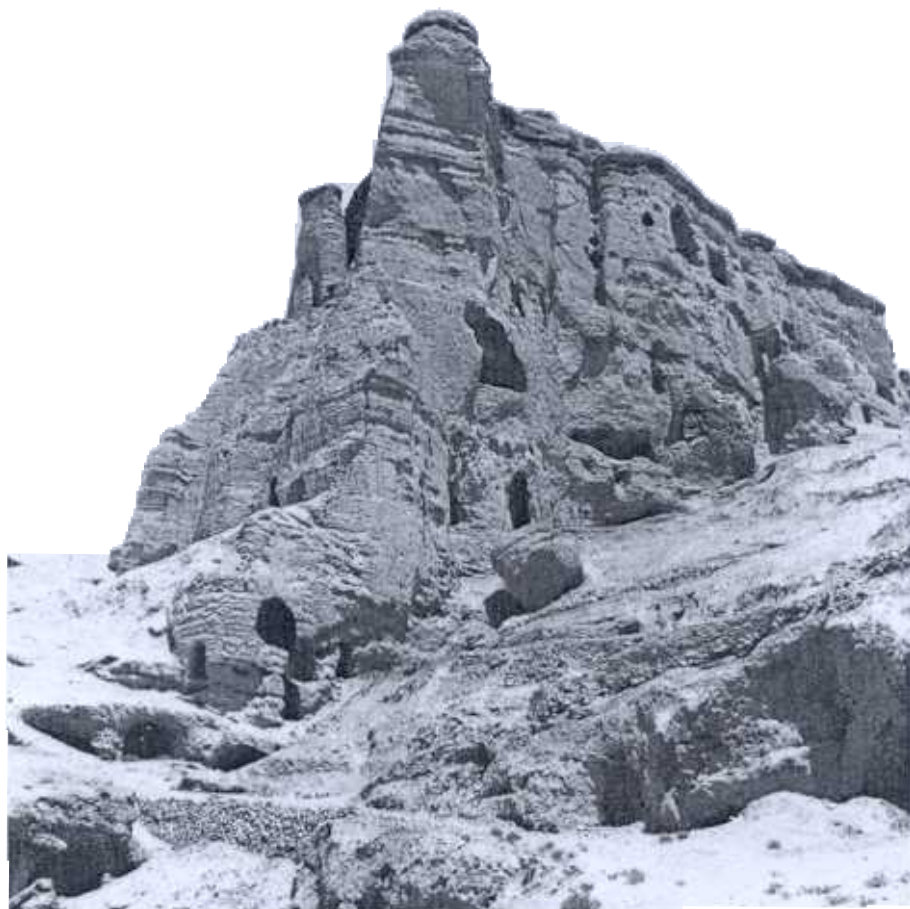
FIG. 1. A view showing the weathering of the rock and dislodgement of boulders

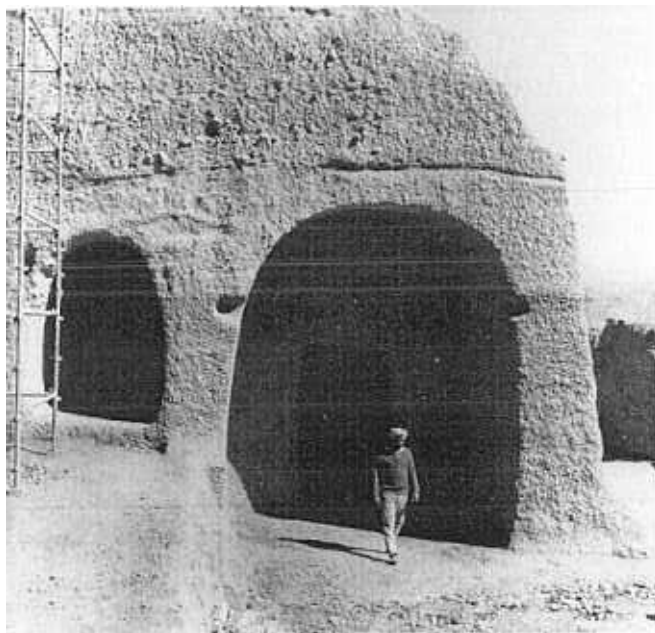
FIG. 3. A damaged shrine after restoration.

The shrine at the outer end of the eastern wall was damaged and had lost a portion of its roof. There were traces of paintings in the extant squinches. The entrance to this shrine was blocked with rubble masonry, and after its removal and cleaning of the shrine, the missing portion of the side wall and the roof were restored in rubble masonry provided with nominal reinforcement. From the top of the roof a masonry wall was raised to support the overhanging portion of the rock. The masonry was covered with a coat of plaster (*Fig. 3*) to match the rock.

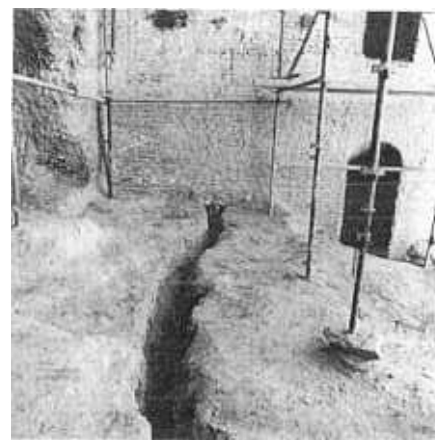
FIG. 4. A crack passing through the porch of a shrine.

that extended both to the west and east passed through the porch of shrines in the second level (*Fig. 4*). These cracks had to be filled in (*Fig. 5*), and on the western side, the cracked portion was secured by rock-bolting. The crack on the eastern side had been filled in earlier and a mud-brick staircase (*Fig. 6*) had been built to lead up to the shrines at the upper level. The crack was then properly filled in by rock-bolting and the staircase was restored (*Fig. 7*) with cement-concrete. For the safety of visitors dwarf walls were put up in front of those shrines which had open fronts. These walls were aligned so as not to be mistaken for parts of the original layout.

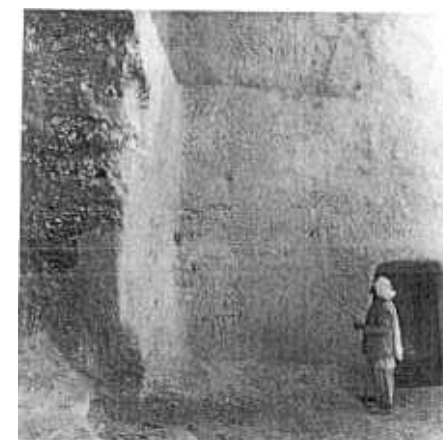
FIG. 5. The shrine after restoration.

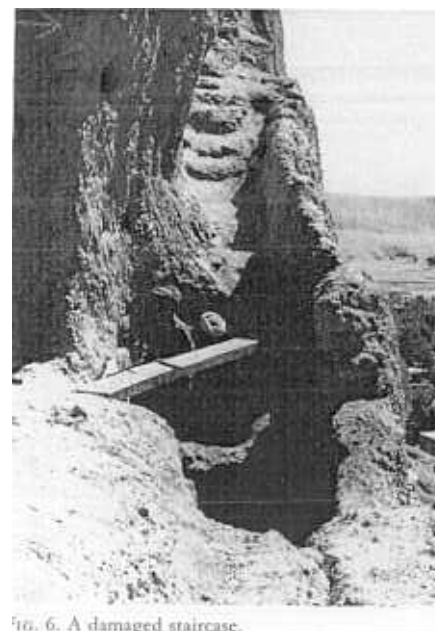
FIG. 6. A damaged staircase.

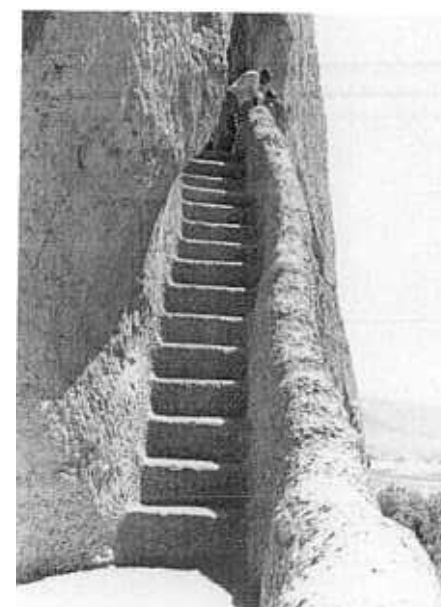
The staircase after restoration.

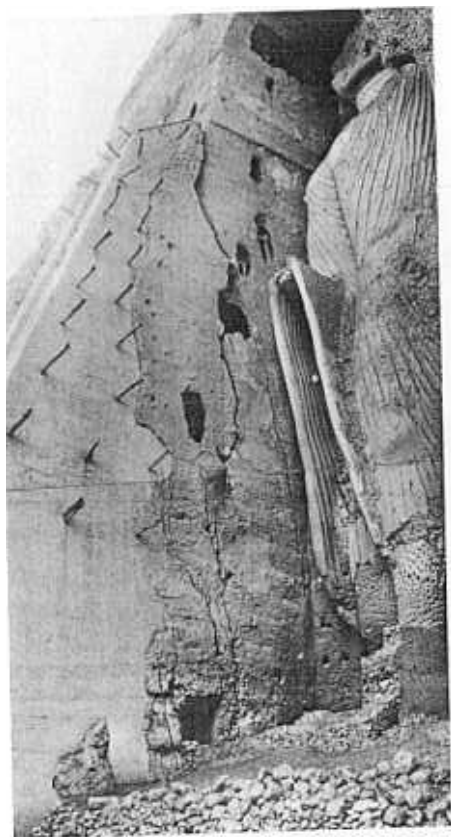
FIG. 8. The fractured west wall of the Buddha shrine and the buttress wall.

Once arrangements had been made to divert the water that would otherwise flow over the facade and travel inside the ceiling, attention was turned to the major task of repairing the fractured wall. The gap (Fig. 8) at the top between the separated portion of the wall and the parent rock was widening gradually due to annual deposition of snow. The severed portion of the rock had to be secured in position and the buttress wall treated in a proper manner. This involved filling in all the cracks and fissures in the wall to stop any ingress of water and tying up the fractured portion so that it might not slip down or be thrown out by tremors of even moderate intensity.

portion by rock-bolting. Advantage was taken of the existing support, so that the proposed work should not create any disturbance. To reduce the vibration to the barest minimum, a rotary core-drilling machine with diamond bits was used. In the mass of the rock the depths of the holes were staggered. The cracks on both the faces of the wall were stitched with a network of mild steel rods embedded in the rock and covered with cement concrete. The wide gaps were filled (Fig. 9) with rubble masonry, and the cracks, depending on their width, were filled with either a weak concreted mortar or a liquid lime, cement and sand mortar commensurate with the strength of the rock. As an additional protective measure against the tremors, belts of flat iron bars were installed around the separated chunk of rock. The iron bars were concealed in chases cut into the rock and covered over with concrete. The ends of the bars were driven deep into the solid rock of the back wall for anchorage.

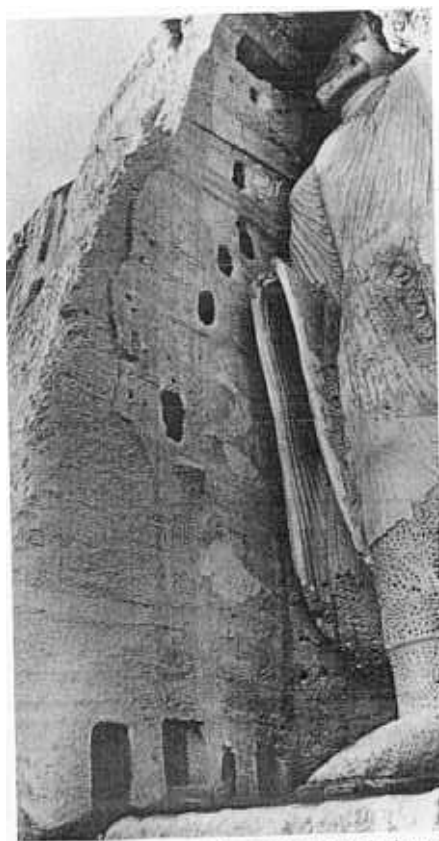
FIG. 9. The west wall after restoration; the buttress wall has been reconditioned and the original entrance to the staircase has been restored.

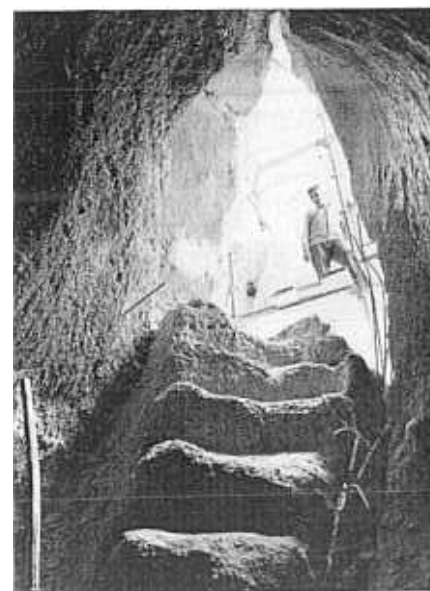
Inside the west wall there is a spiral staircase which leads from ground level to the shrines at the three levels, one above the other, and to the tunnelled gallery in the three sides of the shrine, from which one can view the painted ceiling. With the separation of the rock, a fissure (Fig. 10) had developed and the staircase was severely damaged; a portion of it, above the bottom-most flight, was missing. At one place the fissure had torn off the stairs in the middle; at another, travelling along the inner wall, it had

FIG. 10. The damaged staircase.

pushed out the stairs with the separated portion from the parent body, and at yet another place the outer wall was moving out. The disrupted staircase, therefore, was consolidated by the introduction of reinforced concrete portals hooked into the walls and tied at the bottom. The damaged steps were then reconditioned. The portion of the staircase blocked by masonry was dug out and steps with a headway in conformity with the existing pattern were created to restore its original form (Fig. 11). The original entrance at ground level, which had been blocked with rubble masonry, was also restored. This internal treatment of the staircase was a considerable help towards fastening externally the detached portion to the parent body once more. After securing the fractured portion of the wall in position, it was decided to partially remove the obtrusive buttress wall without disturbing the balance established by the buttress wall as a prop. The unsightly wall was only to be trimmed and treated in an aesthetic manner to merge with the rock. The cavity of the shrine on which the buttress wall was erected was filled up with masonry and a reinforced concrete column was raised on it. To ensure the stability of the wall, and to prevent any dislocation of the material below its foundation, a toe wall in rubble masonry was constructed after removal of the loose materials.

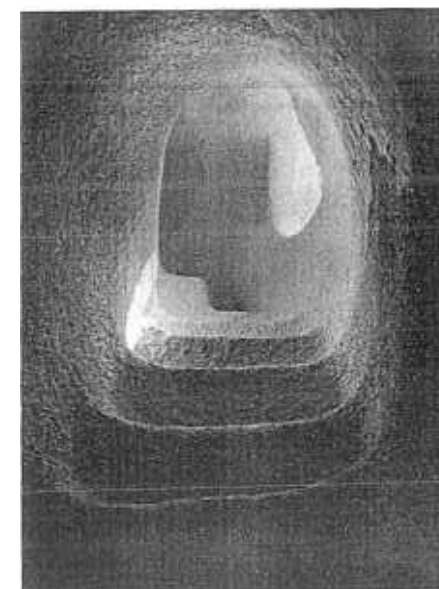
FIG. 11. The staircase after restoration.

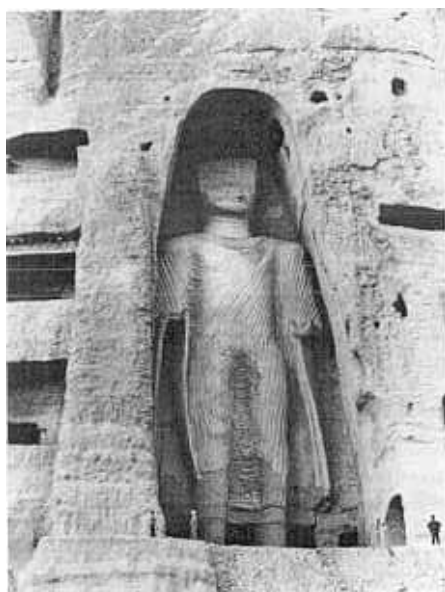
FIG. 12. The buttress wall after reconditioning, and after the repair of the image.

The brick-faced masonry wall (Fig. 12) was trimmed, and the entire surface covered with cement-concrete plaster, in a manner designed to simulate the undulating rock surface (Fig. 13). The use of 'cut blocks' of rock in the supporting structure was suggested by one conservator; but masonry with cement-concrete plaster was used in preference to these, mainly because, owing to its strength, homogeneity and mass, it was more durable. It could also more readily be made to match the irregular surface and contour of the rock. In the case of the Nubian monuments in Egypt, the precious stone carvings were to be preserved along with the shrines, and for this reason the entire mass of rock was sawn into blocks which were transported to the new site and re-assembled there; whereas at Bamian the main job was to secure the detached mass of plain rock by providing a 'suitably fashioned' support that would not interfere with the general disposition of the rock facade, yet would remain separate from the original rock.

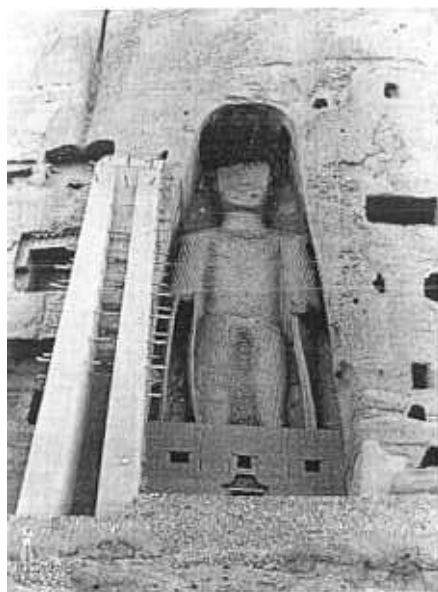
FIG. 13. The brick-faced masonry buttress wall and the modern house in front of the image.

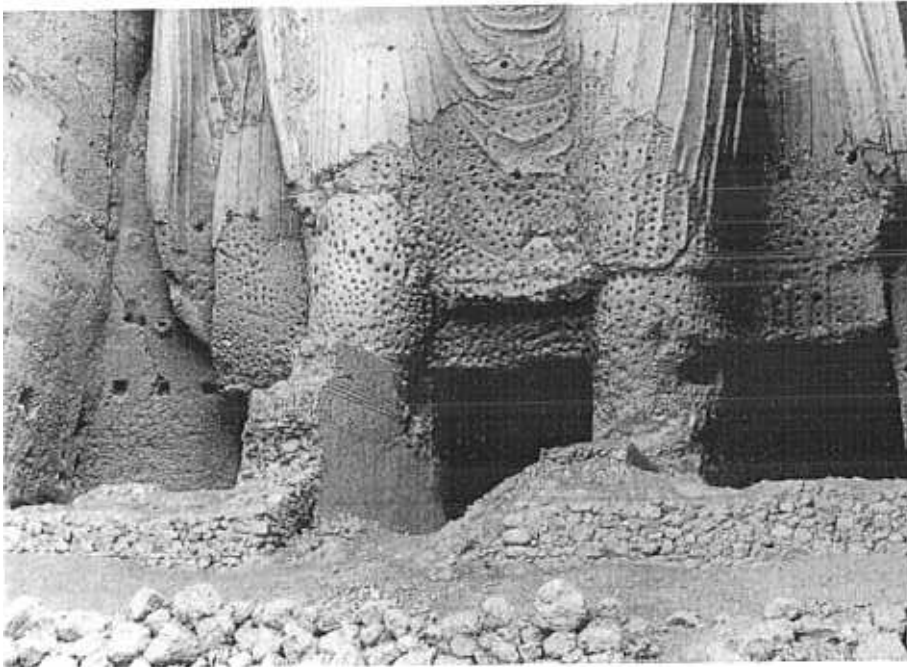
FIG. 14. The feet of the Small Buddha, showing the damage and the remains of modern walls.

In the course of the preservation work no part of the body has been replaced. The feet have been consolidated and finished with an irregular surface (Figs 14, 15) without there being any attempt to reproduce the toes. The crack above the ankle has been repaired by inserting bolts and then filling the gap with cement-concrete to match the rock surface. The broken edges of the garment have been filleted and the holes and hollows found on the surface filled up to arrest any further damage. The shoulders, bereft of any plaster, presented a surface of bare eroded rock. This exposed rock surface (Fig. 16) was treated with a layer of plaster and the folds of the garment were repaired with a rough surface, as though the finishing coat of plaster were lacking. The contrast is well demonstrated in the area between the neck and the right breast. Even where patching has been done, the repaired surfaces (Fig. 17) have been so finished as to look weathered. On the portions of the chin and the neck where the plaster is missing, no attempt has been made to replaster the surface; the broken edge of the plaster has merely been filleted to halt any further disintegration. Such restraint was exercised mainly with a view to

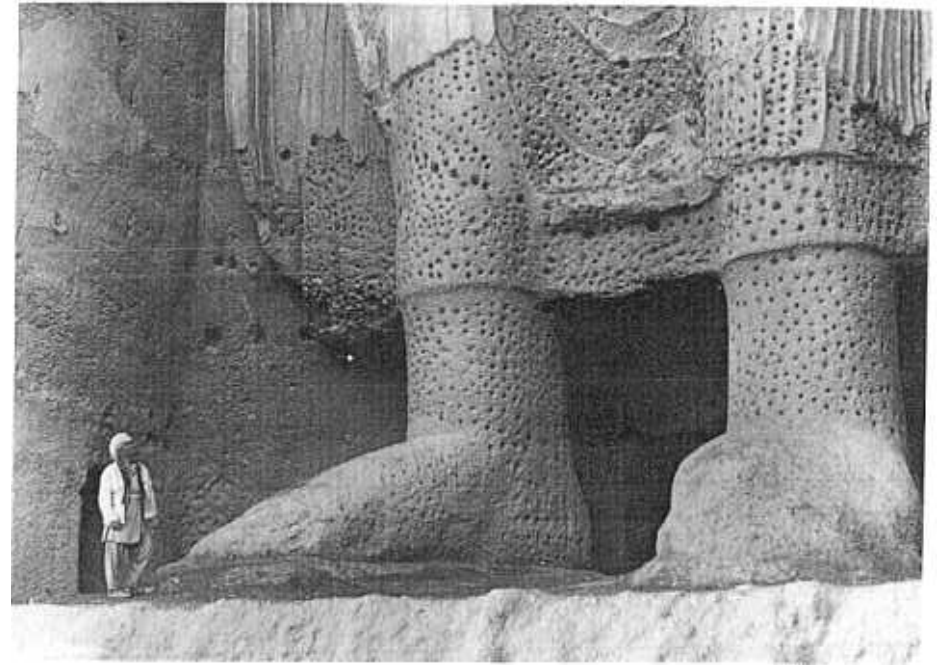
FIG. 15. The feet of the Small Buddha after consolidation.

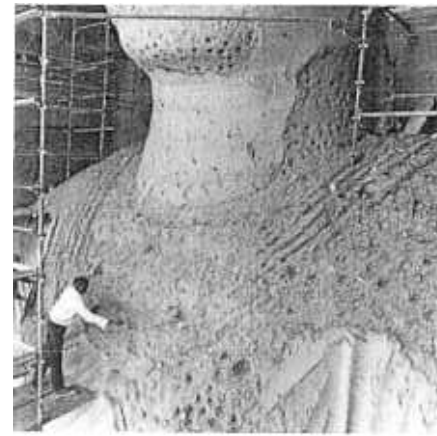
FIG. 16. The chest of the Small Buddha, showing the damage.

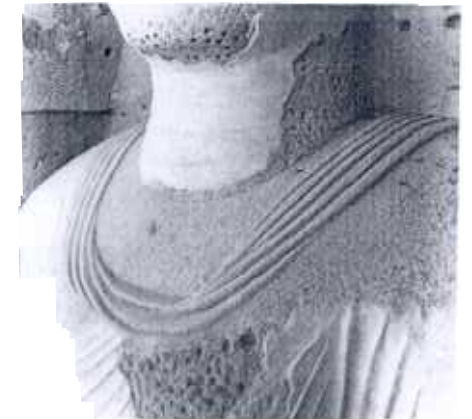
FIG. 17. The chest of the Small Buddha after restoration. Its traditional appearance has been preserved.

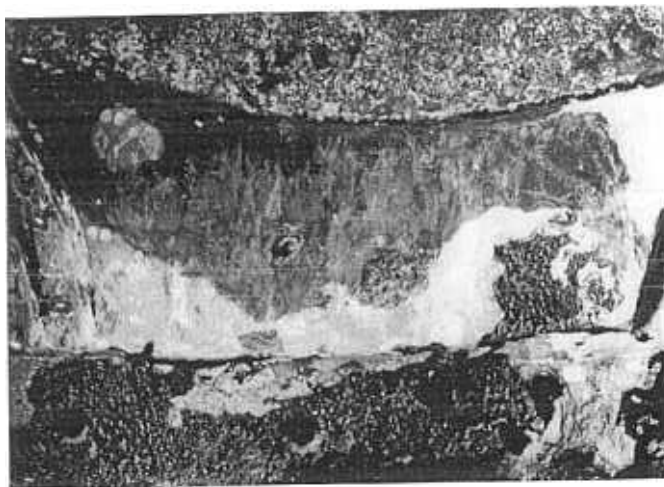
FIG. 18. A thick coat of soot on the whole of the painted surface.

For cleaning the accretionary deposits from the painted surface the solvents used were ethyl alcohol, acetone, cellosolve, ethylene glycol, ethylene dichloride and butylacetate. The loose pigments were fixed with a thin solution of polyvinyl acetate dissolved in toluene, alcohol and ethylene dichloride. For a preservative layer polyvinyl acetate was used, often more than one coat having to be applied as the painted surface was found to be highly absorbent but care was taken not to produce a glossy surface. Polyvinyl acetate was chosen as a preservative mainly because it was reversible.

The chemical treatment of the plastered surface covered with a layer of soot (Fig. 18) has revealed some interesting paintings hitherto unknown. For the first time in the mural paintings in Afghanistan, an incident from Buddha's life—the miracle of Sravasti, (Fig. 19) could be identified. In it the Buddha is shown with flaming shoulders, as shown in a few Gandhara sculptures and in an image recently found at Mathura in India. Another notable discovery is that the face of the huge figure of the Sun God, painted on the ceiling of the main shrine of the Small Buddha somewhat in the fashion of Zeus, has two pairs of eyes, one pair over the other.

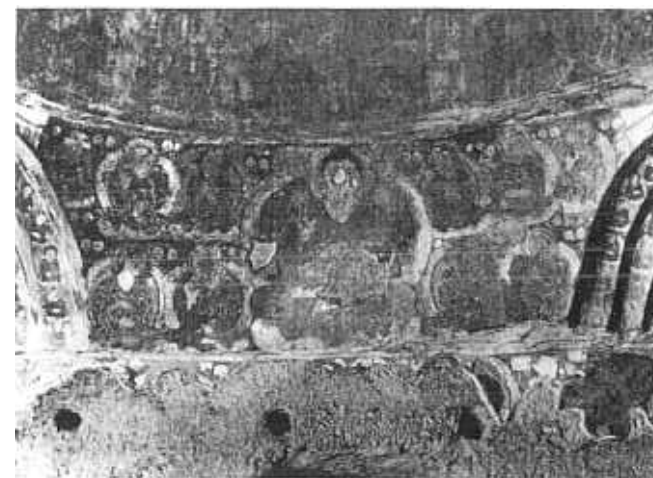
FIG. 19. The painting of the 'Miracle of Sravasti' after cleaning off the soot and conservation.
