## Collaboration in Cairo: the conservation of the Madrasa el Gawhariya

OLE ROSS\*

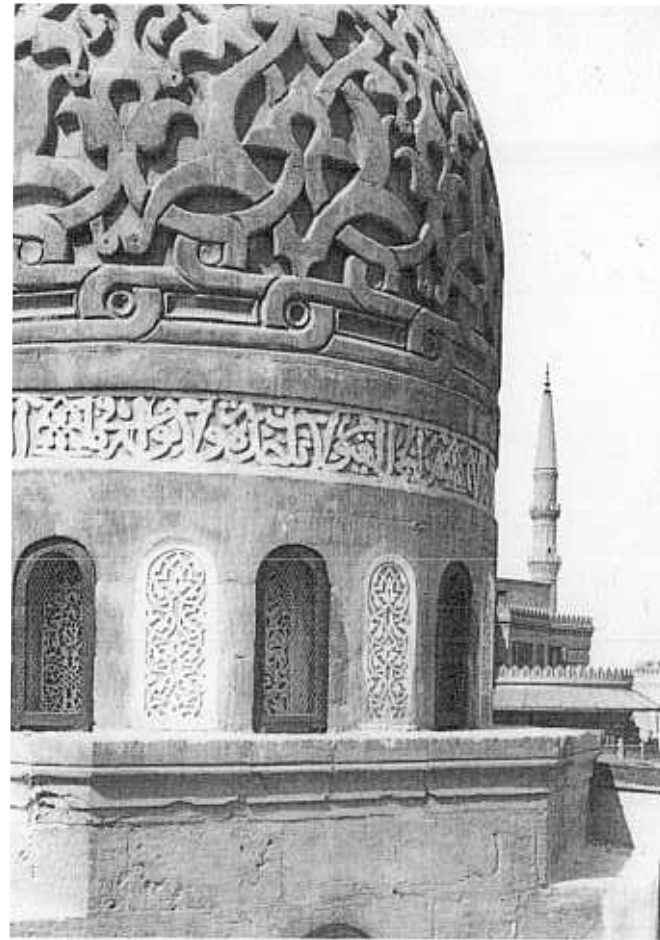
FIG. 1. Part of the dome after restoration.

The dome showed evidence of cracking and weathering of the stone. There was discussion about how to reinforce it and Dr Bernard Feilden (then Director of ICCROM), being in Cairo at the time, suggested the use of stainless steel rods laid in the bottom of the joints before sealing them with mortar. However, this turned out not to be necessary, as the thrust calculations showed that the dome was stable and secure. The cracks were of an old date. We discovered that the use of gypsum in the mortar had resulted in a bone-hard consistency when mixed with slaked lime in the proportion 1:1. The presence of the lime made it possible to work up the mortar again after the gypsum had hardened, thus extending the use of the mortar in the cracks and joints of the dome. The mortar expanded slightly due to the gypsum, and so closed the joints completely. Both the joints and the cracks were then sealed with a mortar incorporating crushed limestone and sand, so being given the same rate of expansion as the limestone of the dome. Finally it was washed with limewater for a week in order to harden and stabilize the surface.

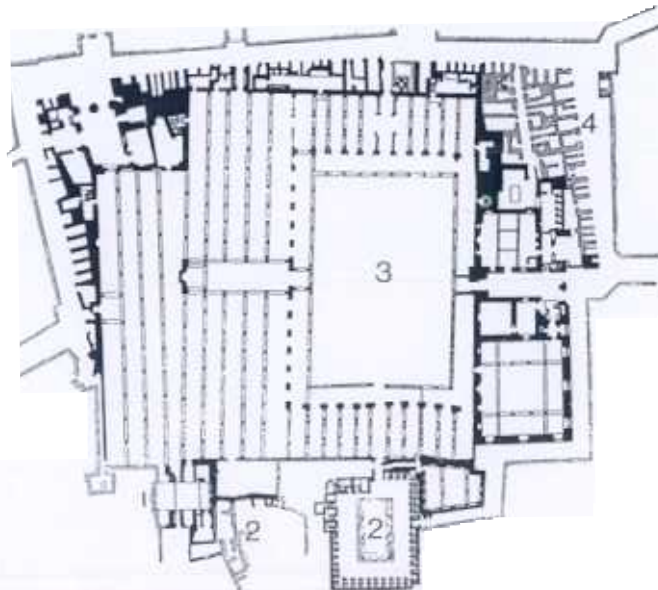
FIG. 2. Plan of the Al Azhar Mosque. 1. Madrasa el Gawhariya. 2. Buildings now demolished. 3. The open courtyard of the Al Azhar. 4. Bazaars.

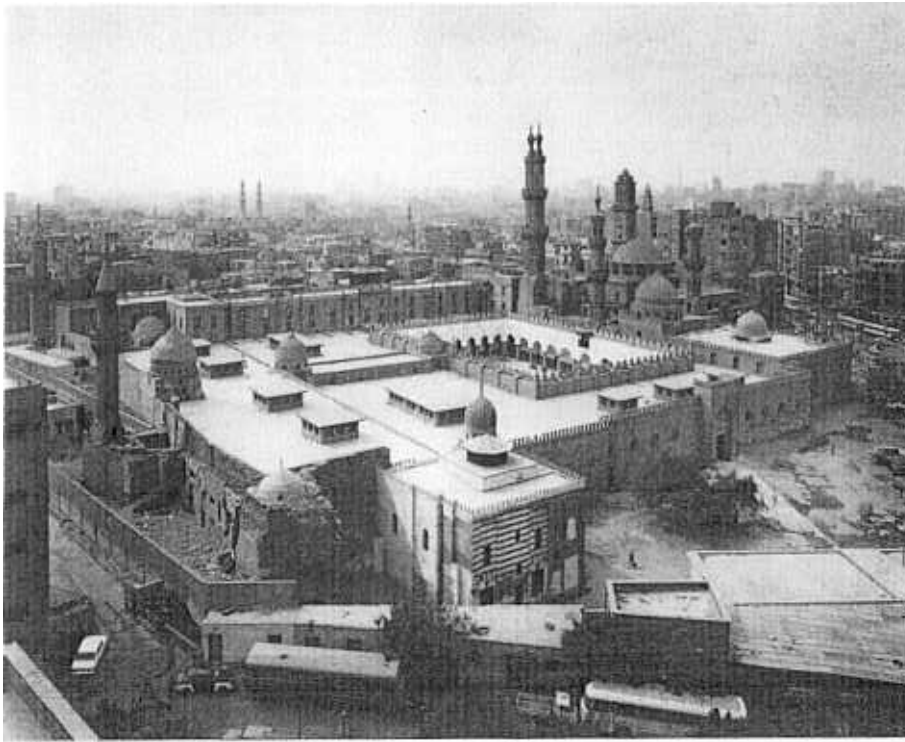
FIG. 3. The Mosque of Al Azhar. In the foreground is the restored Madrasa el Gawhariya and the restored open space which, until a few years ago, was filled with buildings.

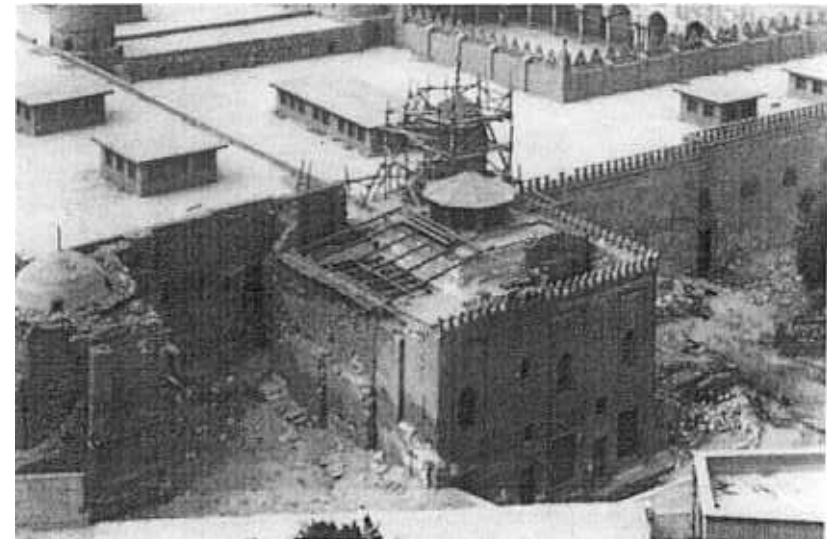
FIG. 4. The Madrasa before work started. Notice the raised level around the building.

<sup>10</sup> The debris had reached a level 4 m above the the present street, and 6 m above the 1440s level of Cairo.

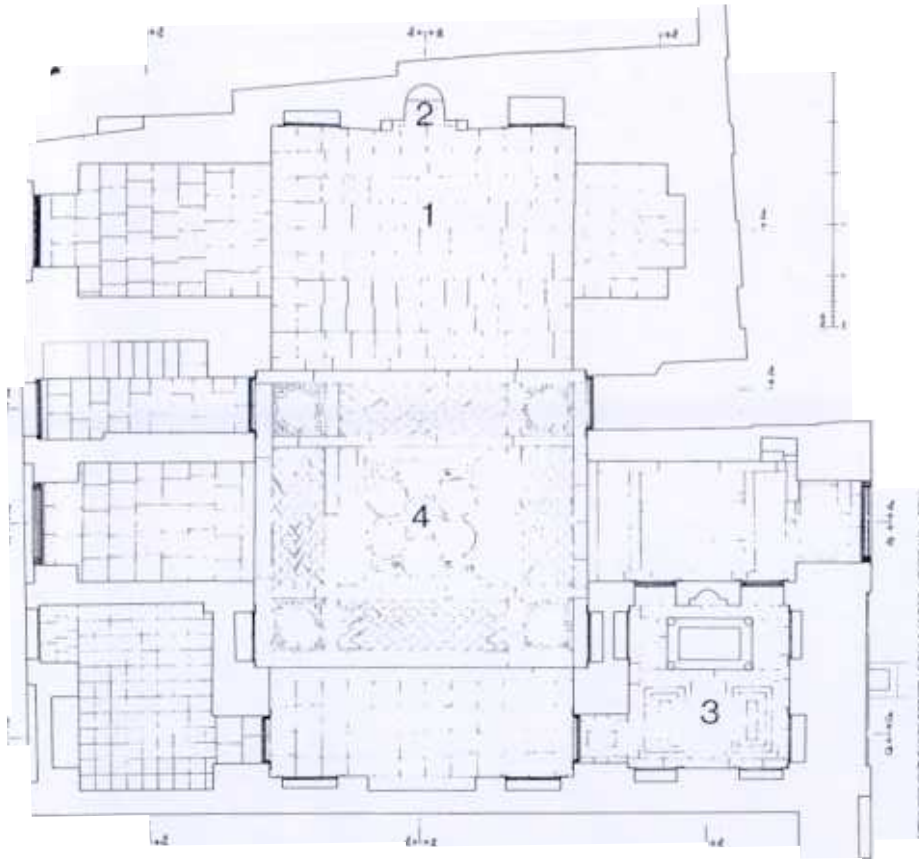
FIG. 5. Plan of the Madrasa. 1. The *qibla-ivan*. 2. The *mihrab*. 3. The mausoleum. 4. The courtyard.

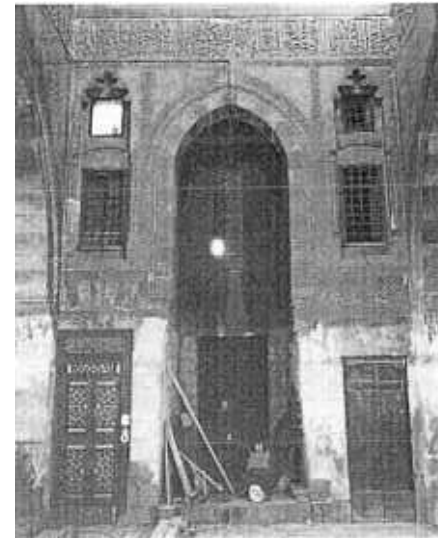
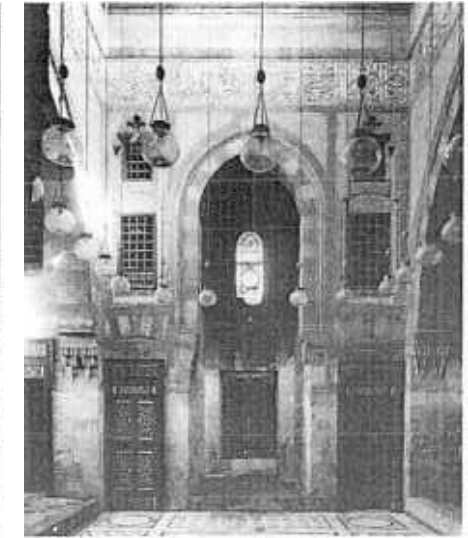
FIG. 6

FIGS 6; 7. The north *ivan* before and after restoration.

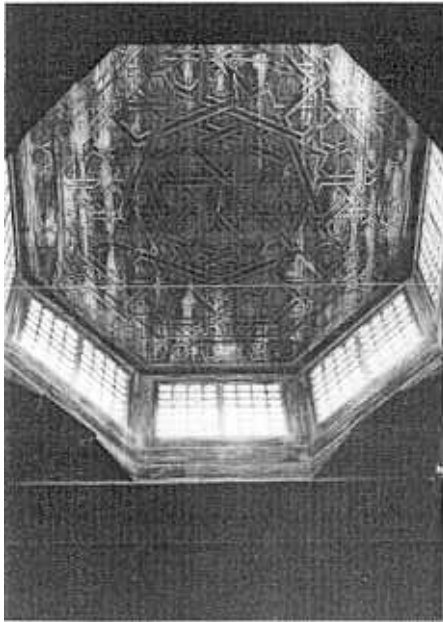
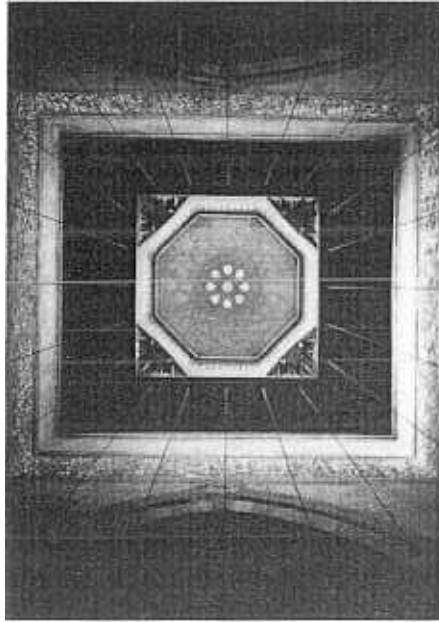
FIG. 8.

FIGS 8, 9. The lantern before and after restoration.

The relatively new covering of the courtyard, including the lantern, was the subject of much discussion. We believed that it had been put up in 1883, when the *madrassa* was turned into a part of the Al Azhar library, but we had no direct proof until we found one of the original crenellations built into the base of the roof. This was proof that the courtyard had been open; but should it be restored to its original form? Though not the best representative of its kind, the roof and its lantern was regarded as a valuable protection against the fierce climate; and as the building was to be used as a school after its restoration, we decided to leave this later roof, restoring it and covering it with lead according to the traditional Egyptian method.

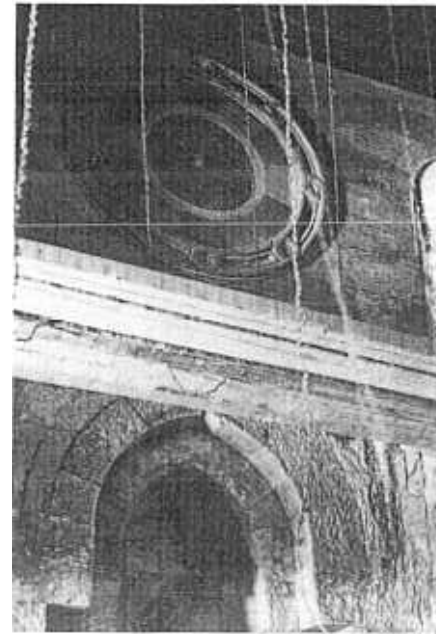
FIG. 10. (left) The original *mihrab* found during the restoration of the marble facing.

found underneath (Fig. 10). It was in fact a structural part of the *qibla*-wall itself and made of the same limestone, the outer edges being lined with yellow stones, like those of the walls and arches of the courtyard (Fig. 7). The top of the original *mihrab* had the same zig-zag pattern as the marble decoration, but in yellow and white. As we began to make these discoveries, we began to appreciate the interior's harmony and unity.

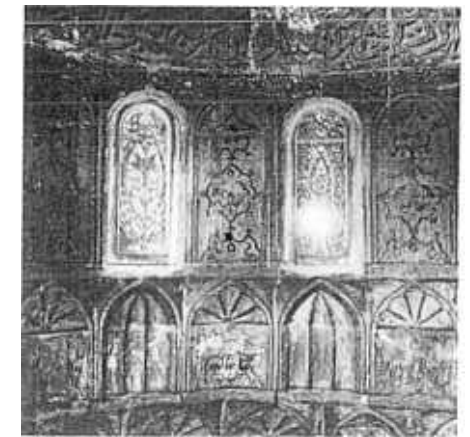
FIG. 11. (below) The transitional octagon and gypsum windows of the dome.

the square of the room to the circle of the dome's base is effected by means of an octagon (Fig. 11). The dome rests on a drum, which is perforated by openings and niches, sixteen in all, every second being a gypsum window with coloured glass through which the light is filtered. A second layer of light enters through eight windows in the transitional octagon. The resultant feeling of weightlessness is further reinforced by the decoration of the dome itself, in which a painted green network on a white stucco ground creates a *treillage*-like effect (Fig. 12). A marble cenotaph on the floor in front of a *mihrab* indicates the spot underneath which the founder is buried, the grave itself being in a vaulted tomb under the mausoleum. From outside, the dome rises above the roofs of Al Azhar (Figs 1, 13), strangely different in form from the rounded *muqarnas*-vaults of the interior with its sharp prismatic appearance. The surface is carved with two interwoven arabesque motifs, which produce a changing effect of light and shadow during the blazing Cairo days.

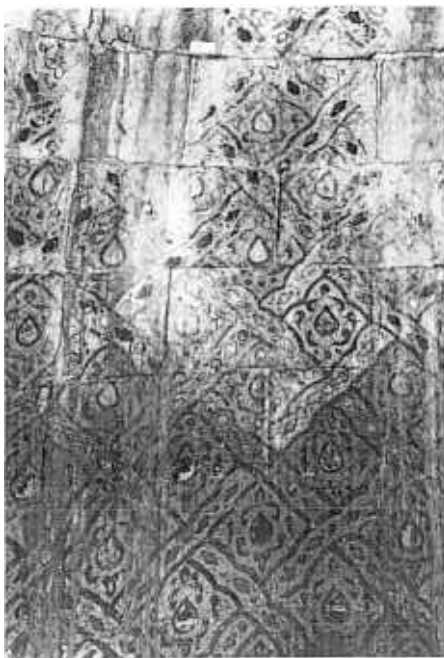
FIG. 12. (left) A detail of the decoration of the dome.

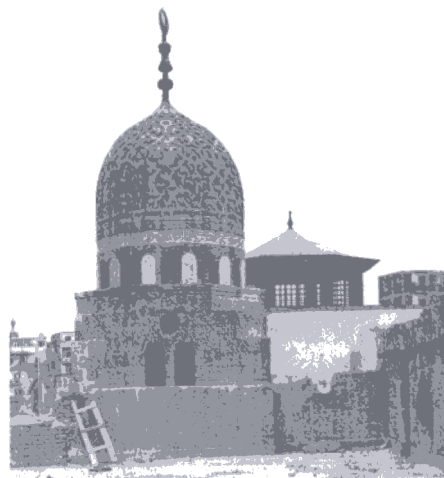
FIG. 13. (below) The dome and lantern seen from the roof of the Al Azhar Mosque after restoration.

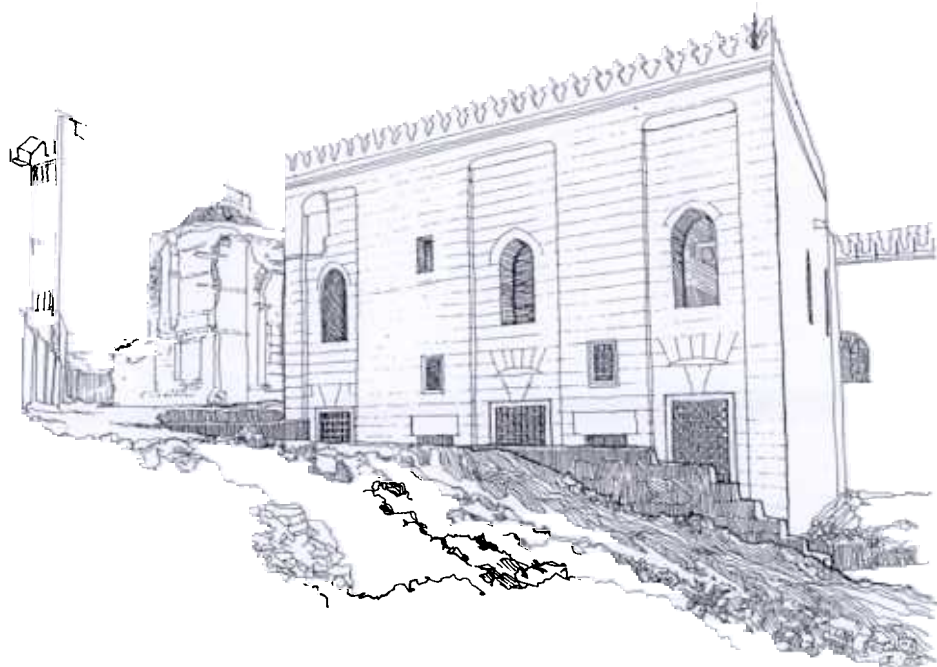
FIG. 14. The north-east facade before restoration; a drawing by the author.

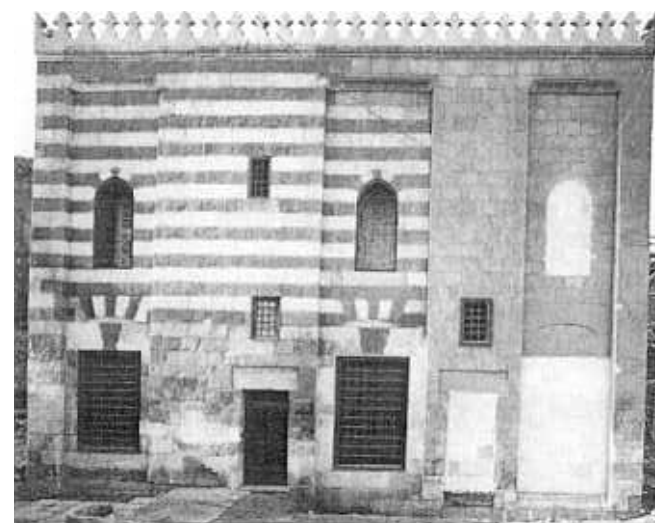
FIG. 15. A part of the north-east facade after restoration.

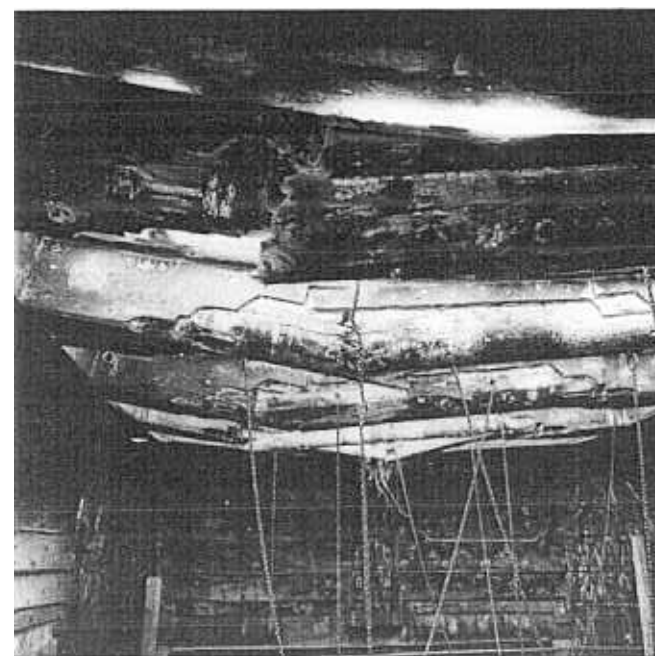
FIG. 16. The broken beams of the ceiling over the *qibla-iwan*. Note the original copper chains for the oil lamps which had disappeared.

decorated ceiling beams. In order to secure the latter, which were broken, it was necessary to support them and build a new independent roof. This extra layer of beams created a problem. It was not possible to use the same construction as originally,<sup>11</sup> because the total thickness would have been too great, and as it was necessary to protect the layer of bitumen from the sun's heat, polystyrene was used as insulation under the traditional finish of stone flags laid in sand and lime mortar.<sup>12</sup> During the clearing and excavation of the roofs many original parts were discovered, the most important being the two centre panels from the south *iwān*. These had been used in a later reconstruction of the roof, and were found broken into pieces under about seven cubic metres of debris. All the painted decoration had gone, but the carved swirls of flowers clearly showed the design. They have been collected and put up again in their original positions.

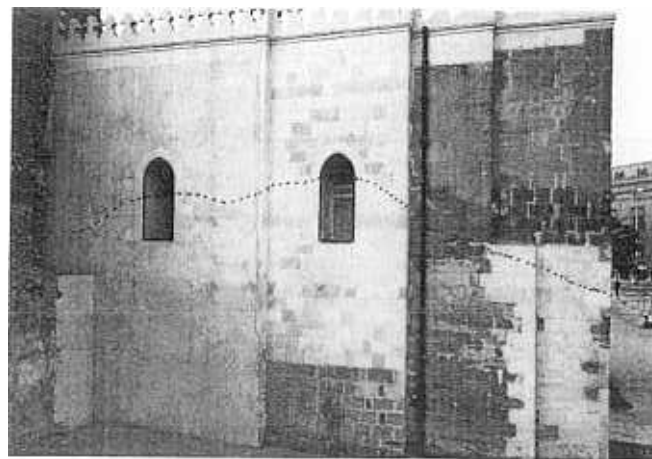
FIG. 17. The *qibla*-wall after restoration. The two original panels have been opened up, and two of the four new gypsum windows have been inserted. The dotted line indicates the level of the debris piled against the wall.

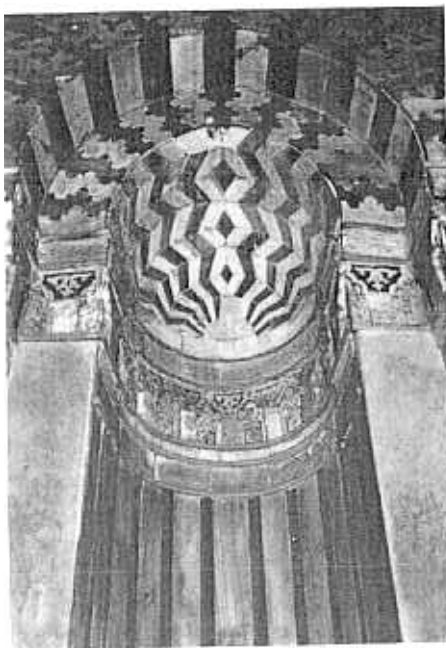
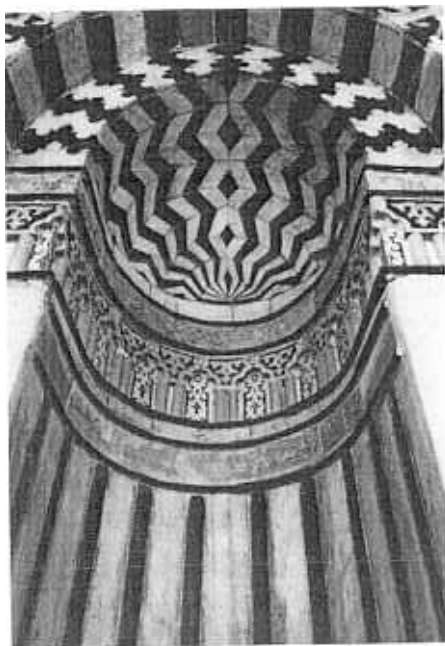
FIG. 18.

FIGS 18, 19. The central part of the *mihrab* before and after restoration

*mihrab*, a layer of lead was inserted under the marble panelling; this was possible because only one-third of the thickness of the *qibla*-wall remained after the demolition of the neighbouring building. The entire marble facing had to be numbered and taken down in order to clean the walls, and it was later replaced (Figs 18, 19).

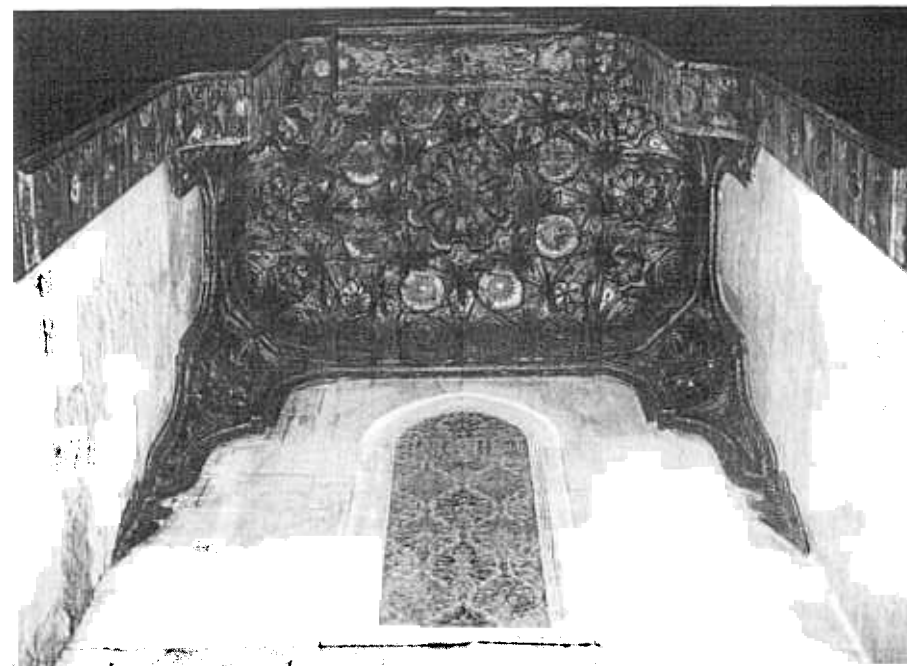
FIG. 20. The stalactite ceiling and the original panel from the *qibla*-wall after restoration.

colour, from the originals; but nevertheless they unify the ceilings. The cartouches were not touched; but in all the ceilings the missing gilded parts were regilded to give them a sparkling effect close to the original (Fig. 20).

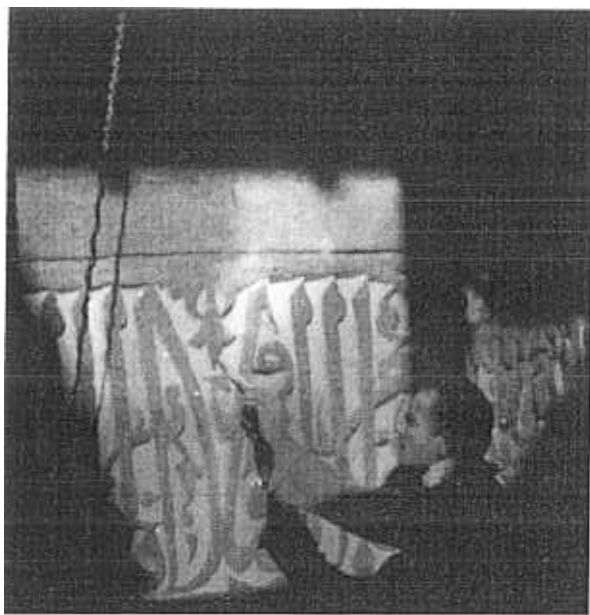
FIG. 21. The author at work on the restoration of the Koranic inscription in the courtyard. It was treated like the outside decoration of the dome, the missing parts being remodelled in a lime-gypsum-sand mortar.

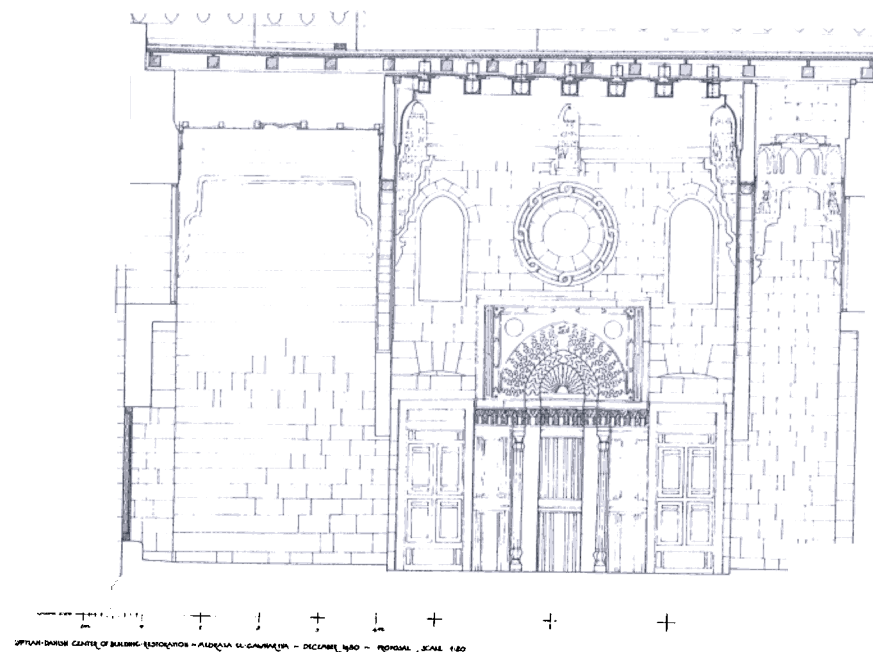
FIG. 22. A detail of the drawing made to show the proposal for the restored interior.

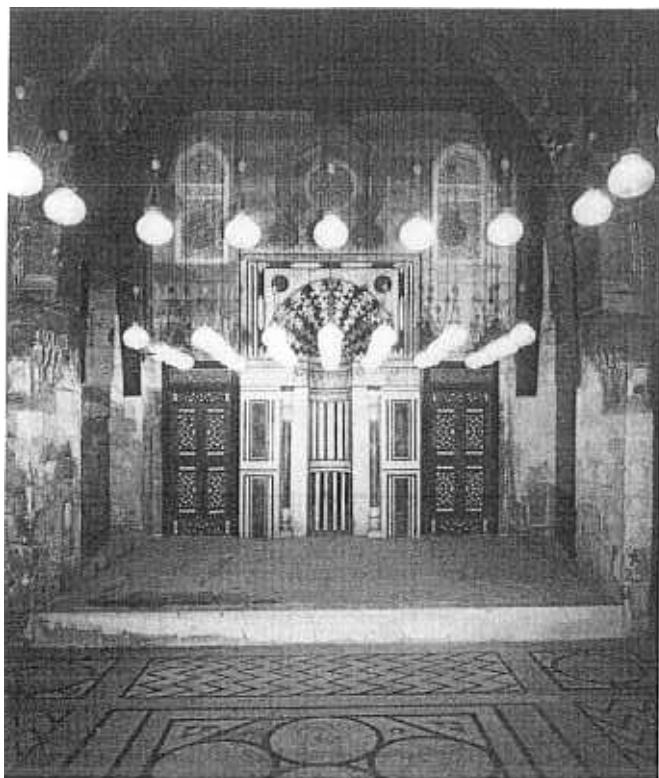
FIG. 23. The Madrasa after restoration, showing also the lamps which have been added to improve the quality of lighting as this space will be used for teaching.
