Project for the Arch of Septimius Severus, Rome

ROBERTO NARDI*

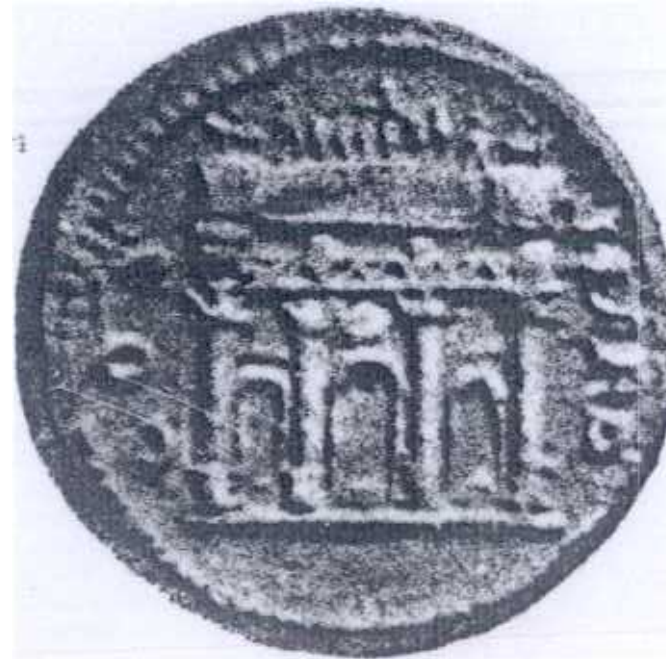
FIG. 1. Roman coin representing the monument. The acroterial figures crowning the monument are shown here. There is a central chariot with six horses driven by a figure and two horse riders on each side. Furthermore one can see a stylized criss-cross motif at the base of the attic; it probably represented a protective and decorative balustrade on the accessible cornice that surrounds the arch.

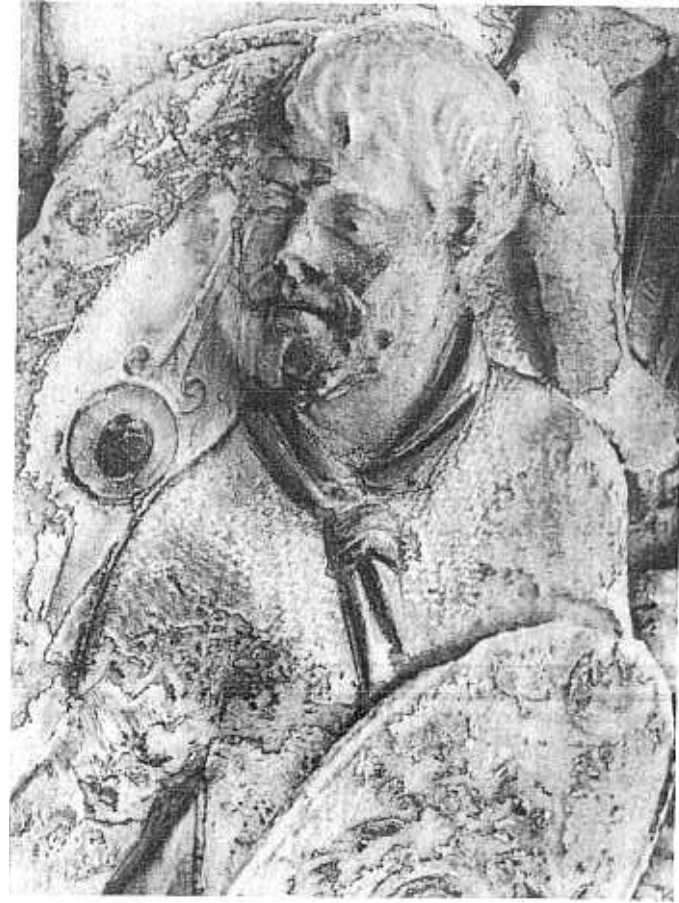
The results were interesting: all the above-mentioned cases were found to be present; among others, there was a layer painted on to finished marble, perfectly conserved; it even still had tool marks and measuring lines on the surface (*Fig. 9*).

FIG. 9. Trajan's Column. A thin coating is still present on the surface of many Roman monuments, preserving ancient measuring and tool marks. This is the case with some loricated figures on Trajan's Column; the sharpness of the tool marks and the perfection with which the details are rendered prove that the coating was layered over at a time when the carved marble surface was still perfectly intact, almost fresh from the sculptor's hands. Whether this was a definitive form or just a preparation coat before an eventual colored painting of the surfaces, is a question that cannot be answered due to the total absence of secure evidence.

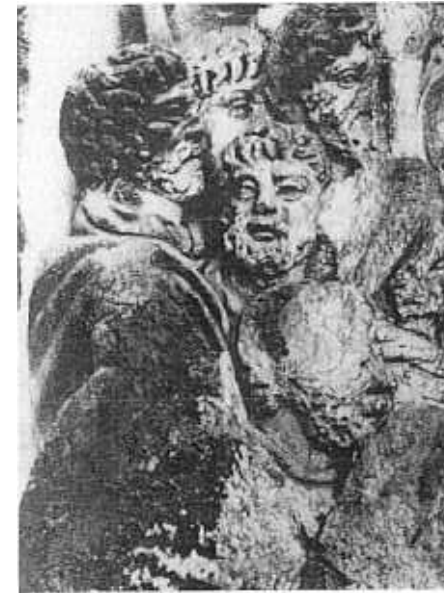
FIG. 10. Askev Collection. Arch of Septimius Severus. Southern figured panel, S-SE face. 1935. From photographs such as these it is possible to study, with a certain amount of approximation, the ways and the time-spans in which forms of deterioration manifested themselves over the last forty years.

Help in this area came from photographic documents dating from the mid-nineteenth century up to the present. Although limited to general observations only rarely well-defined, it is possible to draw valuable information from these documents, such as, for example, the fall of marble fragments (figured reliefs or cornices), the presence of black crusts and protective layers, the movements of rainwater, and so forth (*Figs 10, 11*).

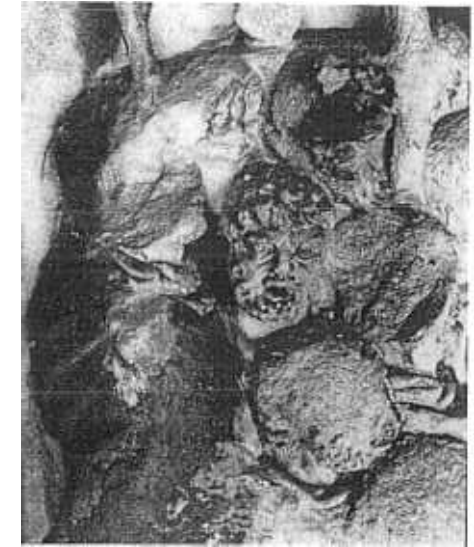
FIG. 11. Arch of Septimius Severus. Southern panel, S-SE face. Present reproduction (photo by Mecci, 1983) of the area shown in *Fig. 10*. Besides more minute observations one can identify, from this photographic comparison, even microscopic damage, such as, for example, the fall of the head of the man up in the left (compare with *Fig. 10*). This is a small example of how short the life-expectancy is of sculptures on exposed Roman monuments unless we intervene immediately.
