KELMSCOTT MANOR, THE HOME OF WILLIAM MORRIS  
AND ITS REPAIR FOR THE SOCIETY OF ANTIQUARIES OF LONDON

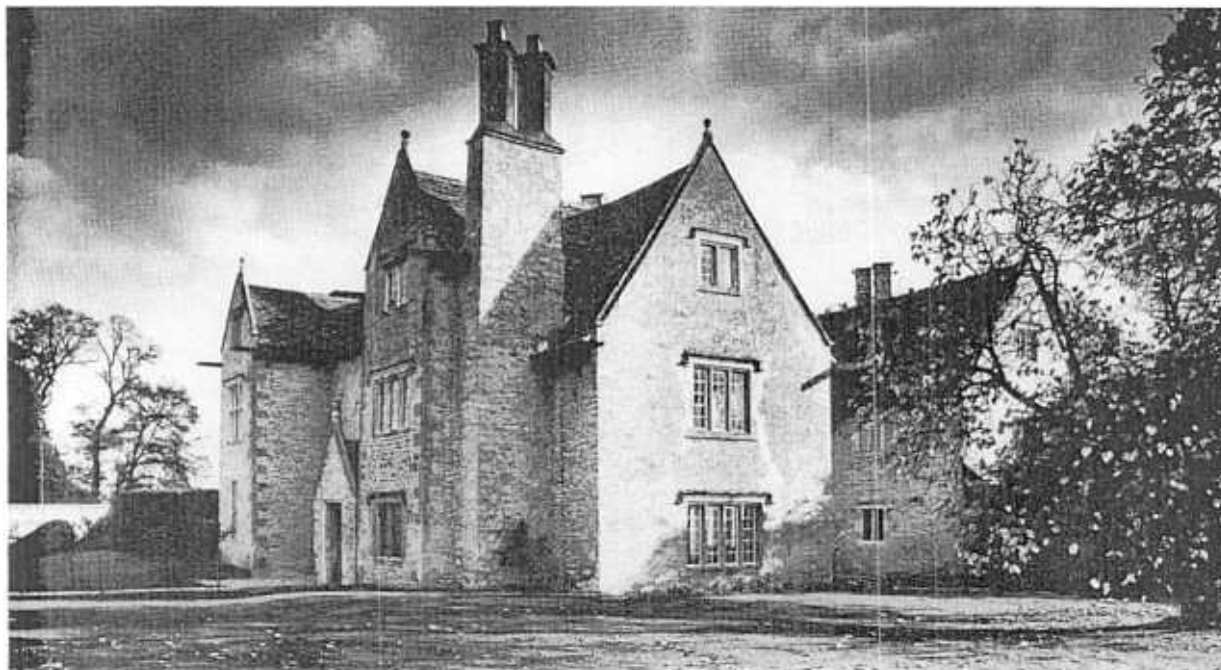
Fig. 1. — Kelmscott Manor from the north west, after renovation.

*Fig. 1. — Le Manoir de Kelmscott vu du nord-est, après les travaux de rénovation.*

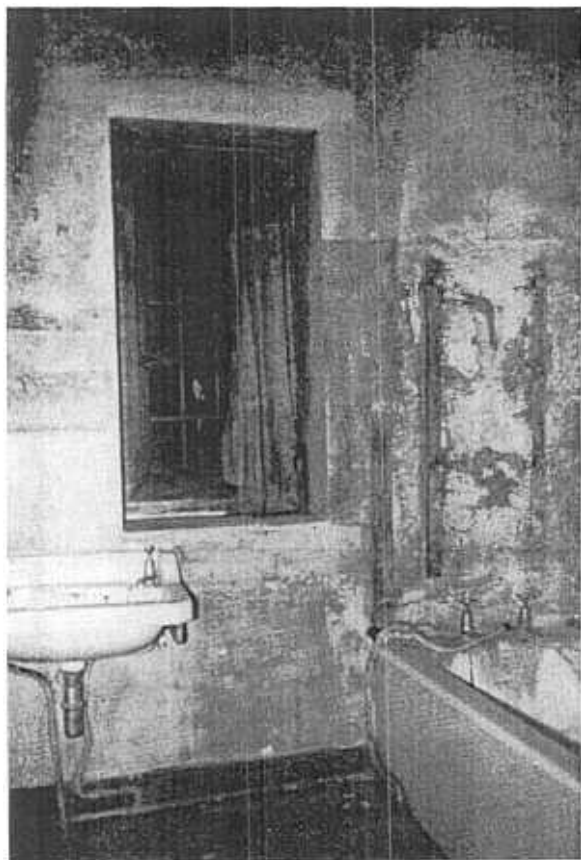
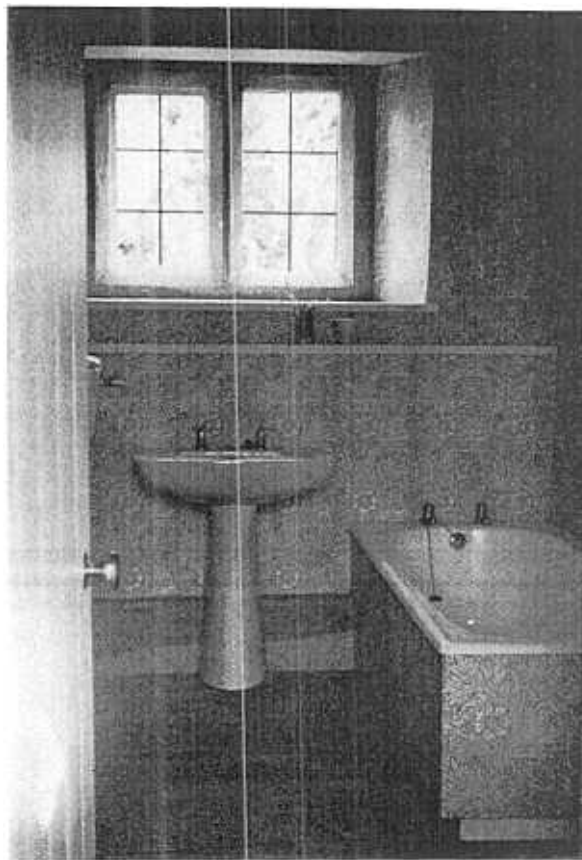
Fig. 7, 8. — The east bathroom before and after re-conditioning. The wallpaper, here and elsewhere in the Manor, is a modern

reprint from Morris' original blocks, produced by Messrs. Sanderson Ltd.

The private accommodation was accordingly re-ordered and equipped to a good standard of present day convenience. A new Kitchen was formed in the former Scullery, and the old Kitchen was converted into a Dining Room. The intrusive cloakroom was demolished and a new one formed in the service wing. Three new Bathrooms were formed, and fully adequate services were installed, together with central heating, the latter being underfloor in the principal ground floor rooms.

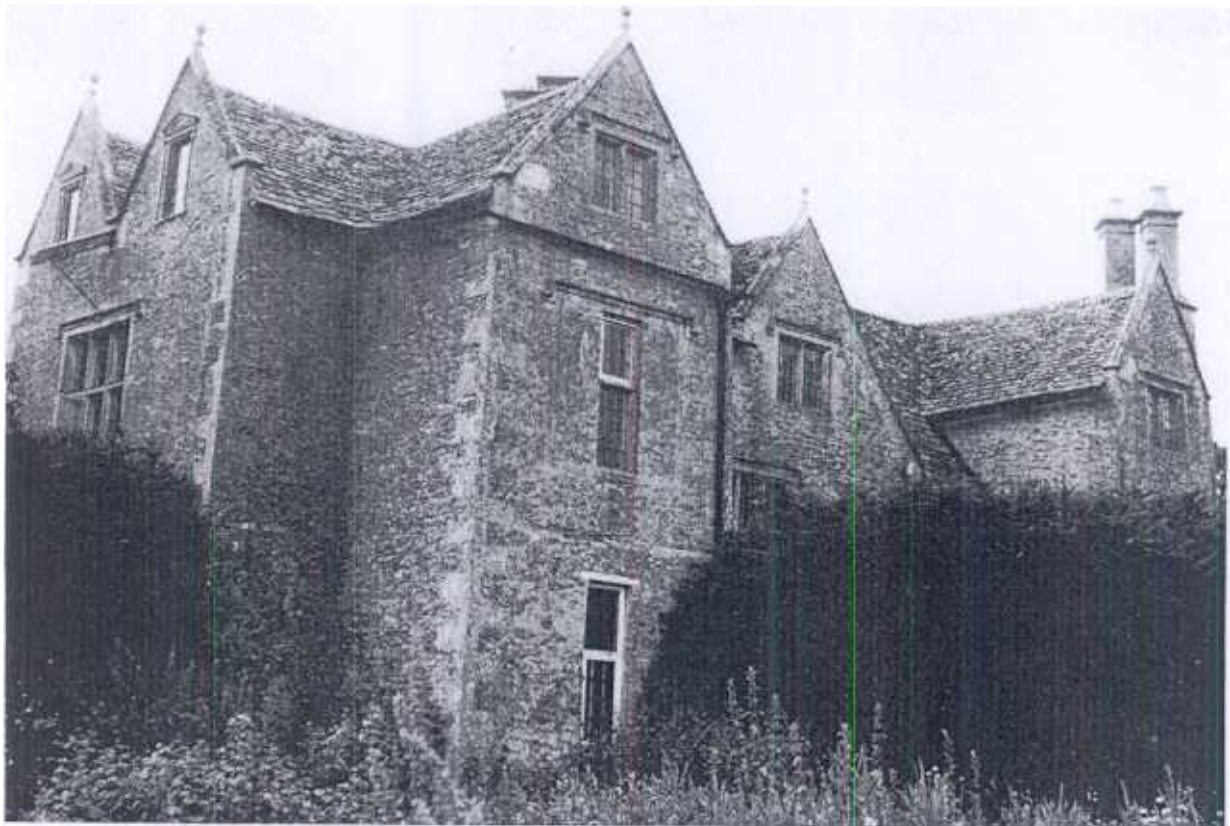
Fig. 11. — Kelmscott Manor from the north-east before renovation was started.

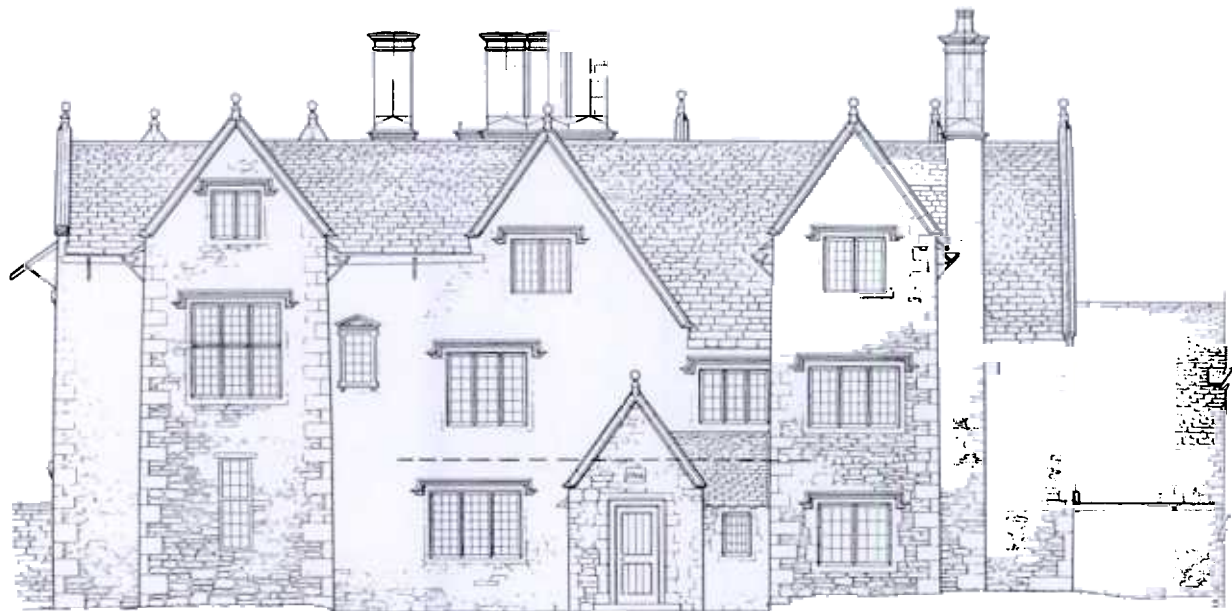
NORTH ELEVATION

Fig. 15. — The North Elevation as it now is, re-ordered and with the new porch and public entrance. The dotted lines show the position of the reinforced concrete beam inserted length by length to distribute the weight.

Sophisticated repair techniques can usually fulfil this edict, and the structure can be saved with a minimum of disturbance to the original work. In the north wall, a reinforced concrete beam was inserted, set length by length into the core of the wall. This at the same time evenly re-distributed the heavy loads and also tied together the loose masonry.

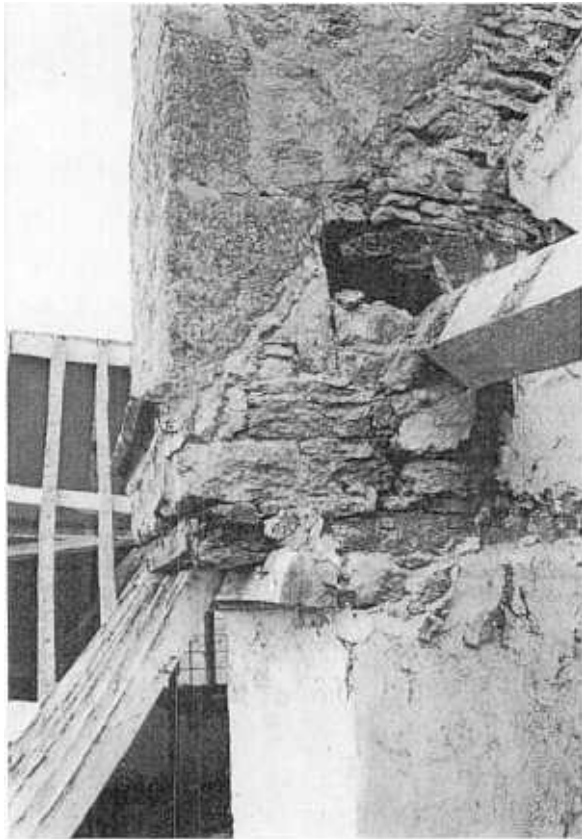
Elsewhere too, the strength and adaptability of reinforced concrete enabled serious defects to be remedied by conservative repair. A great central stone chimney stack was found to be set eccentrically upon its base and widely cantilevered outwards at one side. This projection was supported on a heavy oak bressumer, carried in turn upon plates built into the masonry. But all the timber, carrying the great weight of masonry

Fig. 16. — The condition of the base of the central chimney stack as revealed by opening-up.

above, was completely rotten. Tell-tale cracks had already appeared in the stonework above and spoke of its failure. Here, the rotten timbers were little by little carefully removed, and replaced by concrete underpinning, bonded securely to the old stonework. Any other method would have necessitated the demolition and rebuilding of the whole of the chimney, at great expense and with much loss of original work. Perhaps the most serious example of Kelmscott's 'penchant' for concealing its worst defects was found in Morris's own Bedroom. Here, investigation of a sag in the ceiling revealed that a great mass of masonry, carrying in turn part of the roof, was supported by a single oak plank, no thicker than a broom handle. Its deflection showed that it was literally at breaking point and a catastrophic collapse could have occurred at any time. This again was shored up and replaced with reinforced concrete, without further disturbance.

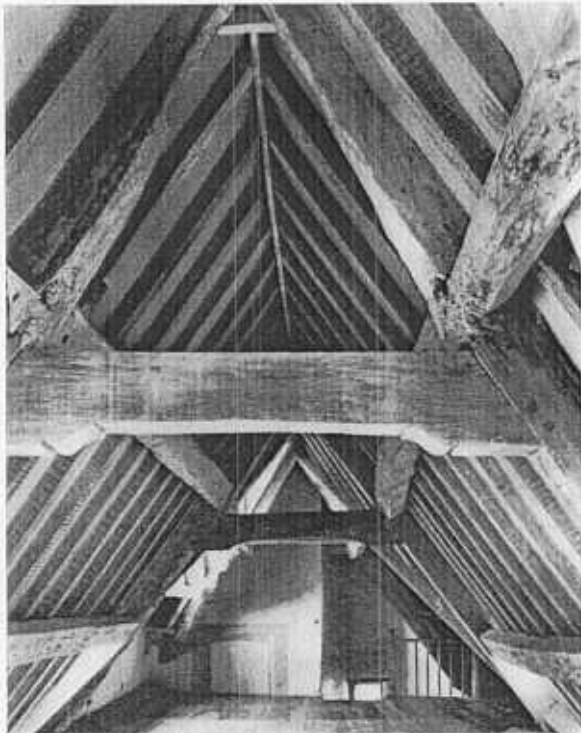
Fig. 19. — The great attic over the main range of the sixteenth century house after repair.

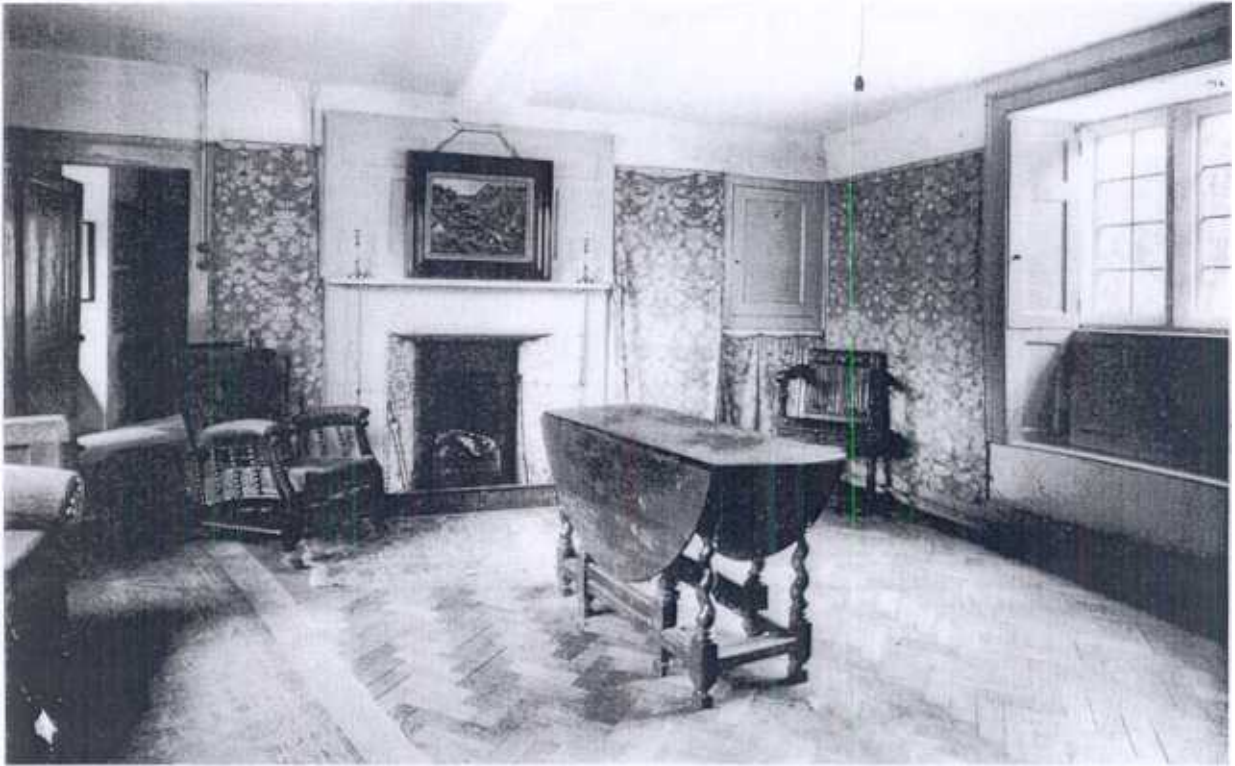
Fig. 23, 24. — The former Victorian grate in the dining room (above) and the original stone fireplace discovered behind it (below) and left exposed.

decided that the original fireplace was of over-riding value and interest, and it was carefully conserved and left exposed as a fine and veracious feature of the room. But in Morris's Bedroom, when a blocked 16th-century window opening was discovered, it was decided that priority should here be given to retaining the room as Morris knew it. So it was carefully covered in again. When the re-decoration of the house came to be considered, there was really very little doubt that Morris's own wallpaper designs should again be used. The original papers were so damaged and mutilated as to be beyond repair. But the designs are in any case as valid now as when they were first designed, and fortunately they remain readily available. So the
