EXPERIMENTS IN MUDBRICK CONSERVATION AT TEPE NUSH-I JAN

HILARY LEWIS

JULY 1980

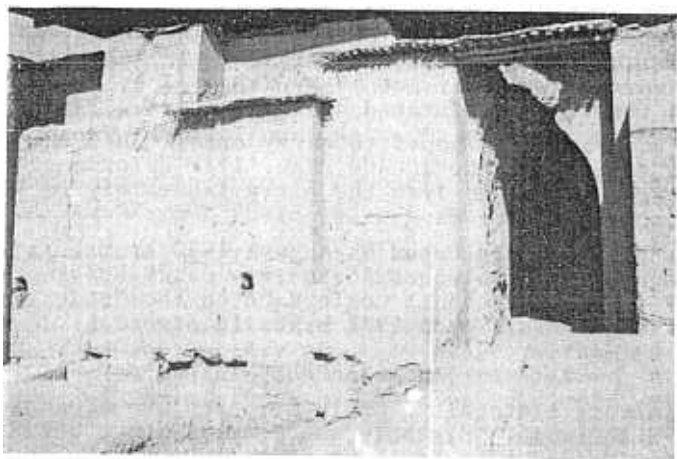
Damage caused by animal scavengers in lower parts of walls
 Conservation efforts:
 Note a) replacement of brickwork where original appearance certain
 b) protective coating of mudplaster (kaghel)
 c) protective roofing using reed and kaghel, extended beyond the limits of the walls by wooden slats.

not so protected but instead are capped by layers of stiff reed mats and kaghel, with a layer of guni (sacking soaked in tar or similar bituminous material) laid between. The latter acts as a form of damp course. Wooden slats extend the capping beyond the width of the wall. This method is useful because it is flexible enough to follow the contours of uneven wall surfaces and it has proved to be efficient.

Where walls have been damaged by erosion, pitting or other types of disturbance and where the appearance of the original wall is certain-Median bricks from the blocked areas of the site are used to build up the line of the walls. It is proposed that all reconstituted areas be demarcated using a thin line as has been done at Masada. Replacement of damaged brickwork helps alleviate further erosion and weather damage in general.

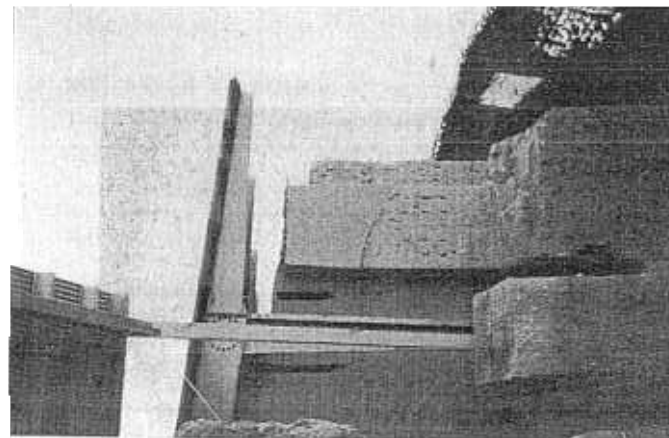
Illustrating a) steel roofs
 b) replacements of brickwork
 c) protective coating of kaghel

In 1974 Silurian steel roofs (28 x 24 m.) on free-standing columns about 7 m. in height were erected over the site. These have been very important in the conservation of the site because they guard against the serious damage caused by rain, snow and the impact of run-off water. Gutters are attached to the roofs and the water collected runs down closed drainpipes. Initially vertical, these drainpipes then slope gently underneath the visitors' walks to the edge of the mound so that the run-off is carried away from the buildings. The pipes are buried because if exposed, they tend to be damaged, displaced or removed altogether and catastrophic results follow.

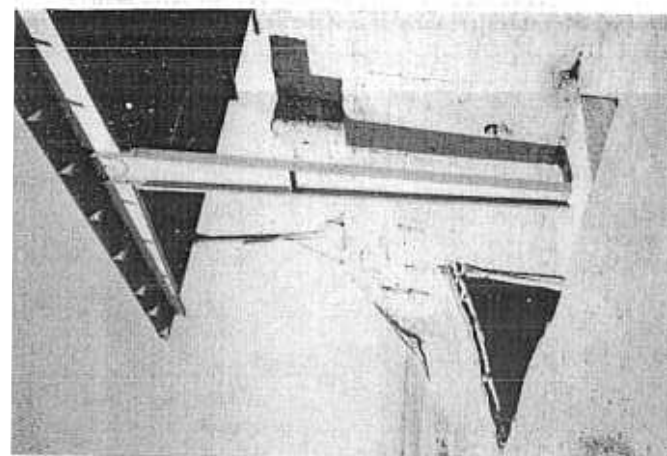
Siluran steel roofing on free-standing columns
 Note drainpipe system for carrying water away from the buildings.
 Also: standart village roofing temporarily protecting trenches.

Standard village roofing techniques have been used to protect some of the excavation trenches temporarily. These consist of long wooden poles with smaller cross struts supporting reed matting and kaghel. For extra protection polythene, perforated to prevent condensation, is laid over the first layer of mud and below a second layer.
