## LISTED BUILDINGS: POLICY AND PRACTICE

LISEN BULL &amp; UNNI GRØNN

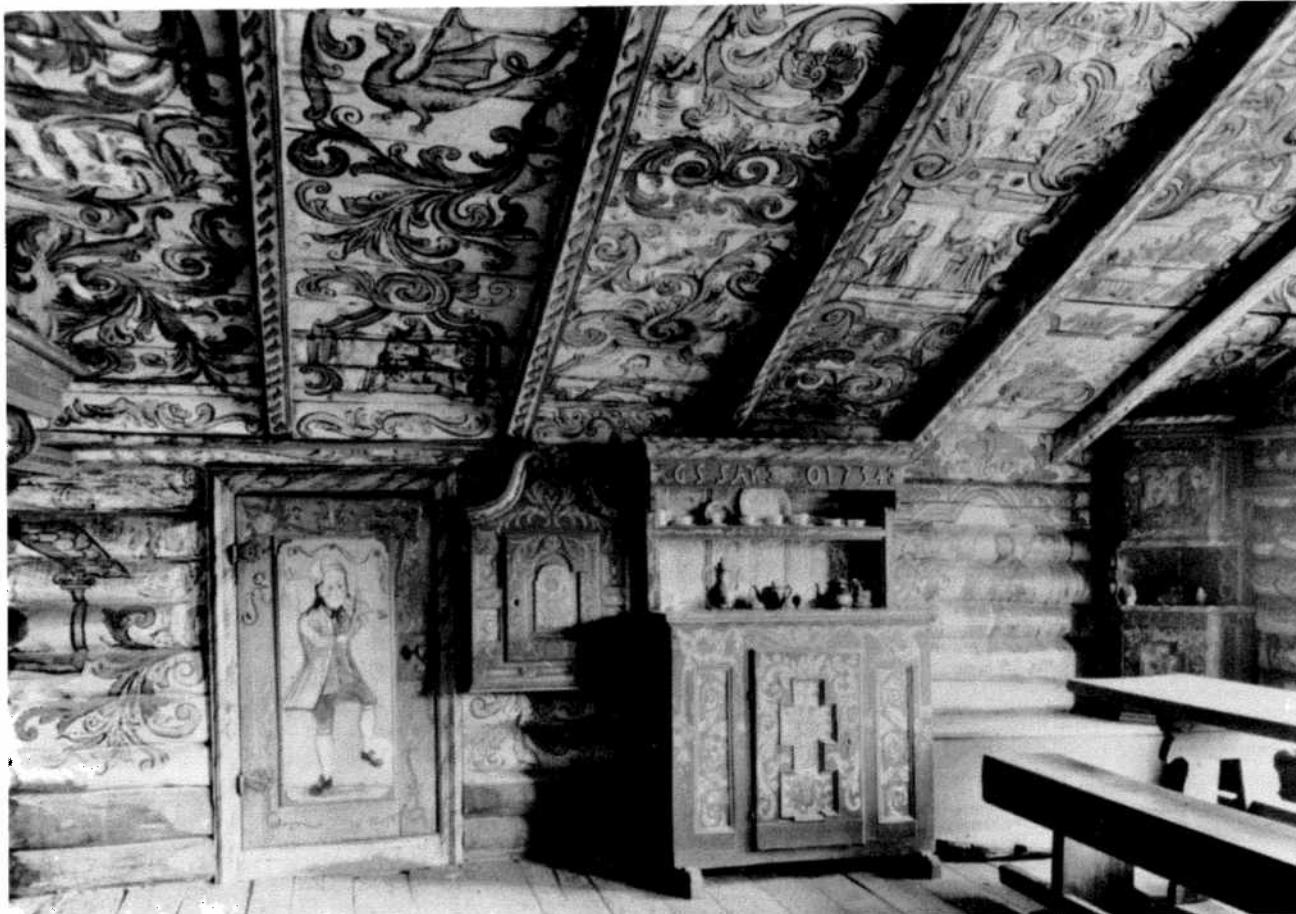
Ryen in Heddal, Telemark. The house has been protected since 1923. The main room in the farmhouse was decorated with traditional rose-painting in 1782 by Olav Hansson and it was mainly the artistic quality of this which led to the proposal for protection. Rose-painting was common in all the valleys of E Norway at the end of the eighteenth century, both in the forested areas and in the high mountains. The main room always had its traditional fixtures and fittings with special places for the bed, long table and side-board, making these rooms rather unsuitable as living-rooms by today's standards. Where the house is small, the only solution is to allow the erection of a new house on the farm.

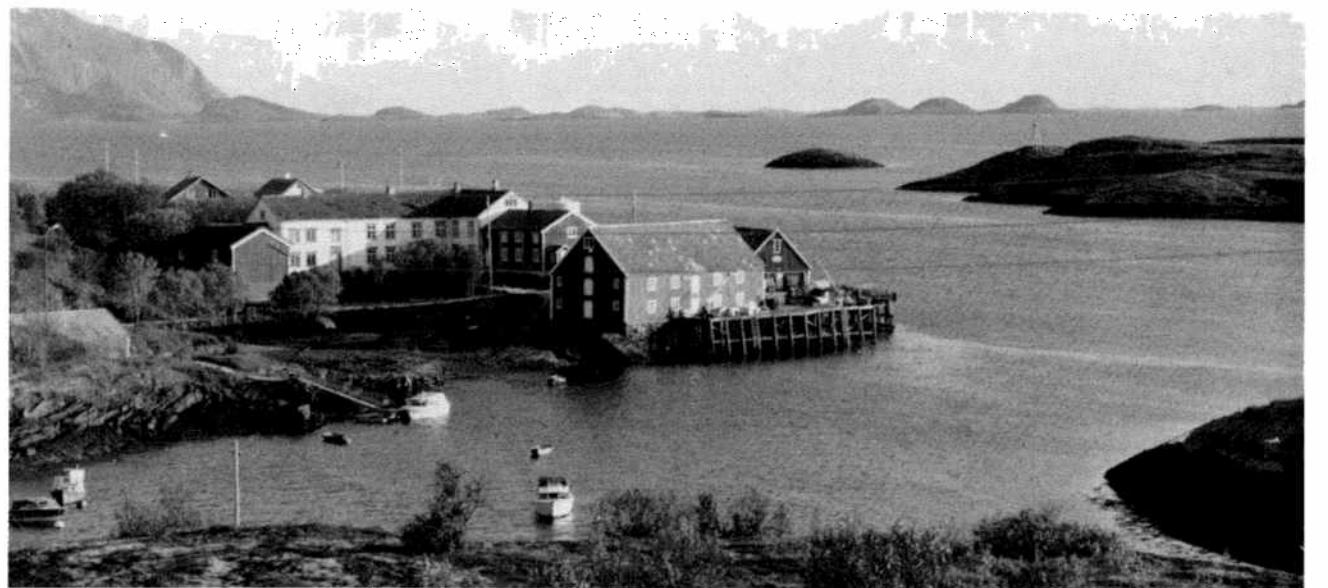
*Selsøyvik, Rødøy, Nordland. This north Norwegian trading post with buildings from the eighteenth and nineteenth centuries was added to the list of protected buildings in 1942, showing that the importance of conserving an entire environment, and not just fine examples of individual houses, was recognised quite early. The owner runs a modern fishery today. For the sake of efficiency, the warehouse standing on the wharf (in the foreground) was modernised and joined to a new building which was designed to fit in with the existing group of buildings. The result was very satisfactory, from both a conservation and a commercial point of view, and shared 3rd place in the Council of Europe's architectural competition «A future for the past of the rural heritage 1985/86».*

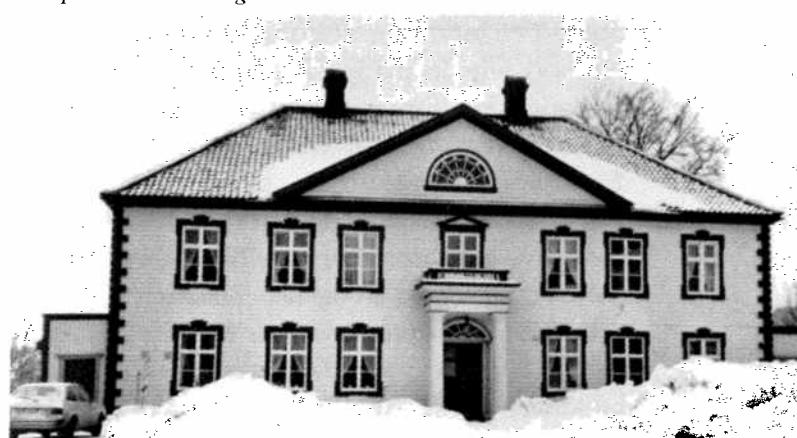
*Strømsbo, Arendal, on the south coast, was given its present appearance in 1804. It was listed in 1924. The house clearly demonstrates how architectural impulses from the stone buildings in Europe influenced the wooden architecture of Norway. The wooden cladding and finer details, however, are very vulnerable in the hard Norwegian climate, and maintenance is difficult. Before replacing any of the original parts, a thorough evaluation of their condition is necessary, and the work must be continually followed up to hinder the replacement of too much and to ensure that any new pieces are exact copies of the original.*

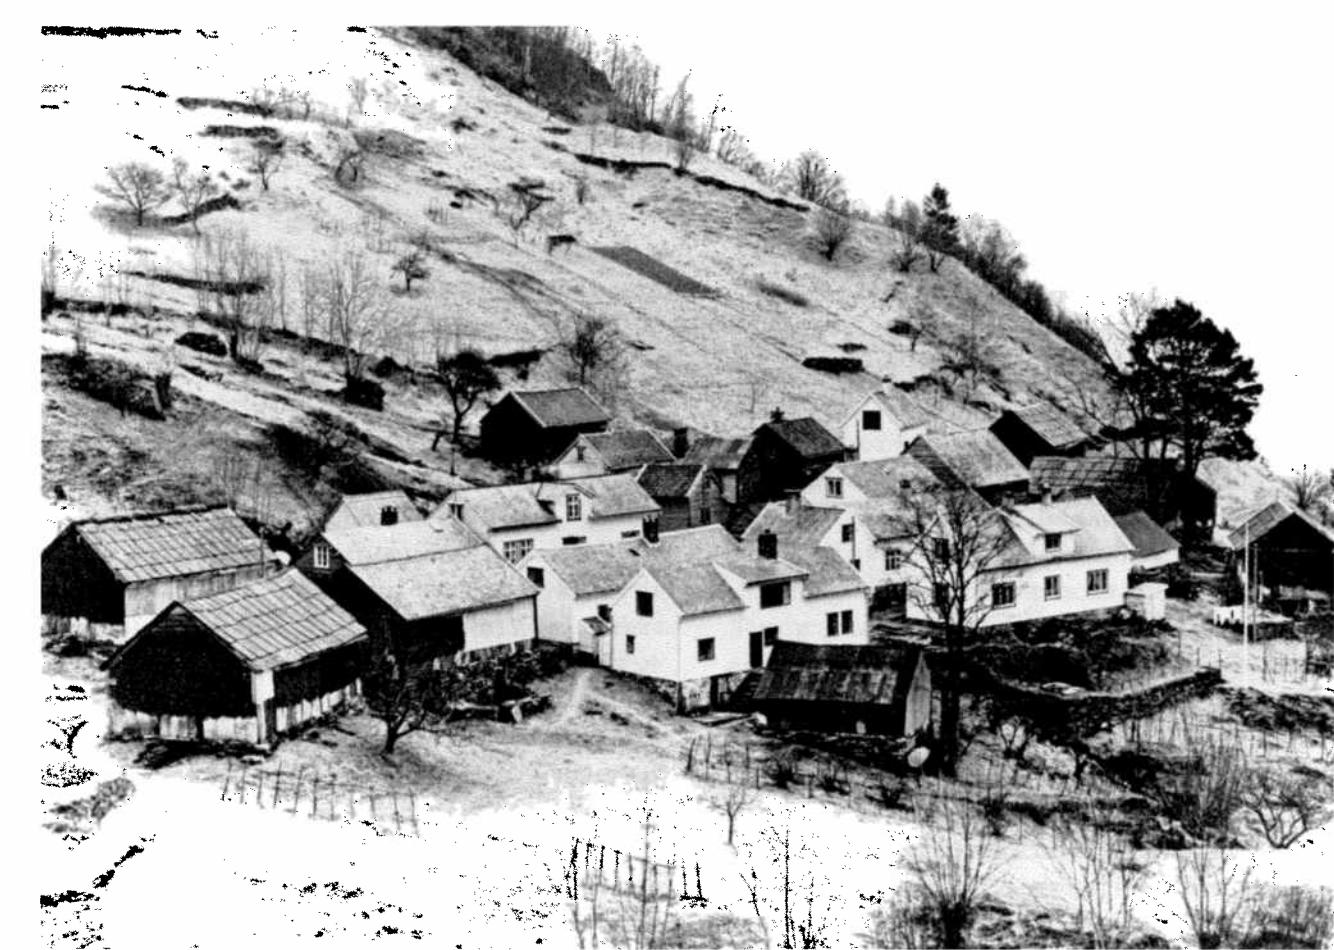
Havråtunet, a small nucleated farming settlement at Osterøya, north-east of Bergen, in Hordaland. The cluster of houses and out-buildings lies high on the steep side of the fjord. Norway has no villages such as are found in other European countries, and perhaps the nucleated farming settlements of W Norway are the closest comparison. The out-buildings are post-built structures with a thick cladding of juniper branches. A protection order for the whole settlement is in preparation, which will include the surrounding countryside, so that both the many traces of earlier farming activity on the hillside and the effect of the settlement in the landscape can be preserved. At the same time, the Nature Conservancy authorities are working out a management scheme to hinder the natural recolonisation of the ancient agricultural land. This is one of several examples where the protection order includes both the monument and its environment, a course of action made possible by an amendment to the Protection of Buildings Act in 1975.

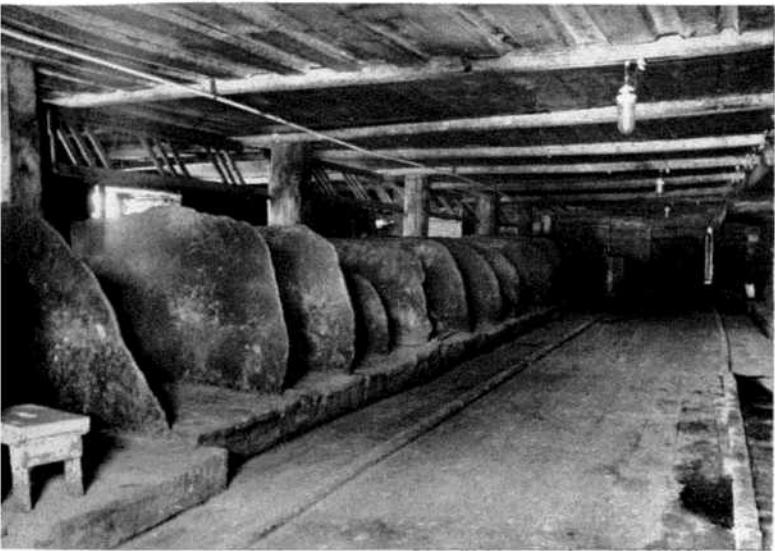
In the 1960s the farm at Tofte was modernised. The cow-byre from 1822, which still contained the original fittings, including the great upright stone slabs separating the stalls, was so large that it could easily be converted to a modern cow-shed. The original and valuable interior was therefore lost, but the external appearance of the farm as a whole was considered more important, and it still remains free of new buildings.

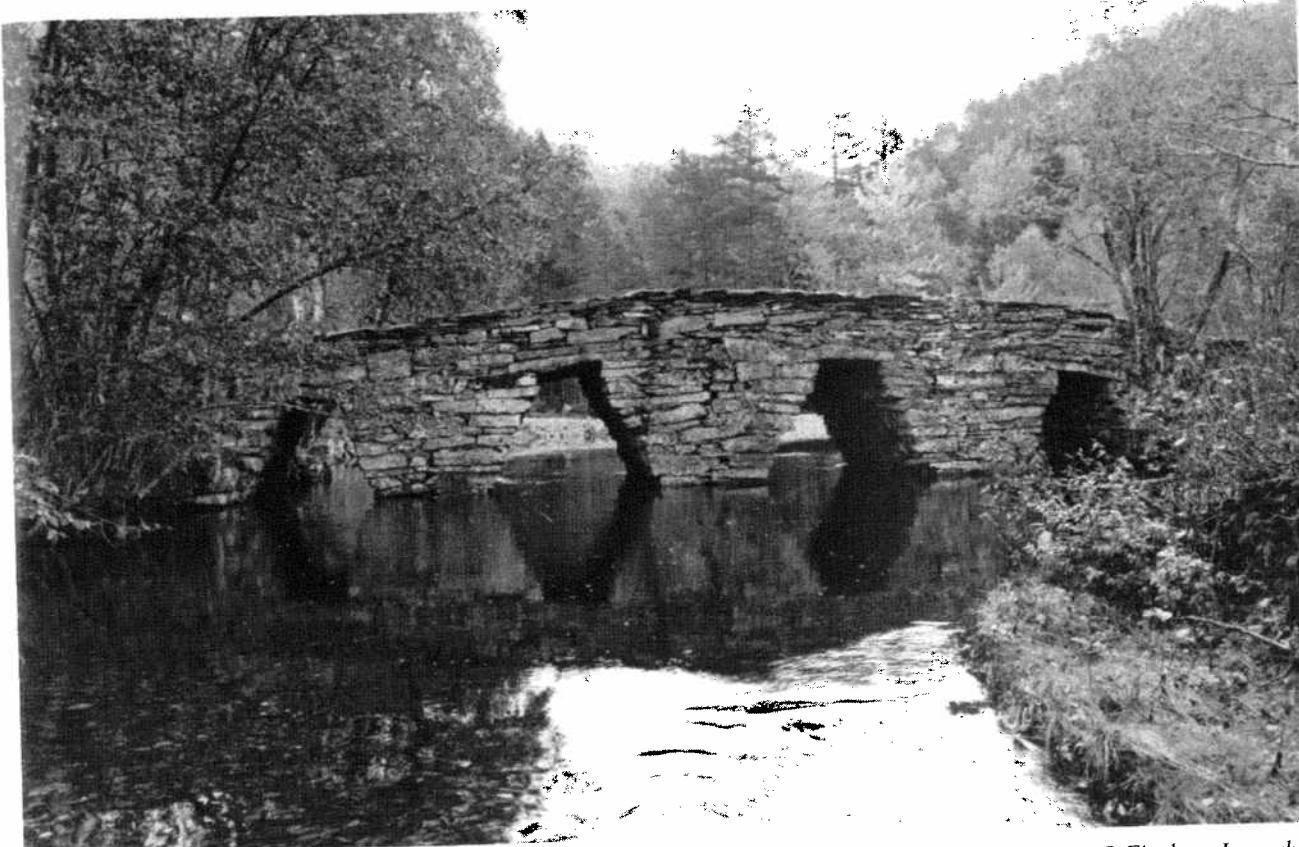
Pont de pierre à Sinderøyane, Stryn, Sogn & Fjordane. Les arches sont construites avec un encorbellement en saillie, en pierre sèche. Les ponts constituent justement une de ces catégories nombreuses de monuments techniques que l'on pourrait ajouter à la liste des bâtiments et monuments classés, si l'on veut donner une image plus complète de notre passé. Because of their size, bridges like this are unable to take modern vehicles, but light traffic and pedestrians present no problem. Once they have been repaired and consolidated, they require a minimum of maintenance and can continue to tell their story for a very long time to come, as well as being a sculptural attraction in the cultural landscape.

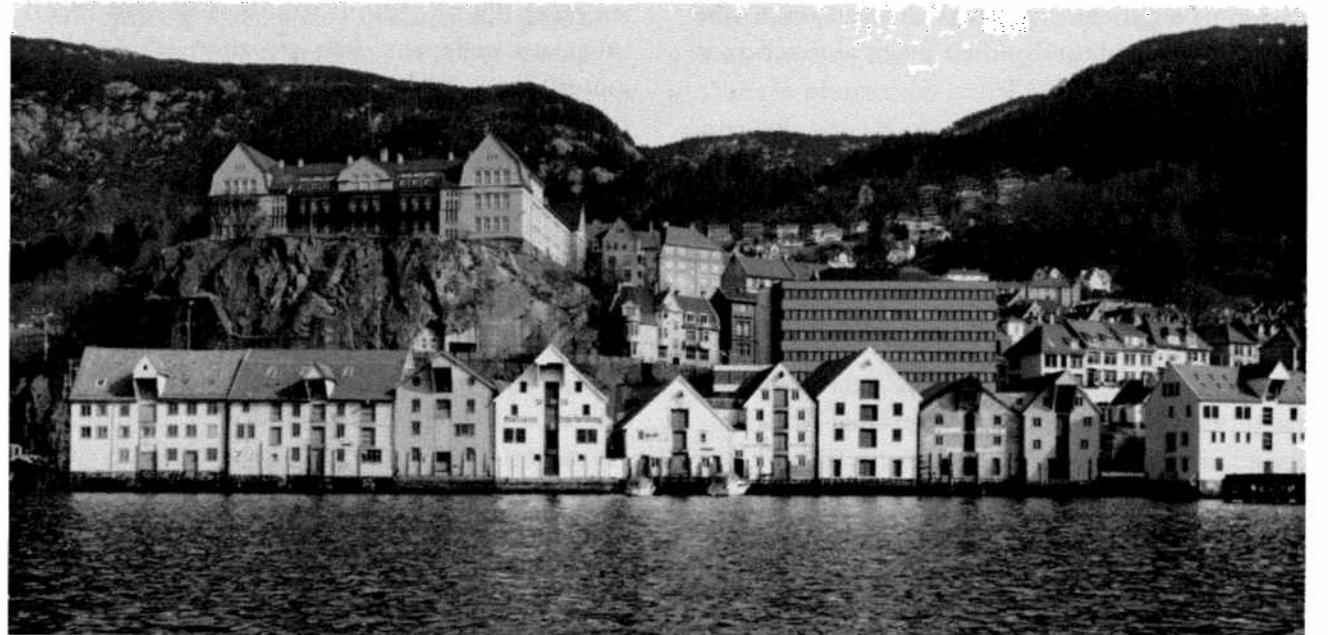
*Skuteviken in Bergen. Buildings directly associated with commerce and industry are poorly represented on the list of protected buildings. Some of the wharf-side warehouses from Skuteviken still contain much of the original seventeenth century structure, but despite their age, a protection order was not proposed until 1983.*

*This type of building is particularly vulnerable: they are now poorly suited to their original storage function because the low ceilings and relatively weak construction make the use of mechanized transport impossible. At the same time, they often occupy central sites in the port area and this is one of the reasons why so few have survived in some parts of the country. A change of use must often be accepted in order to establish an economic basis for their preservation. In a number of cases they have acquired new functions, serving now as restaurants, museums or offices (such as the warehouse on the extreme right), but this can make it difficult to retain their rugged wharfside character.*

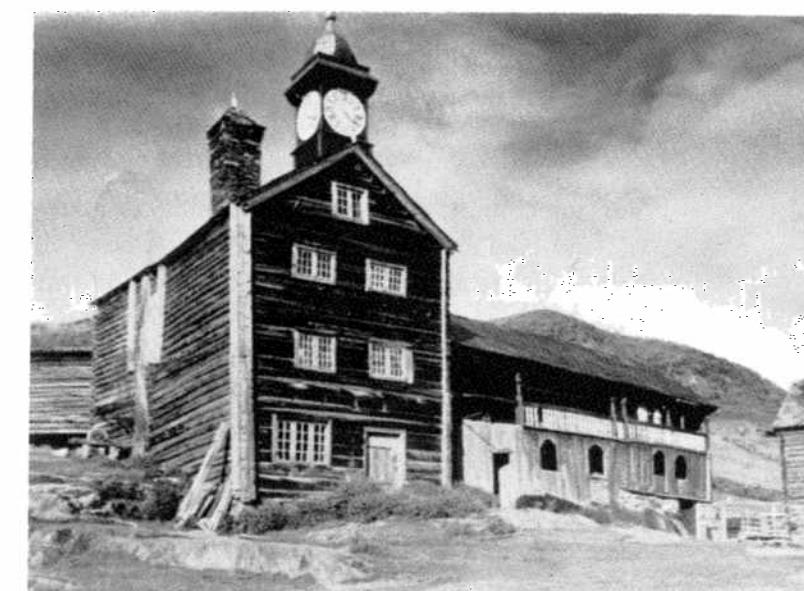
*The rural settlements in the upper part of the Gudbrandsdal valley are well represented on the list of protected buildings, thanks to the work of the early conservationists. Tofte, near Dovre in Oppland, was protected in 1923 and the order covered the entire group of farm buildings. In the early days of conservation work, this farm complex must have been an obvious candidate for selection because of its «grand and noble style», as it was described at the time. The great dimensions of the buildings and rich decoration are indicative of prosperity. Despite its size and some unusual and extravagant details, the architecture is firmly anchored in the local tradition.*

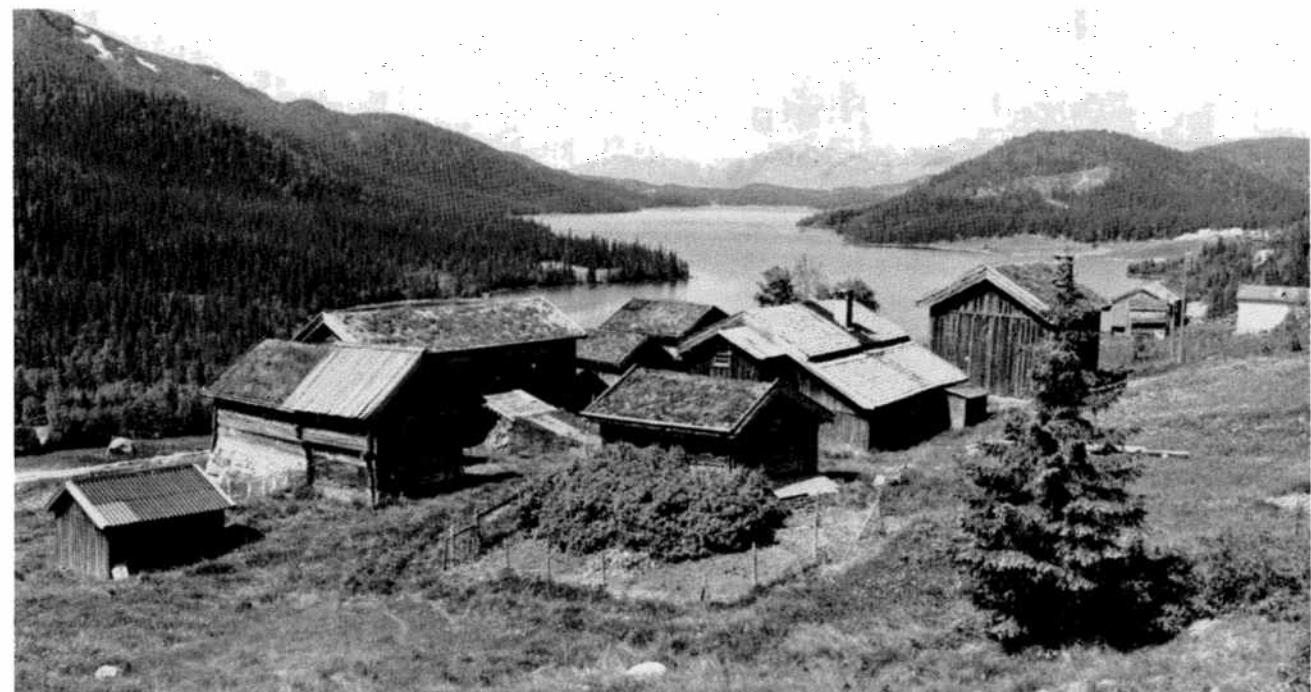
*Øygarden Søndre, Rauland, Telemark. A typical example of an early farm with many small timber buildings. It was protected in 1969. When the present owner took over the farm some years ago, the original farmhouse became the home of the retired farmer and it was therefore necessary to build a new house. If it had been attached to the small group of original buildings, it would have destroyed the form and dimensions of the settlement. It was therefore placed a short distance away, but nevertheless in close contact with the farm buildings.*
