HÅKON CHRISTIE:

## Preservation of original Structures of Urnes Stave Church. Why, and how?

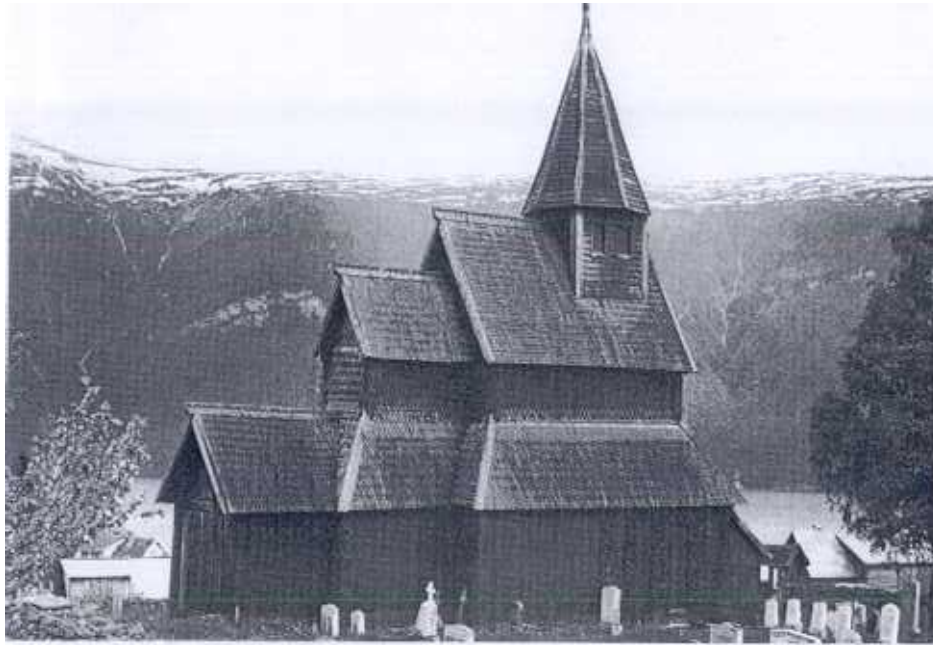
*Urnes stave church: Northside with wood-carvings from an earlier building.  
L'église d'Urnes: partie nord et sculptures provenant d'un édifice antérieur.  
Photo Rikantikvaren 1972*

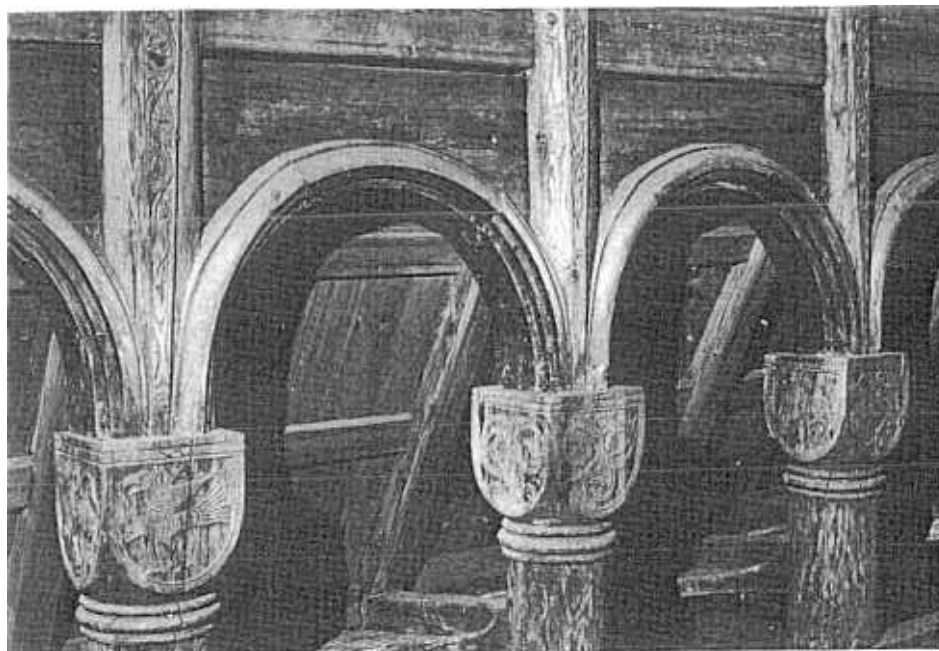
*Northside in the nave with carved capitals.  
Partie nord de la nef avec chapiteaux sculptés.  
Photo Riksantikvaren 1972.*
