PANU KAILA:

Myllymäki – a test Project of Preserving wooden Monument as Museum Object

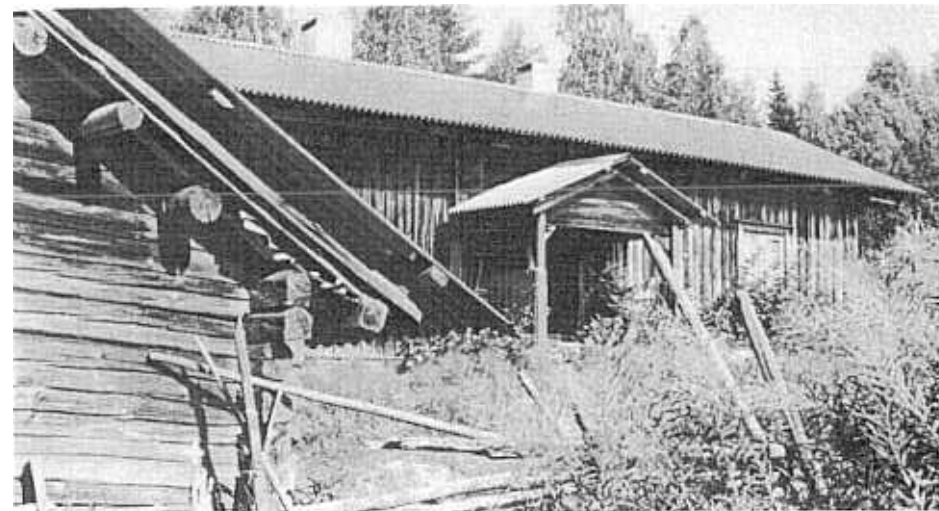
Fig. 2 The main building with its protective tin roof. The eaves might well have been longer to provide better protection against sun and rain.

La maison d'habitation avec la toiture protectrice en tôle. Celle-ci aurait pu être plus couvrante afin d'assurer une meilleure protection contre la pluie et le soleil.

The first step to protect Myllymäki's buildings was to cover them temporarily, at first just with cheap plastic wrappings and then with tin roof shelters. The new rafters of tin roof were placed on original wooden roof. A better but more expensive way would have been a separate construction supported directly from the ground, which would also allow a better ventilation and less condensation between these two roofs. Only in one structure which was quite badly damaged this kind of shed was built.

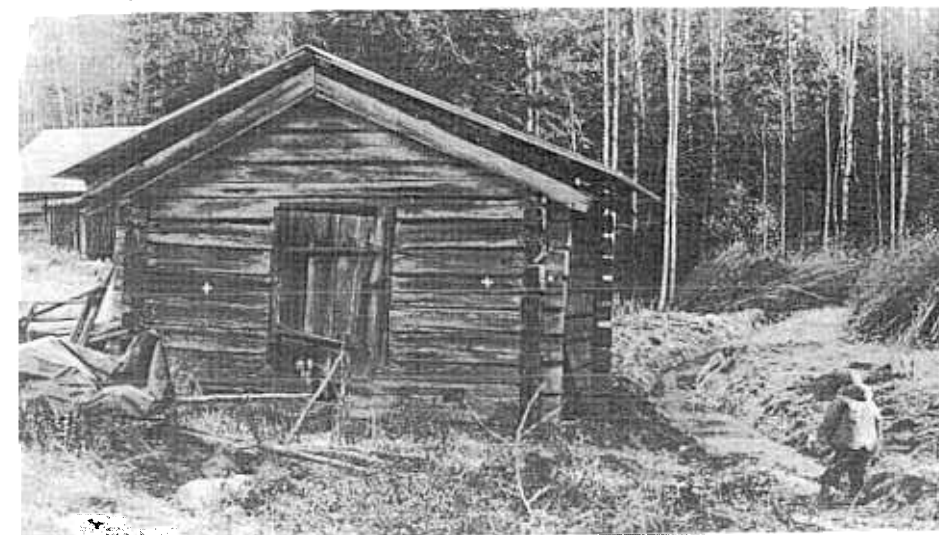
Fig. 3 This former granary (marked 1839) was standing in water every spring and autumn. Now the old ditch was opened again. The sill beams were impregnated with toxicant.

L'ancien grenier datant de 1839 a subi les inondations continuelles du printemps et de l'automne. L'ancien fossé d'irrigation est maintenant rétabli. Les parties basses ont été enduites d'un produit chimique.

When the roofs were protected, the sill beams lying on wet ground were in danger. An effective drainage will help in many cases, but sometimes it is very difficult to get the ground dry enough without extensive constructions. In two small buildings the sill beams were therefore treated with toxicants. The structures were lifted slightly from the ground. – The floors inside were carefully collected away in advance. The sill beams and 2-3 timbers above them were taken away and placed into wooden boxes of frames, to avoid damage during transportation and treatment. Then they were taken to an impregnation plant, dried naturally and vacuum-pressure treated with pentachlorophenol. After this the timbers were placed back to their original position.

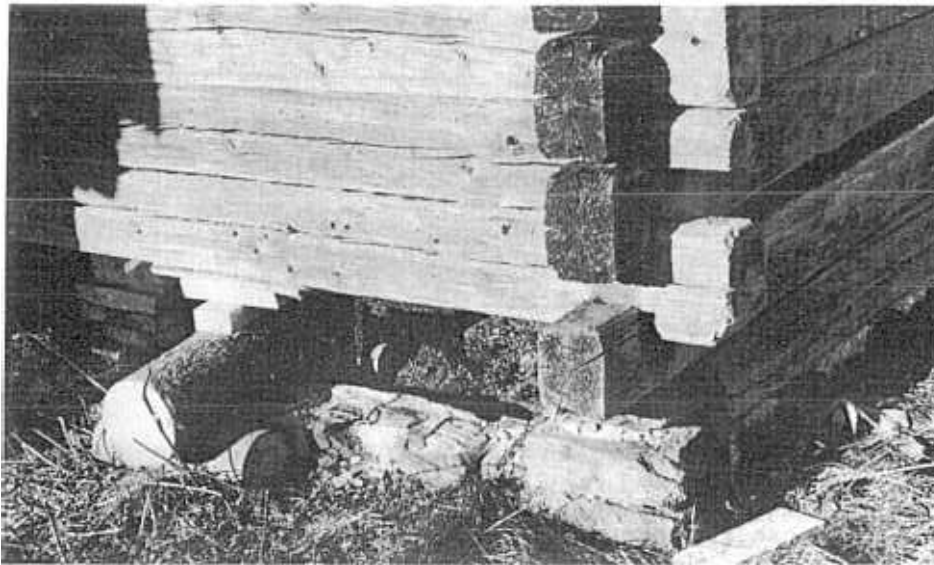
*Fig. 4 A building has been lifted up and the sill beams removed for treatment.
Un bâtiment a été soulevé et la poutre de base enlevée pour être traitée.*

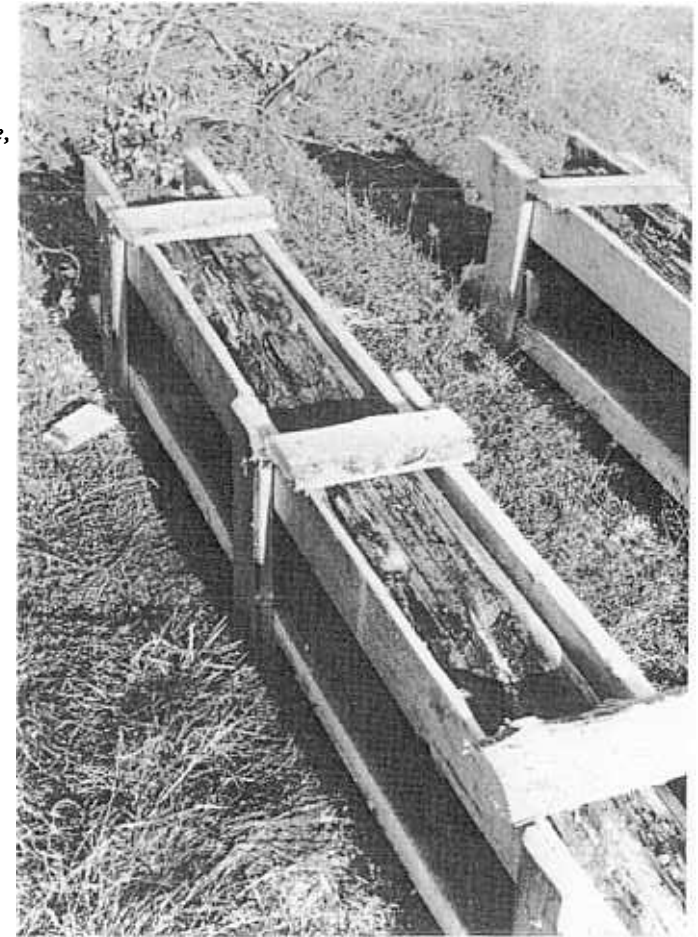
*Fig. 5 The sill beams in their boxes waiting for transportation to the impregnation plant. No reparation was made, nor lichens or moss removed.
Les poutres dans leurs caisses avant d'être transportées. Elles n'ont subi aucune réparation préalable, on n'a enlevé ni lichens ni mousse.*

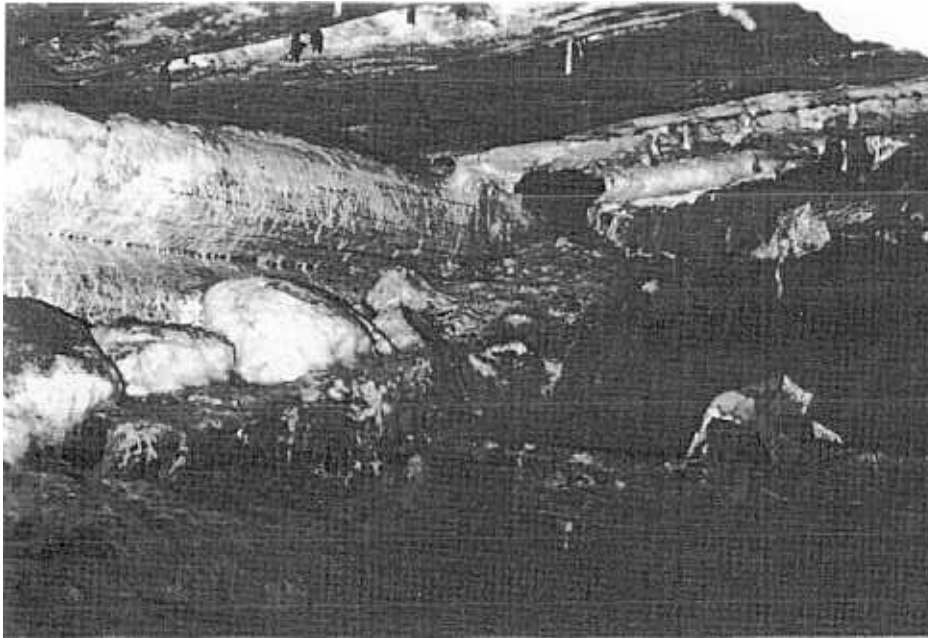
Fig. 6 The nightmare in the sub floor space. The mycelium of dry rot is covering both the wooden beams and the ground. The effort is made to eradicate it with ventilation and drainage and with some toxicants, without removing any timber.

Vue de cauchemar sous le plancher. Les champignons couvrent le sol et le bois. On a essayé d'en venir à bout par une bonne ventilation et le drainage ainsi que l'enduit de produits toxiques, sans toutefois déplacer les poutres.

In the main building we were faced with a problem: the dry rot. The farmer had closed the traditional ventilation openings in the foundation wall already many decades ago. As long as the house was heated, the warmth was leaking easily under the room through the plank floor thus keeping the ground dry. When Mykkymäki was abandoned, a very active dry rot attacked the sill beams and other timber constructions in the sub floor space. The missing gutters of the new tin roof also contributed to the high dampness of the ground.

The dry rot have been repelled by digging an effective ventilation to the sub floor space. The ground was drained by an open ditch. None of the infected timber was removed. The fungus was scratched off from the surface and the timber was then brushed with creosote oil. In couple of places the fungus was left untouched and a piece of green board was placed on it. If the fungus is not capable to go on its growth on the board, it shows that the wood is now too well ventilated for the dry rot and the situation is in control. The visible fungus was also removed from the ground where some borax was then strewn. The final success of these operations is still unknown, but with a regular follow up there is no danger of a sudden destruction.

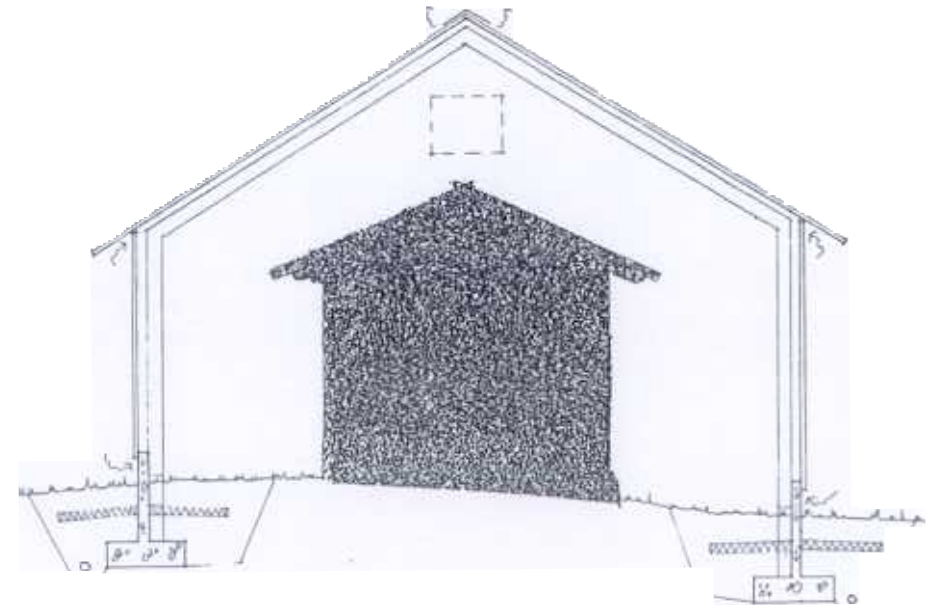
Fig. 7 A first sketch of the shelter to be built around the sauna. The ground will be provided with an effective drainage system. The walls will be made of opaque fiberglass-plastic sheets with adjustable ventilation openings.

Premier projet d'abri qui recouvrira le sauna. Le sol sera bien drainé, les murs seront de fibre de verre opaque avec des ouvertures réglables aménagées pour la ventilation.

In Myllymäki the first test building will be constructed this year to protect the sauna which stands a little aside from the other buildings. The inside climate will be controlled for several years to gain information of the effect of this closed hall, its humidity, temperature and ventilation. An open shed would be quite effective, too, but the control of ground humidity and the protection against housebreaking is better achieved by a more closed structure. Only after the results of this test project the future of the whole area will be decided.
