**CONSERVATION OF WOODEN MONUMENTS
PROCEEDINGS OF THE ICOMOS WOOD COMMITTEE
IV INTERNATIONAL SYMPOSIUM
CANADA, JUNE 1982**

**CONSERVATION OF WOODEN MONUMENTS 31 MAI 1983
PROCEEDINGS OF THE ICOMOS WOOD COMMITTEE
IV INTERNATIONAL SYMPOSIUM
CANADA, JUNE 1982**

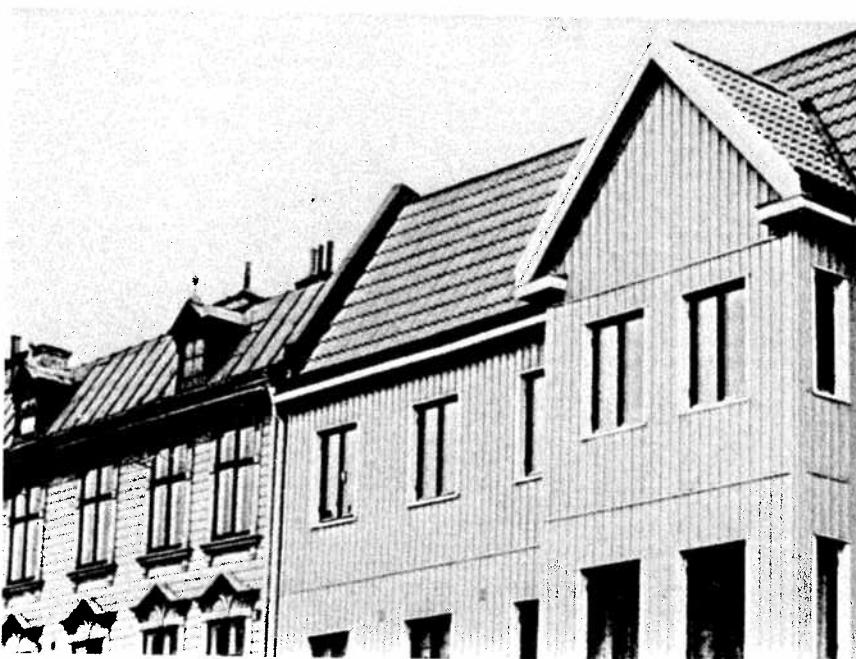
Fig. 4. New exterior insulation and new windows severely damage the building from a historical and aesthetic point of view. The two buildings in this picture originally had the same decorative elements.

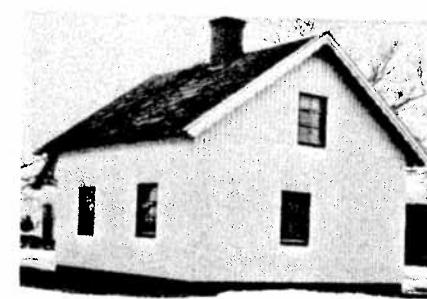
Fig. 6. After thermal insulation siding application.

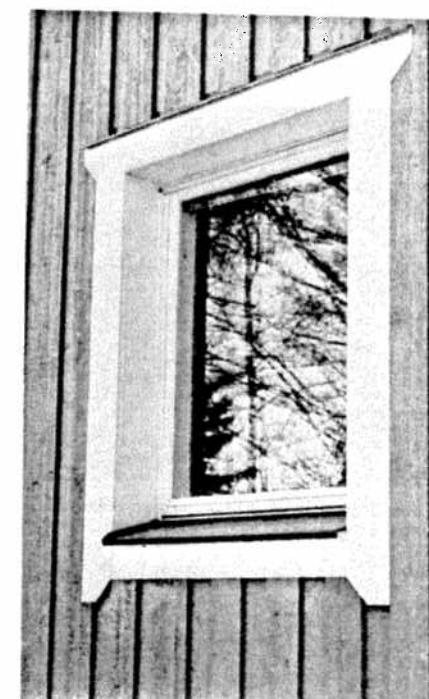
Fig. 8. After the addition of thermal insulation, new windows are recessed.

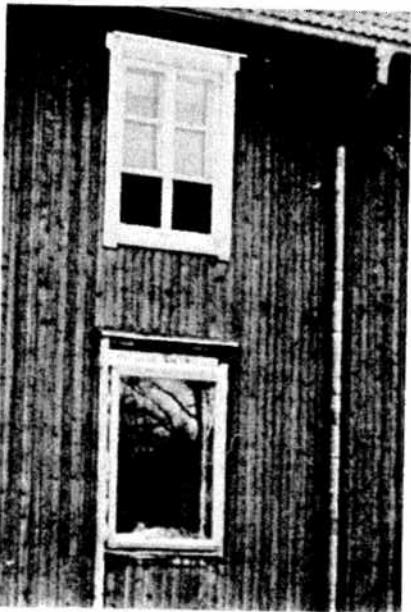
Fig. 9. Replacement windows often change the character of a building. The lower windows are newly triple glazed.

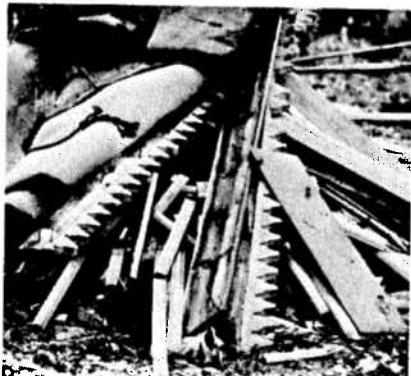
Fig. 10. While restoring the exterior of a building, old decorative details are often discarded.

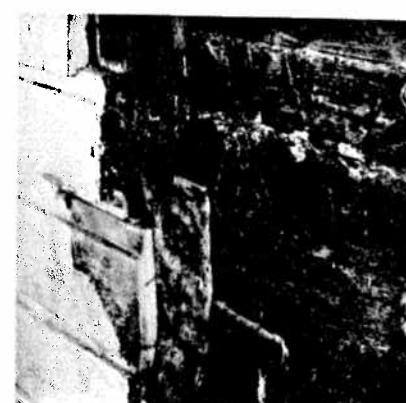
Fig. 3. A wind-proof wall from outside. The logs are well packed with oakum, with birch bark in double layers, and a tight weatherboarding overall. Degerö manor, 1818.

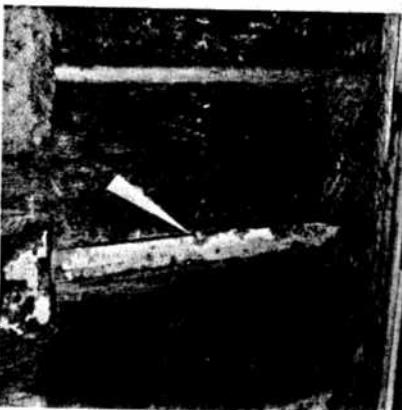
Fig. 5. The joints of logs are filled with wooden sticks. An arrow points at a wooden pin which nails the stick onto the wall. Nails made of iron were too expensive.
Kronoby parsonage, 1794.

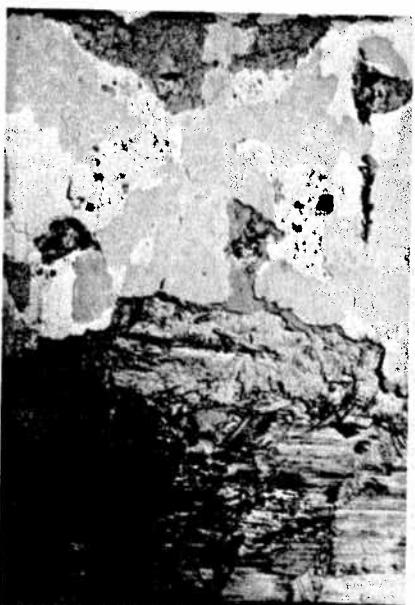
Fig. 8. It was very usual to plaster the walls inside especially in sleeping rooms to make them warmer. The plaster was generally made of earth mixed with straw like in this picture. Chaff, shives and manure were also used, and saw dust. The plaster was painted with distemper.
Bodom manor.

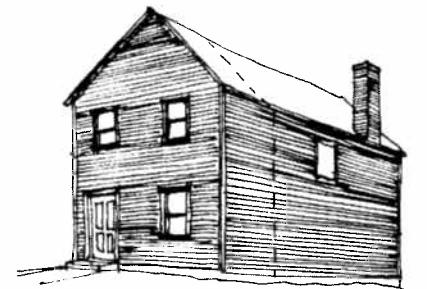
Fig. 4. A house in Halifax, N.S. which has recently been rebuilt externally, in order to remove urea formaldehyde insulation. The house was reinsulated, sheathed and clad, and extended at the same time.

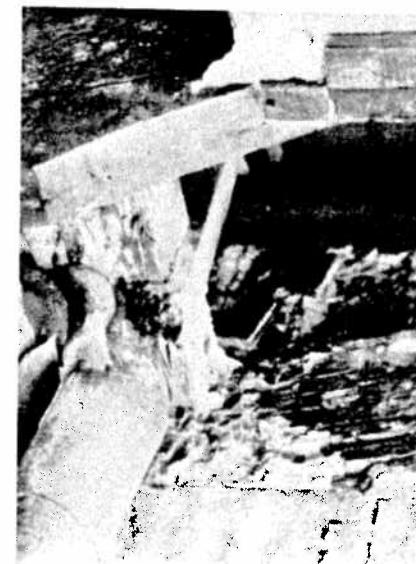
Fig. 3. Pourriture des brisis.

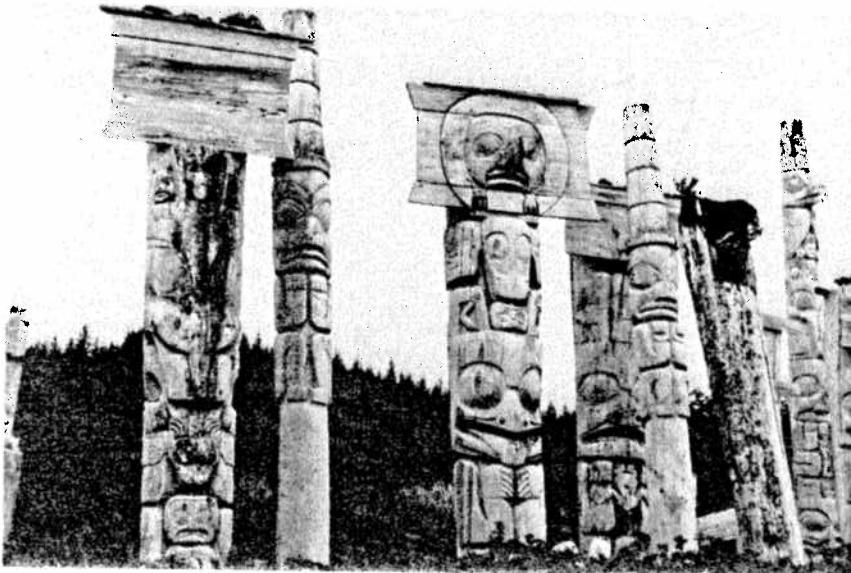
Fig. 3. Totem poles at Ninstints Village in 1901. The photo was taken several years after abandonment. Credit British Columbia Provincial Museum.

The totem poles with the cross head board are carved *mortuary poles*. The remains of the dead were placed in a burial niche behind the head board.

The two small figure poles with the potlatch hats are *memorial poles* which were erected in honour of a person who died. A large *house frontal pole* with three human figures on a bird head is shown at the far right.

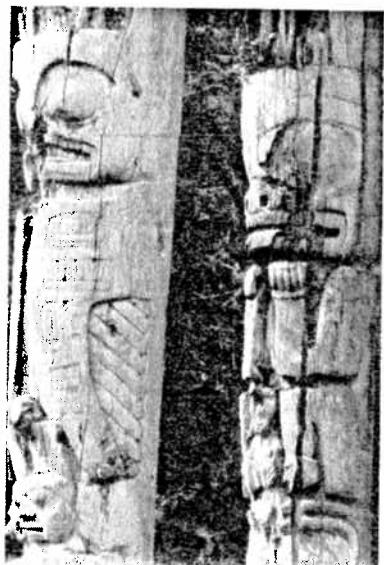
Fig. 4. Totem poles Ninstints Village 1982. Credit Vicky Husband, Victoria, B.C.

— Many of the mortuary poles are noticeably larger at the top than at the base. In this case the top of the pole is the wider base of the tree from which the pole was made.

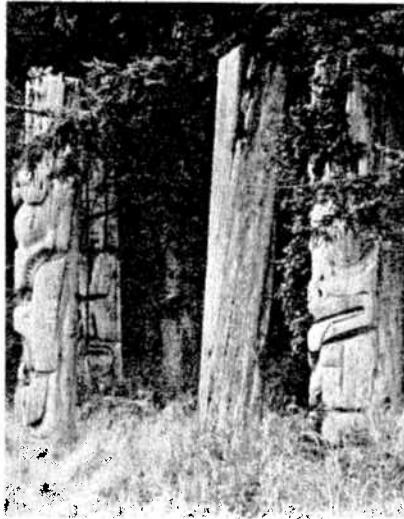
Fig. 5. In 1977 these mortuary poles are seen in a shroud of spruce foliage. Vascular plants are growing in the burial niche at the top.

— Most of the totem poles at Ninstints in 1980 were in this vegetation type of "young Sitka spruce, grass and moss". Credit Jim Haggarty, British Columbia Provincial Museum.

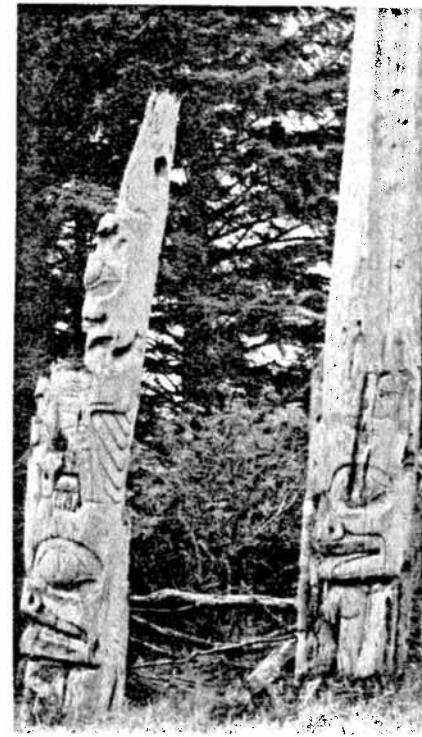
Fig. 7. Some of the poles are physically intact, others have portions split off them by the falling of spruce trees growing in the burial niche.

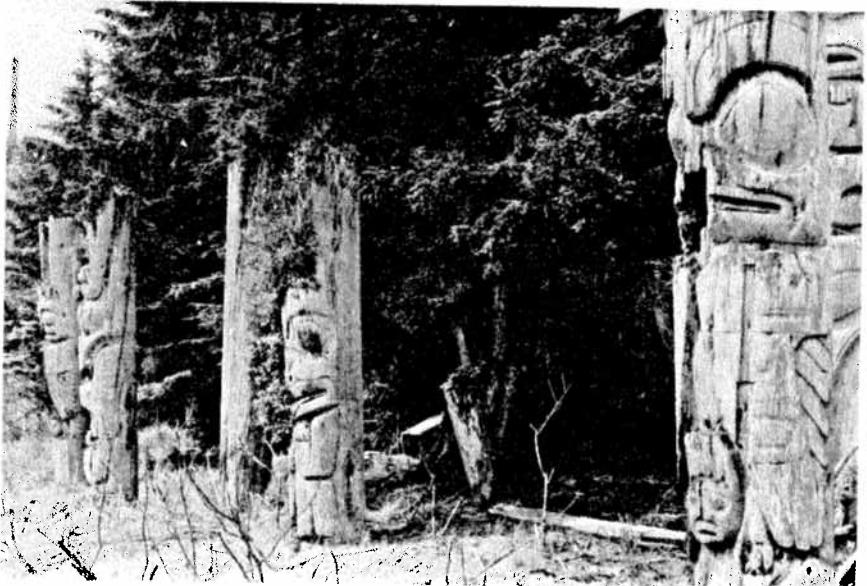
Fig. 12. Ninstints Village in 1957. Another dramatic loss of herbaceous ground cover of 1936 (Fig. 11). This could be due to fire, salt water damage or shade from the overhanging Sitka spruce trees. Credit B. Atkins, British Columbia Provincial Museum.

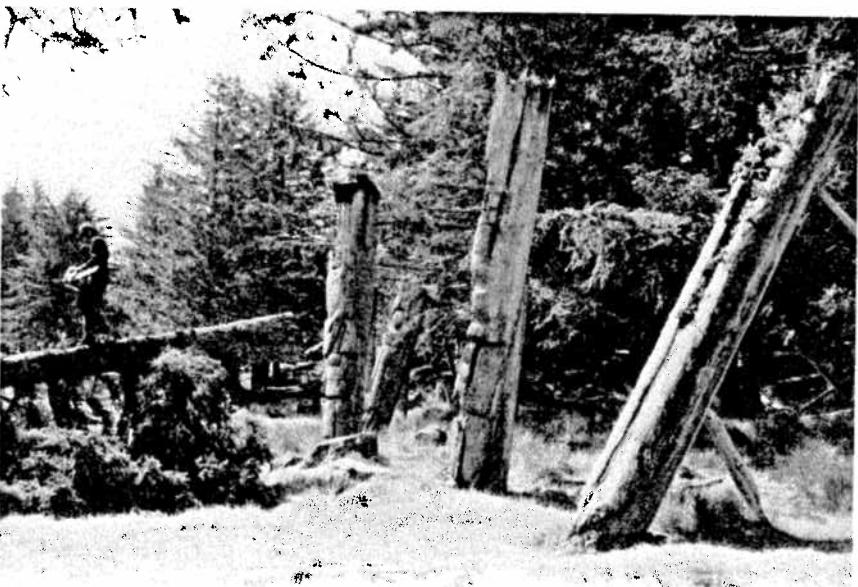
Fig. 13. Ninstints Village in 1982. Tom Greene, a Haida from Skidegate, skillfully felled eighteen large Sitka spruce trees among the cultural remains without any damage to the remains. The trees in this area were shown to be 50-56 years old. Credit Vicky Husband, Victoria, B.C.

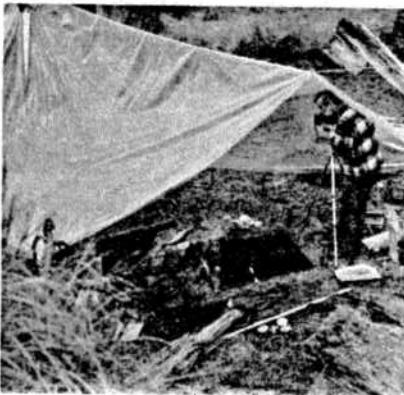
Fig. 14. The excavation of the buried base of one of the totem poles cut down and removed in 1957 was undertaken by D. Abbott (above) and R. Powell, Archaeology Division of British Columbia Provincial Museum. Credit Ruth Kirk, Tacoma, Washington.

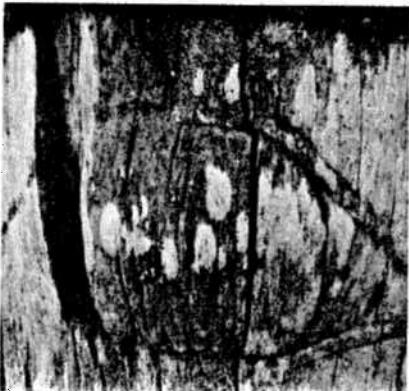
Fig. 18. The weathered surface shows variation in color. These sharply defined white spots provoked analysis (Figs. 19 and 20). Credit M.L. Florian, British Columbia Provincial Museum.

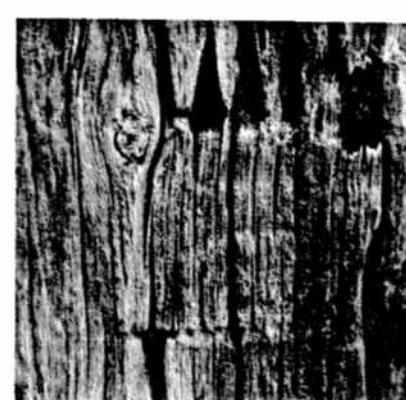
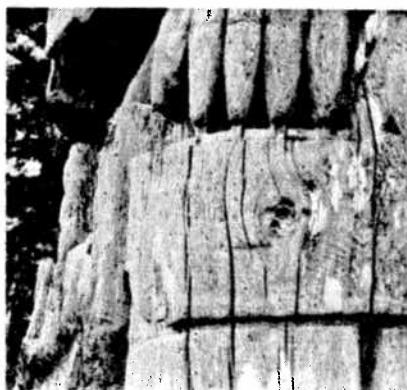
Fig. 23. See caption below.

Fig. 23 and 24. These two photographs show the same region on a totem pole but Figure 23 is taken of the southeast side of the pole and Figure 24 the northeast side. The differential weathering pattern is a result of the direction of exposure. The intense weathering is due to wind and rain direction. Credit M.L. Florian, British Columbia Provincial Museum.

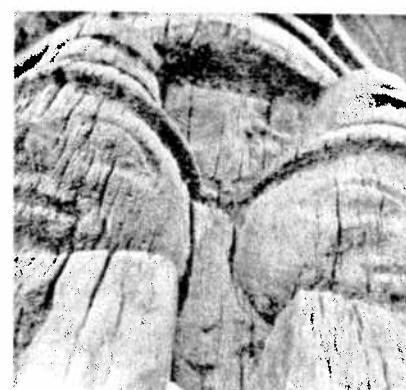
Fig. 25. A similar differential weathering pattern is apparent on a totem pole removed from Ninstints in 1957. Credit M.L. Florian, British Columbia Provincial Museum.

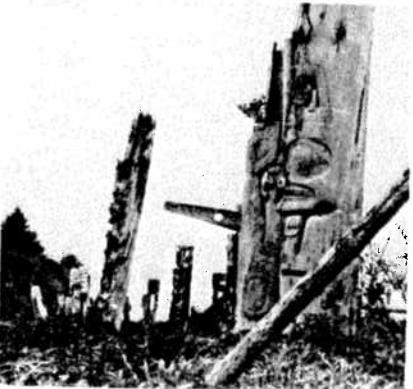
Fig. 26. This photograph taken in 1901 shows the dramatic effects of the fire of 1892 which burnt the southeast end of Ninstints Village removing a possible wind shelter and damaging many totem poles. Credit Newcombe, British Columbia Provincial Museum.

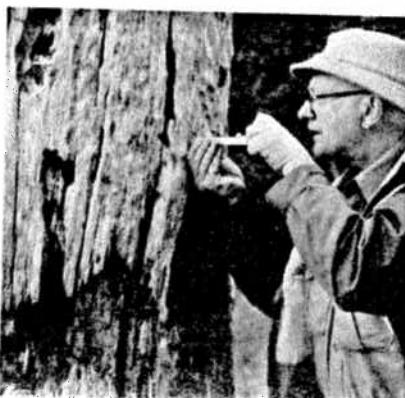
Fig. 27. Hugh V. Martin, MacMillan Bloedel Research Laboratory, Vancouver, B.C. taking depth of penetration measurements on the tangential surface of the totem pole with a spring steele vernier depth gauge. Credit Ruth Kirk, Tacoma, Washington.

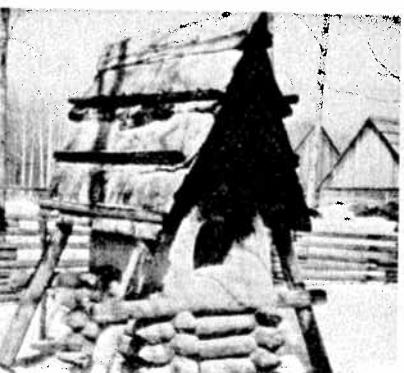
Fig. 12. Maximum use of timber Old Fort William, Ontario. (Northwest Company trading fort). Early 19th century reconstructed oven.

Wood was used to an incredible degree, particularly in remote trading posts like Old Fort William, Ontario. Figure 12 is a reconstruction; the original Old Fort William, which is

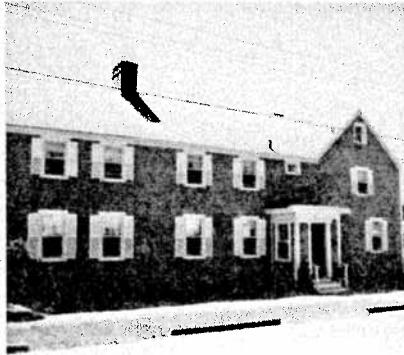
Fig. 13. English-style 18th Century century framed house developed in Maine and transferred to St. Andrews, N.B. by loyalists.

Figure 13 shows the continuance of medieval tradition surviving to the late 19th century. This is essentially an English, or maybe even a Scandinavian, frame building erected somewhere near Ottawa in about the 1880's. You see the plaster on the inside of the house and vertical board and batton on the outside, keeping the weather out.

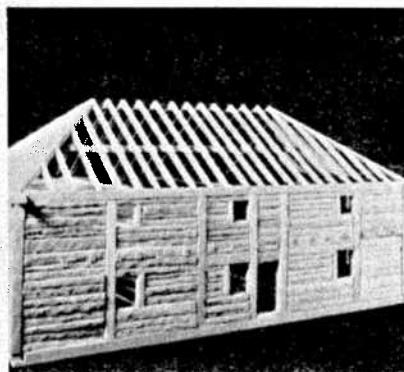
Fig. 15. Model of warehouse built of *poteaux en coulisse* also known as Red River Frame or Hudson's Bay Company Frame. Fort St. James, British Columbia.

In Figure 15, we have a rather strange type of structure: the poteaux en coulisse or Red River frame or Hudson's Bay Company frame, as it is variously known - a style of construction which can, in fact, be traced back, if you care to do the detective work, to prehistoric Poland. What the linkages are in between, I don't think any of us are really quite sure; indeed, there may not be any. This was a company style of architecture for more than 100 years. These were very substantial buildings, which could be taken apart, transported to another site and put together again. These buildings moved around a lot.

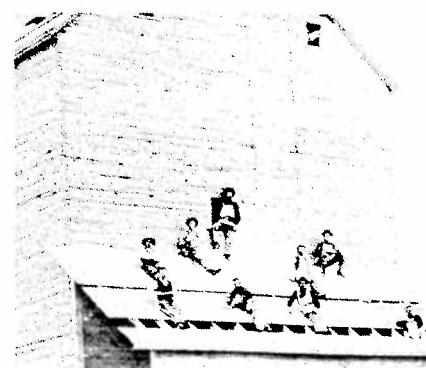
Fig. 18. Gretna, Manitoba 1881, horizontal plank or stacked plank construction.

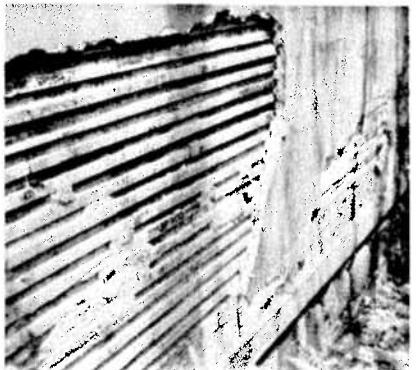
Fig. 19. Ca. 1830 southern Ontario staggered horizontal plank.

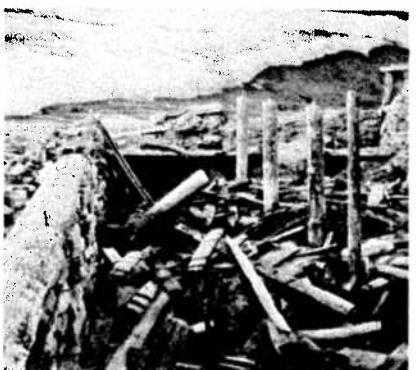
Fig. 21. Dealey Island supply cache 1853. Canadian white pine spars, masts, and white oak barrel staves.

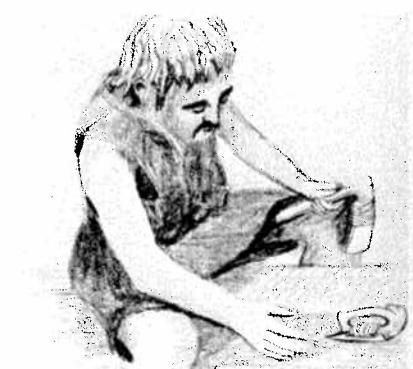
Fig. 24. Sea Shell adze.

In West Coast Indian architecture, in many cases, the timbers were split from the live trees. Great planks - huge timbers - were cut out of their parent trees with wedges. You can see the planks of split timbers on the early 19th century model in Figure 24. The finishes of these split timbers were frequently obtained by working with a small adze, traditionally made with shells or from stone and, subsequently, from copper and other metals after the period of European contact.

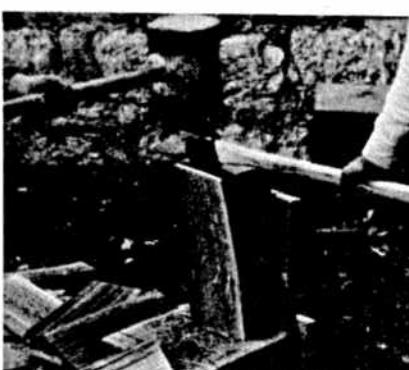
Fig. 26. Using a slitting axe or froe to split riven boards.

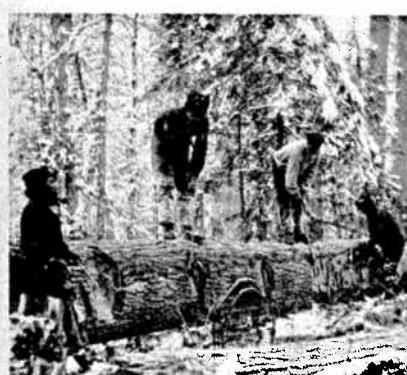
Fig. 27. Blocking, hacking and hewing, Muskoka, Ontario 1873.

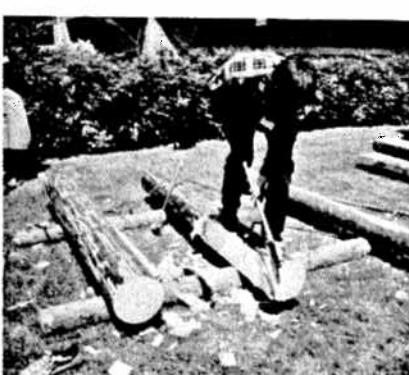
Fig. 28. Modern axe work often speeded up by a chainsaw and then finished with a broad axe.

constructions of these early timber buildings, can be seen in Figure 28. The hard work of reducing the timber to an approximately square section is done with a chainsaw, cutting at right angles to the grain, and then the final slabbing or removal of the waste wood is done with a broad axe. Then we frequently have to go back and put in some extra axe cuts, to simulate the original texture produced by the felling axes.

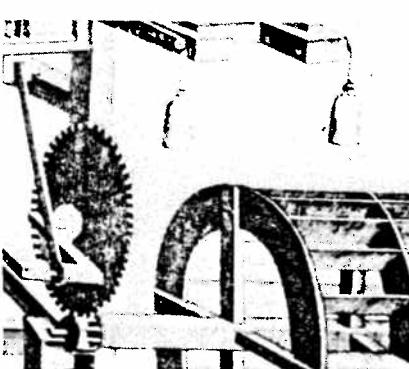
Fig. 30. John Evelyn "de Sylva" 1670 reciprocating saw mill.

Writing in England in the 17th century, John Evelyn, in his book *de Sylva* ("On Forests"), illustrated a watermill with a reciprocating saw using three blades, called a gangsaw (Fig. 30). John Evelyn recommended that this type of mill should be constructed in North America to aid in the exploitation of the forests. In Figure 31, you see a water-powered gangsaw at King's Landing in New Brunswick. Figure 32 shows the saw within the mill at King's Landing - a single, very heavy blade moving up and down in what was known as a sash frame. In Figure 33, one can see what may be a Canadian invention; it's called the muley saw. It has a very thick blade braced by two pieces of wood - one on either side - acting as two cheek-pieces to stiffen the blade. The advantage of this was that you could put very much larger tree trunks through the saw. With the sash-framed blade, the size of the frame which held the saw blade restricted the size of the log. Thus, the muley saw was an improvement; but it wasn't an improvement for very long, because, as we know from various references in England and elsewhere, the circular saw was invented somewhere towards the end of the 18th century, possibly in the 1780's.

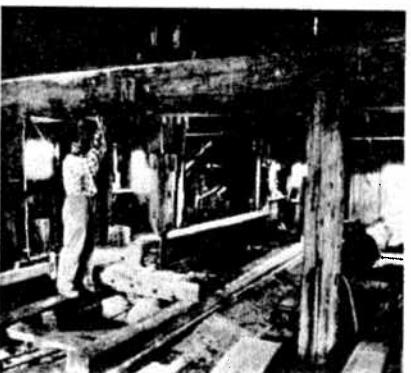
Fig. 33. King's Landing sash saw mid 19th century.

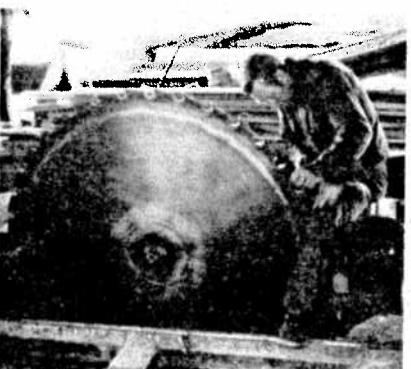
Fig. 36. Removable teeth patent circular saw. First introduction ca. 1840.

The introduction of the circular saw and the introduction of steam power were of great importance. Steam power was used not just in fixed mills, but in portable sawmills, which could be taken out into the forest or around the country. From the middle of the 19th century, portable steam engines - mobile steam sawmills - became quite common. Another very important invention of the 19th century actually dates back to about the 1840's. It is the replaceable saw tooth. The circular saw, shown in Figure 36, actually has teeth that can be removed, so that rather than the saw getting smaller in diameter every time you sharpened it, you could take the tooth out and replace it when it became blunt - an extremely important development.

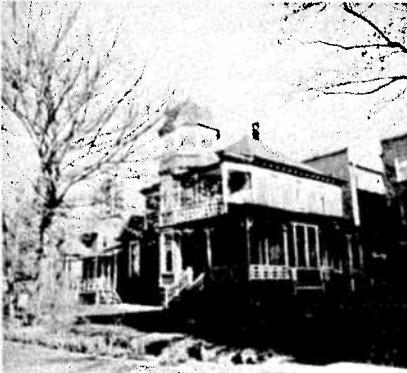
Fig. 37. Roedde House 1893, Vancouver, all elements are machine-made.

By the end of the 19th century, architectural uniformity had begun in Canada: the ethnic and regional differences were disappearing and were being replaced by structures like Vancouver House (Fig. 37) and this house in Ottawa (Fig. 39), both of which are from the 1880's and both of which are almost entirely machine-made. All of the timbers in Vancouver House have been through sawmills and planing mills. A sample taken from the boarding of Vancouver House (Fig. 38) appears to be redwood, showing signs of having been attacked by dry-wood termites - an insect which does not exist in Canada. The timber has been imported from California. This is such a strange thing that they should be importing timber to Canada; presumably, it was because the mills further to the south were operating at full production, and maybe it was cheaper to bring the material from there.

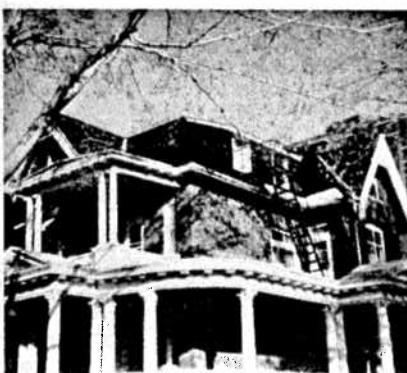
Fig. 39. Machine-made woodwork, Ottawa House late 19th century.

However, the last two illustrations (Figs. 39 and 40) demonstrate the diversity of building processes that still existed in Canada by 1880. The house in Figure 39 was constructed in Ottawa using machines. At the same time, Indians were still constructing tepees in the ancient way. The evolution process continues. The photo of the Blackfoot and his home (Fig. 40) was taken on the site of what is now Calgary.

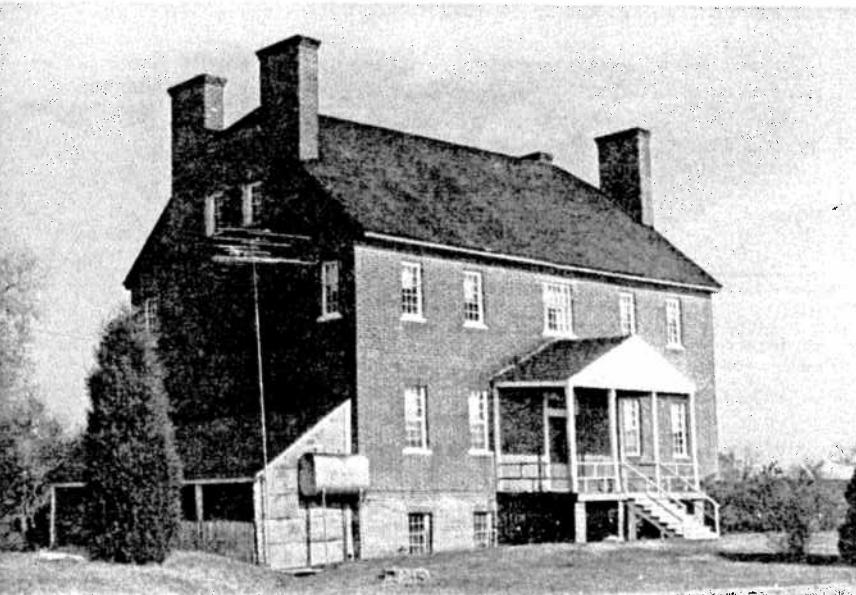
Fig. 1. (a) The present St. Francis Xavier Roman Catholic Church (SM-59), and (b) Newtown Manor House (SM-58), Newtown Neck, St. Mary's Country, Maryland. (M.R. Edwards, Maryland Historical Trust).

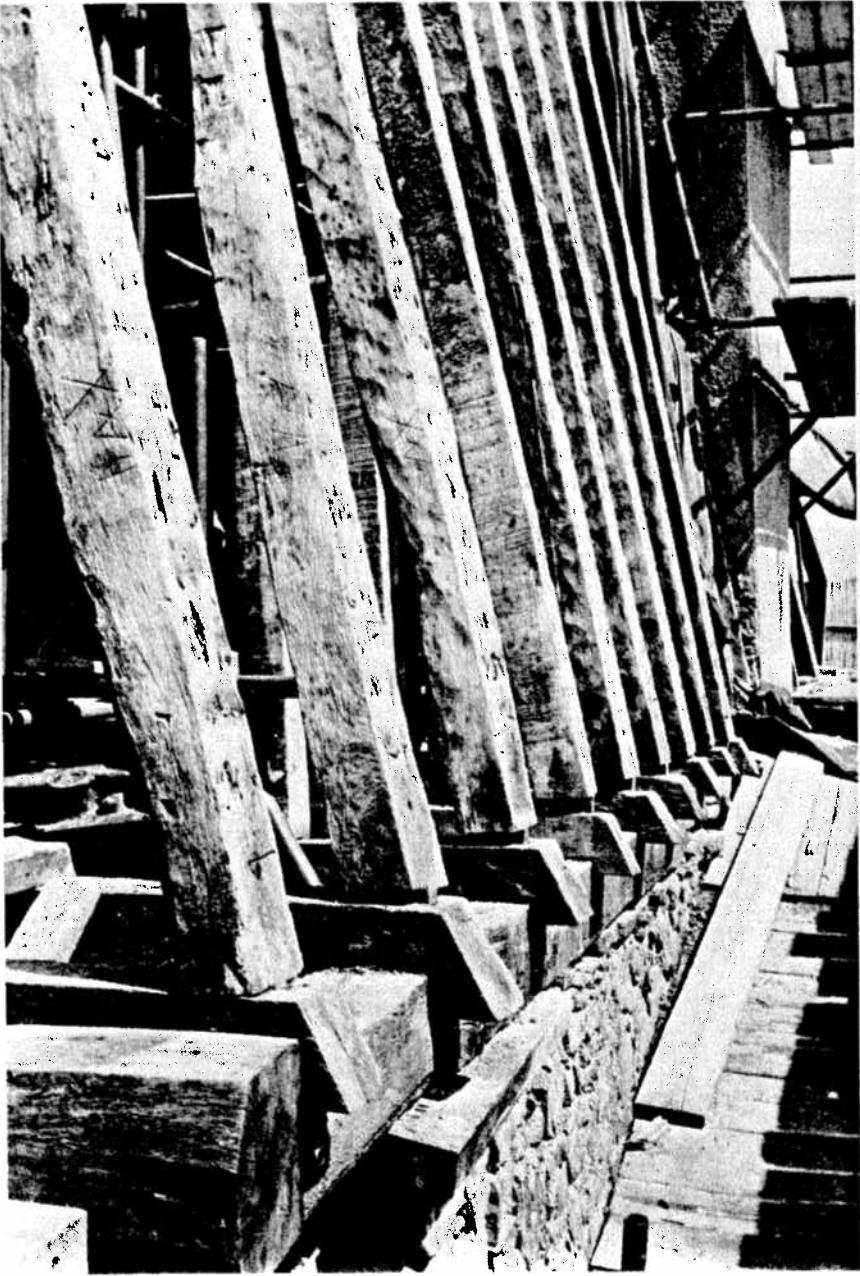
Fig. 4. La Pacaudière — le Petit Louvre, marques originelles de montage.
