Winfried Brenne

## Practical Experience with the Buildings of the Avant-garde in Berlin and East Germany

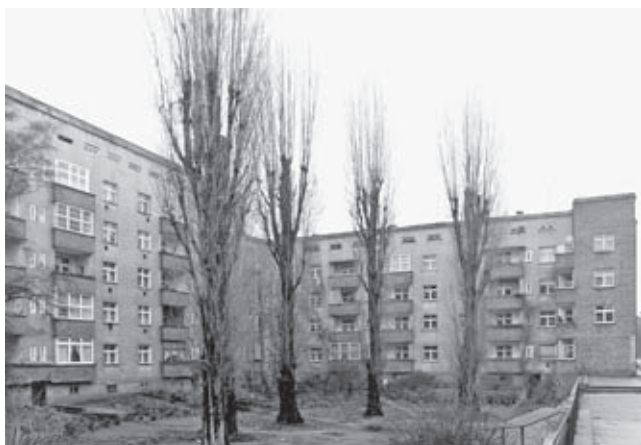
*Housing block Ernst-Fürstenberg-Strasse, courtyard, before restoration, 1997*

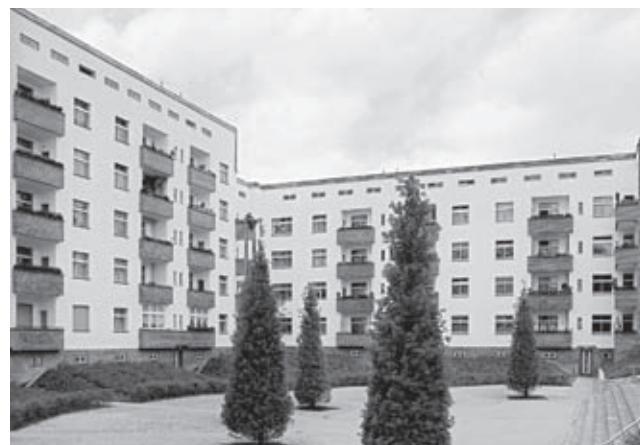
*Housing block Ernst-Fürstenberg-Strasse, courtyard, after restoration, 1998*

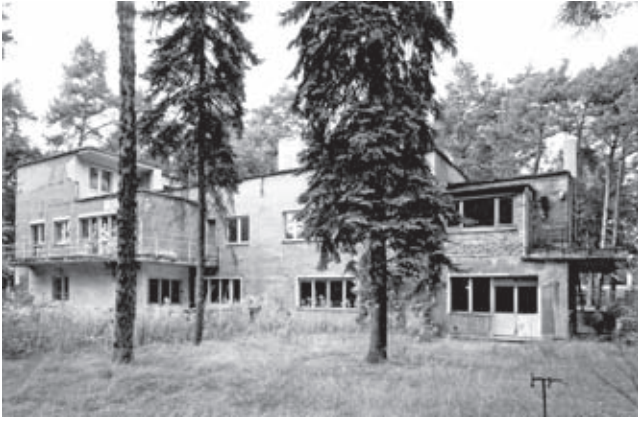
*Master House Muche/Schlemmer in Dessau, southern facade (to the garden) before restoration, 1998*

The forced closing of the Dessau Bauhaus in the year 1932 and the assumption of power by the Nazis in 1933 ultimately led to alterations of the houses with ideologically motivated defacement of its Bauhaus architecture in the year 1939 (removal of the large studio and staircase windows and of the staircase head). During the East German period, further interventions (e.g. annexes and replastering) and failure to carry out repairs led to further impacts on the appearance of the houses and to further damage. It was not until after German reunification in 1990 that work would begin on repairing the masters’ houses, including the Muche/Schlemmer house.

Although the Muche/Schlemmer house had been disfigured to the point where it could hardly be recognised, the existent fabric originated primarily from the time of the original construction. The building’s condition was entirely satisfactory from the points of view of its statics and physical structure, even though not all the values measured were in keeping with today’s standards. On the basis of the inventory, the decision was taken to make the original architecture of the Bauhaus period visible again. Accordingly, the work centred around restoration of the large glazings of the ateliers and staircases, as well as reconstruction of the staircase head of the Muche house, which had been carted away. With reconstruction of this staircase head, restoration of the cubature with its details was much less of a problem than walling in a suitable material with the physical constructive properties of the existent masonry.

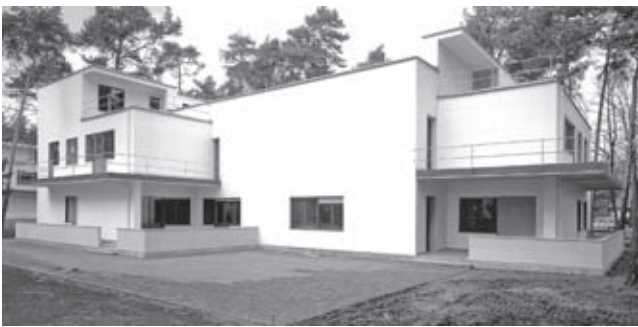
*Master House Muche/Schlemmer in Dessau, southern facade (to the garden) after restoration, 2002*

Restorations of the condition at the time of the original construction were also made possible by the findings of colours and materials of the surfaces of facades, walls and various fittings so that – at least in some areas – it

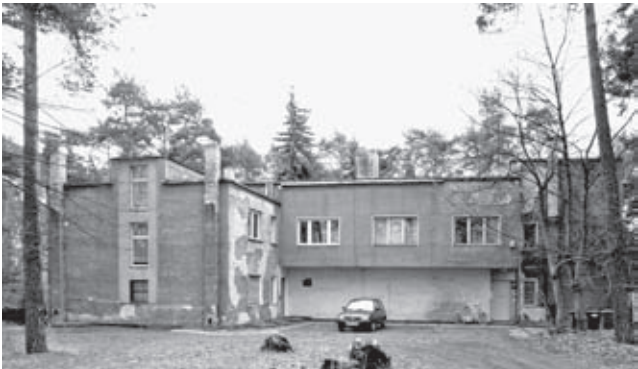
*Master House Muche/Schlemmer in Dessau, northern facade after restoration, 1998*

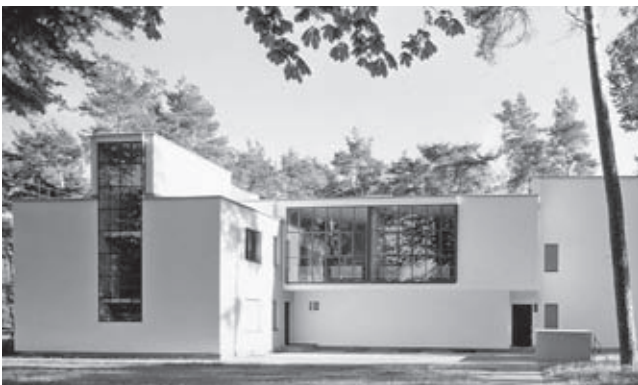
*Master House Muche/Schlemmer in Dessau, northern facade after restoration, 2002*

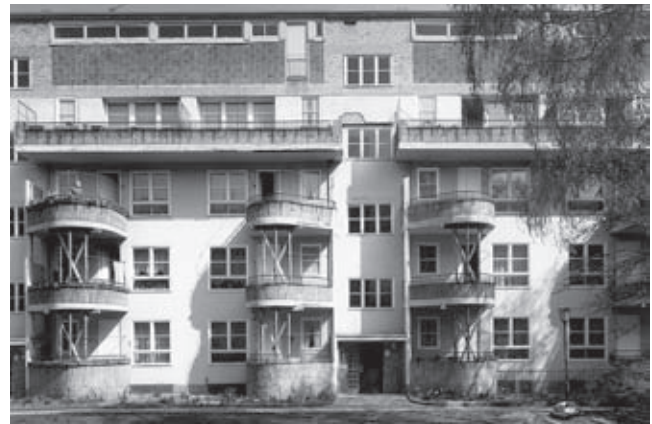
In the Großsiedlung Siemensstadt<sup>3</sup> erected between 1929 and 1931, the balconies, because of their swinging form, were an indispensable design element for the exterior effect of the facades, especially because they were done by Hugo Häring, but unfortunately they had serious structural damage, most of which had been caused by corrosion. Häring selected a steel construction for the

*Siemensstadt. Row houses by Hugo Häring. Balconies before restoration*

balconies which, in accordance with the swinging form, consisted of curved edge supports of steel; in addition, the balcony roofs were steel stone roofs and a 10cm steel pipe bore the load. Examination of the buildings showed that when they were erected there was an error of execution relative to the plans in connection with the steel pipe. Over the years, this error had led to formation of corrosion of all the constructive steel parts because of accumulation of dampness and a lack of ventilation. This ultimately busted the parapets and thus had devastating consequences for the entire structural safety of the balconies.

The renovation concept of the housing company originally foresaw a “modern” solution with new balconies of prefabricated concrete parts. Not until the comprehensive inventory, which exposed the causes of the damages, was available, was it possible to convince this company that it would be better to retain the existent balconies, with work

carried out by craftsmen familiar with the requirements of historic architecture.

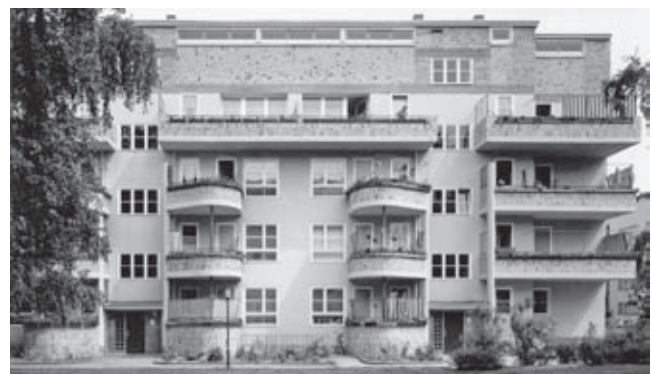
*Siemensstadt. Row houses by Hugo Häring. Restored facade with balconies, 2005*

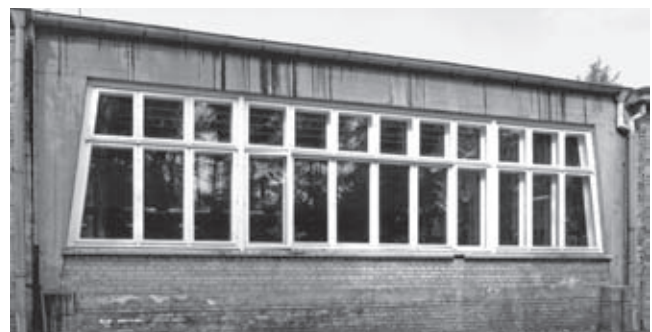
*Former school of the German Trade Union (ADGB) in Bernau near Berlin, window of the refectory before reconstruction, 2001*

A clear example of the topic of windows is given by the restored steel windows of the former School of the German Federal Trades Union (ADGB) in Bernau, which was erected in 1928–1930 in accordance with plans by Hannes Meyer. The architecture of this school lives from its steel windows with their filigree profile thicknesses. Unfortunately, at a later time these windows were replaced by clumsy wooden windows which at the time of restoration were falling apart and had to be replaced by new windows. Profiles from Switzerland of milled, bent steel were taken to produce steel windows that were largely true to the original, with the profile thicknesses also being approximately those of the originals. At the same time, insulation glass panes (in contrast to the simple glazing of the originals) were installed to achieve approximate fulfilment of today's requirements for thermal protection. Scarcely visible ventilation slits underneath each window's metal plates are another contemporary ingredient introduced for physical reasons (fresh air ventilation during the night). When the work is over, the school will once again be equipped with steel windows throughout.

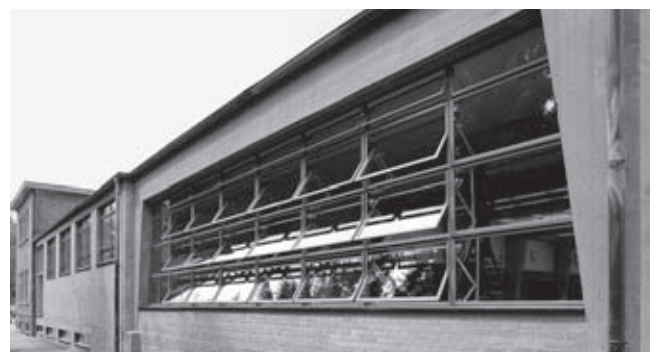
*Former school of the German Trade Union (ADGB) in Bernau near Berlin, window of the refectory after reconstruction 2006*

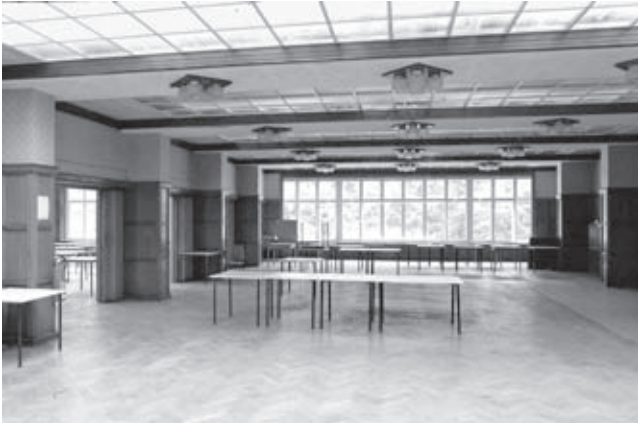
*Former school of the German Trade Union (ADGB) in Bernau near Berlin, refectory before the reconstruction, 1998*

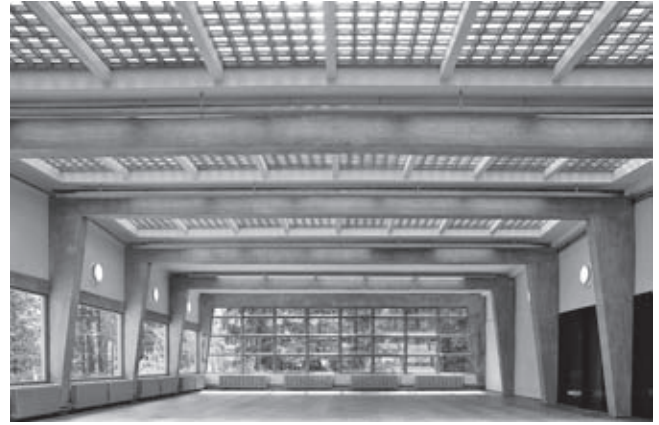
*Former school of the German Trade Union (ADGB) in Bernau near Berlin, refectory after the restoration in 2006*
