R. SENGUPTA
 CONSERVATION IN INDIA - SOME TYPICAL CASES

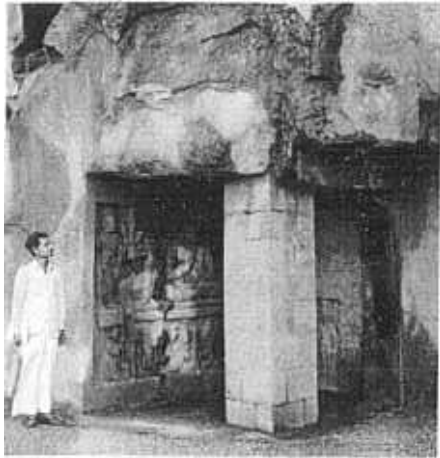
Pl. 4 - Ellora. Masonry pillar supporting the cracked roof of the cell in front of shrine 3.

front of shrine 3 at Ellora. The roof was supported with an «L» shaped R.C.C. beam concealed in the ceiling with supports in the right and back walls in place of an ashlar masonry support that was obstructing the view of the sculptures on the walls. The crack at the top was completely sealed off through the insertion of iron clamps and grouting with cement mortar.

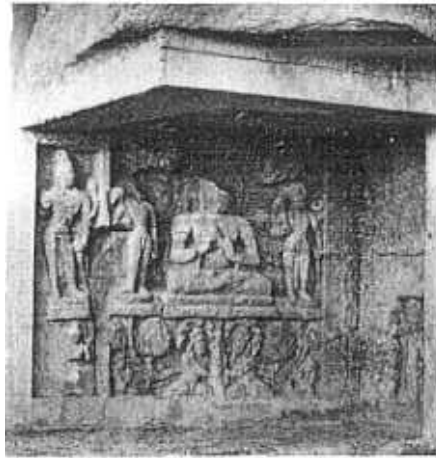
Pl. 5 - Ellora. The cell after introduction of R.C.C. beam to support the roof and removal of the pillar.
