R. GILYARD-BEER
PROBLEMS CONNECTED WITH THE PRESERVATION
AND DISPLAY OF A MEDIEVAL PAVEMENT IN NORFOLK

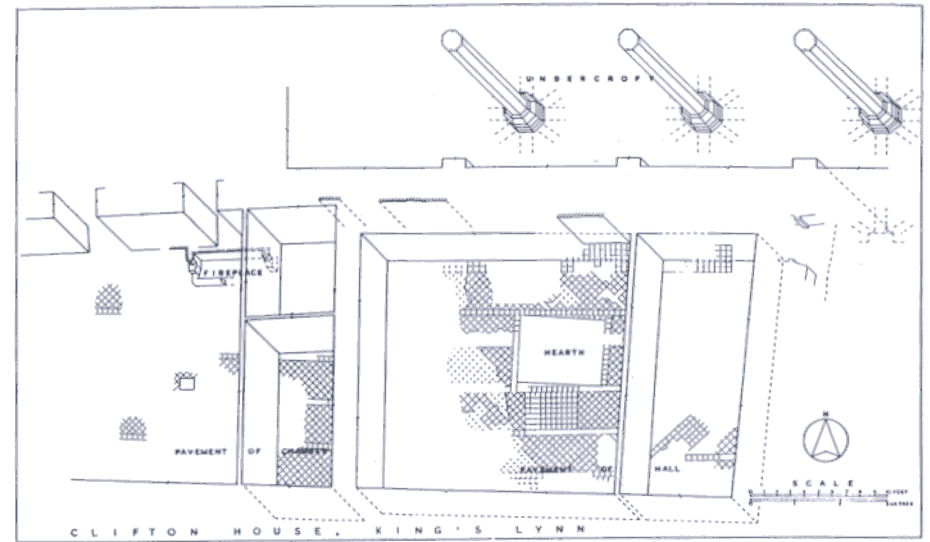
Fig. 1 - Plan of Clifton House, King's Lynn; showing relationship of 14th century pavements to overlying building.

Briefly, these further excavations revealed that the present Clifton House had been built over the remains of a fourteenth-century house consisting of a ground floor hall with open hearth, lying parallel to Queen Street and extending southwards beneath the garden of Clifton House, with a substantial ground floor chamber to the west and the surviving undercroft to the north, now recognisable as the typical basement of a first floor chamber beyond the high end of the hall. Although robbed and mutilated in places by later reconstructions of Clifton House, the north end of the hall and the whole of the western chamber retained substantial areas of their original earthenware tiled pavements in a condition which clearly showed that they had suffered no significant modifications since the buildings to which they belonged were demolished in the later Middle Ages, even to the extent of retaining traces of the soot from the last fires to burn on the open hearth in the hall.

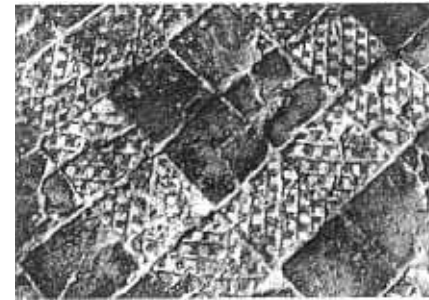
Fig. 2 - Area of relatively well-preserved tiles after treatment.

Whilst many of the tiles were in good condition, many had also been broken by constant wear, some to the extent that in an individual tile, whilst retaining its pattern and shape, might consist of forty or fifty minute fragments. Added to this, the mortar bed on which the tiles were set had long since lost its capacity to hold them in position and they had been kept in place for the last five centuries by the earth and debris now excavated from above them. Delicate excavation of the gaps in the pavements also revealed evidence of the indents made by the missing tiles on the mortar bed, the condition of which

In the areas where tiles still existed, their upper surface was cleaned of dust and they were also delimited into compartments of convenient size by hardboard shuttering. The outer edge of the shuttering was placed flush with the edges of the groups of tiles so that when it was finally removed about 1/2 in. of the edge of the tiles would remain visible. When the upper surface of the tiles had been gently dried by electric heaters, a liberal coating of a proprietary soluble adhesive was applied to these surfaces and stout lining paper was pasted over this. The moulds formed by the hardboard shuttering were then filled with a wet solution of dental plaster reinforced with woven scrim soaked in plaster.

When the plaster had set, levels related to the datum lines were marked on its upper surface in the same way as they had been marked on the casts of the indents. Each compartment of tiles was then freed from its original perished mortar bed by inserting beneath it a specially prepared tool with a long thin blade. During this operation the adhesive and the lining paper kept the tiles firmly knit in position, and the rigidity of the plaster enabled each compartment to be lifted with ease and safety. As each set of tiles was lifted, it was turned upside down and the under surface of the tiles was cleaned and then covered by a three-quarter inch bed of *ciment fondu* reinforced with 1/2 in. mesh galvanised wire.

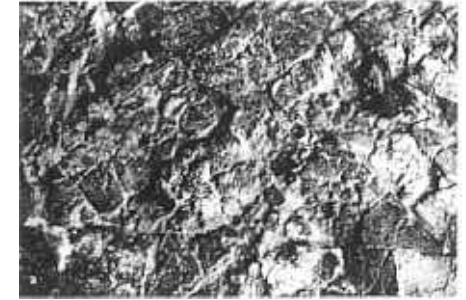
Fig. 3 - Area of badly fractured tiles after treatment.

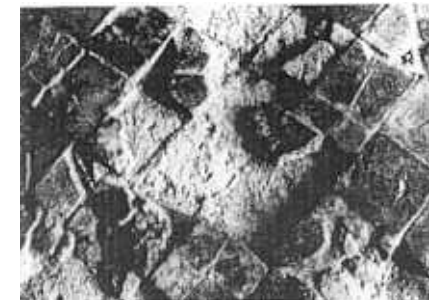
Fig. 4 - Indents of missing tiles on mortar bed, after treatment.

was so friable that this evidence — which enabled the pattern of the complete pavement to be worked out and appreciated — could not be expected to survive exposure for long. The main problems of preservation were therefore the renewal of the perished mortar bed without disturbing the tiles, and the perpetuation of the indents on that same perished bed. These problems were solved in the following ways.

In the areas where tiles were missing, the original mortar bed was cleaned of residual dust from the excavation by means of a vacuum cleaner, and a light coating of shutter oil was applied to the indents with a soft brush. Areas of convenient size on the bed were then enclosed by hardboard shuttering and casts of the indents were made in dental plaster, the upper surface of each cast being marked at three points with levels taken from the datum lines. After a period of 12 hours for initial drying, the casts were lifted and their under-sides were cleaned. They were then stacked in a warm atmosphere to take their final set.

In this finishing bed the tiles themselves were finally reset, the level and position of each compartment being checked by the datum lines. As noted above, the edges of the tiles in each compartment projected slightly beyond their plaster backing, which allowed their position in relation to the adjoining compartments to be checked visually. The lime mortar raft was extended over the areas of missing tiles, and the casts of the indents were coated with shutter oil

and impressed on the surface of the raft, the level of the back of each cast being checked from the datum.

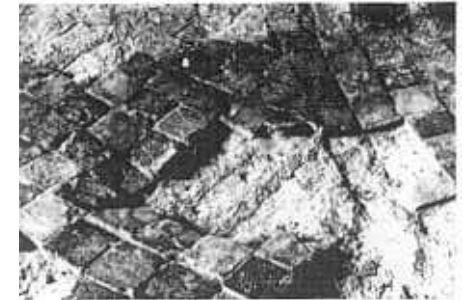
Fig. 5 - Variation in levels of tiles preserved in final treatment.

After the pavements had been photographed and detailed plans of them had been made, datum lines were established on the walls of the rooms and the levels of the surface of the pavements were related to them.
