## POLAR HERITAGE

### **'Haudegen' – A German Marine Weather Station in Svalbard – slowly decaying!**

### **Climate change in the western Canadian Arctic threatens cultural resources**

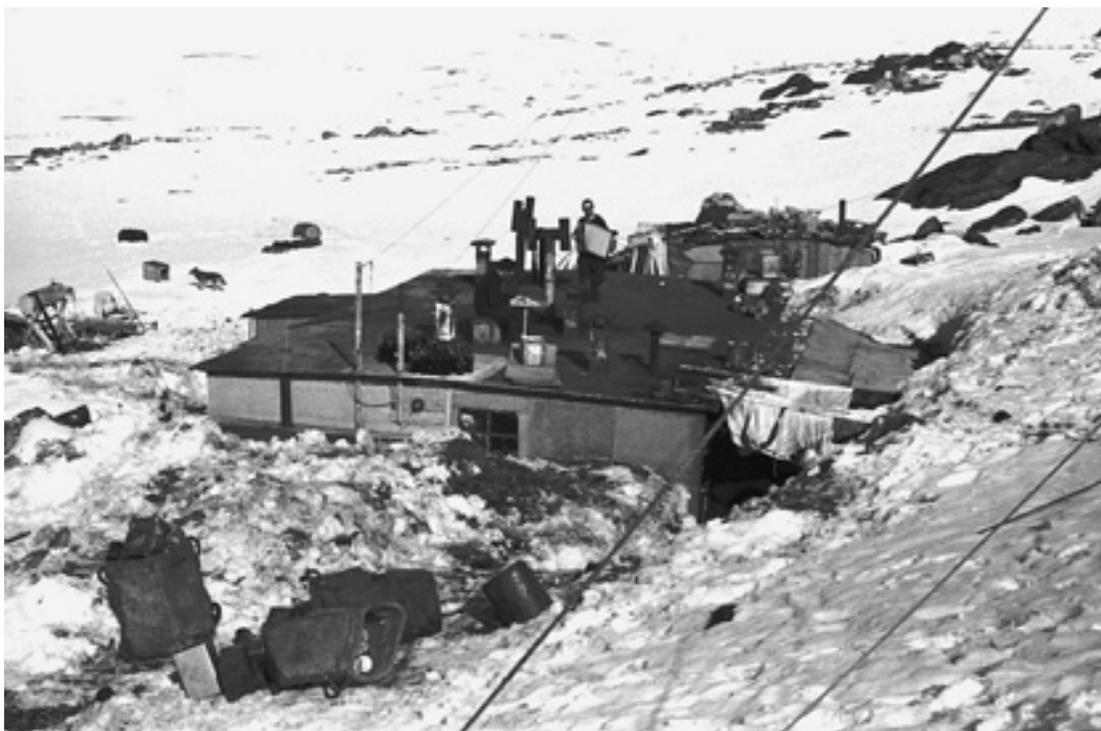
'Haudegen' Station in Nordaustlandet (Svalbard), spring 1945 (photo in possession of E. Dege, Kiel)

Station 'Haudegen' at Wordiebukta (Wordie Bay) in Rijpfjord on Nordaustlandet, Svalbard operated from 1944 to 1945 and is the only German station that was not destroyed after its detection. The base hut was erected 150 m from the shore on the western foothill of Lookout Rock, using six prefabricated walls and trusses in a pattern of cubes 3 m x 3 m x 2.2 m. The hut was also given a double thickness of walls, floor and roof covered with a tarpaulin.

The completed hut measured 6 m x 9 m, and consisted of the team leader's room, a dormitory with seven beds, a mess-hall, kitchen, battery-charging room, wireless room with three beds, workshop, porch and toilet, store for coal and wood, and outer porch. Solid boxes were used to make a table and benches in the mess hall, and they also served as shelves for a library of about 200 books and for various supplies. The hut was surrounded by a walkway, which was built of stacked provision cases covered by

canvas. With this insulation the hut was strengthened against being blown away during heavy westerly winter storms. Camouflage netting was draped over the entire building and the nearby weather screen. During winter the snow cover totally concealed the station within the landscape.

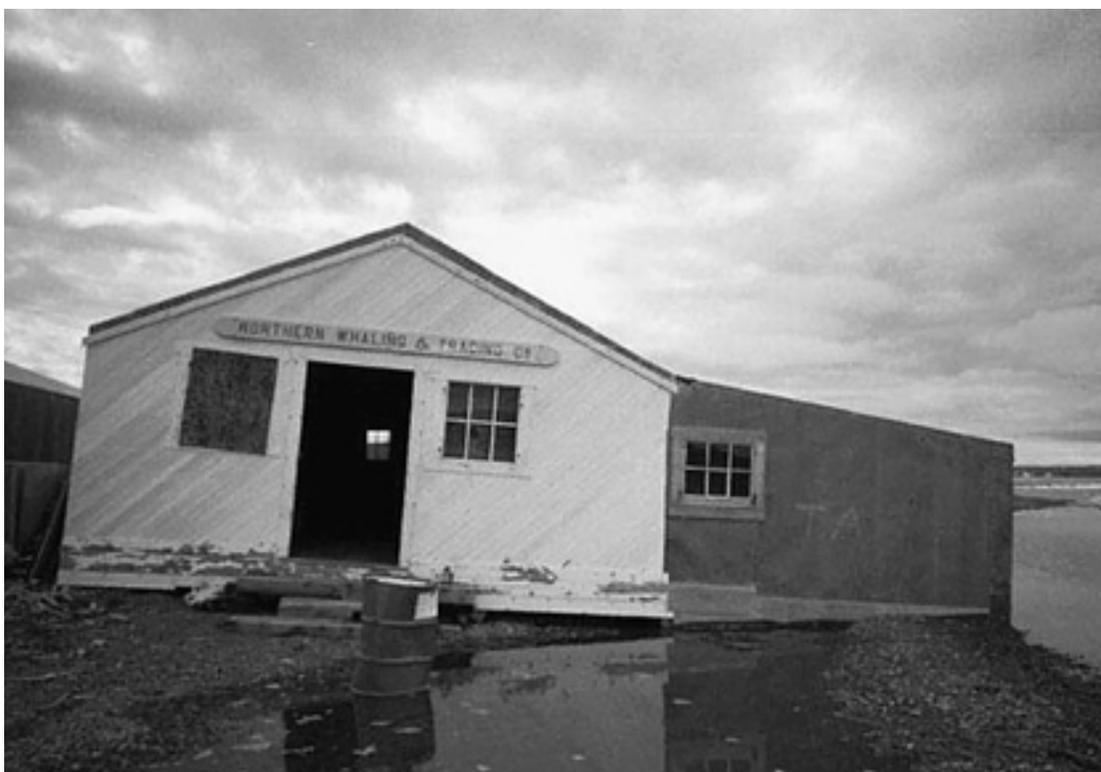
Northern Whaling and Trading Company Store, Pauline Cove, Western Canada Arctic, prior to dismantling of shed addition in 2000

Violent late summer and autumn storms have endangered a number of structures from the historic settlement, along the spit of Pauline Cove. Sea ice has been driven up against the Northern Whaling and Trading Company Store, leading to the dismantling of a sheet-metal clad shed along the west side of the building in 2000. The floor frame of the shed was left in place, along with industrial, neoprene sand bags, in an attempt to stabilise the low-lying shore of the spit, which is being reshaped and eroded. This effort proved in vain and in 2003 the building and adjacent Canada Customs Warehouse were braced, lifted and moved back from the shore. These buildings will need to be moved further back in 2004 as well as a hunters' and travellers' survival cabin.
