## The In Situ Protection of a Dutch Colonial Vessel in Sri Lankan Waters

**M. R. Manders**

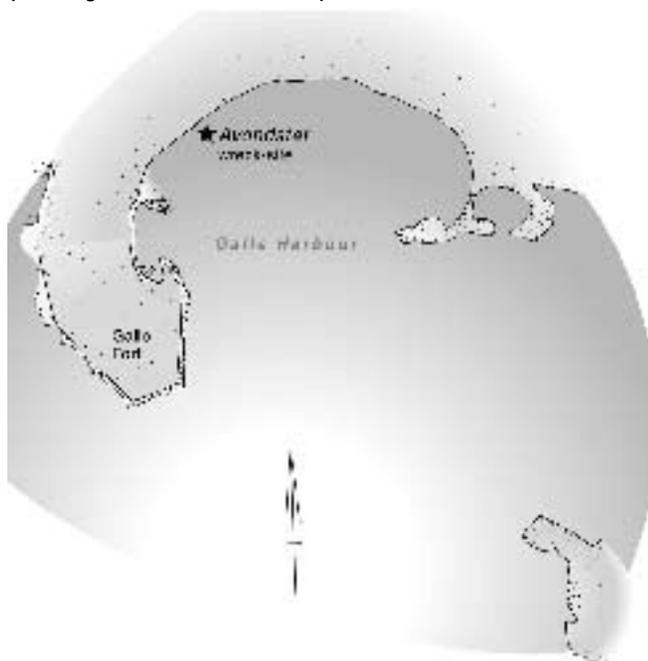
**Figure 1: Location of the *Avondster* wreck in Galle Harbour (Drawing M. Manders/M.Kosian)**

On the 2nd of July 1659, during a calm night, a Dutch Eastindiamen (VOC), called the *Avondster*, ran ashore in Galle Harbour in the south of Sri Lanka and wrecked. The ship had been loading a cargo of areca nuts (Areca Catechu) for India. These are the seeds of a palm tree and an ingredient of sirih, a kind of chew (Figure 1).

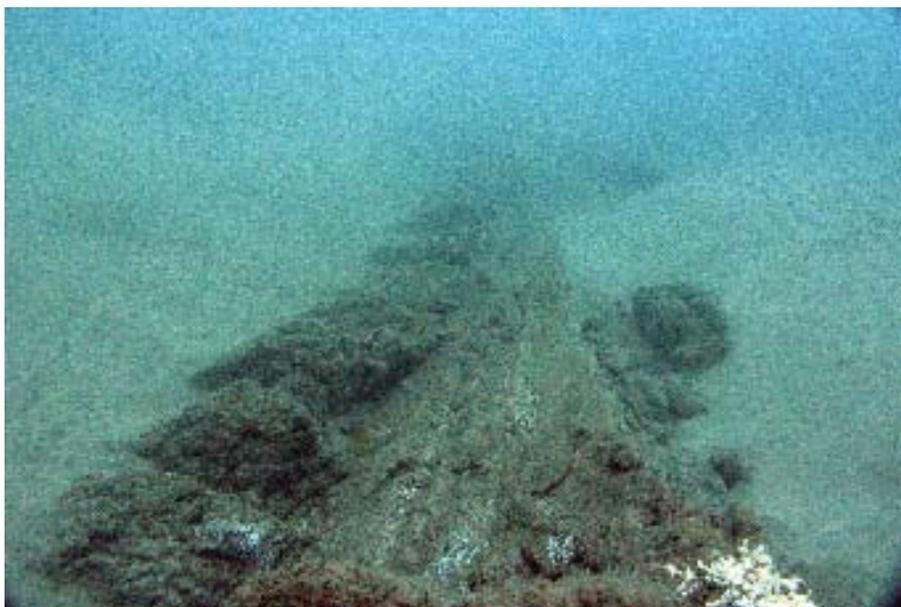
Figure 2: The exposed site of the *Avondster*. After so many centuries, much of its wood is still preserved (R. Muthucumarana)

By observing the remains of the ship, this is what probably happened: the stern of the *Avondster* hit the sandy seabed and ran ashore on a gradually sloping sandy coast near the Dutch Fort of Galle. Due to the constant pressure of the waves, the sternpost broke off from the rest of the ship. The waves were also responsible for the breaking of the portside under the bilge and the starboard side just above the first deck. Fine fluvial sediment of the river that deposited its water and waste into the bay and coarser marine sand covered the entire wreck. It must have been covered with fine sand and silt very soon after wrecking, which left it in an anaerobic condition for many centuries. In comparison to most other wrecks in tropical waters, the conservation conditions were extremely good for a long time, protecting a large part of the *Avondster*'s wooden structure (Figure 2).

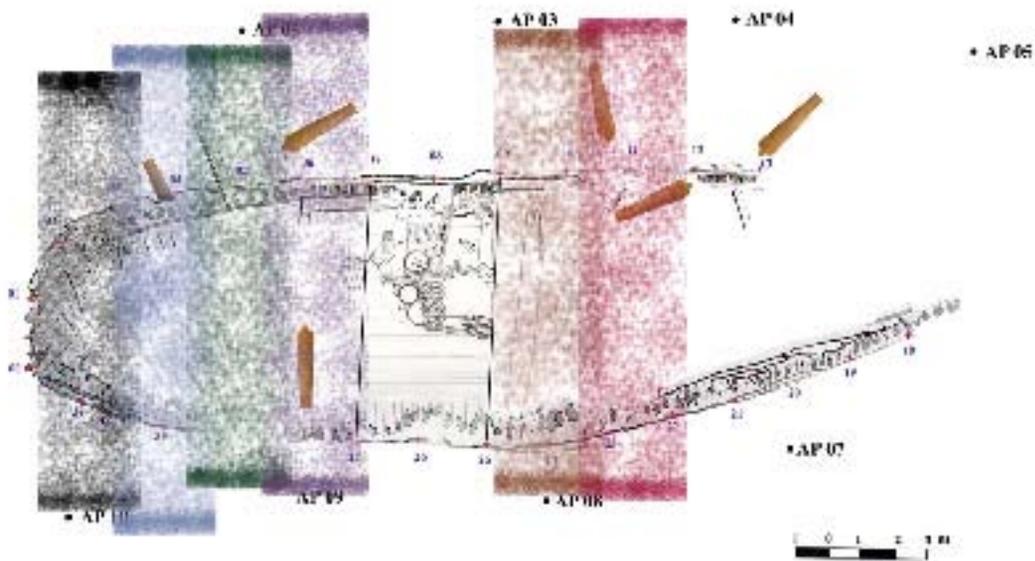
Figure 3: Schematic impression on where the polypropylene nets have been placed on the *Avondster* wreck (R. Muthucumarana)

it protected in an anaerobic environment. These tests were executed in February 2003, and because the results were very promising, an effort was made to cover the whole site in November that same year. The non-woven polypropylene net is fabricated in Sri Lanka and is normally used for filtering water and for shrimp fishing. In December 2003, the whole bow section was covered with five nets that were 4 meters wide and 25 meters long. They are placed squared on the wreck site covering the hull and the area where parts of the broken-off starboard side are possibly still lying under the sand. The strips of netting are weighted at both ends with sandbags. On the site, the nets extend 4 metres out of the portside of the wreck and 8 metres and more from the starboard side because here more parts of the wreck and objects are expected to be found (Figure 3).

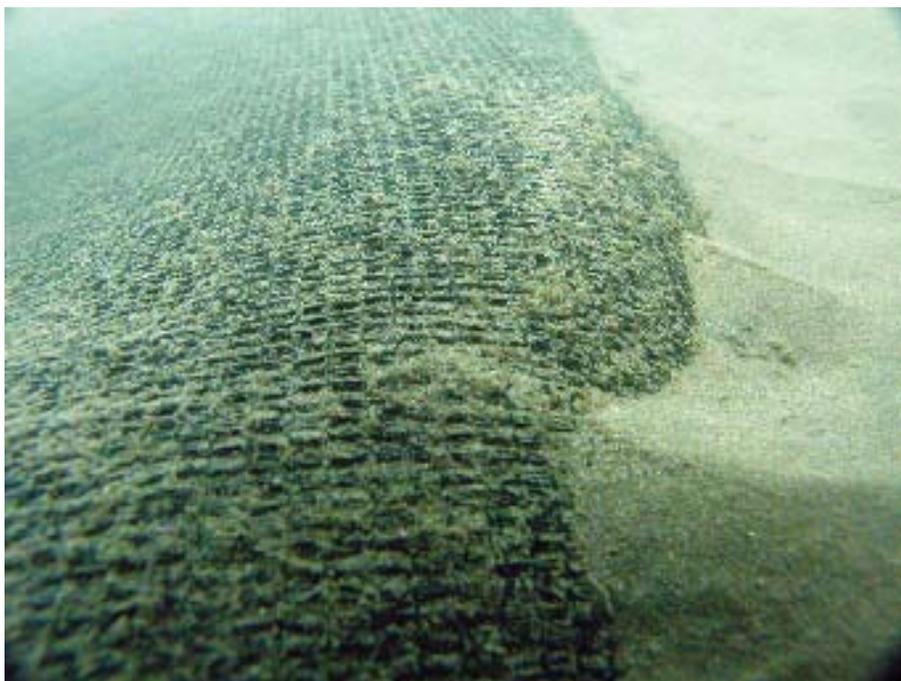
Figure 4: Sand is penetrating the little holes in the net, covering the wrecksite with a protective sediment layer (R. Muthucumarana)

The results of the protection are even more promising than the first test. Within one week after installation, the whole bow side was covered again with sand. This means that in places there was sediment buildup of more than 1 metre. Finally, the whole site has to be protected in order to be effective. For this protection, fourteen nets with a width of 4 metres and a length of 25 meters are needed. The total material cost of this physical protection of the *Avondster* wreck (about 500 square metres) is approximately € 2,000. The complete covering of the site has not been executed yet (Figure 4).
