Burevestnik Factory Club. Short Notes on the Restoration and Conversion Project

Burevestnik workers club, Moscow, 1927–29, arch. K. Melnikov, after the restoration in 2003

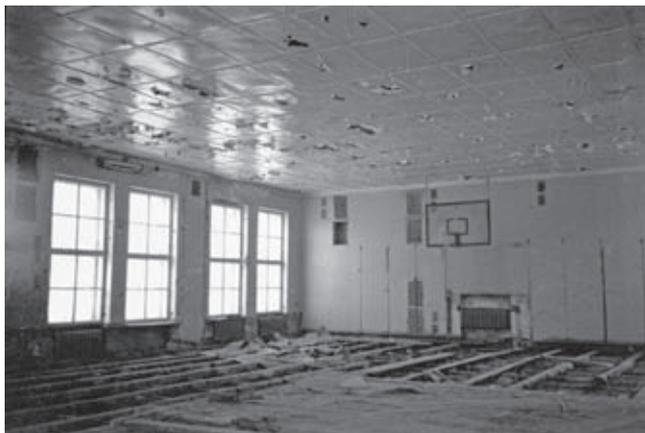
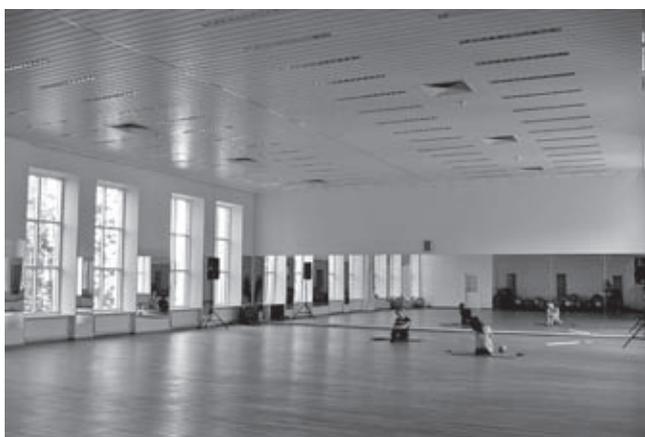
Burevestnik workers club, Moscow, 1927–29, arch. K. Melnikov. Gymnastic Hall before and after the restoration in 2003

We get an idea of the original interior decoration, structural design, and equipment from photographs taken in the 1930s and from individual surviving fragments discovered during the course of investigation of the building. The second floor of the tower has original decoration intact in the "Stalinist Classical" style². There are interesting photographs that give an idea both of the way the ceiling in the foyer was painted and of the damage done to the latter's interior by the decision not to build the swimming pool. Visual perception of the foyer is distorted by the fact that there are twice as many reinforced-concrete columns as there would have been had the pool been built. These columns end in pyramidal capitals of various sizes that support the ceiling. The auditorium and sports halls are spanned by metal girders to the lower parts of which are attached suspended ceilings.

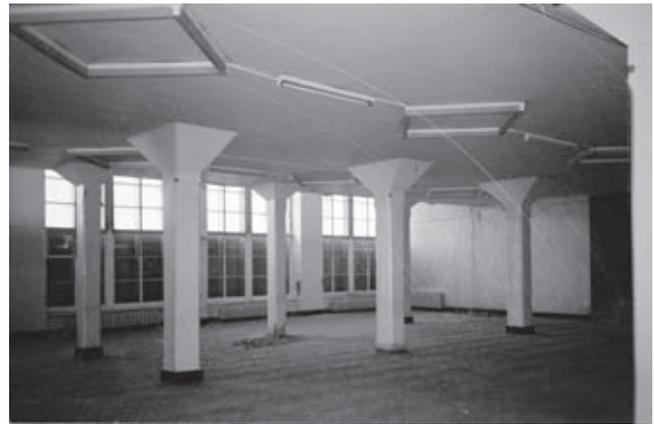
Burevestnik workers club, Moscow, 1927–29, arch. K. Melnikov. Vestibule before the restoration in 2000

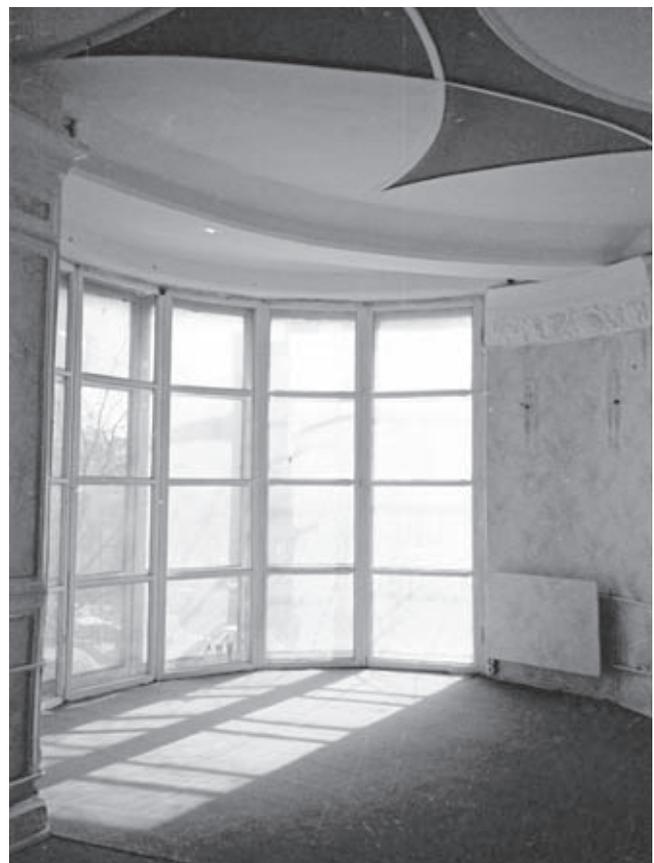
Burevestnik workers club, Moscow, 1927–29, arch. K. Melnikov. Clubroom before the restoration in 2000
