BULGARIA

Heritage in Danger

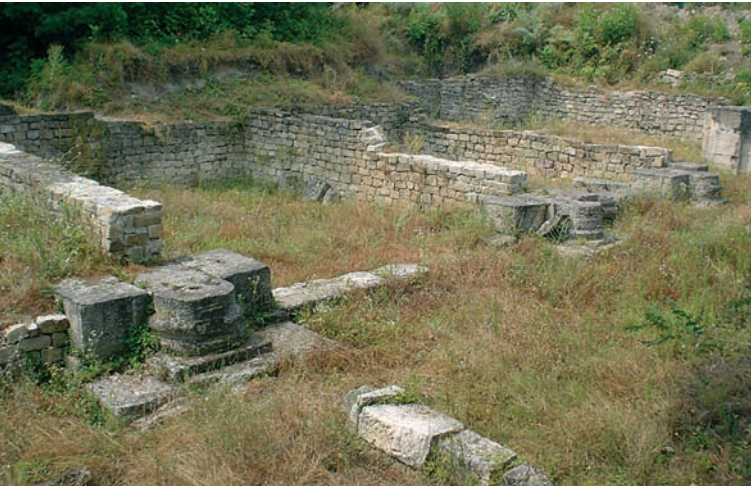
Novae archaeological reserve

- Lack of funds for conservation and maintenance;
- Aggression caused by natural agents – erosion, geological instability of the ground, unfavourable climate with great temperature fluctuations, intensive invasion of vegetation; and
- Vandalism and treasure hunting due to the remoteness of the site from the town and the lack of security.

The risk factors mentioned above are a serious threat to the site and question not only its adequate presentation, but also its physical survival.

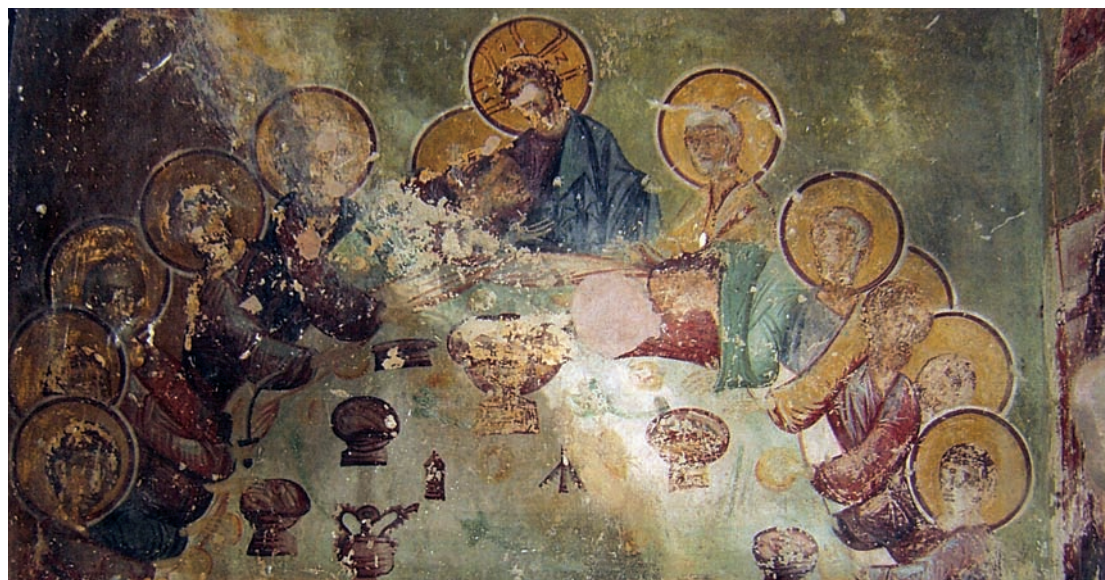
The building and the wall paintings of the church of St. Todor have suffered heavy damages caused by natural destructive processes throughout its long life, by seismic influences, and unfortunately also by acts of vandalism. The church has a partially destroyed structure; the wall paintings are in a rather bad state. In the last century a temporary wooden protective cover was built above to protect the church from further destruction. Unfortunately, the cover itself is now also in a rather bad condition.

Wall paintings in the church of St Todor near Boboshevo

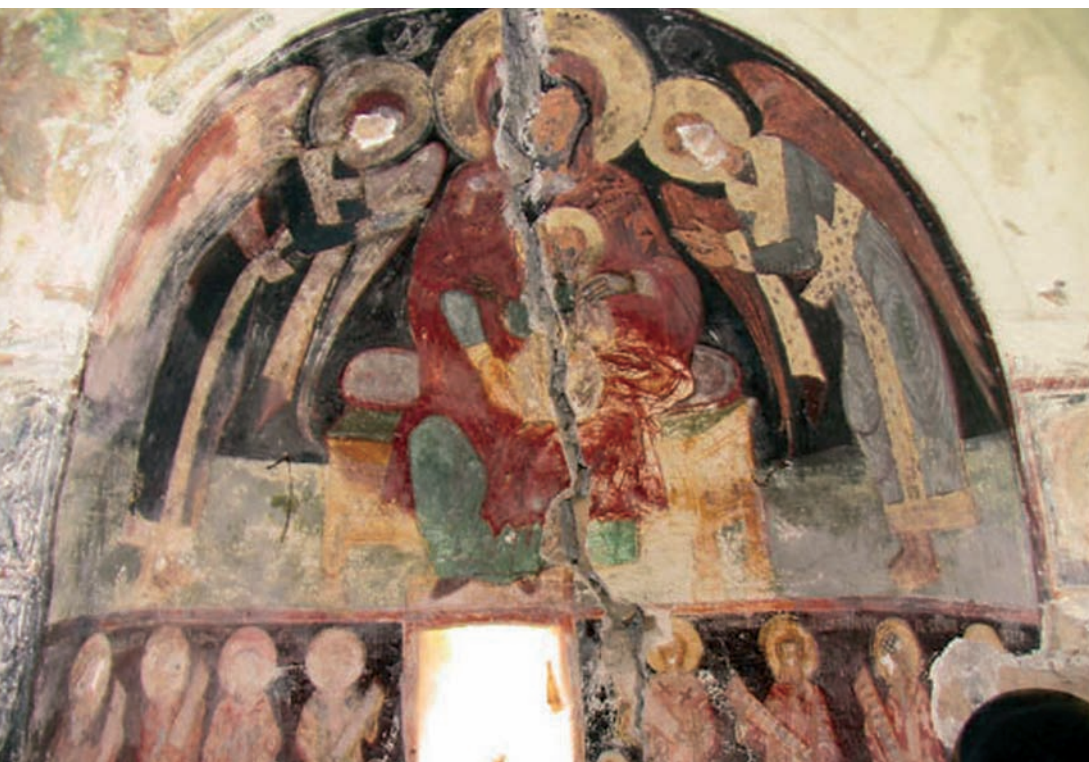
Wall painting in the apse of the monastery church of St Archangel Mihail in Dolna Beshoviza

The present state of the monastery is disastrous: its west wing is destroyed, its east wing could fall down any minute; the church has serious cracks and unless the treasure hunting excavations in its foundations stop, the church is under serious threat. Urgent measures have to be taken immediately in order to save the surviving building structure of the monument, and in the next stage to carry out the necessary research and design work for future restoration activities.

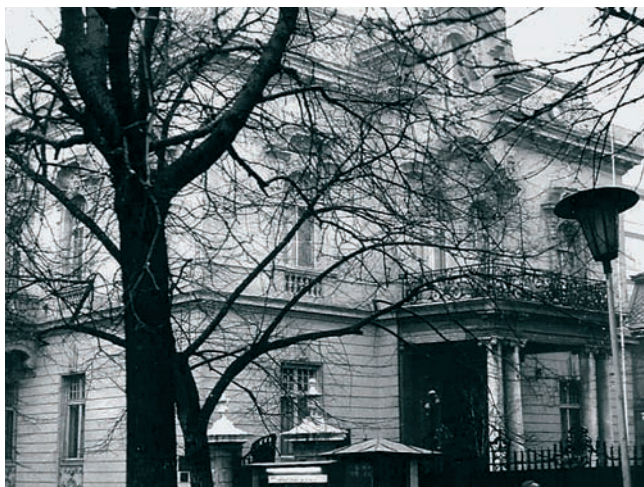
The house of Dimitar Jablanski in Sofia

The building at present is deserted, abandoned and left to destruction. There are indications that the new owner is striving for maximum utilisation of the extremely expensive ground of the building, aiming at impressive profit.

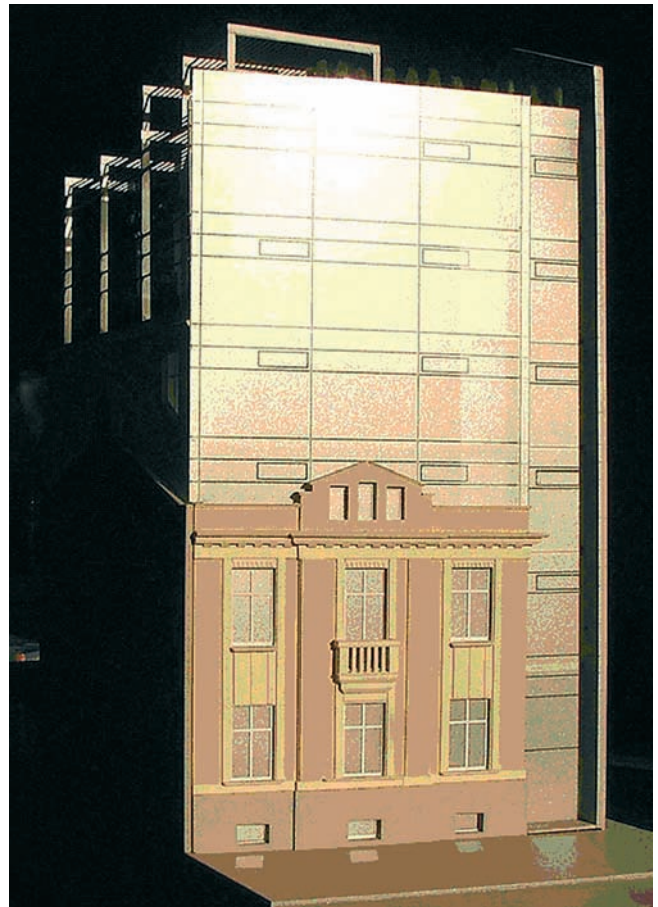
Sofia, façade of the house of Nicola Moushanov integrated into new building

It would be a bit incorrect to say that this monument is at risk, as actually it does not exist anymore – the building was destroyed, in its place a modern six storey apartment hotel was erected. The National Institute for Monuments of Culture reduced the category of the monument, and afterwards it authorised the project for the new hotel with the main motif that the memory of the monument has been preserved there – in the street façade of the hotel a “quotation” (though not literal) of the house façade was incorporated.
