Failure is not always what it seems to be Timber Roof Trusses Behaving Badly

Richard I. Ortega, PE, AIA, FAPT

Senior Associate and Director of Preservation Technology, RMJM Hillier, Philadelphia, Pennsylvania, USA

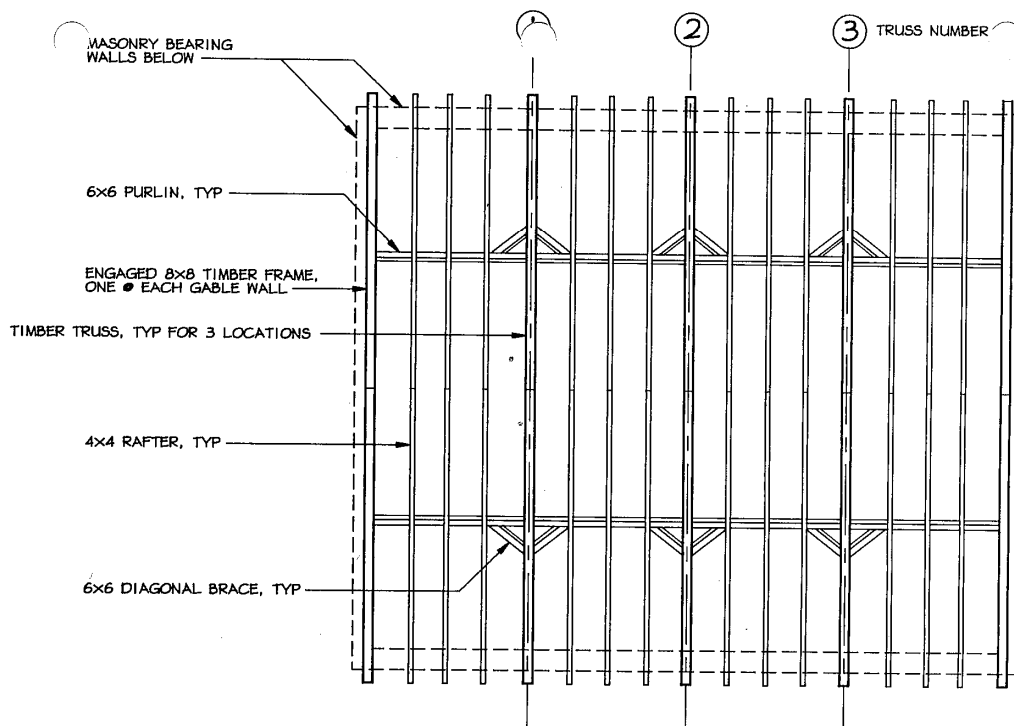
B	ORTEGA CONSULTING <small>Post Office Box 428 Media, PA 19063 (215) 585-1131</small>	DRAWING TITLE: ROOF FRAMING PLAN	SCALE: 1/8" = 1'-0"
			DATE: 3/12/92 DRAWN BY: RDN APPROVED BY: PROJECT #: 92-03B

At variance with the analyses, our survey of the trusses found numerous failures:

- All the trusses exhibited numerous failed pegged joints. In addition to the failed pegs, a few of the joints where the pegs were intact exhibited failure of the tenons.
- All the lapped joints of the trusses had rotated to some extent producing gaps at the far ends of the laps and localized crushing at the near ends of the joints.
- All of the top chords had failed.
- Several of the joints connecting the horizontal tie to the top chord had failed in tension.

We also closely examined the 20" thick masonry walls supporting the trusses and found that the tops of both walls had bowed outward as much as 6". This observation meant that our initial assumption that the masonry walls provided unyielding support for the trusses was not realistic. Thus, the same truss geometry was re-analyzed with one bearing end modeled as a roller so that spreading of the truss was theoretically permitted. The results of this analysis were consistent with the observed failures in the truss: the diagonal scissor chords go into tension to resist the spreading of the truss, and many of the truss members become overstressed.

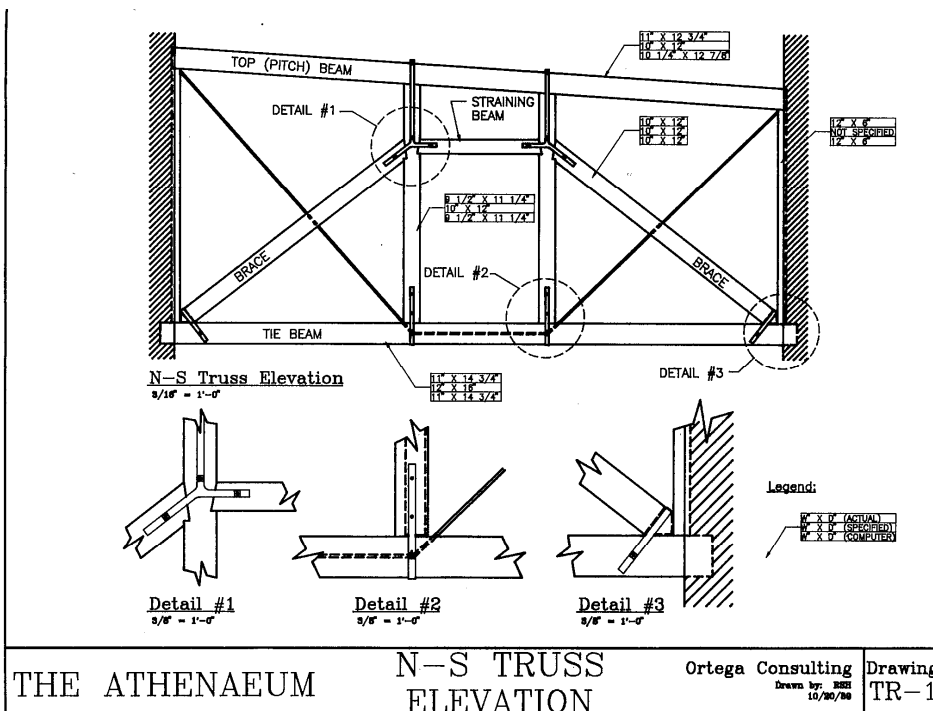
A survey of the framing found it to be generally as specified. Aside from some minor dimensional variations, the queen posts, straining beams, braces, pitch beams, iron straps, and rod conform to the specifications (see Drawing TR-1). The bottom chord, or tie beams, is smaller than specified, using two 5-1/2 by 14-3/4 inch timbers with a gap in between for the suspension rod. Likewise, the bolt below the queen posts, under which the suspension rod passes, appears to be only 7/8 inch in diameter instead of the 2 inches specified. The end posts, which are not mentioned at all in the specifications, are partially concealed in chases in the exterior masonry walls, but appear to be 6 by 12 inch pine timbers. We were not able to confirm the existence of the cast iron collars at the ends of the pitch beams and the rod connections to them as they were inaccessible.

This sent us back to re-examine the trusses more carefully for damage which could have caused the excessive deflections. The joints appeared tight and there were no apparent failures of the connections. We had limited access to the heel joints, but saw no evidence of movement or shear block failure. The rods seemed reasonably tight. We found checking in most of the members, but no signs of failure. There seemed to be no mechanism to account for the excessive deflections.

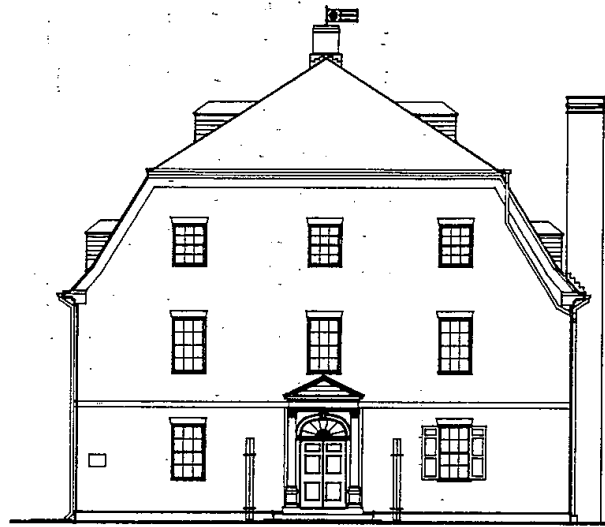
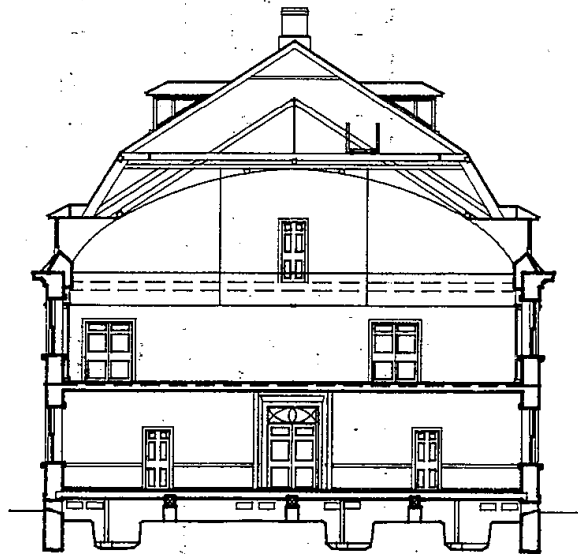
DRAWING No: 2	ORTEGA CONSULTING Post Office Box 428 Media, PA 19063 (215) 586-1131	DRAWING TITLE: FEAST HALL	SCALE: NO SCALE DATE: 7/5/95 DRAWN BY: SMW APPROVED BY: PROJECT #: 94-21A
-------------------------	---	-------------------------------------	---

The exterior brick masonry walls were in generally good condition with no visible cracks, the north and south walls (the walls upon which the roof trusses bear) were visibly out of plumb. At the cornice, about 25' above grade, the walls leaned outward 8", but 6" of that occurred in the upper half of the wall, between the cornice and the second floor.

Inspection and sounding of the ties-rods yielded the surprising finding that they were slack – i.e. were not loaded.

These observations were at variance with the results of our analyses and modeling of the trusses, which, among other findings, could not replicate the 6" displacement of the truss bearings (the calculated amount was 1-1/2"), and resulted in a 12 Kip tensile load on the tie-rod.

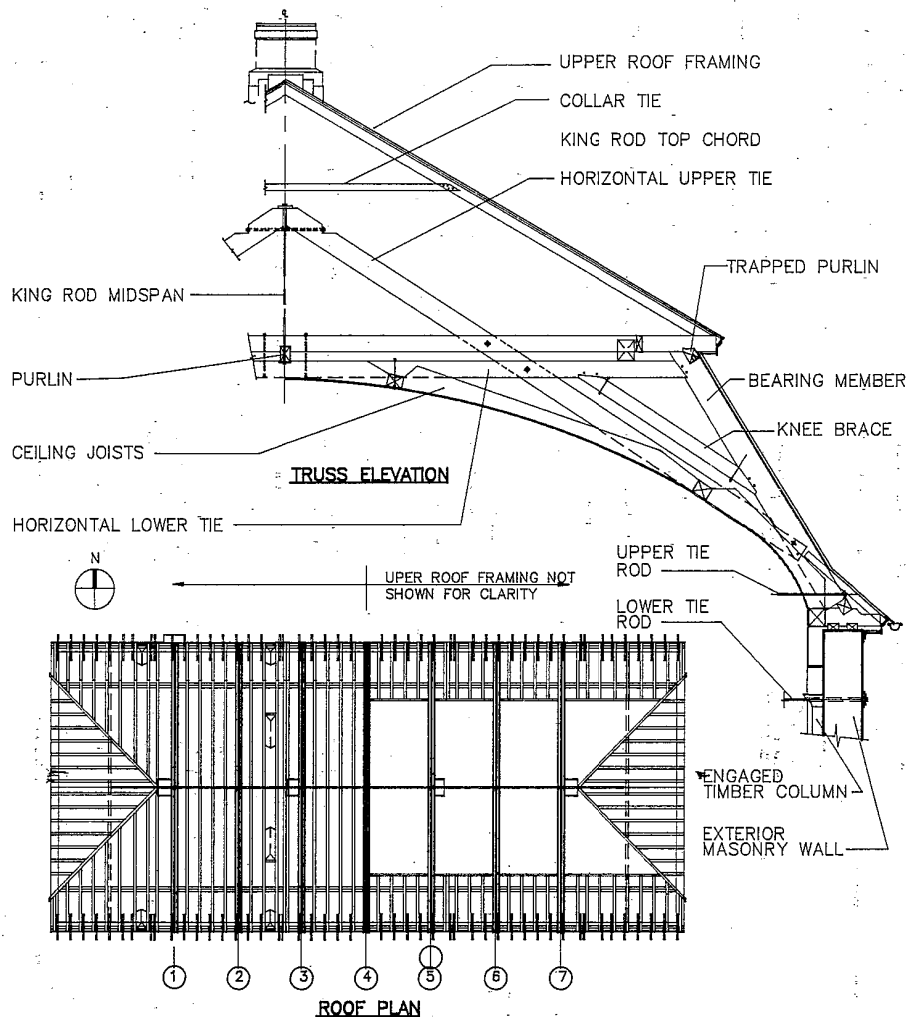
DRAWING No. 3	ORTEGA CONSULTING Post Office Box 428 Media, PA 19063 (215) 585-1131	DRAWING TITLE: FEAST HALL	SCALE: NO SCALE DATE: 7/5/95 DRAWN BY: SMW APPROVED BY: PROJECT #: 94-21A
-------------------------	--	-------------------------------------	---

- At least half the scribe marks on the braced frames are on the concealed faces of the pairs of frames – i.e on the surface facing the other braced frame in pair rather than on the face toward the next truss.

- All the treenails of the mortise-and-tenon joints were driven from the concealed face.

These new observations led us to reach some startling conclusions regarding the sequence of the timber framing and the source of the truss and wall distortions.
