ICOMOS Sri Lanka

**Preliminary Survey of Tsunami-affected Monuments and  
Sites in the Maritime Region of Sri Lanka**

The Southern Maritime Region:  
from the Walawe Ganga to the Nilvala Ganga

March 2005

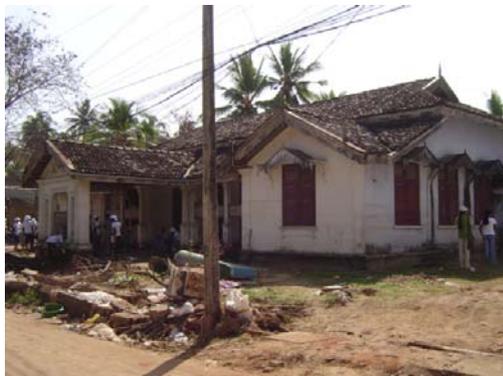
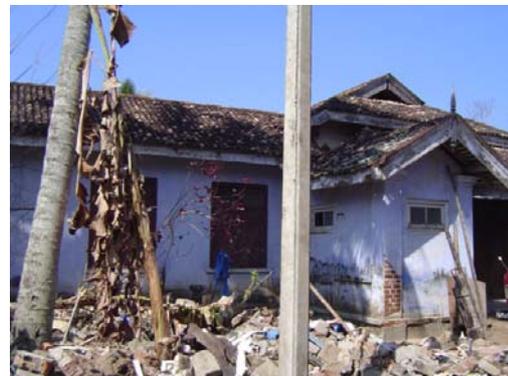
**No: M/M/F/03**

This bungalow that may be dated to the early part of the 20<sup>th</sup> century is located about 120 m inland from the sea. During the present survey the owner was not present and this house could only be observed from the outside.

The foundation of this structure seems to have been constructed of rubble, while the walls are of brick. The house is sheltered with half round tiles and the roof is generally in good condition. The house floor is made of cement rendering. The interior of the house is approached through a gabled roofed sun shade and a pillared open verandah. This verandah has typical timber lattice screens between the pillars. They are unharmed.

The doors and the windows are built of timber and timber framed glass. Though the levels of the tidal waves in this area had been around 6 feet, the damage to the structure is minimal. Only a single door on the rear side and the plaster in a few places are slightly damaged. However the brick boundary wall is completely destroyed.

**Level of Intervention** : Significant Level of Intervention (10-30%)  
**Estimated Cost for the Conservation: Rs. 110,000.00**  
**Location Map/GIS Coordinates** : Map-i/ M/M/F/03

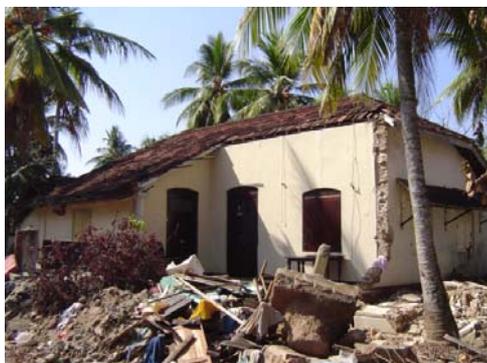
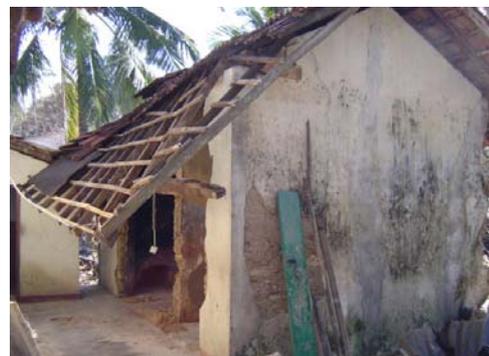
This partly damaged house that may be dated to the early part of the 20<sup>th</sup> century is situated about 100m inland from the sea.

As is clear from the debris of the completely destroyed front verandah, the foundation and the walls of the house are constructed of both cabock and limestone. The doors and windows are built of timber. The front door is ornamented /decorated with beautifully carved timber floral designs on its upper end. Pieces of stained glass are mounted in these timber carvings. Some damage to the doors and windows were noted.

Since the owner was not present during our survey, the house could only be observed from outside. The house floor is built of cement rendering. As mentioned above, the round pillared front verandah is completely destroyed. A part of the rear side verandah is also damaged. Other than this damage, the structure is stable. The Calicut tiled roof is also in a good condition. The building can be easily restored.

**Level of Intervention** : **Substantial Level of Intervention (30% - 60%)**  
**Estimated Cost for the Conservation** : **Rs. 422,500.00**  
**Location Map/GIS Coordinates** : **Map- i /M/M/F/04**

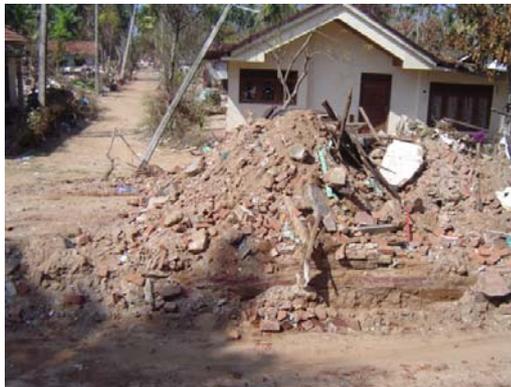
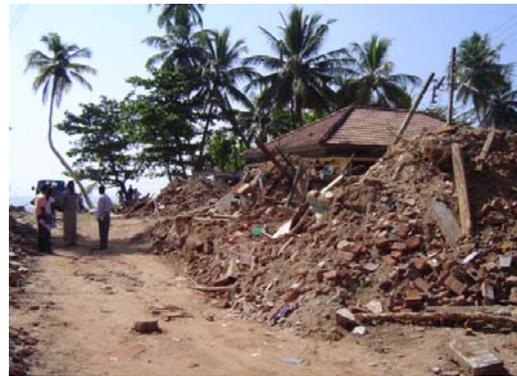
No: M/M/F/05

This completely destroyed house is situated just 50m inland from the sea – in an area which is completely devastated by the tidal waves. The owner of the house claims that this had been constructed in the early part of the last century. As is clear from the debris, the foundation of this building had been constructed of rubble while the walls are of brick. The house had been roofed in Calicut tiles and the house floor made of cement rendering. Doors and windows were built of timber. Nothing remains for conservation.

**Level of Intervention** : **Totally Destroyed (100%)**  
**Estimated Cost for the Conservation** : **NA**  
**Location Map/GIS Coordinates** : **Map-i/ M/M/F/05**

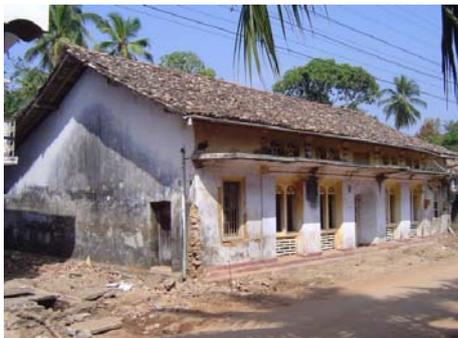
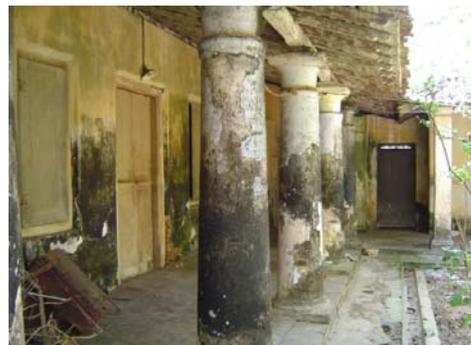
At the time of our survey, the owner was not present and therefore only the front verandah could be examined. This house is situated about 150m from the sea. Though the sea water reached the house premises, no apparent interferences were caused.

There is a plain/square columned open verandah on the front of the building. This verandah is sheltered by a roof separate from the rest of the roof. This verandah is protected by a concrete grill and above it a timber lattice protection built between the pillars. The verandah (and the house itself) is divided into two by a partition. Both the concrete grills and the timber lattice are severely damaged and need to be repaired soon.

The foundation and the walls of this building are built of brick. The wall plaster seems to be very fragile and tends to come off the wall. Fungal impact on the plaster was also noted. The house is sheltered with half round tiles. It is in a deteriorating state and needs to be repaired.

The doors are both timber and glass in timber frames. The timber door that leads to the front verandah is in a decayed condition and needs repair. The cement rendering floor is not damaged. This building can be easily repaired.

**Level of Intervention** : Significant Level of Intervention (10- 30%)  
**Estimated Cost for the Conservation** : Rs. 1,544,000.00  
**Location Map/GIS Coordinates** : Map- i/M/M/F/06

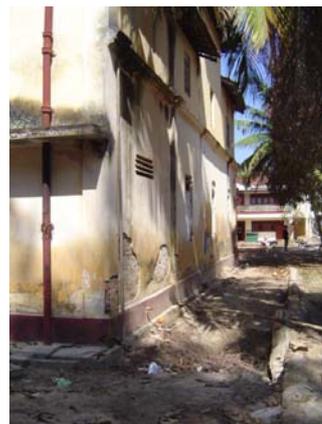
Constructed by a police officer named Don Jayawickrama Weerasuriya, this is a work of the later part of the 19<sup>th</sup> century. The roof tiles are said to contain a manufacturing date of 1867. As it is located about 75 meters inland from the sea at a very low elevation, this house is highly vulnerable to sea erosion. The garden around the house is badly eroded and the pavement and the foundation have sunk to the ground. This has led to cracks on the walls. Pre-tsunami cracks have also been aggravated. Cracks on the front side columns have made the structure somewhat unstable. In places the plaster has come off the walls.

The house is doubled storied by way of having a timber mezzanine. Its foundation is built of cabock while the walls are of both brick and cabock. The Calicut tiled roof is in a state of decay. Fungal impacts are visible on the plaster.

The doors and windows are timber paneled glass. About 60% of the doors have either been destroyed or damaged, while the windows too are damaged. The salt water impact can also be seen on the cement rendering floor. The boundary wall is completely demolished.

The rear – sea facing – kitchen, probably not of the same age as the house is badly damaged. Some furniture of antique value has also been damaged. Attention should be given to conserving this building.

**Level of Intervention** : Substantial Level of Intervention (30- 60%)  
**Estimated Cost for the Conservation** : Rs. 289,000.00  
**Location Map/GIS Coordinates** : Map-i /M/M/F07

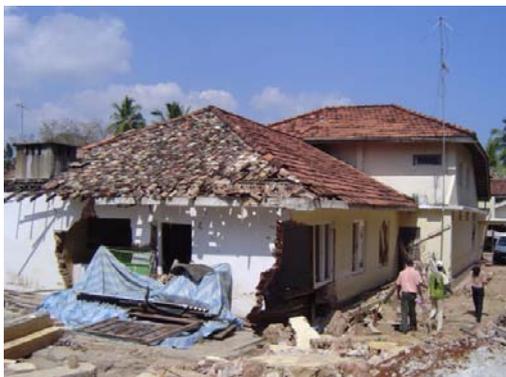
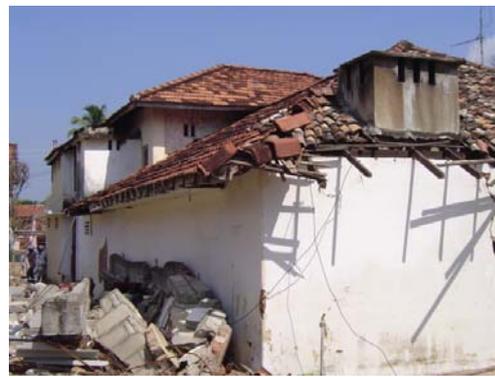
This house which is supposed to belong to a date in the early 20<sup>th</sup> century is in two parts. The front part of the house, which is probably the oldest construct, is double storied with a timber mezzanine. The mezzanine is accessed through a timber staircase. This portion of the house was not affected much by the tidal waves but some of the doors and windows are damaged. However the household belongings such as furniture of antique value have been badly damaged or totally destroyed.

The rear side of the building which is used as the kitchen is said to be a later addition. Considerable portions of walls in this part are broken down, making the building structurally unstable.

The construction material of the foundation is not known. However, the kitchen which is badly damaged is built of brick. The floor is cement rendered. The original half round tiles of the roof have been replaced with the recent Calicut variety. The roof of the kitchen is still sheltered with half round tiles. Except for the damaged portion of the kitchen, the roof of the rest of the building is in good condition. The floor is cement rendered. Most of the glass windows are damaged.

**Level of Intervention** : **Significant Level of Intervention (10 – 30%)**  
**Estimated Cost for the Conservation** : **Rs. 345,000.00**  
**Location Map/GIS Coordinates** : **Map i-/M/M/F/08**

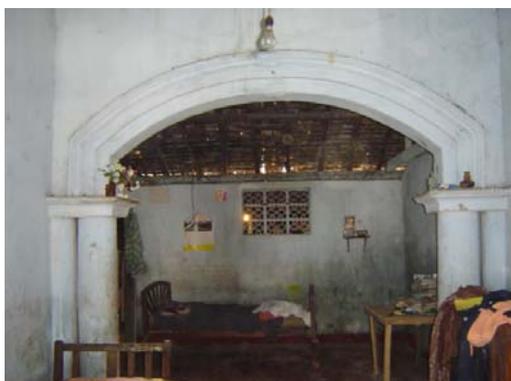
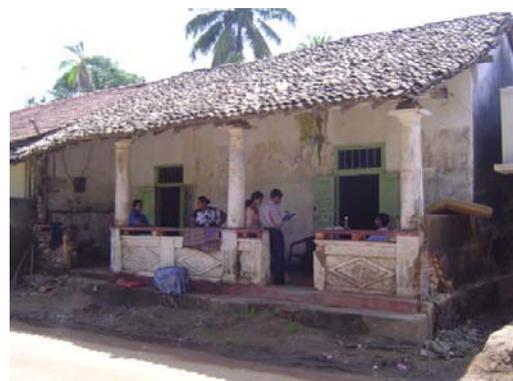
This house is situated about 75 meters inland from the sea. It has retained its original character, though now in a deteriorating condition.

The foundation of this house has been constructed of limestone while the walls are of brick. There is a round columned open verandah on the front side and it is strengthened with a half wall between pillars. One of the corner pillars is severely damaged, making that part of the roof vulnerable to collapse.

Tsunami and pre-tsunami cracks and plaster damage were noted on the walls. Some of the pre-tsunami damage has been aggravated due to the pressure of the tidal waves. The house is sheltered with half-round tiles and the entire roof is in a deteriorated condition. The doors of this building are made of timber. There are no windows for the entire house. The floor is of cement rendering.

**Level of Intervention** : Substantial Level of Intervention (30-60%)  
**Estimated Cost for the Conservation** : Rs. 280,000.00  
**Location Map/GIS Coordinates** : Map-i/M/M/F/09

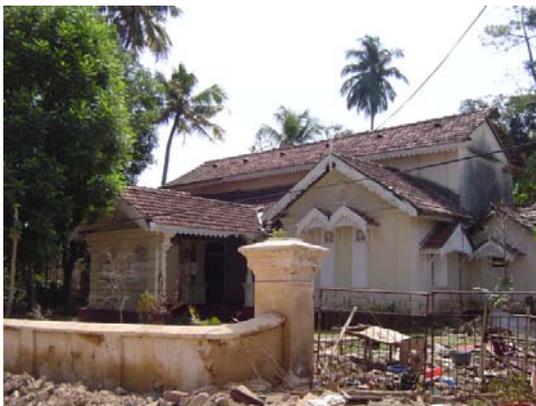
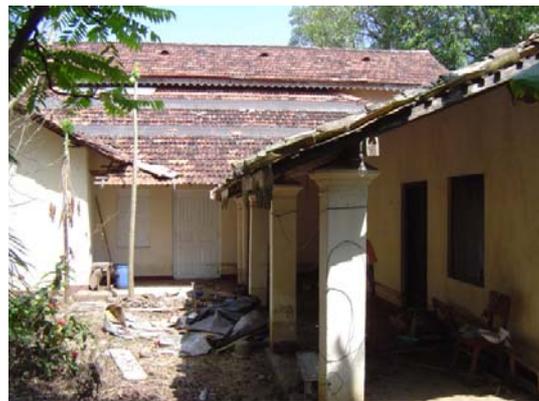
The building, which was probably built during the early part of the 20<sup>th</sup> century is well preserved and can be taken as an example of the architecture of that period. It is situated about 75 meters from the sea. Since the owners were not present during our survey, the building could only be viewed from the front. Though the tsunami waters reached the premises, no damage to the building is visible. The house is roofed in Calicut tiles and the doors and windows are made of timber. The upper most portions of the doors and windows consist of beautifully carved timber. As can be seen from outside, the building could only be viewed from the front. No immediate conservation is required.

**Level of Intervention** : Minimal Level of Intervention (0 -10%)  
**Estimated Cost for the Conservation** : NA  
**Location Map/GIS Coordinates** : Map-i/M/M/F/10

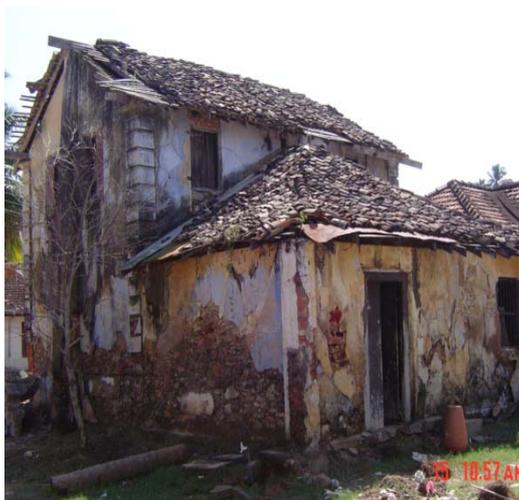
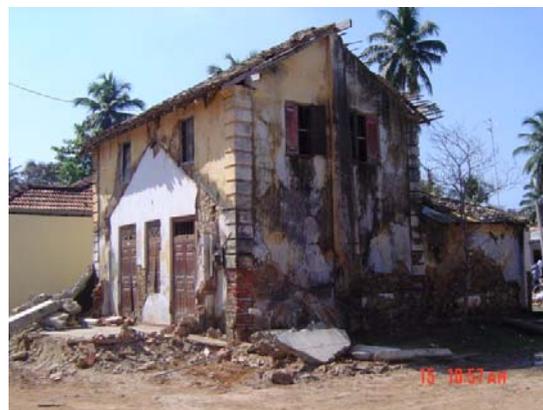
NO: M/M/F/11

As is clear from the demolished part of the house, the foundation was built of limestone, while the walls are of both limestone and brick. The walls are severely damaged due to weathering. The plaster is very fragile and tends to come off the wall. The total damage to the walls is about 60%.

The house floor is cement rendered of which approximately 50% is damaged. The roof is sheltered with half round tiles. The roof is in a state of decay and needs immediate repair. The timber doors and windows can be repaired.

**Level of Intervention** : Badly Damage and require Restoration (60 - 90%)  
**Estimated Cost for the Conservation** : Rs. 660,000.00  
**Location Map/GIS Coordinates** : Map-i /M/M/F/11

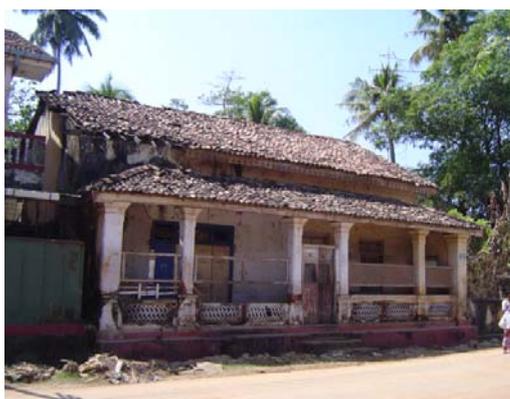
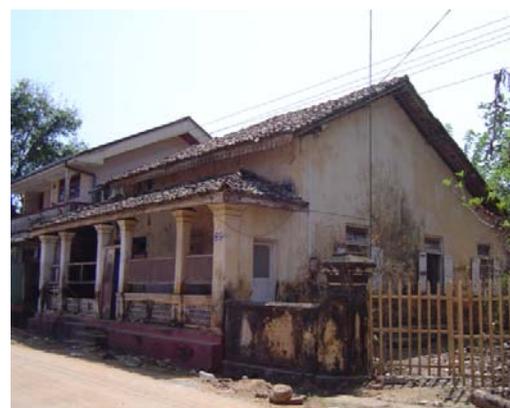
During our survey, the owner was not present and therefore only the front verandah could be examined. The house is situated about 150 meters from the sea. Though the sea later reached the house premises no apparent interference to the house is noted.

There is a plain/square columned open verandah in the front of the building. A roof separate from the rest of the roofs, shelters this verandah. This verandah has a concrete grill protection and a lattice protection above the grill built between the pillars. The verandah (and the house itself) is divided into two by a partition. Both the concrete grills and the timber lattice are severely damaged and need repair soon.

The foundation and the walls of this building are built of brick. The wall plaster is very fragile and tends to come off. Fungal/algae impact on the plaster was also noted.

The house is sheltered with half round tiles. It is in a deteriorating state and needs repair. The doors are both timber and glass in timber frames. The timber doors that lead to the front verandah are in a state of decay and should be repaired. The house floor is cement rendered and no apparent damage was noted. This building can be easily repaired

**Level of Intervention** : **Significant Level of Intervention (10-30%)**  
**Estimated Cost for the Conservation** : **Rs. 318,000.00**  
**Location Map/GIS Coordinates** : **Map i/M/M/F/13**

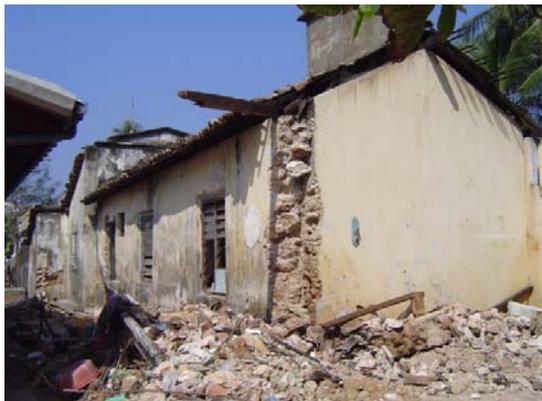
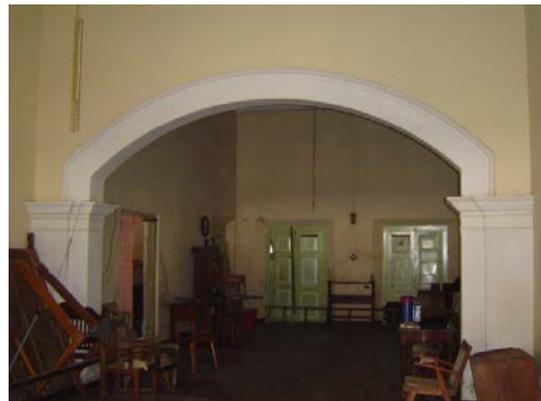
NO: M/M/F/14

Both the foundation and the wall of this house are built of cobblestone while the floor is cement rendered. The roof is sheltered with half round tiles and is in good condition. There are spacious round columned verandahs all around the house and they are in very good condition.

The house has a spacious *zaal* and a number of living rooms of which almost all the doors and windows are either severely damaged or totally destroyed. These doors and windows are of timber and timber framed glass.

The rear of the house faces the sea and extensive damage is seen in this part of the building. One of the columns of the verandah is damaged and that part of the roof is unstable.

The rear of the building consisted of two rows of wing rooms leaving a backyard garden between them. Out of these wing rooms, three rooms on the right side used as bedrooms are completely destroyed. Parts of the left side wing rooms used as a kitchen are also damaged but repairable. However these rooms seem to have been constructed at a later period.

Many of the household belongings and furniture of historical value is damaged or destroyed. The boundary wall is completely destroyed and the site is vulnerable to sea erosion. Urgent attention should be paid to conserve this building.

**Level of Intervention** : **Substantial Level of Intervention (60 – 90%)**  
**Estimated Cost for the Conservation** : **Rs. 1,210,000.00**  
**Location Map/GIS Coordinates** : **Map-i/M/M/F/14**

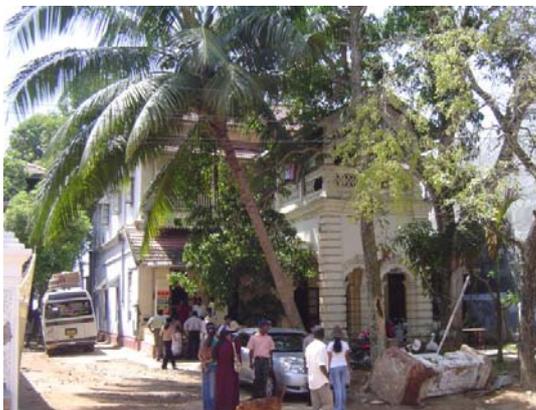
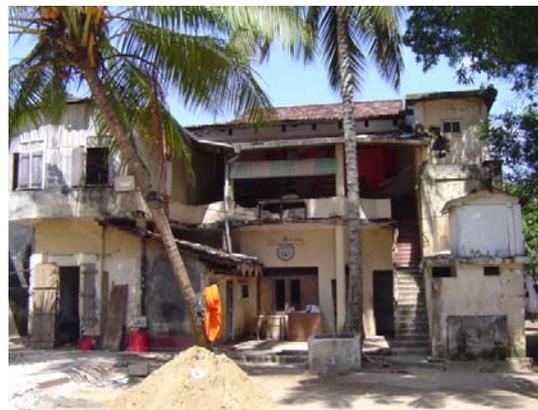
The construction material of the foundation of the *avasaga* is unknown while its walls are built of limestone. The original clay tiled floor has recently been replaced by a granite one. A portico and a pillared open verandah in the front provide the approach to the building. The floor of this double storied building – has a timber mezzanine – and is reached by a timber staircase that is beautifully ornamented with carvings.

<b>Level of Intervention</b>	: <b>Significant Level of Intervention (10-30%)</b>
<b>Estimated Cost for the Conservation</b>	: <b>Rs. 660,000.00</b>
<b>Location Map/GIS Coordinates</b>	: <b>Map-i /M/M/F/15</b>

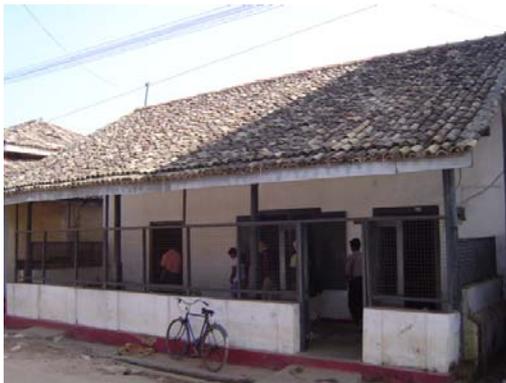
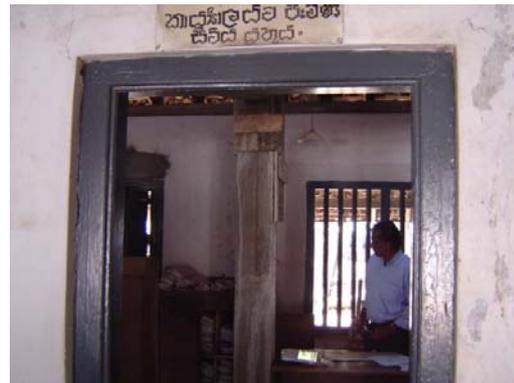
No: M/M/F/16

**Level of Intervention** : Significant Level of Intervention (1 0-30%)  
**Estimated Cost for the Conservation** : Rs. 73,000.00  
**Location Map/GIS Coordinates** : Map-i/M/M/F/16

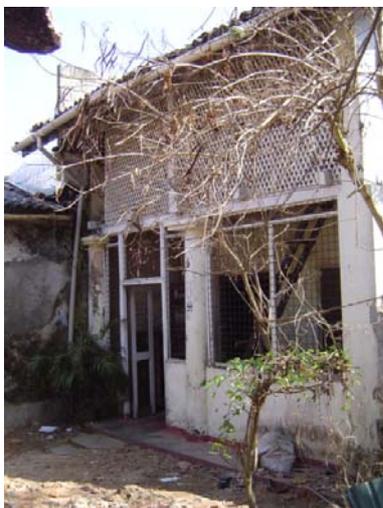
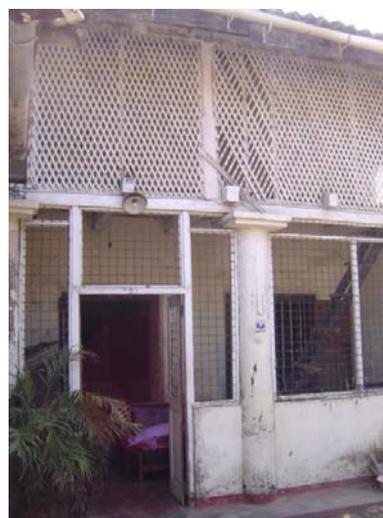
**Level of Intervention** : Significant Level of Intervention (10- 30%)  
**Estimated Cost for the Conservation** : Rs. 475,000.00  
**Location Map/GIS Coordinates** : Map-i/M/M/F/17

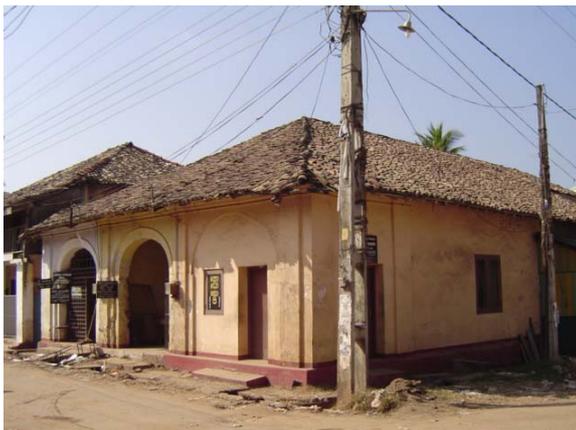
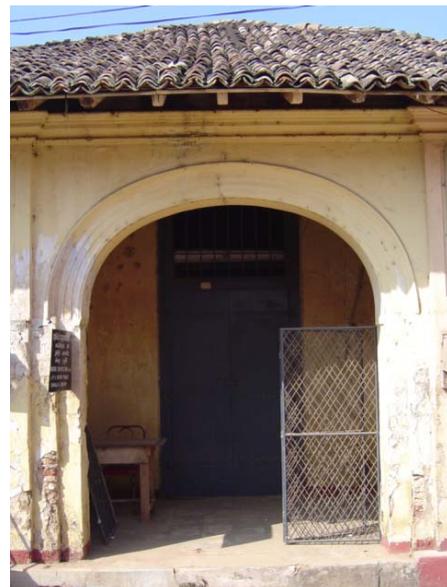
No: M/M/F/18

**Level of Intervention** : Significant Level of Intervention (10%- 30%)  
**Estimated Cost for the Conservation** : Rs. 275,000.00  
**Location Map/GIS Coordinates** : Map-i/M/M/F/18

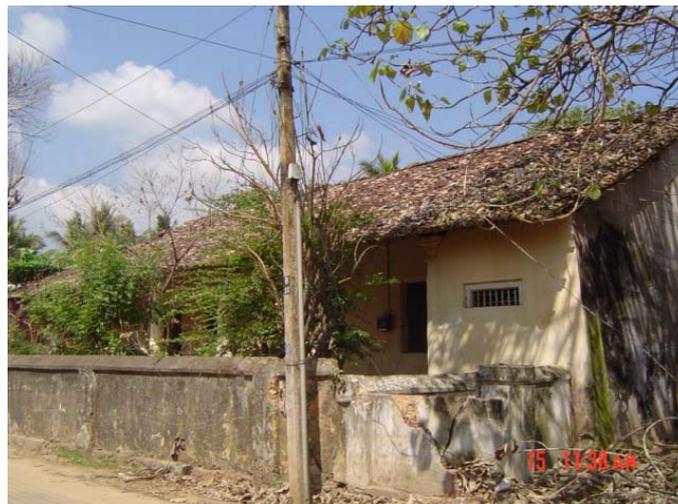
**Level of Intervention** : Minimal Level of Intervention (0-10%)  
**Estimated Cost for the Conservation** : Rs. 80,000.00  
**Location Map/GIS Coordinates** : Map-i/M/M/F/19

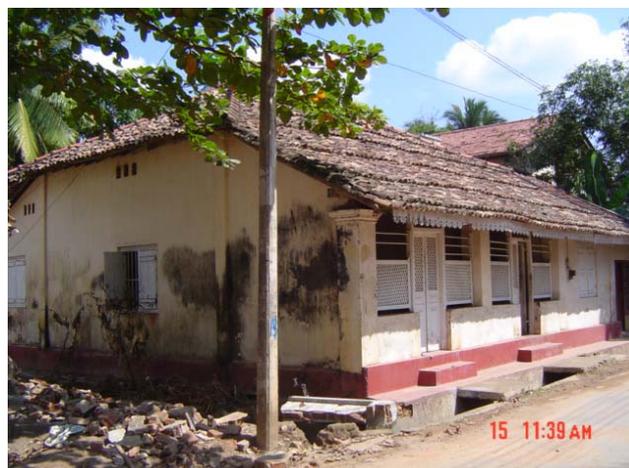
**Level of Intervention** : **Minimal Level of Intervention (0 – 10%)**  
**Estimated Cost for the Conservation** : **Rs. 245,000.00**  
**Location Map/GIS Coordinates** : **Map-i/M/M/F/20**

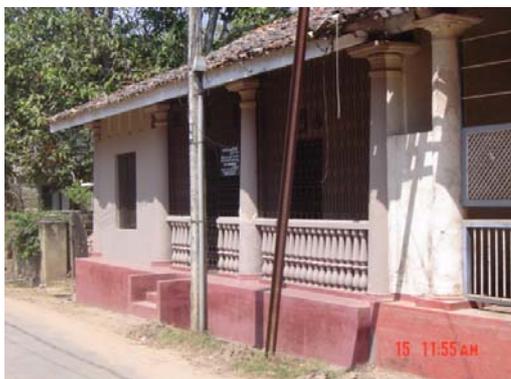
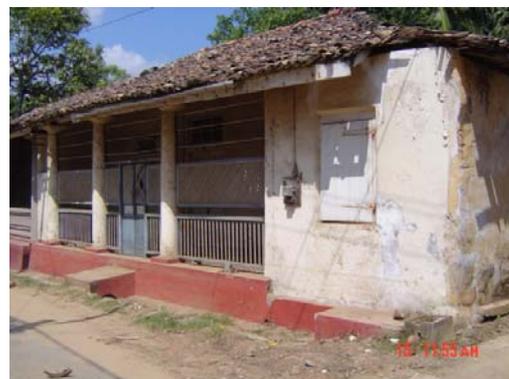
NO: M/M/F/21

**Level of Intervention** : **Minimal Level of Intervention (0 – 10%)**  
**Estimated Cost for the Conservation** : **Rs. 530, 000, 00**  
**Location Map/GIS Coordinates** : **Map-i/M/M/F/21**

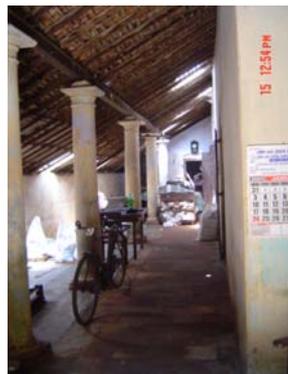
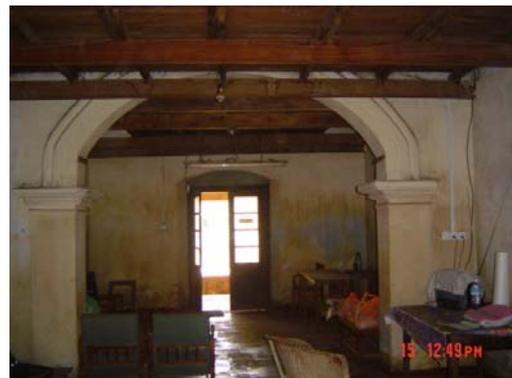
<b>Level of Intervention</b>	: <b>Minimal Level of Intervention 30 – 60%</b>
<b>Estimated Cost for the Conservation</b>	: <b>Rs. 735,000</b>
<b>Location Map/GIS Coordinates</b>	: <b>Map-i/M/M/F/22</b>

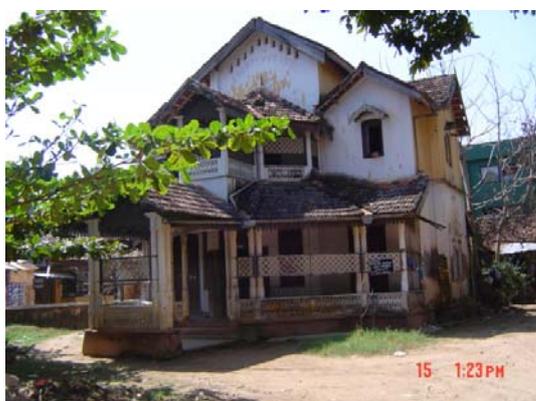
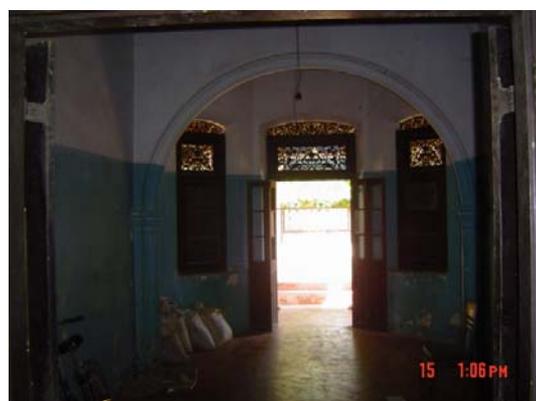
**.Level of Intervention** : Minimal Level of Intervention (0- 10%)  
**Estimated Cost for the Conservation** : Rs. 630,000  
**Location Map/GIS Coordinates** : Map-i/M/M/F/23

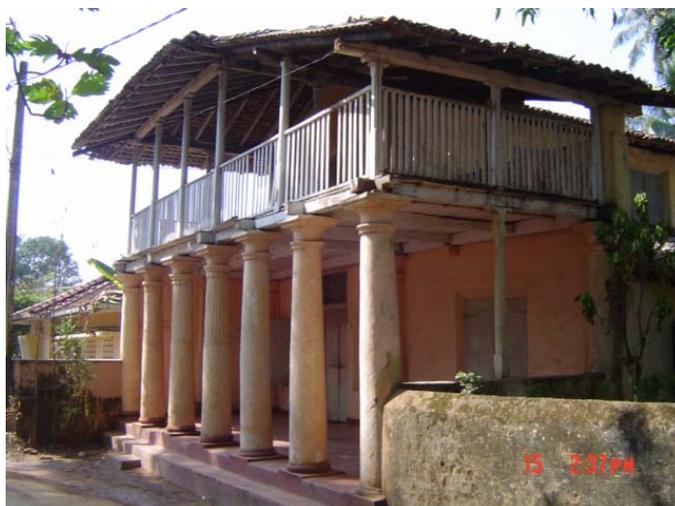
No: M/M/F/24

**Location Map/GIS Coordinates** : Map-i /M/M/F/24

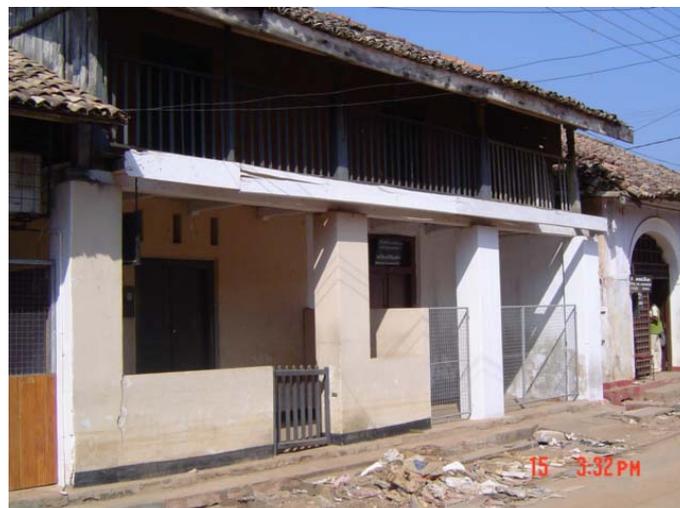
The house has been divided into two by a partition wall and is now used as office rooms. Apparently, the round columned open verandah in front has been modified and the round columns have been replaced by square cement/concrete columns. The left side office has a short wall between the verandahs columns and there is a metal mesh gate built in the other office. In the house that has a shorter wall on the verandah, the original door has been changed. The plaster on the front inner wall should be re-done. The floor is cement rendered.

There is a timber mezzanine/ balcony above the front verandah, which probably extends to the inner *zaal*/the living rooms too. The half round tiled roof above the balcony is held by a row of thin timber posts. There is a timber railing about 4 feet high between the said timber posts. The roof of the house is deteriorated due to weathering. As can be seen from the road, the plaster of the upper part of the building above the first floor is weathered and needs repair.

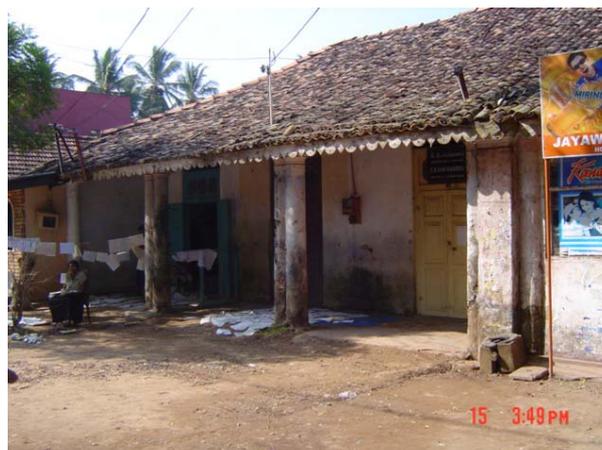
No: M/M/F/28

The other part of the building has retained its original architectural character. There is a round columned open verandah on the front side of this part of the building. The same could have been the situation in the modified part too. The columns in the middle of this verandah are double columned ones while the corner single columned pillars are built along with the side walls. These walls bear evidence of being exposed to weathering for a long period of time. They are badly damaged and the plaster is very fragile. The tidal wave watermark is about four feet high on the walls. The plaster in this area tends to come off due to the impact of salt water. The clay tiled floor also bears the same impact. The half round tiled roof is also in a state of decay and needs immediate repairs.

There are three timber doors leading into the inner house from the front verandah which are in comparatively good condition. The foundation and the walls are said to have been constructed of limestone. Immediate attention should be paid to conserve this building.

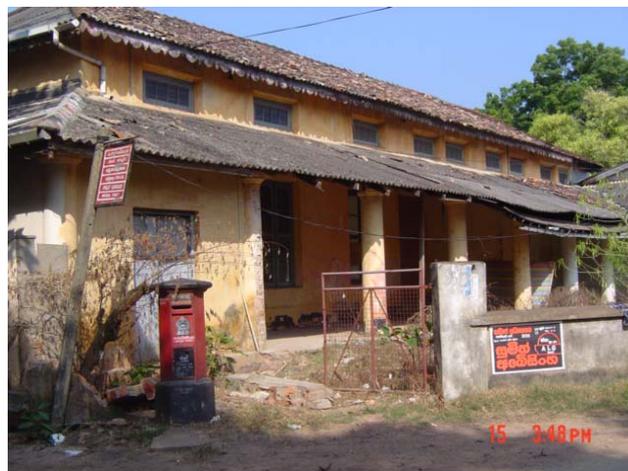
The front side colonnaded verandah, though modified, retains the original Dutch character. The left side end of this verandah has been modified into a room, by building walls between the original free-standing round columns. The open verandah seems to have lead to two sides of the building. The Post Office seems to have been built by modifying the outer side of the verandah. A timber built main door gives access to the interior hall/rooms (?). The windows on either side of the door are both timber and timber framed glass. The walls are in good condition with only minimal plaster damage visible. The front verandah floor is built of cement rendering. However, the nature of the inner house floor is not visible.

The roof above the open verandah is built at a lower level and separated from the higher level main roof. It has been modified and half round tiles have been replaced by asbestos.

The modifications being introduced to the structure cause more damage than the tsunami damage.

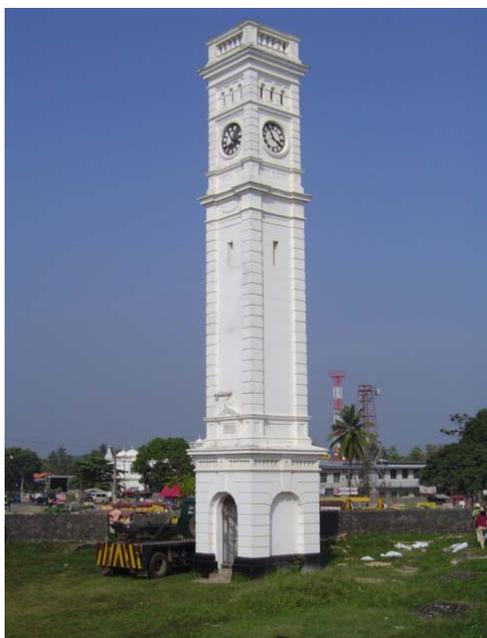
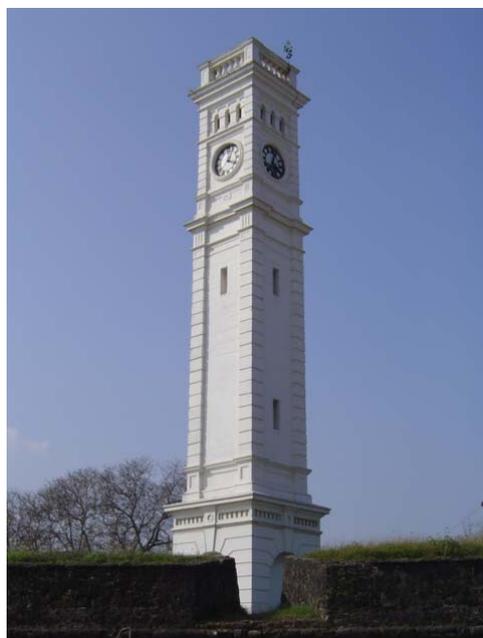
The clock tower was built in May 1883 during the British Period – it is situated on the rampart about 100 m from the sea. The construction material of the foundation and the walls are not known. Like their predecessors, the British too might have used easily available coral/limestone for this purpose. Since this monument is situated on the rampart, the tidal waves did not affect the tower. It is very well maintained and in excellent condition.

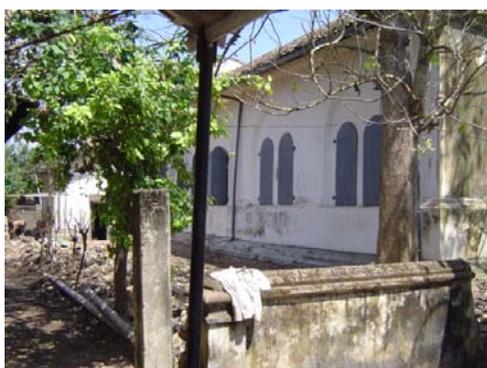
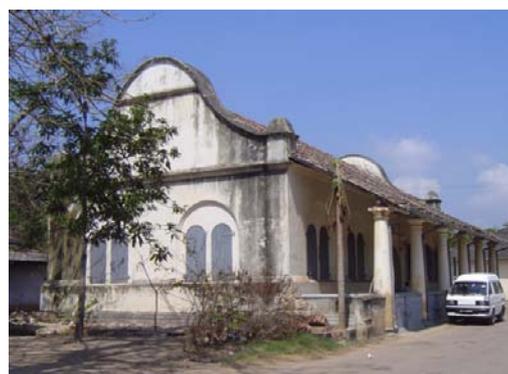
**No: M/M/F/31**

The foundation and the walls of this structure are supposedly made of rubble or limestone. The church is sheltered in half round tiles, while the inside floor of the church is paved with clay tiles and the outside verandah is cement rendering. Beautifully engraved and inscribed gravestones removed from the Dutch (British) cemetery have also been placed inside floor of the church. The tidal wave water level inside the church, as indicated by water marks, had been about 4 feet high. The church had remained in a water logged condition even after the tidal waves have receded, severely affecting the clay tiles on the church floor. Some of these tiles have broken and in other places on the floor have sunk into the ground. Some furniture of antique value has been affected by the salt water.

The round pillared narrow verandah on the front of the building has an iron railing protection and is unharmed. However, the boundary wall facing the sea has been destroyed. The church has already been repaired without any professional consultation. However, archaeologists/ ICOMOS should pay attention before further damage is done.

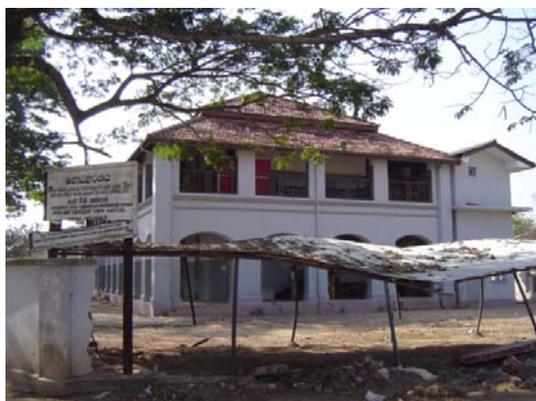
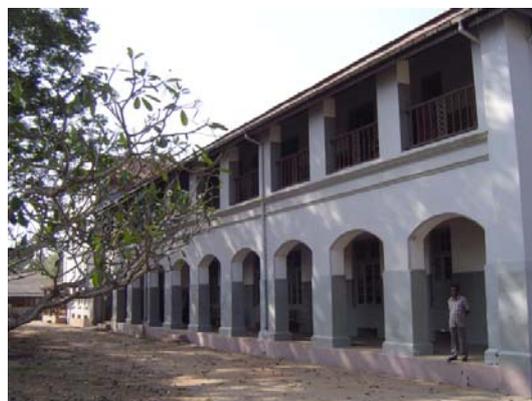
**No: M/M/F/32**

The construction material of the foundation is unknown. Its walls are built of cabock. The Calicut tiled roof is in excellent condition as are the cement rendered floors and the walls. The doors and the windows are both timber and timber framed glass. No apparent damage to the structure by the tsunami is visible. Only the brick built boundary wall is partly damaged.

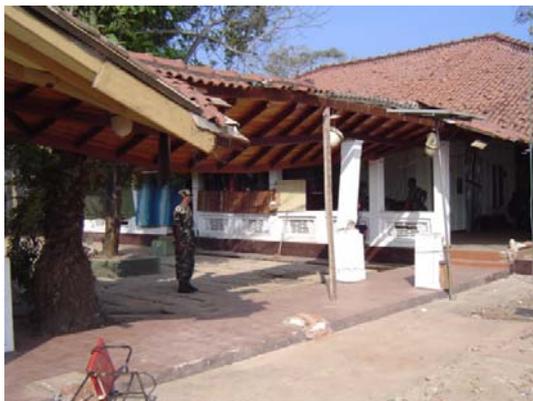
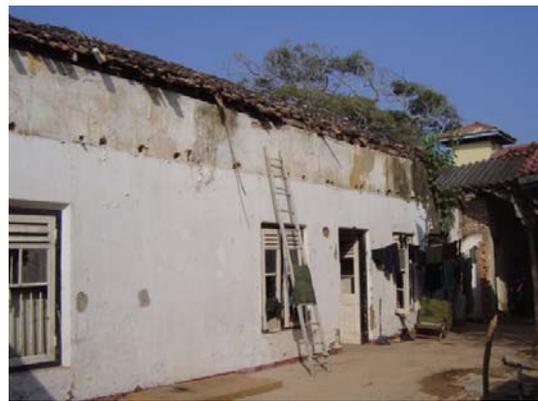
No: M/M/F/33

During our survey none of the hotel management was present and the army had a temporary coordinating office at the site. Thus a close survey of the site was denied. As could be seen from a distance, an old building in front was totally damaged. However the main structure, though substantially damaged, still remains but requires immediate repair. The pillars of the front verandah and its half wall or cement grill work and timber lattice are damaged. Thus the roof is unstable. Timber framed glass doors and windows are either completely destroyed or partly damaged.

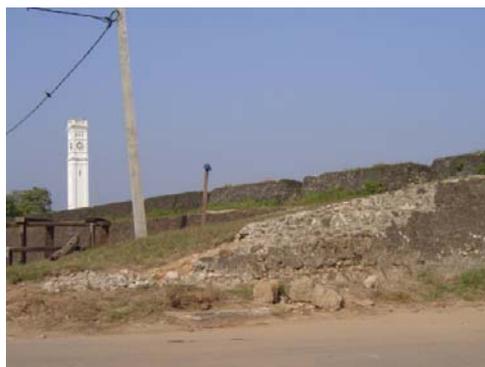
Due to the solidness of the wall, though so closely situated it has received only minimal intervention by the tidal waves. There is slight damage to the approach passage to the wall at the rest house end on the eastern end of the wall. Some limestone /corals have been displaced.

The Matara Fort was gazetted as a protected monument in 1974. Though the damage is so minimal it should be conserved immediately before it is aggravated.

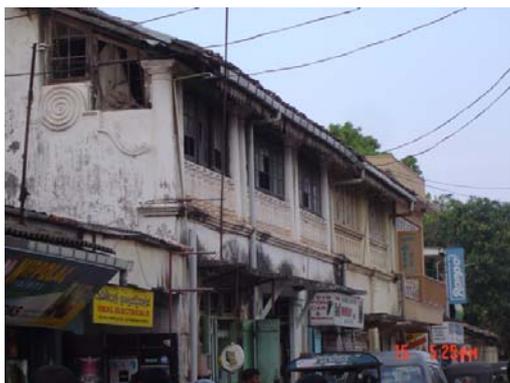
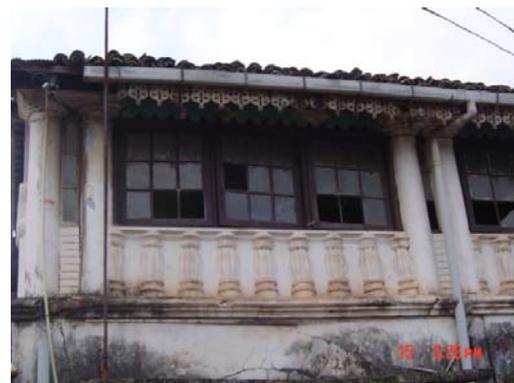
No: M/M/K/37

The construction material of the foundation is thought to be limestone. The walls and the cement rendering floor are damaged due to weathering. The condition of the half round tile sheltered roof cannot be observed.

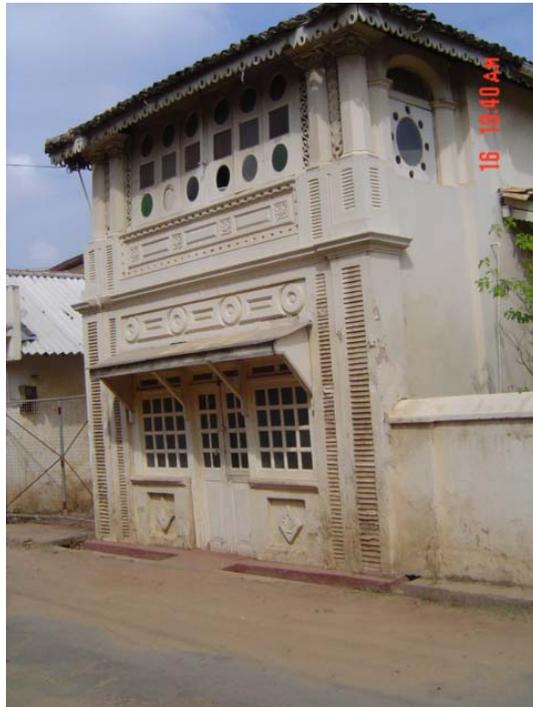
No: M/M/K/38

The owner of the house denied access to the house and it could only be observed from the outside. This two storied building, probably with a timber mezzanine, is located about 800 meters from the sea. Though the Tsunami waves affected this area, this structure is unharmed. The foundation and the walls of this house are said to have been constructed of limestone while the floor is of cement rendering. The Calicut tiled roof is in a state of decay due to weathering. Pre-tsunami cracks on the walls are visible.

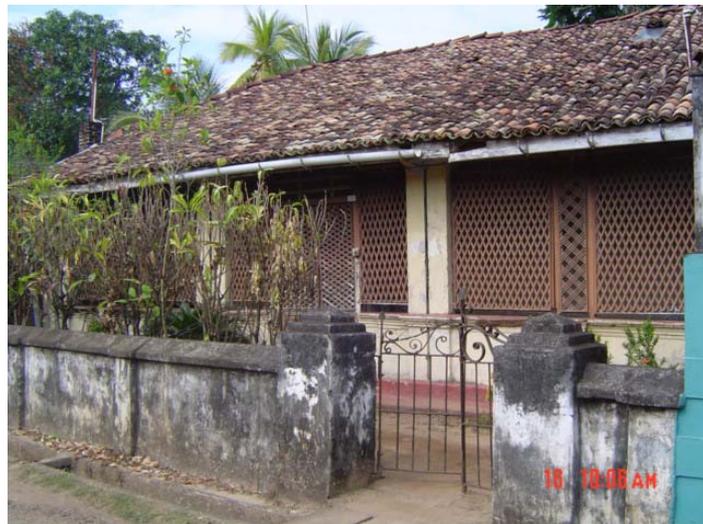
No: M/M/Kn/40

Situated about 400 meters inland from the sea, this structure was not affected by the tidal waves. The half round tiled roof is in a state of decay and requires repairing. The half round tiled roof, brick and cabock built walls and the foundation made of limestone are generally in good condition. Timber doors and windows too, are comparatively well maintained. The floor is cement rendered. The front verandah has a half wall and above it is a timber lattice screen. This lattice work may not be original.

The owner is very anxious to repair/bring down this structure and build a new house here.

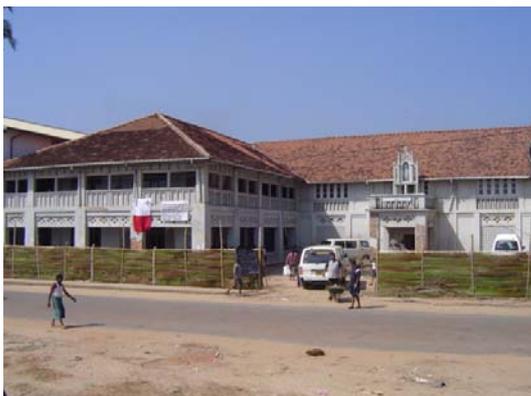
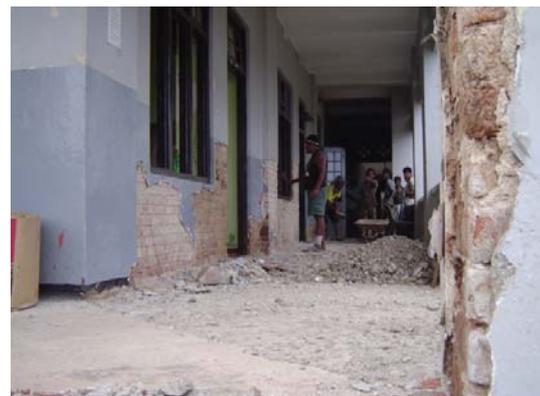
The tidal waves have completely destroyed the boundary walls and damaged the concrete grill work of the outer half wall of the verandah. There is some damage to the plaster too. Some impacts on the floors are also visible. Most of the doors of timber and timber framed glass have either been totally destroyed or badly damaged.

The following day after we recorded this building, the school authorities started renovation work. They removed plaster off the walls up to the level of the water mark and removed the cement floor. They also removed certain portions of the front building in the name of renovations. Thus the post-tsunami renovation work has inflicted more damage to this cultural property than the tsunami. This illustrates the fate of many such buildings where the owners can afford to rebuild them. Therefore, immediate action should be taken to protect such cultural properties.

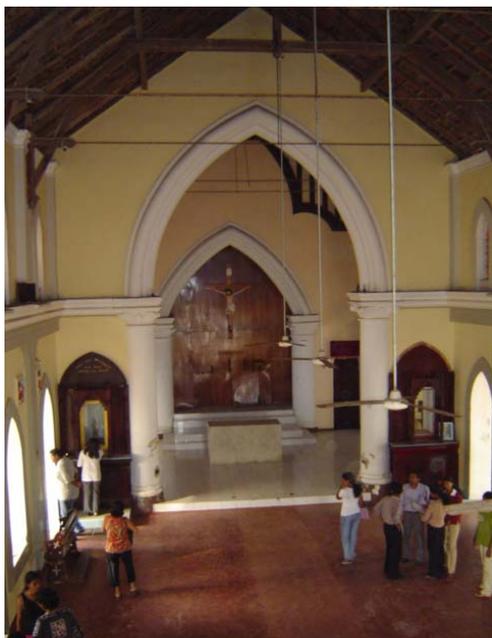
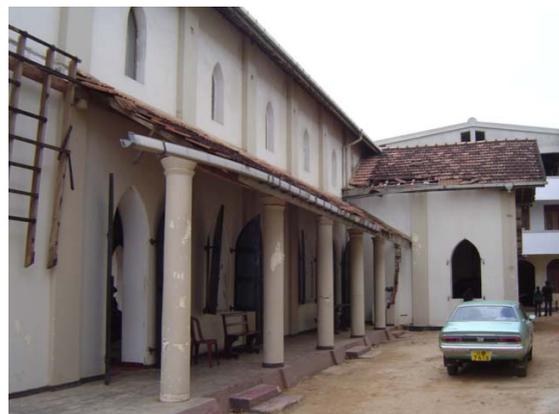
The roof of the church is sheltered in both Calicut tiles and asbestos. The southern side of the roof is damaged due to the tsunami waves. The foundation of the structure is believed to be built of limestone as are the walls. Parts of a wing of walls in front are broken and the columns are cracked. Wall plaster is also damaged but the cement rendering floor is unharmed. The statues are broken and the altar is also damaged. The doors are built of timber while the windows are of timber and stained glass. They too are damaged. The boundary wall is completely destroyed. The repair work was to begin immediately.

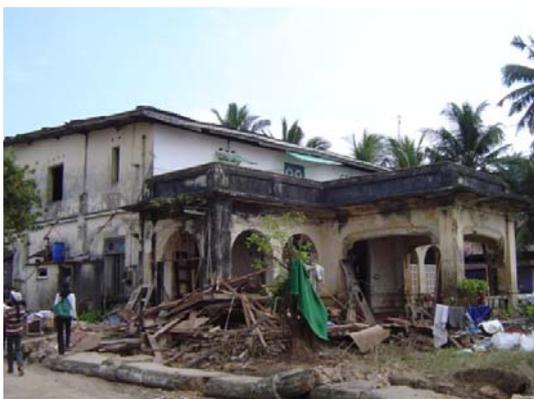
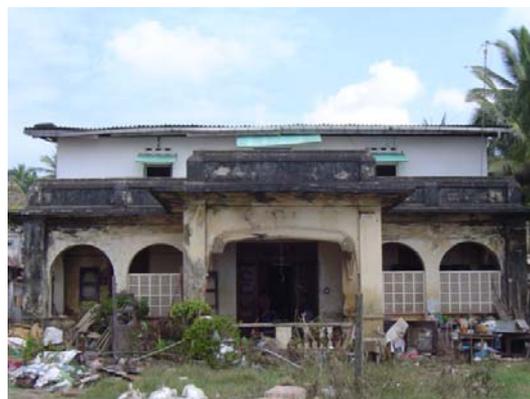
**No: M/M/KS/44**

This building, which has some Islamic architectural characters, is located about 30 meters inland. The present owner claims a history of over 100 years for the original construction. The interior of the house is approached by a portico and a verandah. The building is in a deteriorated condition due to poor maintenance and weathering. The roof of the house is partly of concrete slabs and asbestos. The concrete is badly damaged and the iron mesh of the slab is exposed and corroded.

The brick built wall is slightly cracked and the plaster is damaged due to tidal action and weathering. Algae growth has affected the plaster of the walls. The construction material of the foundation is unknown. The cement rendering floor is decorated with Islamic designs and has cracked due to the tsunami waves.

Approximately 50% of the timber built doors are either damaged or destroyed while about 30% of the timber framed glass windows too are damaged due to the waves. The owners have replaced the doors disregarding their original type. The rear side newly built first floor over the slab does not architecturally fit into the original structure. Some of the furniture of antiques value is damaged or lost. Attention should be paid to immediately restore the building.

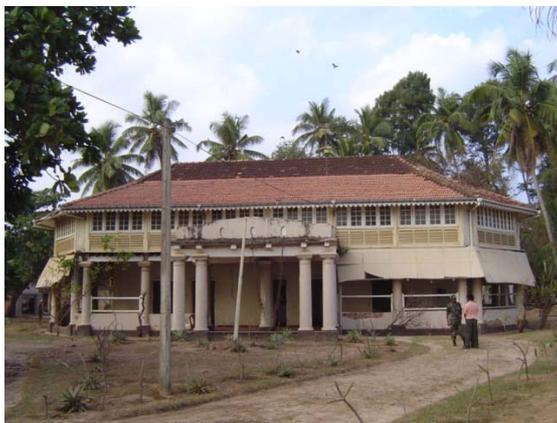
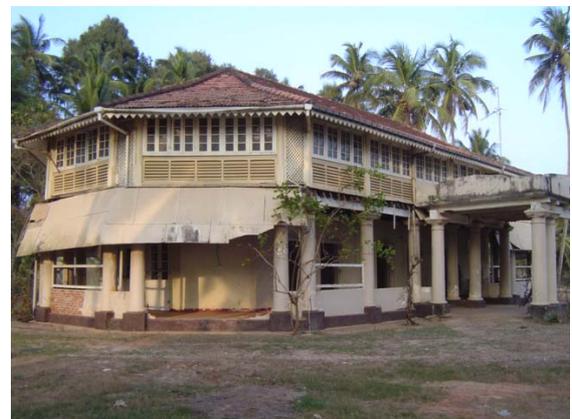
**No: M/M/KS/45**

The construction material of the foundation is unknown. The house walls are built of brick and rubble and the plaster on the walls are damaged. There are pre-tsunami cracks on the walls and vegetation growth is damaging the structure.

There is a round columned sun shade/portico at the front and a verandah all around the house. The half wall between the verandah columns is partly damaged and the timber lattice work above it has been completely destroyed.

The half round tiled roof is in good condition and no damage due to the tsunami is visible. Pre-tsunami cracks on the cement rendering floor are visible. Approximately 80% of the timber framed glass doors are damaged/destroyed while about 10% of the windows are damaged.

The kitchen is located behind this structure and it is joined to the house by a timber pillared open passage. Doors and windows are damaged. The structure is stable but needs urgent attention to restore it. The boundary wall is also partly destroyed.

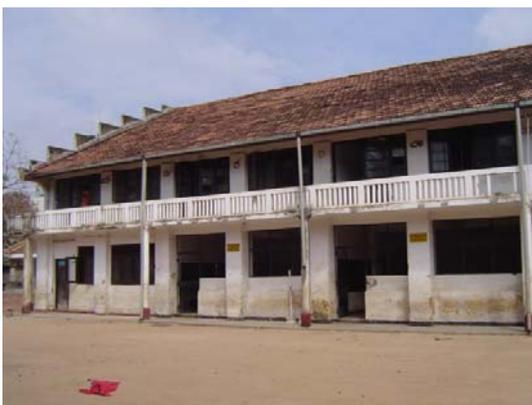
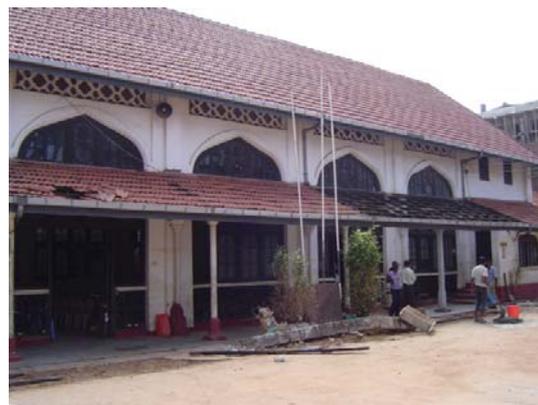
This college built in 1897 is situated about 100 meters from the sea. The Main Hall is the oldest building in the school. The Calicut tiled roof is slightly damaged due to tsunami waves.

Damage to the brick built walls and their plaster is minimal. Slight damage to the timber and glass doors and windows were noticed. The cement rendering floor is unharmed and the foundation of which the construction material is unknown is unaffected. The front side boundary wall is completely destroyed. The repair work had already begun as the principal was keen to re-open the school soon.

**Level of Intervention** : **Minimal Level of Intervention (10-20%)**  
**Estimated Cost for the Conservation** : **Rs. 378,000.00**  
**Location Map/GIS Coordinates** : **Map-i/M/M.KS/52**
