ICOMOS Sri Lanka

**Preliminary Survey of Tsunami-affected Monuments and  
Sites in the Maritime Region of Sri Lanka**

The Southern Maritime Region:  
from the Walawe Ganga to the Nilvala Ganga

March 2005

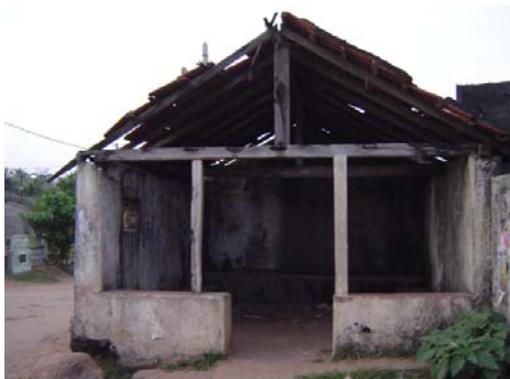
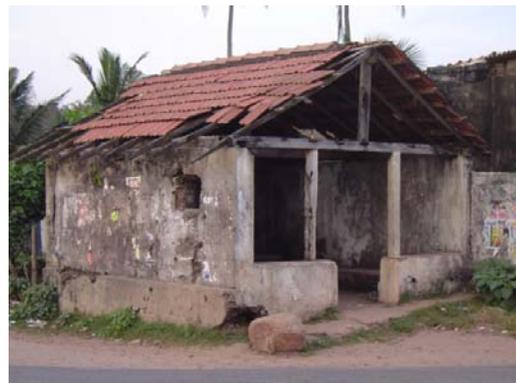
This single cell structure is situated about 20 meters from the sea at the Rassandeniya junction about 800 meters from the University of Ruhuna – between the 164 – 165 km posts. This single celled structure with brick walls is sheltered in Calicut tiles and is in a poor state of preservation. The cement rendering floor is also damaged. The foundation is limestone. This monument is situated at a higher elevation for which reason it was unharmed by the tidal waves. Damage is due to negligence and weathering. Urgent attention is required to preserve this historic monument.

**Level of Intervention** : **Minimal Level of Intervention (10 - 20%)**  
**Estimated Cost for the Conservation** : **Rs. 80,000.00**  
**Location Map/GIS Coordinates** : **Map-i/M/M/M/54**

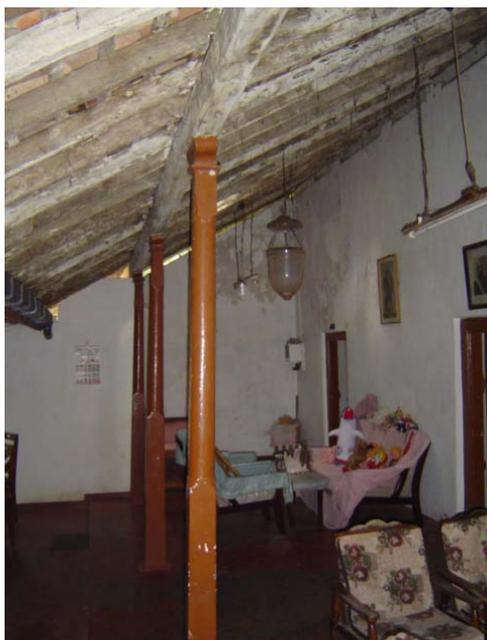
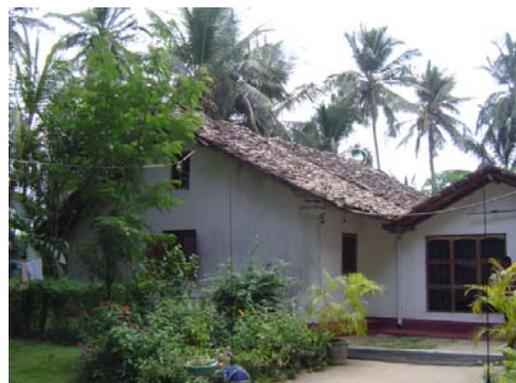
Tsunami tidal waves did not affect this house. The foundation and the walls of this house are built of limestone while the floor is cement rendered. The house is roofed in half round tiles. The roof and walls are in a state of decay.

**Level of Intervention** : **Minimal level of Intervention (0-10%)**  
**Estimated Cost for the Conservation** : **Rs. 300,000.00**  
**Location Map/GIS Coordinates** : **Map-i/M/D/DW/57**

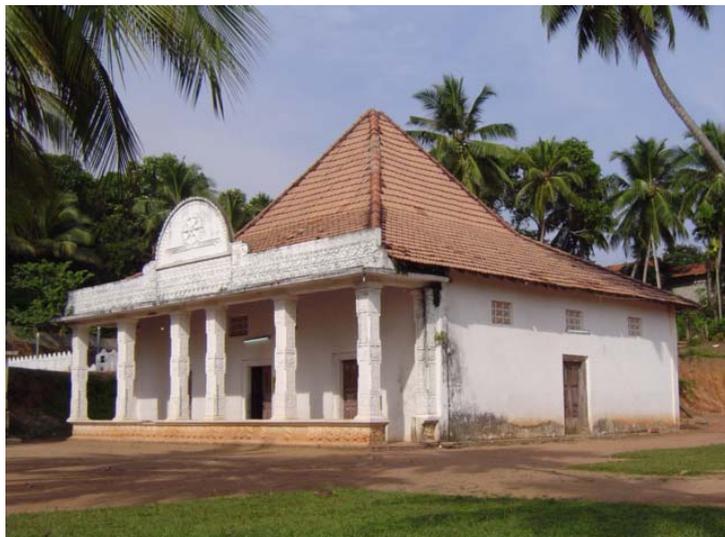
This structure was unaffected by the tsunami. The construction material of the foundation and the walls are unknown. The floor is cement rendered and the roof is sheltered in Calicut tiles.

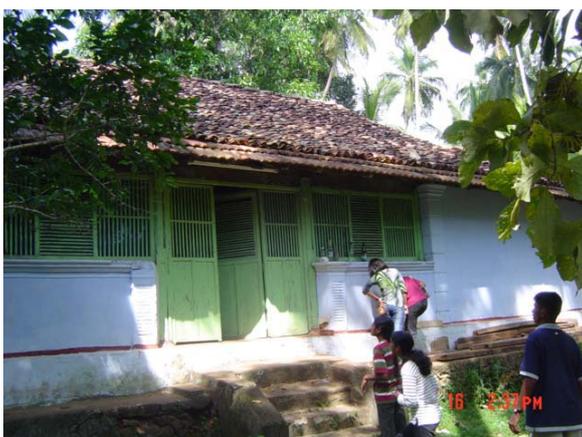
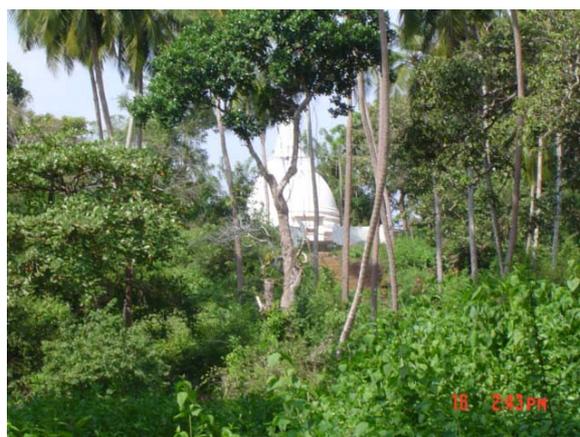
The oldest construction in the *vihara* premises is the *avasage*. The original half round tiled roof is in a state of decay. A portion of this roof is sheltered in Calicut tiles. The roof should be repaired immediately.

**Level of Intervention** : Minimal Level of Intervention (0-10%)  
**Estimated Cost for the Conservation** :Rs. 150,000.00  
**Location Map/GIS Coordinates** : Map-i/M/D/W/66

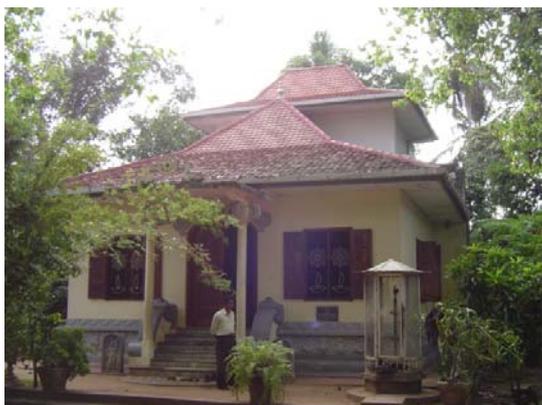
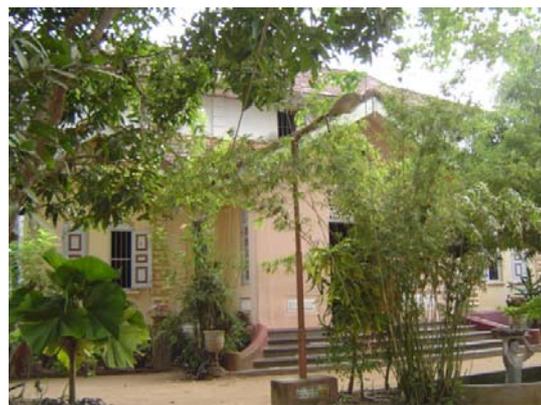
The *avasage* is the oldest building in the temple. The construction material of the foundation and the walls are unknown. The roof is sheltered is Calicut tiles. The doors and windows are timber. The floor is cement rendered. No urgent conservation in required
