**RENOVATION OF THE ROMANESQUE CATHEDRAL
OF RODA DE ISABENA IN THE PYRENEES (PROVINCE OF HUESCA)
AND OF ITS URBAN SETTING**

Architect : Francisco Pons-Sorolla Y Arnau.

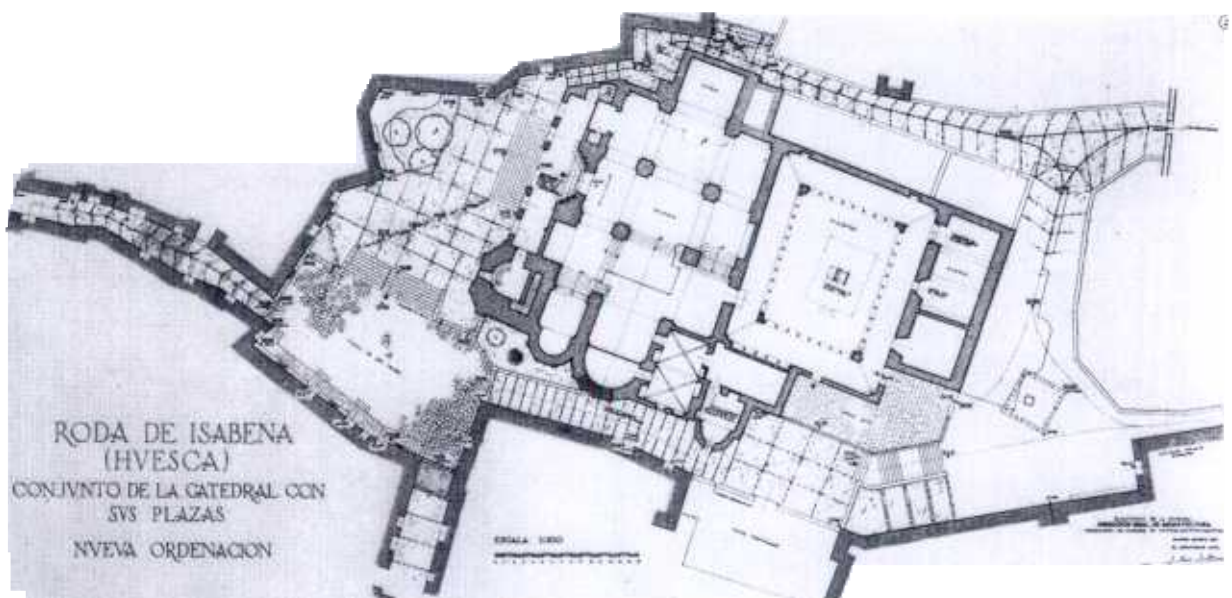
Fig. 8. Overall plan of the renovation scheme.

The renovation scheme covered the central nucleus of the town, consisting of the Cathedral with the buildings adjacent to it, the surrounding streets and squares with the houses in them, and the Bishop's Palace. The work was done with an eye to the unity of the whole, as the strongly homogeneous character of the area demanded. Operations lasted from 1962 to 1967, the total amount invested being five million pesetas.
