The restoration of the *nirvana-stupa* of
the Buddha at Kusinara, India

R. SENGUPTA

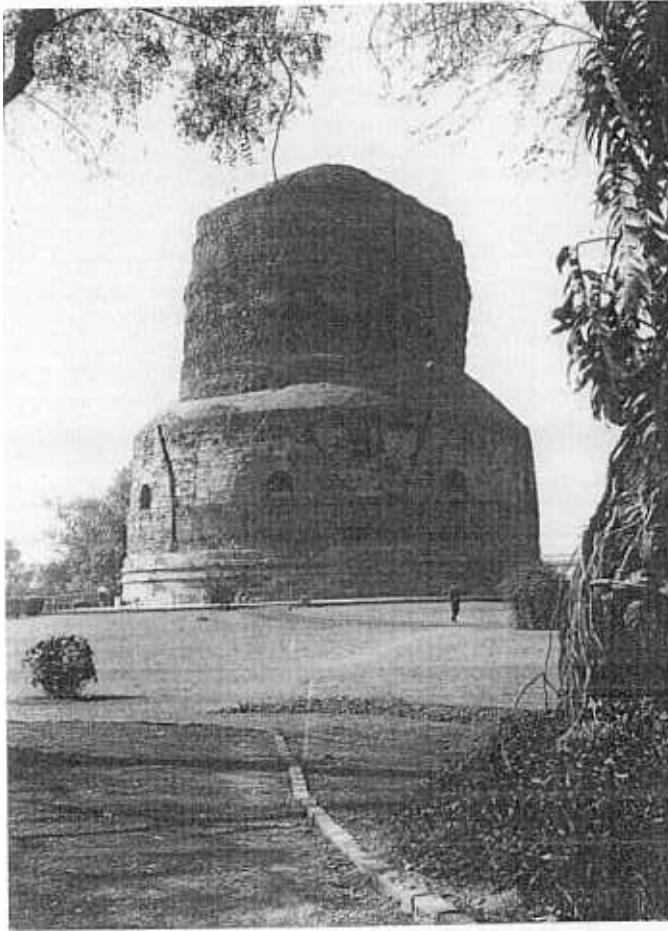
The ruins of *stupas*, the Dhameka at Sarnath and the Ramabhar at Kusinara (Fig. 4) are solid structures. For that reason this *stupa* also was assumed to be of similar construction, and it was suggested that the cracks be opened up for repair with full-sized bricks so that proper bonding could be established. It seemed unthinkable that such a huge structure should have a thin encasing wall only. Had the facts of past restorations been maintained and available, it would have been possible to take immediate remedial measures by covering the *stupa* to prevent further seepage of rain water, removing the saturated filling from inside the structure by opening a section of the shell, and withdrawing the cause of the outward thrust that was causing the cracks. Thereafter, further measures to control the capillarity and to strengthen the faulty structure could have been taken.

FIG. 4. The Dhameka *stupa* at Sarnath; note the shape and the solid brickwork.

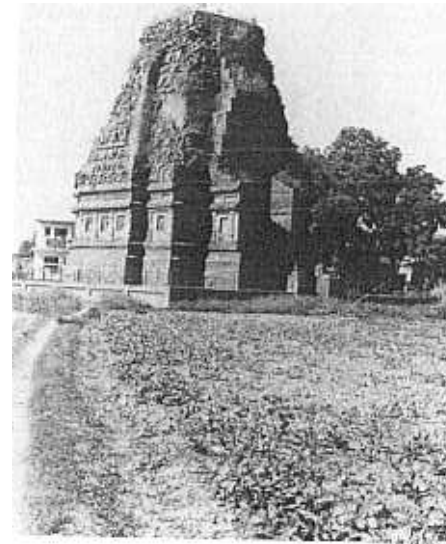
The temple itself was restored in 1876 by Carlleyle,³ reputedly following the available evidence of the earlier construction. From old drawings it appears that the temple had lateral projections similar to those of the Vaital deul (seventh century AD) at Bhubanesvar, the Bhitargaon temple (sixth century AD) (Figs 7, 8), and Telika Mandir (c. sixth century AD) at Gwalior. During the restoration Carlleyle did not follow the

FIG. 7. The Bhitargaon temple.

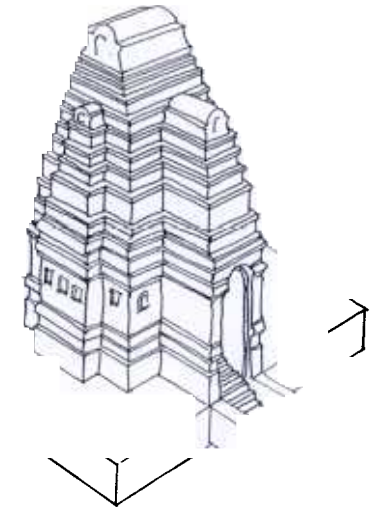
FIG. 8. Conjectural form of the Bhitargaon temple (after Percy Brown), which is suggestive of the likely shape of the *nirvana* temple.
