CONSERVATION OF PAINTED LIME PLASTER ON MUD BRICK WALLS
AT TUMACACORI NATIONAL MONUMENT, U.S.A.

ANTHONY CROSBY

JULY, 1980

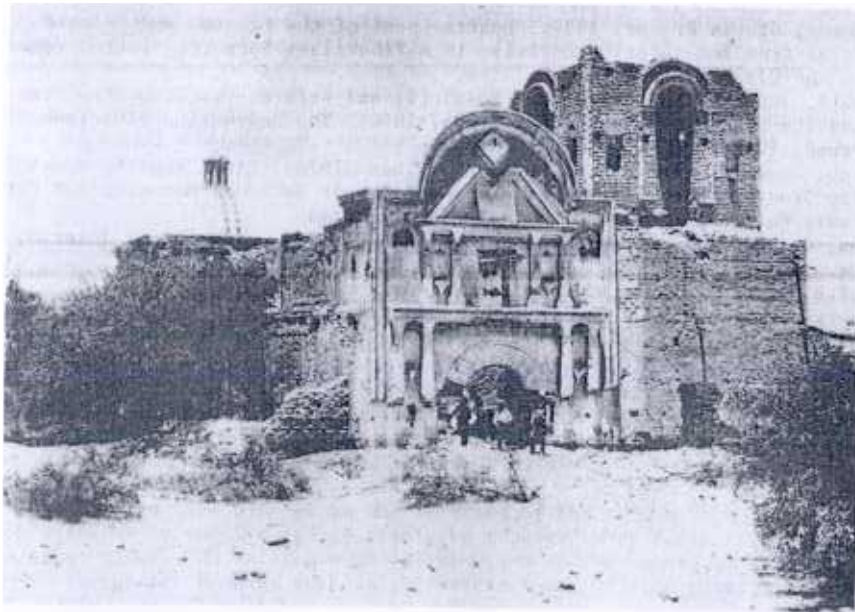
In 1767 the Jesuits were expelled from the New World and the Franciscan Order was placed in charge of this mission area. The Franciscans probably utilized the existing Jesuit structures at Tumacacori until the last years of the 18th century. By ca. 1790 they had begun work on new adobe buildings and had undertaken a major alteration of the existing structures at the same location. Construction continued intermittently on this complex until about 1827 when the recently established country of Mexico ordered the expulsion of all Spaniards from Mexican lands. The church was never completed, and the associated village was finally abandoned by the indigenous people in 1848 (Figure 1) (Kessell, 1976, p. 308).

Figure 1: Church at Tumacacori in 1889. Photograph #2546, Arizona Historical Society, Tucson, Arizona.

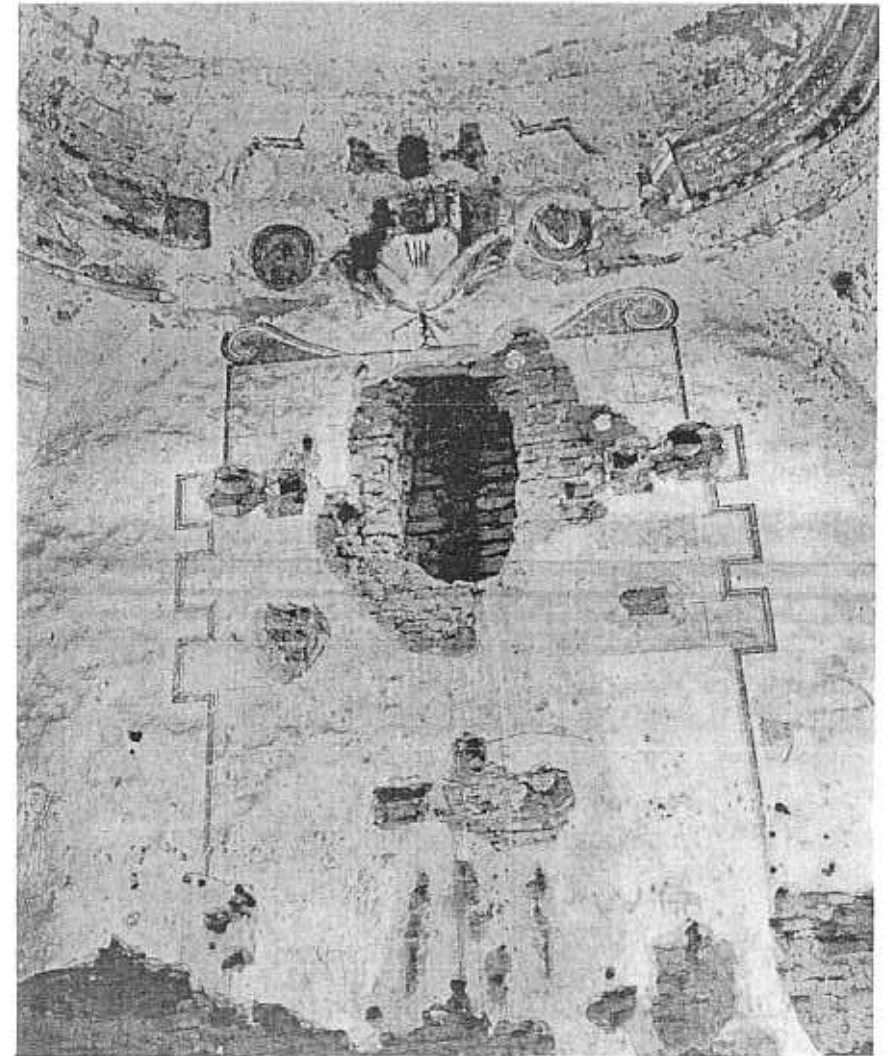
Another obvious problem and the one dealt with in depth here was the loss of the paint in the Sanctuary of the church as it flaked off and fell to the floor. The paint in the Sanctuary is all that is visible of a much more extensive decorative scheme; consequently its preservation was of a high priority (Figure 2). However, it was simply not feasible to begin any extensive conservation work before knowing the actual conditions that led to the loss of the paint. A related problem that has proved more difficult to solve is the loss of the integrity of the bond between the lime plaster ground to the mud brick walls.

Figure 2: Painted tablet, main altar, treasury of the church.
