THE EFFECTS OF MODERN RESTORATION TECHNIQUES ON THE PREHISTORIC TEMPLES OF THE MALTESE ISLANDS

Gennaro TAMPONE, Dipartimento di Storia dell'Architettura e di Restauro delle Strutture Architettoniche, Università di Firenze, ITALIA.

Sergio VANNUCCI, Istituto di Mineralogia e Petrografia dell'Università di Urbino, ITALIA.

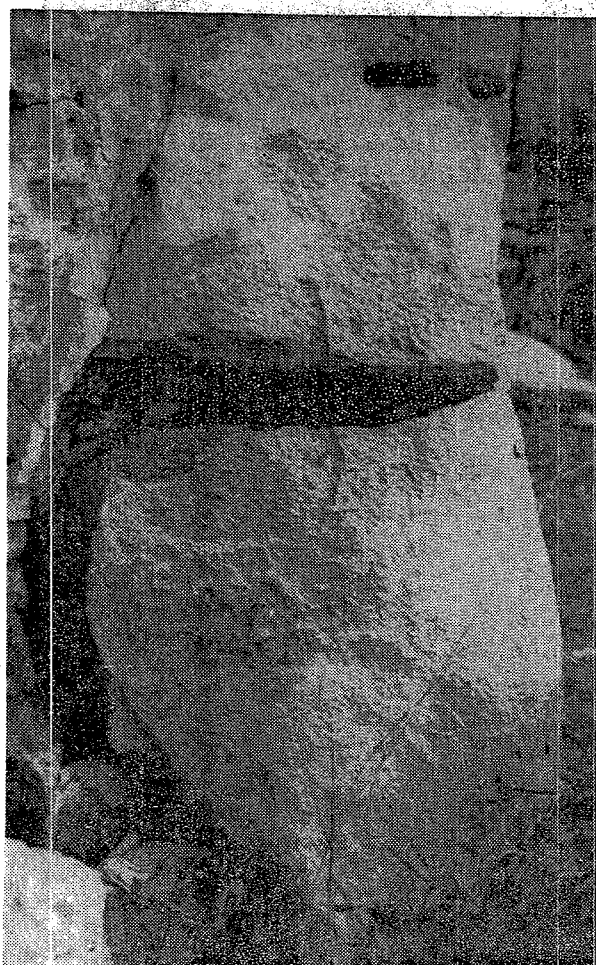
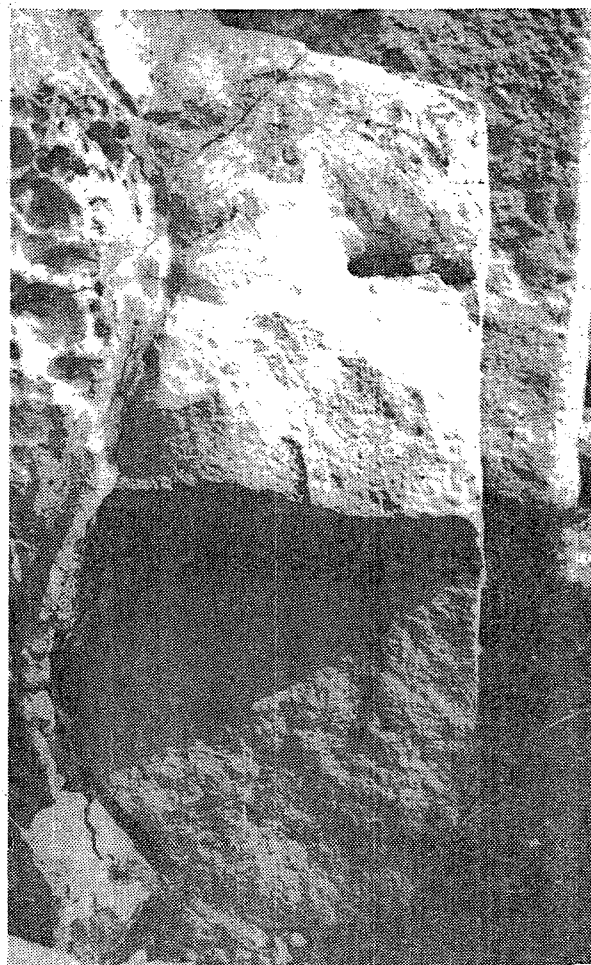
ce in the restoration of stone monuments, can be observed in the Tarxien temple. No records of them can be found but we may suppose that were done soon after excavation. In one case the device itself has broken owing to further movement and in another the crack later by-passed the device. In both cases, in fact, the cause of the cracks had not been removed.

Many of the soft Globigerina Limestone blocks are affected by splitting and by widespread cracks; the mechanical action (the weight of the upper masonry, concentration of pressure in small areas, etc.) must be taken into account as the principal cause of these degradations, but the influence of weather factors must also be acknowledged. The use of iron bars inserted in the broken blocks and sealed to the stone, a method widely adopted in the temples, especially those of Tarxien and Hagar Qim, has in many cases caused severe damage. The different thermal behaviour of the stone, of the concrete or resin sheath, of the metal and the products of corrosion, particularly where the exposure of the blocks renders them subject to a great temperature and humidity gradient, has caused a network of new cracks characterized by rupture surfaces orthogonal to the previous one and a radial disposition around the bar. The consequent penetration of humidity combined with the action of marine salts accounts for the rusting and corrosion of the bar, the increase in volume of the metal and its corrosion products, and a resulting acceleration of the whole complex process.

The defective bond is certainly the cause of concentration of pressure in small areas and, therefore, also the cause of cracks in the underlying blo-

cks, as can be observed in Hagar Qim and Tarxien (see plate). We must, therefore, realize that the use of the most advanced techniques does not in itself produce good results. They cannot be successful where they are not in keeping with the techniques used in the original construction of the monument under restoration or where the possible future effects of such technical intervention are not taken into account.
