**Preliminary Survey of Tsunami-affected Monuments  
and Sites in the Maritime Region of Sri Lanka**

**The Southern Maritime Region:  
from the Nilvala Ganga to the Gin Ganga**

Prof. S. Manawadu  
and  
The ACOMAS Unit of the Department of Architecture  
University of Moratuwa

March 2005

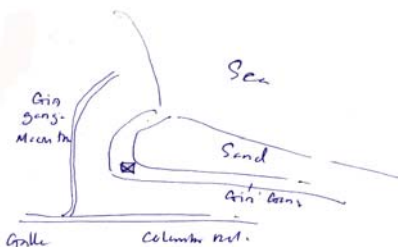
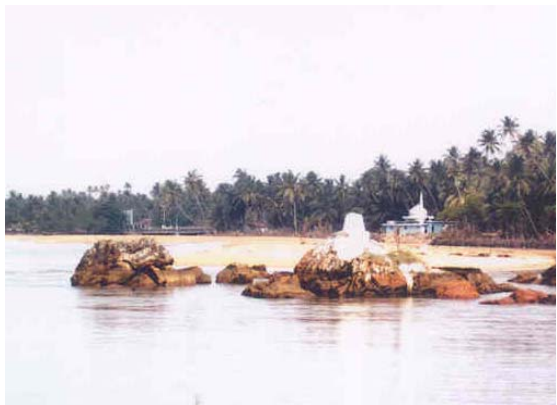
<b>Element</b>		<b>Material</b>		<b>Extent of Damage</b>	
<i>Roof</i>		-			
<i>Walls</i>		Located in the middle of the river mouth on a high boulder			
<i>Doors</i>		- Stupa damaged, small image house washed away			
<i>Windows</i>		- Bo tree plant affected			
<i>Floor</i>		-			
<i>Foundation</i>					
<i>Site</i>					
<i>Other</i>		Can be reconstructed

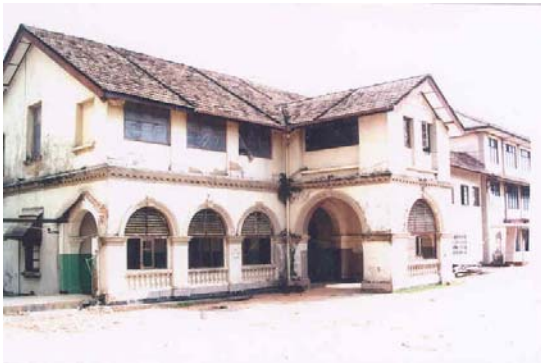
<b>Element</b>		<b>Material</b>		<b>Extent of Damage</b>	
<i>Roof</i>		Calicut tiles		No damage	
<i>Walls</i>		Brick		20%	
<i>Doors</i>		Timber		Ground floor doors 100% damaged	
<i>Windows</i>		Timber		Ground floor windows 100% damaged	
<i>Floor</i>		Cement		30%	
<i>Foundation</i>		Rubble		10%	
<i>Site</i>		Damaged front boundary wall.			
<i>Other</i>		(1914 - British Period) Flood height approximately 10'.0.

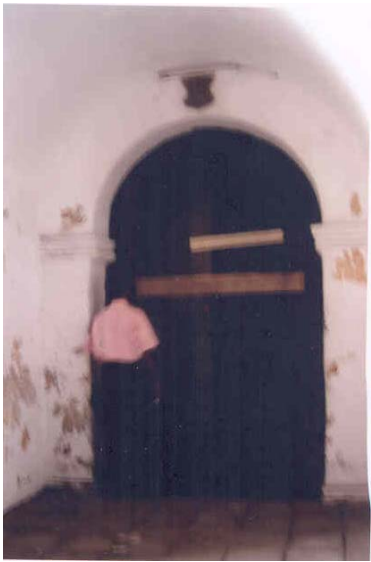
<b><i>Element</i></b>		<b><i>Material</i></b>		<b><i>Extent of Damage</i></b>	
<i>Roof</i>		Half round tiles		No damage	
<i>Walls</i>		Cabock		5% at ground floor level	
<i>Doors</i>		Timber		10% ground floor	
<i>Windows</i>		Timber		10% ground floor	
<i>Floor</i>		Clay tile		Less than 10%	
<i>Foundation</i>		Rubble			
<i>Site</i>		Internal partitions and display objects completely destroyed due to flooding up to 9'.0".			
<i>Other</i>		Large inflow of water from old Port entrance gate door to Hospital Street.

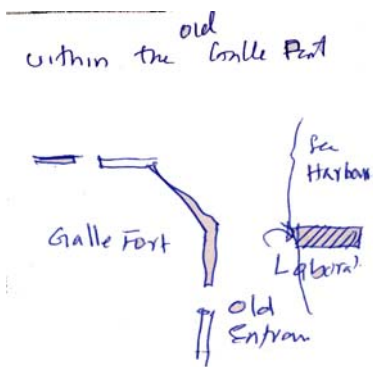
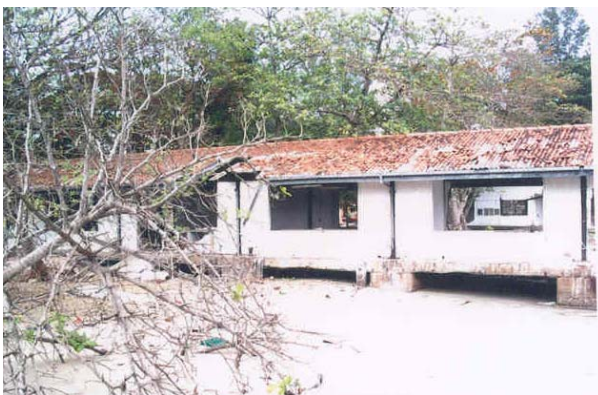
GA 06	Maritime Laboratory	Avondster Project, Fort, Galle	New building accommodating research facilities.	Totally destroyed with equipment	15,000,000.00	Building cost only. Equipment cost is not included.
GA 07	Ramparts behind old Kachcheri of Galle Fort (World Heritage Site)	Fort, Galle	Dutch fortification in stone and coral.	Minimum	2,000,000.00	Three small sections on the western ramparts.
				for investigations	10,000.00	
GA 08	Municipal Fruit Market	Old Matara Road, Galle	Renovated Early British building.	Significant	2,000,000.00	Veranda with its pillars and roof is damaged.
GA 09	Mosque between Old Matara and New Matara Road at Pettigala	Old Matara Road, Galle	New building with only cultural significance.	Significant damage	2,000,000.00	
GA 10	Walle Devalaya	Unawatuna, Galle	New buildings but with cultural significance.	Totally destroyed	3,000,000.00	To be restored as a place of veneration by a large majority.

<b>Element</b>		<b>Material</b>		<b>Extent of Damage</b>	
<i>Roof</i>		Tiles on asbestos		50%	
<i>Walls</i>		Cement block		50%	
<i>Doors</i>				100% damaged	
<i>Windows</i>				100% damaged	
<i>Floor</i>		Cement		30%	
<i>Foundation</i>		Concrete			
<i>Site</i>					
<i>Other</i>

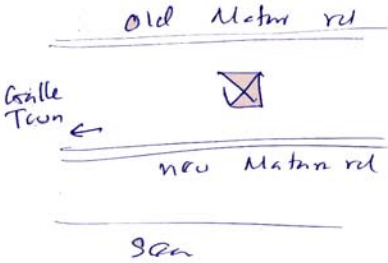
<b>Element</b>		<b>Material</b>	<b>Extent of Damage</b>		
<i>Roof</i>		Except for the middle part, all the structures were completely destroyed.			
<i>Walls</i>					
<i>Doors</i>					
<i>Windows</i>					
<i>Floor</i>					
<i>Foundation</i>					
<i>Site</i>					
<i>Other</i>		Only the centre of the building remains, other structures have been destroyed.

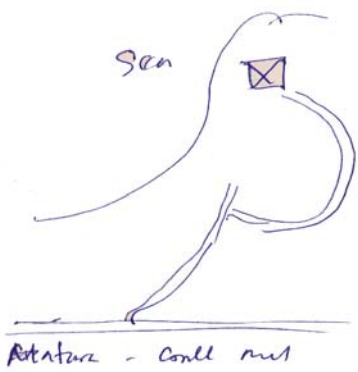
<b>Element</b>	<b>Material</b>	<b>Extent of Damage</b>		
<i>Roof</i>	Calicut tiles	100%		
<i>Walls</i>	Masonry	60%		
<i>Doors</i>	Timber	100%		
<i>Windows</i>	Timber	100%		
<i>Floor</i>	Cement	50%		
<i>Foundation</i>	Rubble	10%		
<i>Site</i>				
<i>Other</i>	Complex of three buildings (all damaged), interior structures partially damaged. Water level above the roof.

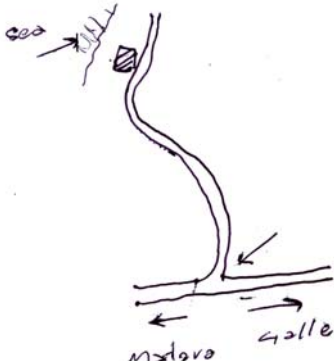
<b>Element</b>		<b>Material</b>		<b>Extent of Damage</b>	
<i>Roof</i>		Half round tiles		70%	
<i>Walls</i>		Lime stone, clay		70%	
<i>Doors</i>		Timber		90%	
<i>Windows</i>		Timber		90%	
<i>Floor</i>		Cement		80%	
<i>Foundation</i>		Rubble		10%	
<i>Site</i>		Sand		10%	
<i>Other</i>

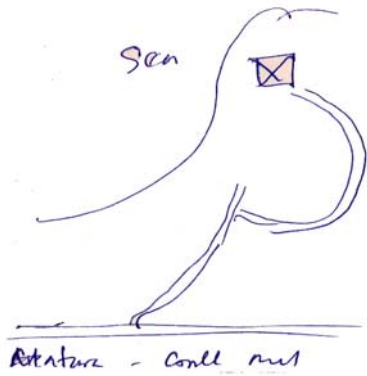
<b>Element</b>		<b>Material</b>		<b>Extent of Damage</b>	
<i>Roof</i>		Calicut tiles and R.C.C.		No damage	
<i>Walls</i>		Masonry		10%	
<i>Doors</i>		Timber		No damage	
<i>Windows</i>		Timber		No damage	
<i>Floor</i>		Cement		No damage	
<i>Foundation</i>					
<i>Site</i>					
<i>Other</i>		4'.0" water level

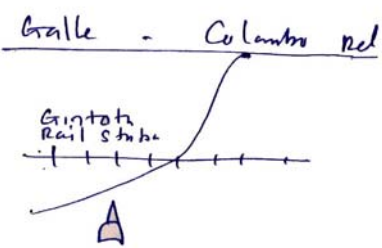
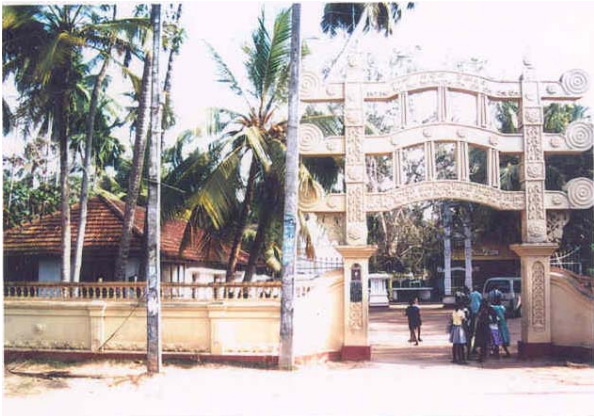
<b>Element</b>		<b>Material</b>		<b>Extent of Damage</b>	
<i>Roof</i>	Tiles		No damage. Flooded by water from the canal.		
<i>Walls</i>	Masonry				
<i>Doors</i>	Timber				
<i>Windows</i>	Timber				
<i>Floor</i>	Cement				
<i>Foundation</i>					
<i>Site</i>					
<i>Other</i>	Contemporary buildings of no particular architectural value.

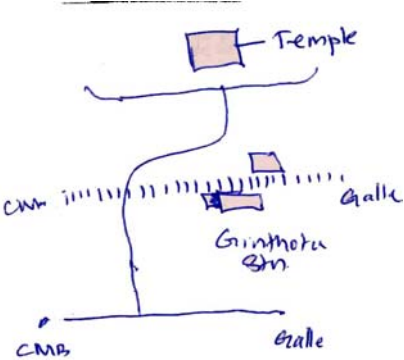
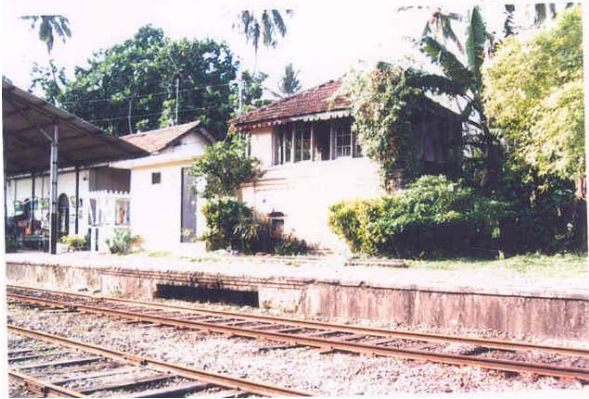
<b>Element</b>		<b>Material</b>		<b>Extent of Damage</b>	
<i>Roof</i>	Calicut tiles		No damage		
<i>Walls</i>					
<i>Doors</i>	Timber				
<i>Windows</i>	Timber				
<i>Floor</i>	Cement				
<i>Foundation</i>					
<i>Site</i>					
<i>Other</i>	Derelict but not due to the tsunami.

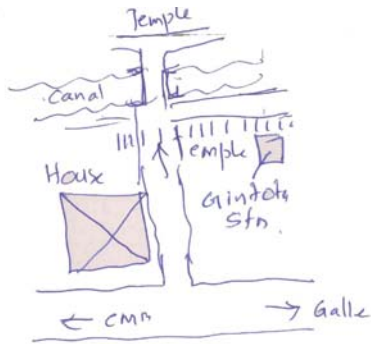
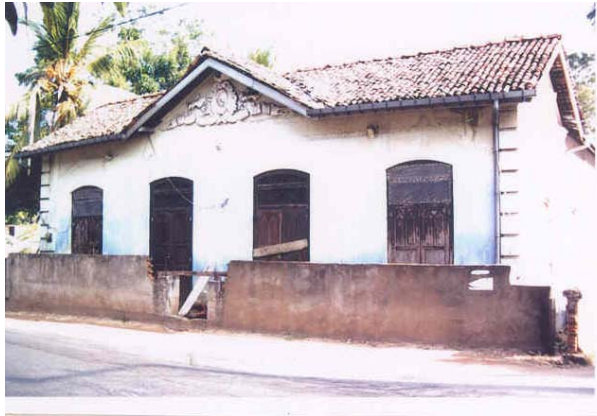
<b>Element</b>		<b>Material</b>		<b>Extent of Damage</b>	
<i>Roof</i>	Half round		No damage		
<i>Walls</i>	Adobe				
<i>Doors</i>	Wooden				
<i>Windows</i>	Wooden				
<i>Floor</i>	Cement				
<i>Foundation</i>	Rubble				
<i>Site</i>	30 - 40P garden with a few trees.				
<i>Other</i>	Site flooded, furniture affected, no physical damage to structure. Occupant temporarily resident in Colombo.

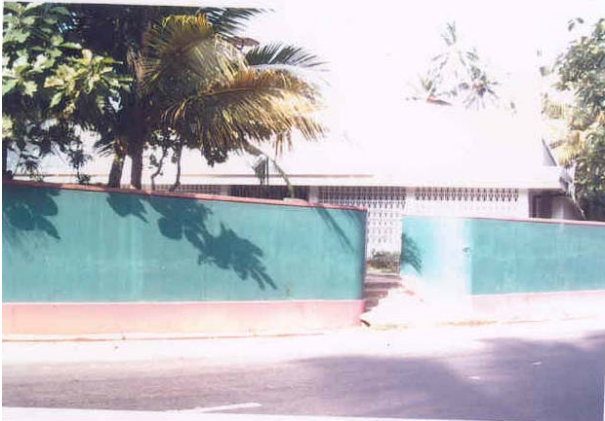
<b>Element</b>		<b>Material</b>		<b>Extent of Damage</b>	
<i>Roof</i>				No damage	
<i>Walls</i>		Masonry			
<i>Doors</i>		Timber			
<i>Windows</i>		Timber			
<i>Floor</i>		Cement			
<i>Foundation</i>		Rubble			
<i>Site</i>					
<i>Other</i>

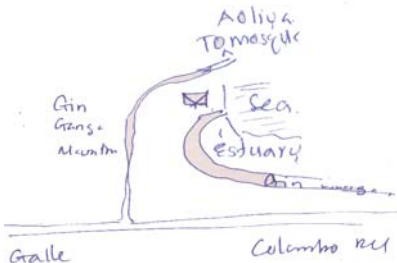
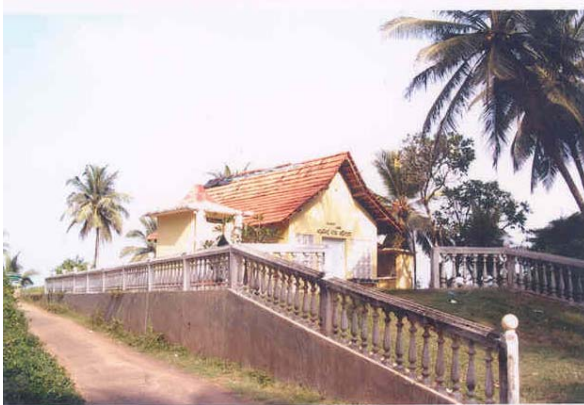
<b>Element</b>		<b>Material</b>		<b>Extent of Damage</b>	
<i>Roof</i>	Calicut tiles		No damage		
<i>Walls</i>					
<i>Doors</i>	Timber				
<i>Windows</i>	Timber				
<i>Floor</i>	Cement				
<i>Foundation</i>	Rubble				
<i>Site</i>					
<i>Other</i>	Buildings are of no architectural value but the site is of socio-historic value.

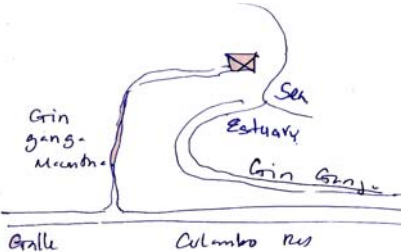
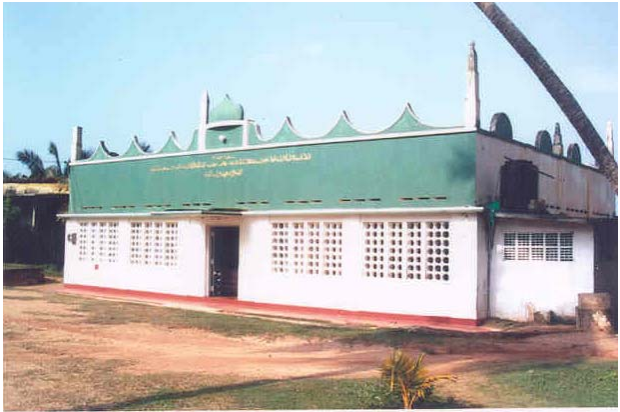
<b>Element</b>		<b>Material</b>		<b>Extent of Damage</b>	
<i>Roof</i>				No damage	
<i>Walls</i>		Masonry			
<i>Doors</i>		Timber			
<i>Windows</i>		Timber			
<i>Floor</i>		Cement			
<i>Foundation</i>		Rubble			
<i>Site</i>		Rear retaining wall was damaged.		50%	
<i>Other</i>

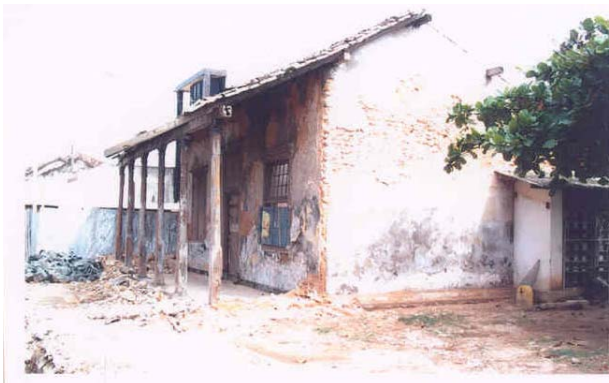
<b><i>Element</i></b>		<b><i>Material</i></b>		<b><i>Extent of Damage</i></b>	
<i>Roof</i>		Half round tiles		50%	
<i>Walls</i>		Sandstone and limestone		20%	
<i>Doors</i>		Timber		50%	
<i>Windows</i>		Timber		60%	
<i>Floor</i>		Cement		50%	
<i>Foundation</i>		Rubble			
<i>Site</i>					
<i>Other</i>		(Marked for demolition for road expansion but worthy of preservation. Cluster of buildings in front towards Colombo, need serious consideration in terms of their grouping and street access to Galle).

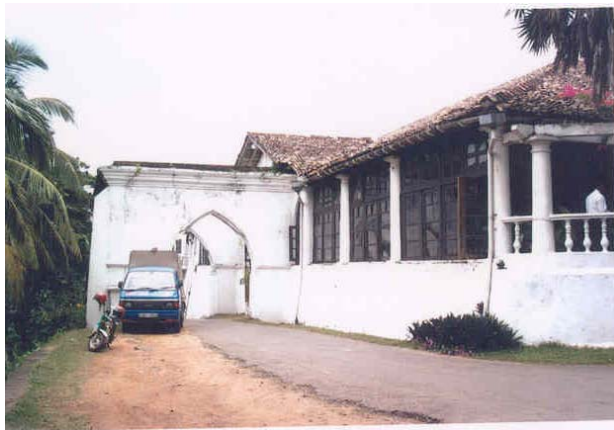
<i>Roof</i>		Tiles			
<i>Walls</i>		Sandstone		Building not affected due to high elevation.	
<i>Doors</i>		Timber			
<i>Windows</i>		Timber			
<i>Floor</i>					
<i>Foundation</i>					
<i>Site</i>		Rear of the site was flooded.			
<i>Other</i>

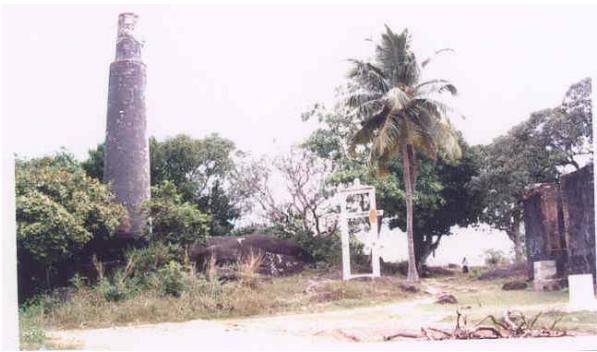
<b>Element</b>		<b>Material</b>		<b>Extent of Damage</b>	
<i>Roof</i>	Tiles		Not affected due to high elevation.		
<i>Walls</i>	Limestone (tower) and brick				
<i>Doors</i>	Timber				
<i>Windows</i>	Timber				
<i>Floor</i>					
<i>Foundation</i>					
<i>Site</i>					
<i>Other</i>

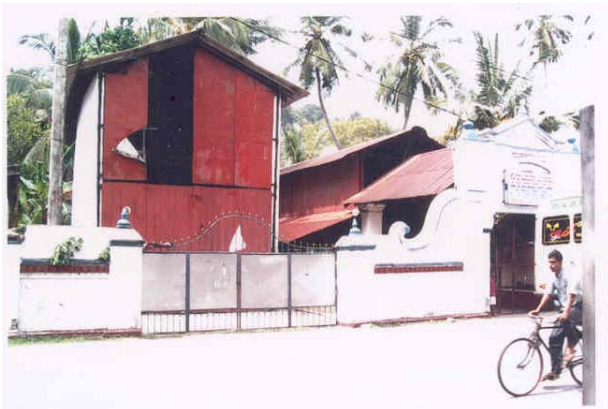
<b>Element</b>		<b>Material</b>		<b>Extent of Damage</b>	
<i>Roof</i>		Calicut tiles		Not affected or damaged (2'.0" water level due to flooding from the rear canal).	
<i>Walls</i>		Masonry			
<i>Doors</i>		Timber			
<i>Windows</i>		Timber			
<i>Floor</i>		Cement			
<i>Foundation</i>		Rubble			
<i>Site</i>					
<i>Other</i>

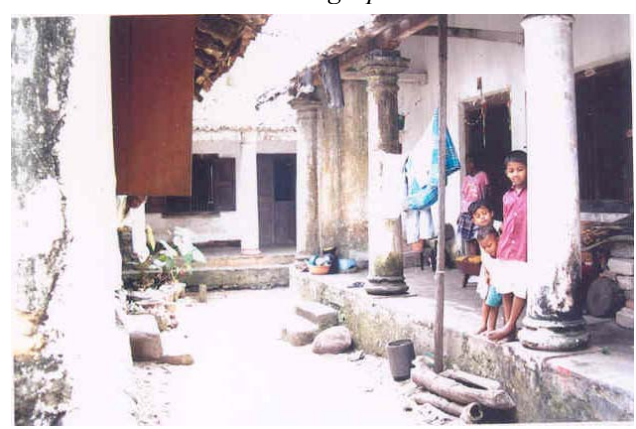
<b>Element</b>		<b>Material</b>		<b>Extent of Damage</b>	
<i>Roof</i>		Half round tiles		No damage due to the tsunami but decaying due to age.	
<i>Walls</i>		Cabock			
<i>Doors</i>		Timber			
<i>Windows</i>		Timber			
<i>Floor</i>		Clay tiles			
<i>Foundation</i>		Rubble			
<i>Site</i>					
<i>Other</i>		Late Dutch and Early British Period building complex.

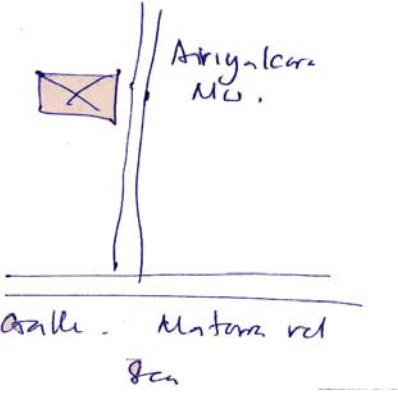
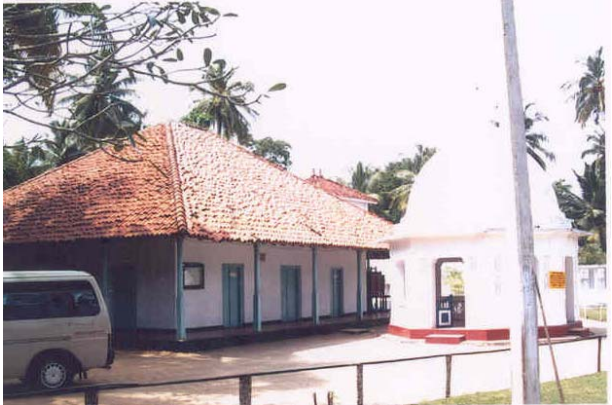
<b>Element</b>		<b>Material</b>		<b>Extent of Damage</b>	
<i>Roof</i>	Clay tiles		No damage		
<i>Walls</i>	Masonry				
<i>Doors</i>	Timber				
<i>Windows</i>	Timber				
<i>Floor</i>	Cement				
<i>Foundation</i>	Rubble				
<i>Site</i>					
<i>Other</i>		Large building complex with image house, preaching hall and <i>avasage</i> .

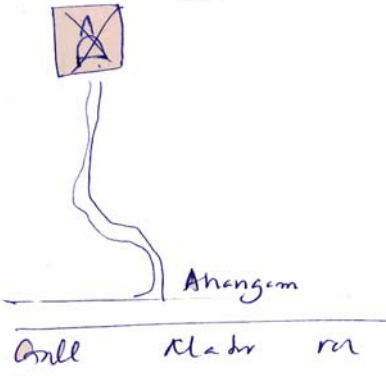
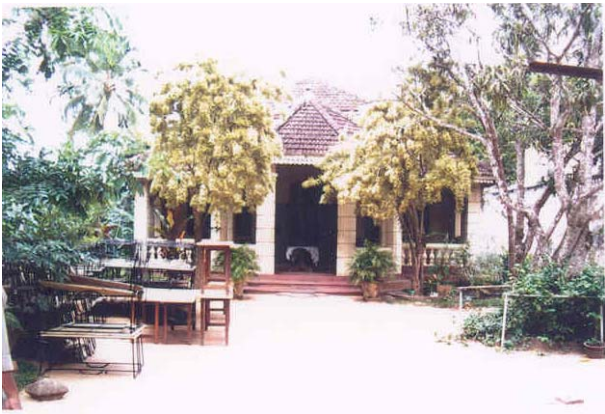
<b>Element</b>	<b>Material</b>	<b>Extent of Damage</b>		
<i>Roof</i>	Tiles	Several buildings of significant architectural value. Not affected.		
<i>Walls</i>	Masonry			
<i>Doors</i>	Timber			
<i>Windows</i>	Timber			
<i>Floor</i>	Cement			
<i>Foundation</i>				
<i>Site</i>				
<i>Other</i>

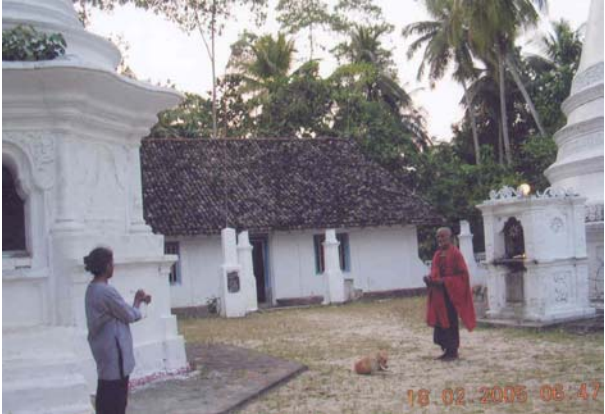
<b>Element</b>		<b>Material</b>		<b>Extent of Damage</b>	
<i>Roof</i>		Clay tiles		No damage	
<i>Walls</i>		Masonry			
<i>Doors</i>		Timber			
<i>Windows</i>		Timber			
<i>Floor</i>		Cement			
<i>Foundation</i>		Rubble			
<i>Site</i>					
<i>Other</i>

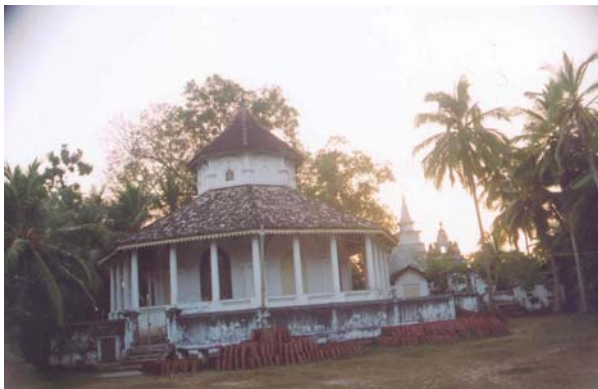
<b>Element</b>		<b>Material</b>	<b>Extent of Damage</b>	
<i>Roof</i>			No damage	
<i>Walls</i>				
<i>Doors</i>				
<i>Windows</i>				
<i>Floor</i>				
<i>Foundation</i>				
<i>Site</i>				
<i>Other</i>

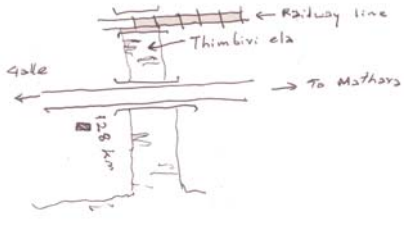
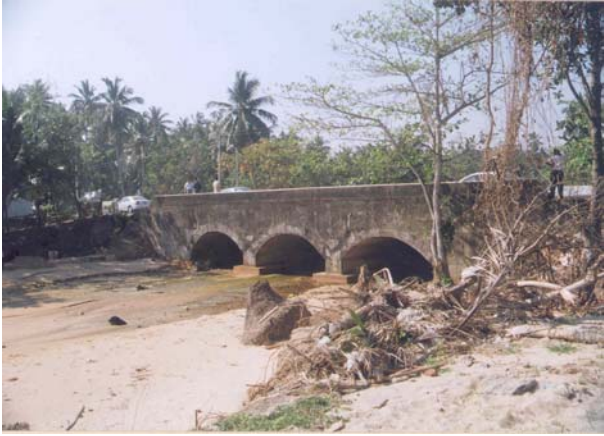
<b>Element</b>		<b>Material</b>		<b>Extent of Damage</b>	
<i>Roof</i>					
<i>Walls</i>					
<i>Doors</i>					
<i>Windows</i>					
<i>Floor</i>					
<i>Foundation</i>					
<i>Site</i>					
<i>Other Arches of the Bridge</i>		Built of brick and later with concrete. No damage.

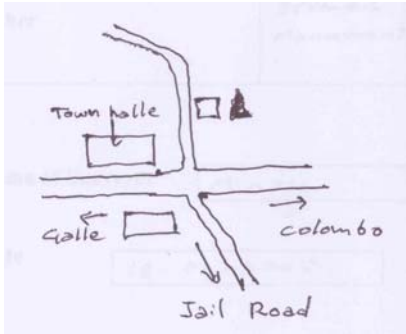
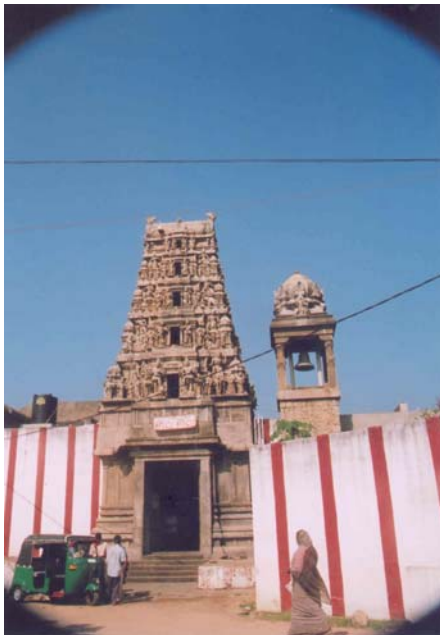
<b><i>Element</i></b>	<b><i>Material</i></b>	<b><i>Extent of Damage</i></b>		
<i>Roof</i>	Asbestos and cement	No damage		
<i>Walls</i>	Cement stone			
<i>Doors</i>	Timber			
<i>Windows</i>	Timber			
<i>Floor</i>	Cement, stone			
<i>Foundation</i>	Rubble			
<i>Site</i>	Sand			
<i>Other</i>	Stones and monuments – stone.

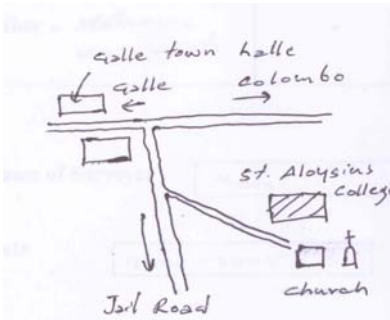
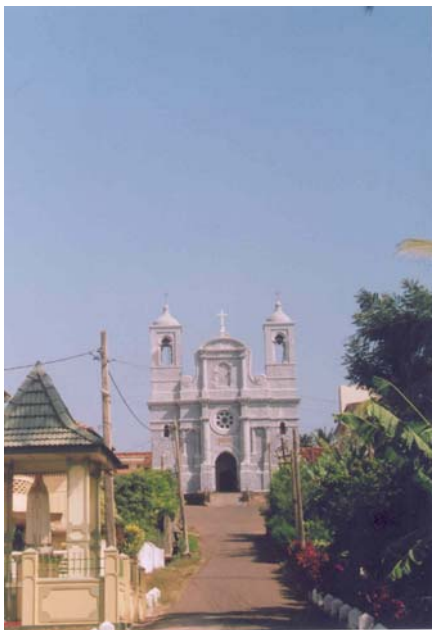
<b><i>Element</i></b>	<b><i>Material</i></b>	<b><i>Extent of Damage</i></b>		
<i>Roof</i>	Calicut tiles	No damage		
<i>Walls</i>	Rubble and brick			
<i>Doors</i>	Timber			
<i>Windows</i>	Timber			
<i>Floor</i>	Cement, stone			
<i>Foundation</i>	Unknown			
<i>Site</i>	Rubble			
<i>Other stone and monuments</i>	-

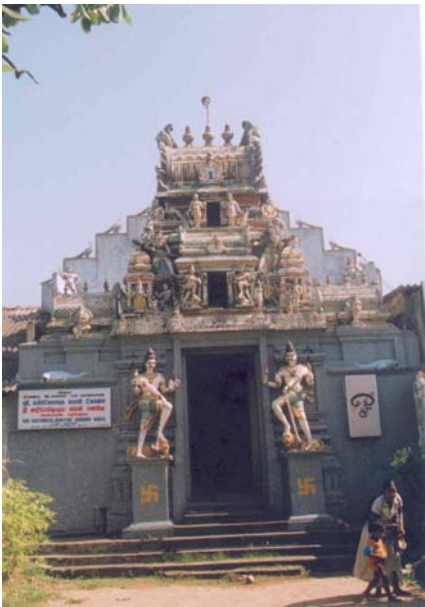
<b>Element</b>		<b>Material</b>		<b>Extent of Damage</b>	
<i>Roof</i>		Asbestos		No damage	
<i>Walls</i>		Bricks			
<i>Doors</i>		Timber			
<i>Windows</i>		Timber			
<i>Floor</i>		Cement, stone			
<i>Foundation</i>		Unknown			
<i>Site</i>		Sand			
<i>Other</i>

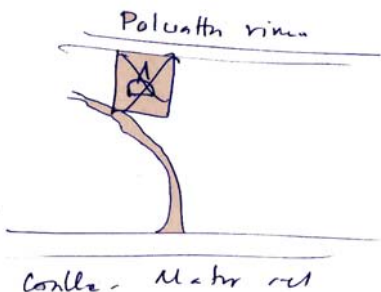
<b><i>Element</i></b>	<b><i>Material</i></b>	<b><i>Extent of Damage</i></b>		
<i>Roof</i>	Calicut tiles	100%		
<i>Walls</i>	Masonry	50%		
<i>Doors</i>	Timber	50%		
<i>Windows</i>	Timber	50%		
<i>Floor</i>	Cement			
<i>Foundation</i>				
<i>Site</i>				
<i>Other</i>	Preaching hall damaged, old <i>avasage</i> slightly damaged.

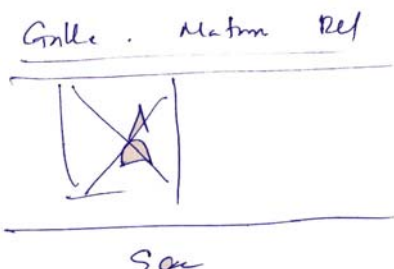
<p>Photograph of the Subadraramaya building, a traditional structure with a tiled roof and a flag.</p>		
<b>Element</b>		<b>Material</b>		<b>Extent of Damage %</b>	
				Preaching Hall	Avasage
<i>Roof</i>	Tiles		100%	50%	
<i>Walls</i>	Masonry		100%	31%	
<i>Doors</i>	Timber		100%	5%	
<i>Windows</i>	Timber		100%	50%	
<i>Floor</i>	Cement		100%	30%	
<i>Foundation</i>	Rubble		100%	-	
<i>Site</i>					
<i>Other</i>

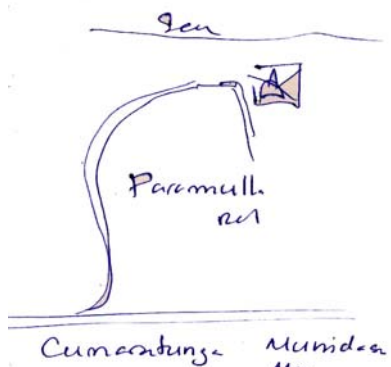
<b>Element</b>		<b>Material</b>		<b>Extent of Damage</b>	
<i>Roof</i>		Tiles		100%	
<i>Walls</i>		Brick		100%	
<i>Doors</i>		Timber		100%	
<i>Windows</i>		Timber		100%	
<i>Floor</i>		Cement		100%	
<i>Foundation</i>		Rubble		100%	
<i>Site</i>					
<i>Other</i>		The monument on the island is partially damaged.

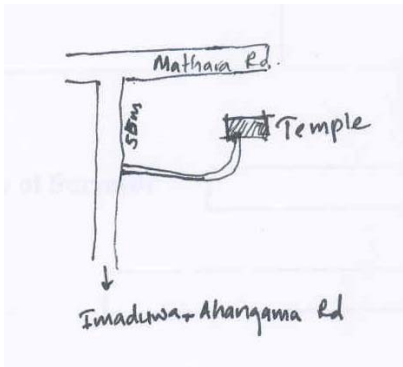
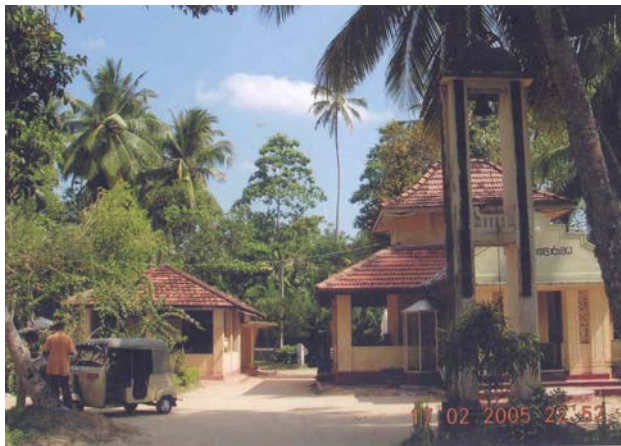
<b>Element</b>		<b>Material</b>		<b>Extent of Damage</b>	
<i>Roof</i>	Tiles		No damage		
<i>Walls</i>	Masonry				
<i>Doors</i>	Timber				
<i>Windows</i>	Timber				
<i>Floor</i>	Cement				
<i>Foundation</i>					
<i>Site</i>					
<i>Other</i>

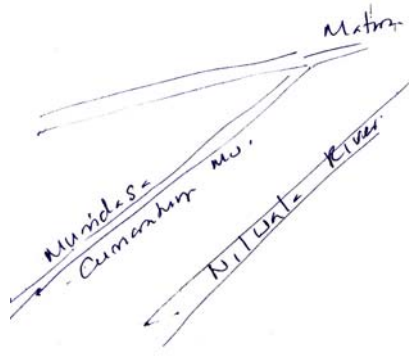
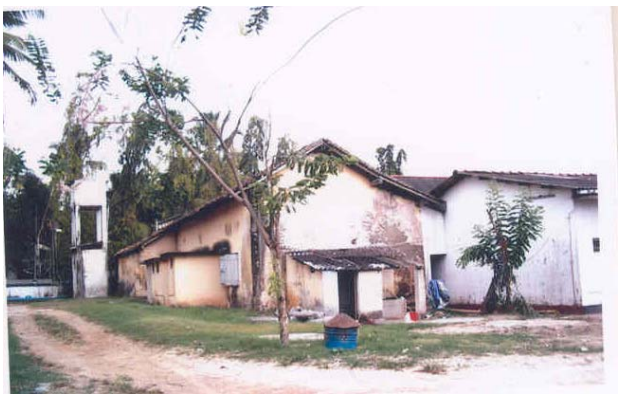
<b>Element</b>		<b>Material</b>		<b>Extent of Damage</b>	
<i>Roof</i>		Half round Tiles			
<i>Walls</i>		Caboock		No significant damage.	
<i>Doors</i>		Timber		Flooded due to close proximity to river (about 2'.0").	
<i>Windows</i>		Timber			
<i>Floor</i>		Cement/terracotta			
<i>Foundation</i>		Rubble			
<i>Site</i>					
<i>Other</i>

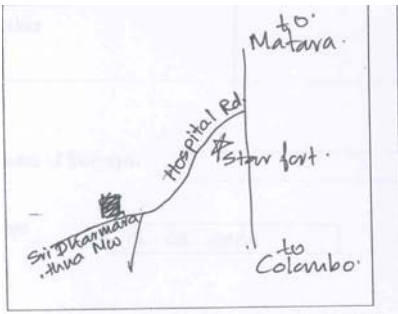
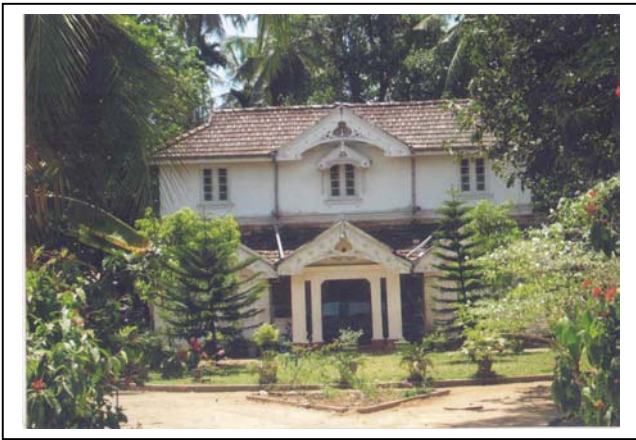
<b>Element</b>	<b>Material</b>	<b>Extent of Damage</b>		
<i>Roof</i>	Tiles	No damage		
<i>Walls</i>	Masonry			
<i>Doors</i>	Timber			
<i>Windows</i>	Timber			
<i>Floor</i>	Cement			
<i>Foundation</i>				
<i>Site</i>				
<i>Other</i>

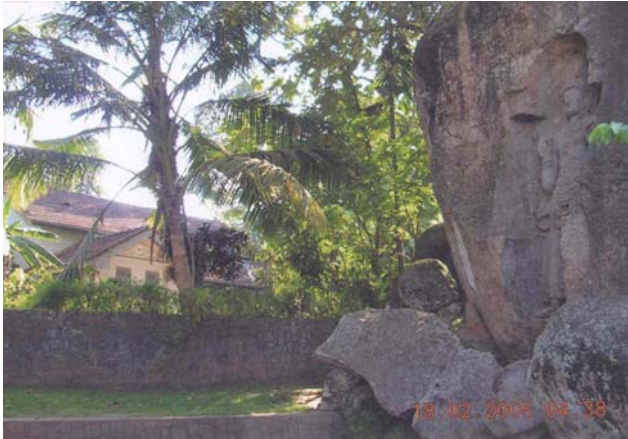
<b><i>Element</i></b>		<b><i>Material</i></b>		<b><i>Extent of Damage</i></b>	
<i>Roof</i>				No damage	
<i>Walls</i>					
<i>Doors</i>					
<i>Windows</i>					
<i>Floor</i>					
<i>Foundation</i>					
<i>Site</i>					
<i>Other</i>

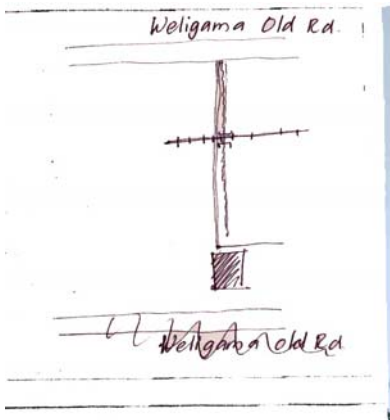
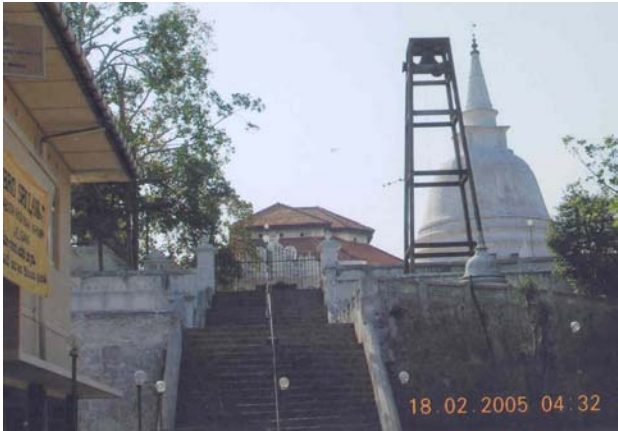
<b>Element</b>		<b>Material</b>		<b>Extent of Damage</b>	
<i>Roof</i>	Tile		No damage		
<i>Walls</i>	Masonry				
<i>Doors</i>	Timber				
<i>Windows</i>	Timber				
<i>Floor</i>	Cement				
<i>Foundation</i>					
<i>Site</i>					
<i>Other</i>

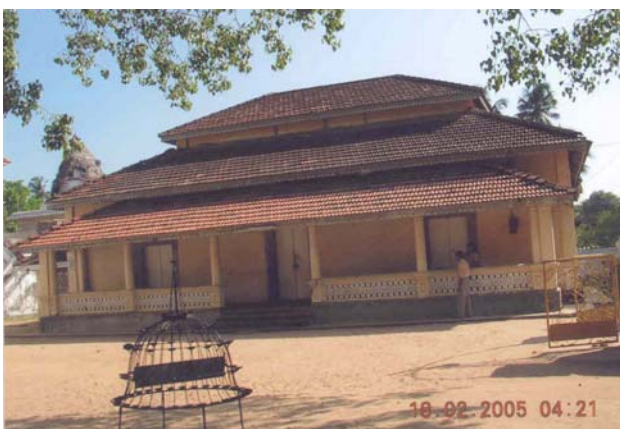
<b>Element</b>	<b>Material</b>	<b>Extent of Damage</b>		
<i>Roof</i>	Tile	No damage		
<i>Walls</i>	Masonry			
<i>Doors</i>	Timber			
<i>Windows</i>	Timber			
<i>Floor</i>	Cement			
<i>Foundation</i>				
<i>Site</i>				
<i>Other</i>

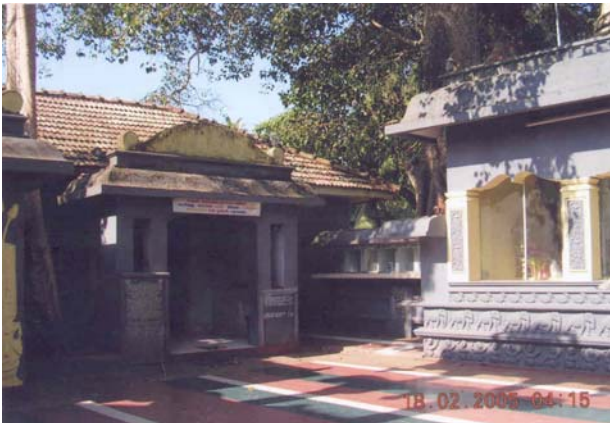
<b>Element</b>		<b>Material</b>		<b>Extent of Damage</b>	
<i>Roof</i>		Tiles		No damage	
<i>Walls</i>		Masonry			
<i>Doors</i>		Timber			
<i>Windows</i>		Timber			
<i>Floor</i>		Cement			
<i>Foundation</i>					
<i>Site</i>					
<i>Other</i>

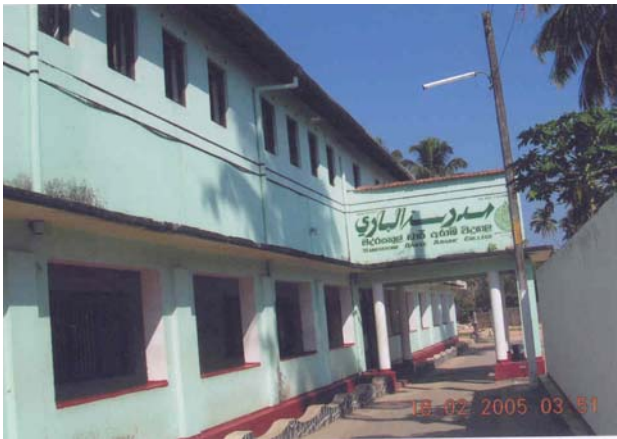
<b>Element</b>		<b>Material</b>		<b>Extent of Damage</b>	
<i>Roof</i>	Tile		No damage		
<i>Walls</i>	Masonry				
<i>Doors</i>	Timber				
<i>Windows</i>	Timber				
<i>Floor</i>	Cement				
<i>Foundation</i>					
<i>Site</i>					
<i>Other</i>

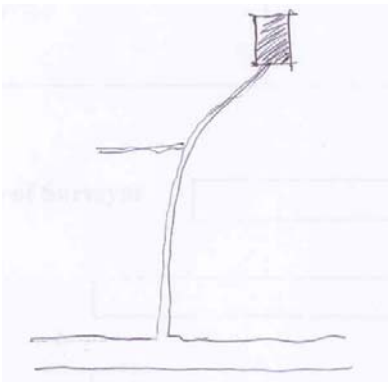
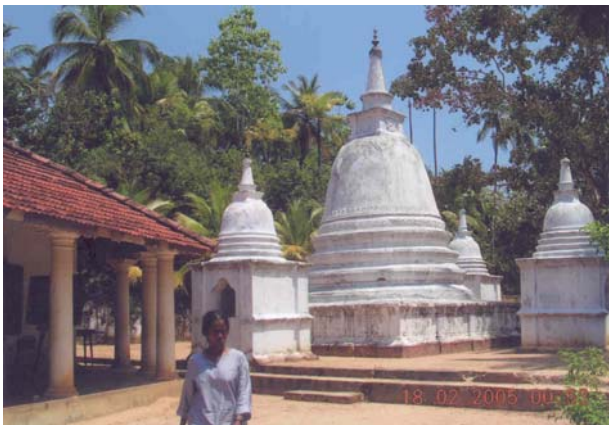
<b><i>Element</i></b>		<b><i>Material</i></b>		<b><i>Extent of Damage</i></b>	
<i>Roof</i>		Tile		No damage	
<i>Walls</i>		Masonry			
<i>Doors</i>		Timber			
<i>Windows</i>		Timber			
<i>Floor</i>		Cement			
<i>Foundation</i>					
<i>Site</i>					
<i>Other</i>

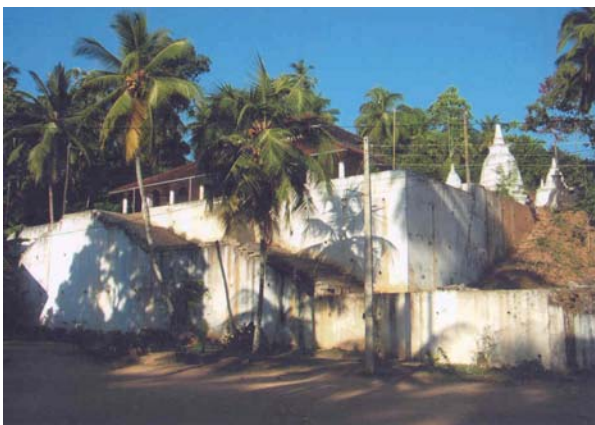
<b><i>Element</i></b>		<b><i>Material</i></b>		<b><i>Extent of Damage</i></b>	
<i>Roof</i>		Tiles		No damage	
<i>Walls</i>		Masonry			
<i>Doors</i>		Timber			
<i>Windows</i>		Timber			
<i>Floor</i>		Cement			
<i>Foundation</i>					
<i>Site</i>					
<i>Other</i>		Functioning as a refuge camp.

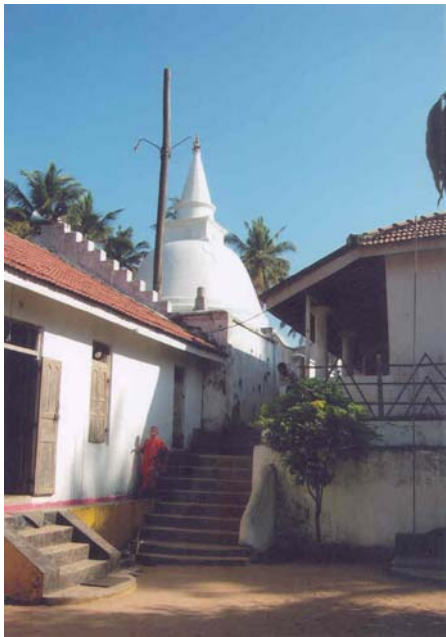
<b><i>Element</i></b>		<b><i>Material</i></b>		<b><i>Extent of Damage</i></b>	
<i>Roof</i>		Tiles			
<i>Walls</i>		Masonry			
<i>Doors</i>		Timber			
<i>Windows</i>		Timber		No damage	
<i>Floor</i>		Cement			
<i>Foundation</i>					
<i>Site</i>					
<i>Other</i>		Damaged due to functioning as a refugee camp after the tsunami.

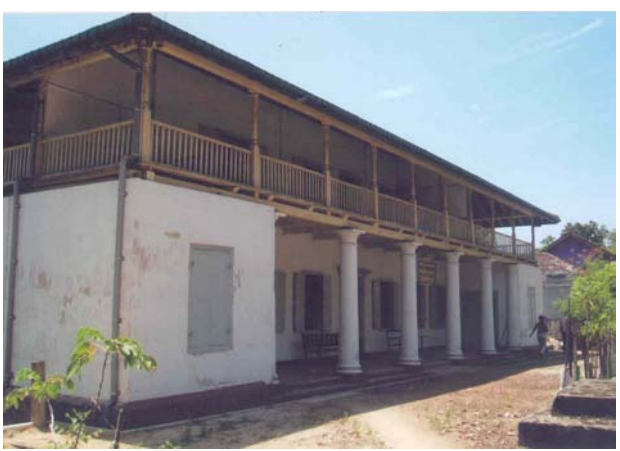
<b>Element</b>		<b>Material</b>		<b>Extent of Damage</b>	
<i>Roof</i>		Tiles		No damage	
<i>Walls</i>		Masonry			
<i>Doors</i>		Timber			
<i>Windows</i>		Timber			
<i>Floor</i>		Cement			
<i>Foundation</i>					
<i>Site</i>					
<i>Other</i>		Water came up to 1'.0" of the building site.

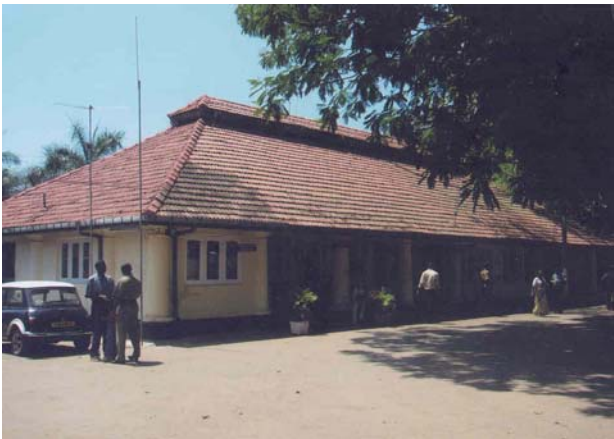
<b><i>Element</i></b>	<b><i>Material</i></b>	<b><i>Extent of Damage</i></b>		
<i>Roof</i>	Timber	No damage		
<i>Walls</i>	Masonry			
<i>Doors</i>	Timber			
<i>Windows</i>	Timber			
<i>Floor</i>	Cement			
<i>Foundation</i>				
<i>Site</i>				
<i>Other</i>	2'0" mud layer deposited at the site after the tsunami.
