## Renders and Materials of Fired Clay other than Brick

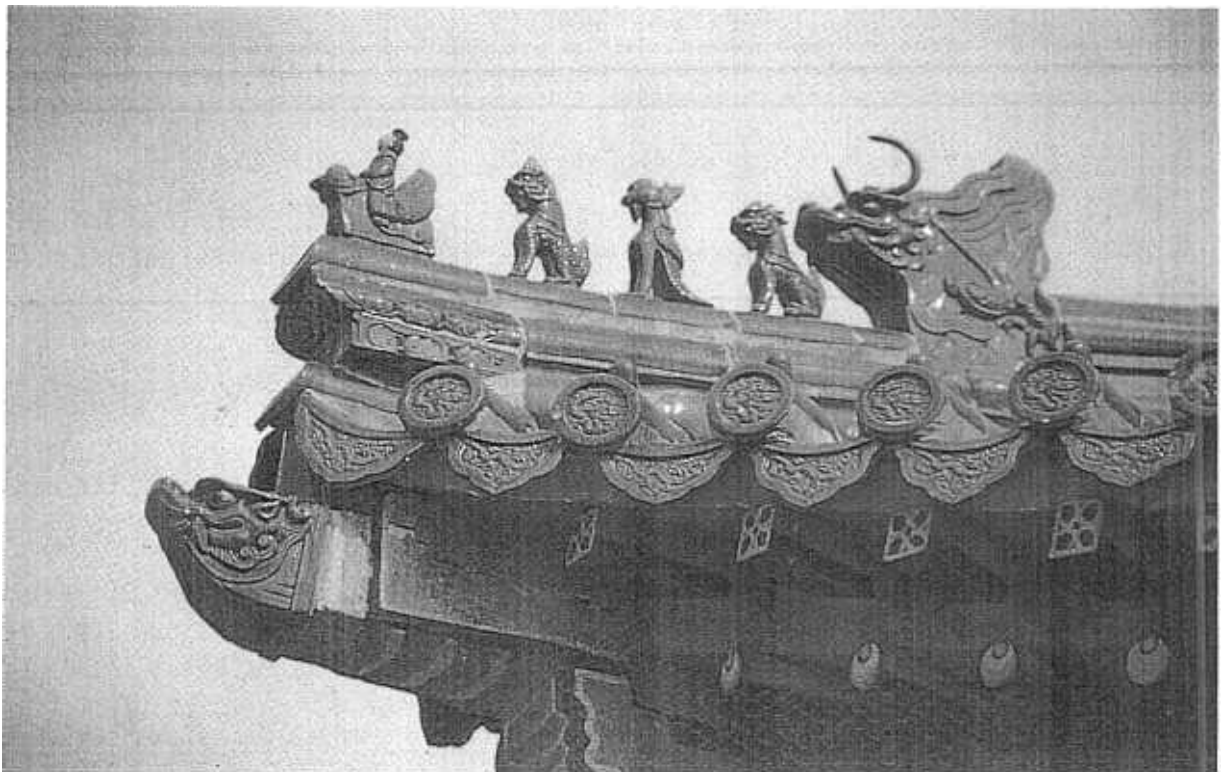
*Decorative glazed roof tiles. (Beijing, China).*

Some roof tiles have become elaborate decorative artefacts in their

own right. Tiles have been glazed and coloured to add sparkle and splendour to buildings. The addition of a glazed surface poses further problems of successful manufacture and the fate of much glazed tiling has been the loss of surface due to the different density as between the body of the tile and the glazed surface. In many cases standards of manufacture have not been the equivalent of the complementary techniques of pottery. Levels of exposure to which such tiles are subject and longevity running into centuries means that their ultimate fate is loss of surface. Although epoxy resin techniques are available for the permanent restoration of tiles in these circumstances, replacement with the equivalent manufactured item is the conservator's normal response. Glazed tilework has been particularly popular throughout the Mediterranean, the Islamic world and in China where the modelling of key pieces such as finials, ridge tiles and terminations has taken on its most elaborate and exciting forms. Dragons, birds, beasts, demons and other mythical creatures, products of the potters art, have been set as finials, ridge pieces, hip terminals and simply as modelled upstanding tiles. In the case of such elaborate pieces the proper answer is the replacement of damaged and worn originals by facsimiles made using the same techniques and materials as originally. A particularly significant original can be repaired using synthetic epoxy resins but its durability will be less than that of the original and inadequate to prolonged exposure and it is best retained as a museum piece.

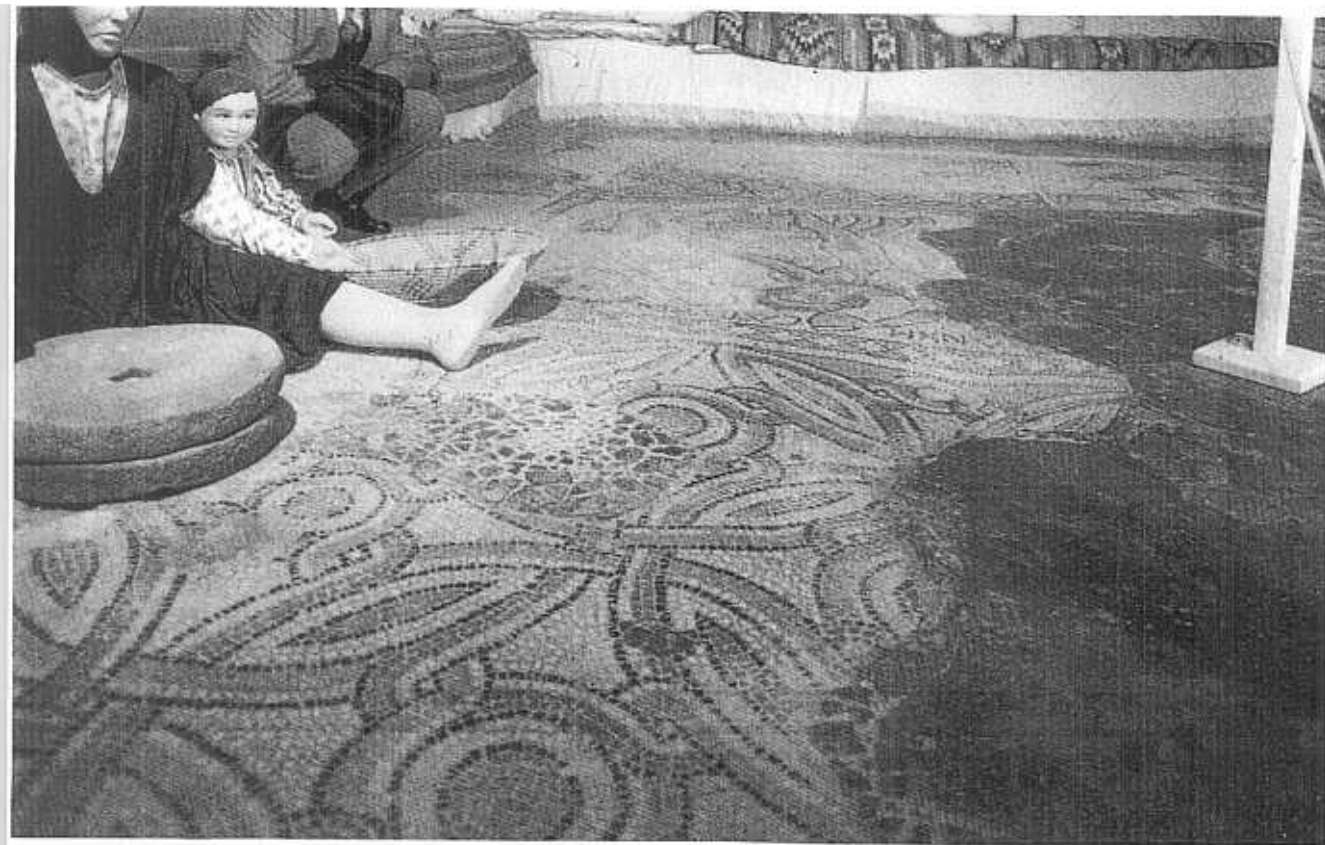
*Terracotta in damaged Roman mosaic flooring. (Jordan).*

Mosaic workers have long used tesserae of terracotta in their work. In Roman mosaics these survive mainly on floors and on walls and vaults of the Byzantine period. The technique is found also in periods of stylistic revival. Repair techniques can vary from the removal of the entire mosaic surface where its background or substrate is insecure or decaying to the replacement of individual tesserae when each new piece is cut to the shape of the missing original as shown by the imprint on the background. Tesserae are secured in place with synthetic adhesives or desirably with a mortar compatible with the original.
