The cleaning and treatment of limestone by the 'lime method'. Part I

JOHN ASHURST*

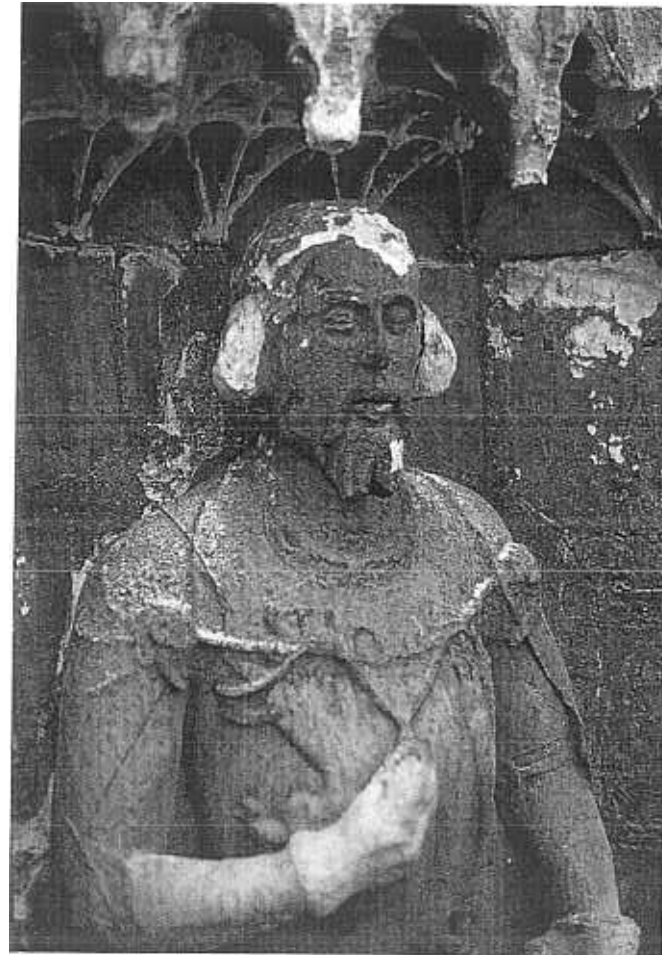
FIG. 1. The Percy statue, Beverley Minster, showing typical sulphation damage and cement repairs. This is one of the few magnesian limestone subjects which has now been treated by the 'lime method'.

In England, the west fronts of Wells and Exeter cathedrals and the ruined west front of Crowland abbey have undergone interesting transformations over the past few years. Heavily soiled, badly repaired limestone sculpture, valuable surfaces fragile with spalling sulphate skins, have been pulled back, in some cases, from the apparent brink of destruction. The dirt and all the wreckage of iron, copper and cement associated with past remedial work has gone. Some observers see a new warmth, clarity and stability in these facades; others see an unnatural uniformity, a blurring of detail and an uncertain future. These façades, and others less well known, have been cleaned, repaired and consolidated using techniques generally summarised together as the 'lime method' (Fig. 1).

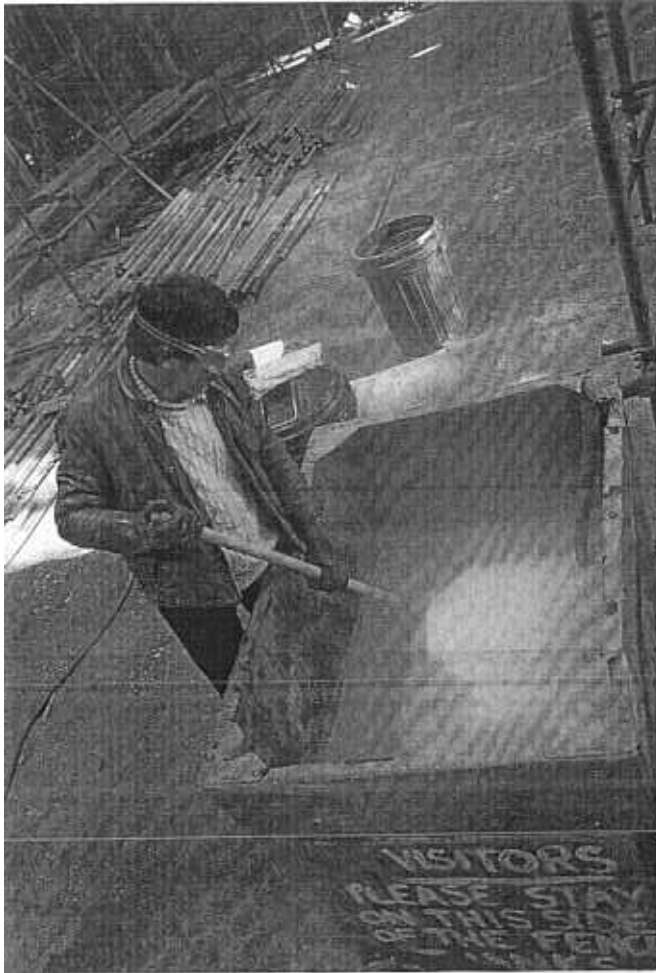
FIG. 3. The slaking tank. Lime slaked in the traditional way is the basic raw material for much of the lime method activity.

The traditional method of cleaning associated with the lime method is by hot lime poultice. In the early days of experiment at Wells, the lime was slaked against the surface of the stone (*Figs 3, 4*). Hot lime is still in use, but is now applied by gloved hand and trowel, pressing the putty well

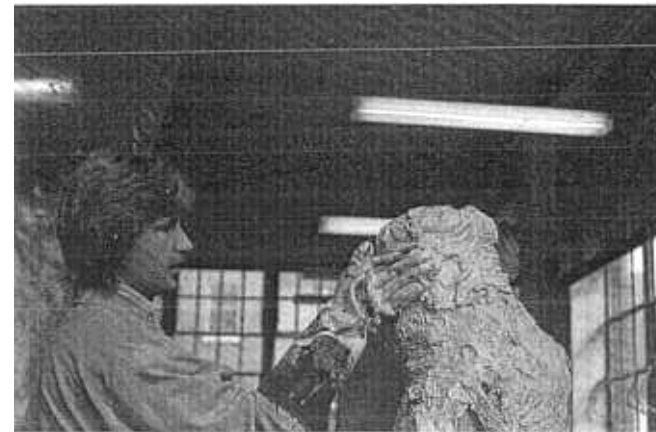
Ho after screening, is applied carefully to a piece of sculpture. Scrim bandages are included to assist adhesion and hold moisture. It is essential that the poultice does not dry out.

into the surface of the pre-wetted stone. When a thick plaster has been applied, it is bound with scrim and wet sacking or underfelt secured with string (Fig. 5). Finally, a heavy duty polythene sheet is tied loosely in position. From time to time, over a period of two to three weeks, the polythene will be lifted and the felt/sacking surface sprayed with water to ensure that the poultice remains damp and soft. It is essential that no drying out occurs which would render the lime useless as a poultice, or bind it to the surface of the stone.

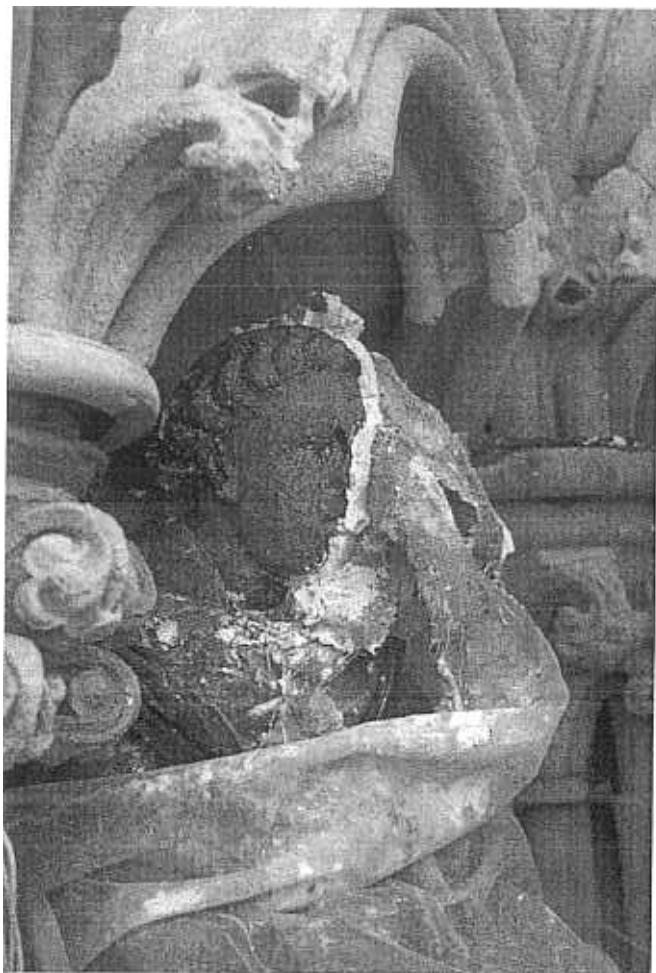
FIG. 6. The shrouds, wet bandages and lime poultice being removed from a figure at Wells. Some of the dirt detaches with the pack, and what remains will usually be more responsive than before to gentle scrubbing.

When the packaging is finally removed, the lime is carefully lifted off in small areas at a time with spatulas or small trowels, taking with it some of the dirt from the contact surface (Fig. 6). Water sprays are used to assist in the removal of the lime and to further soften the dirt. In common with most other poultices, not very much dirt actually detaches with the poultice material; the softened deposit must be worked at with hand sprays, dental picks and small toothbrushes or stencil brushes, to achieve a clean, or relatively clean, surface. In the past, some areas were scraped down, but this practice no longer continues. The scrubbing stage is long and laborious; added to perhaps three weeks of poulticing, the cleaning of

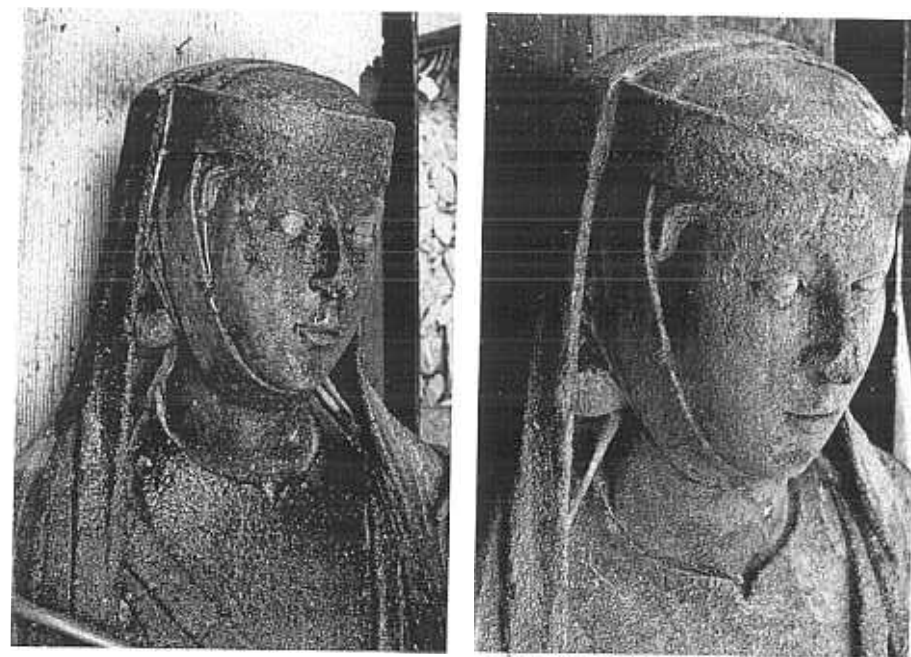
FIGS 7, 8. Before and after effect of cleaning the head of a queen at Wells with lime poultice and water. Cleaning must be followed by consolidation and protection. At this stage the detail is very vulnerable to damage.

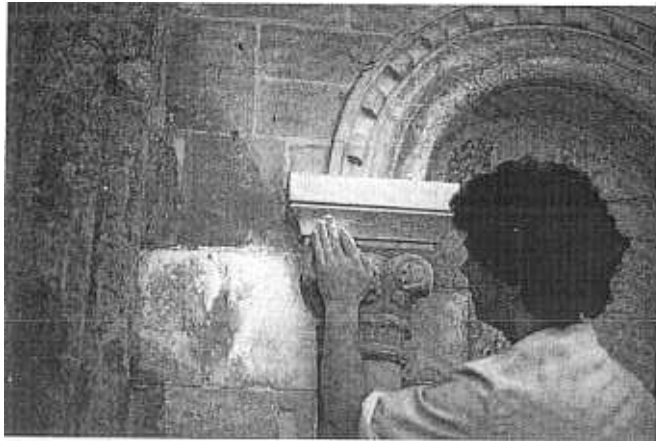
FIG. 12. Architectural detail at Christchurch Priory is shelter-coated after cleaning. The thin lime casein coat has been applied by brush and is being rubbed in by hand, using a small pad of coarse cloth.
